CITY OF ALBUQUERQUE

Site: La Cuentista Unit 2 (D10E002B)

Re: Inspection 8/19/2021 & 8/26/2021

The purpose of this inspection report is to update the status of Double M Properties' site with NPDES permit coverage under NMR1000HM. The site consists of all the lots and HOA tracts in La Cuentista Unit 2 and a portion of a large HOA tract owned by Unit 1 where the pond was deepened and the side slopes flattened. Additional Land disturbing activity is located east of Tract 11 Unit 2 on an additional portion of the Unit 1 HOA's property.

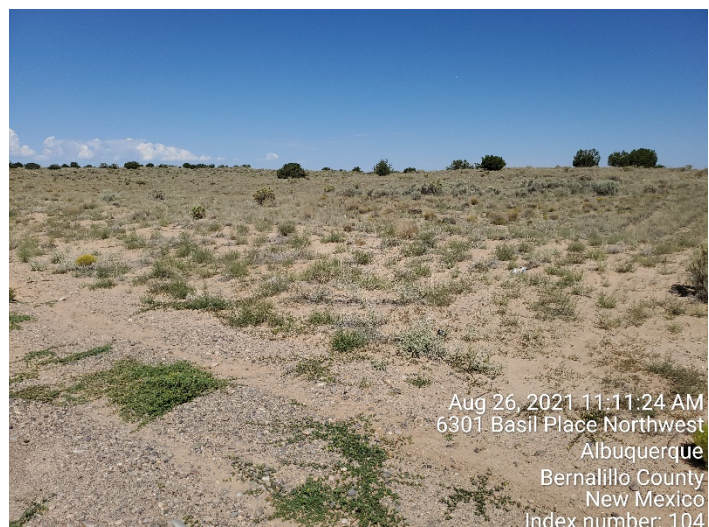
The natural ground cover density was determined by sampling 34 points along a 100’ long transect located 300’ west of Unit 2.

Dirt	22 points=64.7%
Rock	2 points= 5.9%
Litter	2 points= 5.9%
Sage brush	4 points=11.8%
Grass	3 points= 8.8%
Total	34 points=100%

Counting live perennial vegetation only the natural density of ground cover is 20.6%.

Adding rocks and litter the natural density of ground cover is 32.4%. The minimum replacement density is (70% of the natural density) 14% and 23% to satisfy the strict and loose interpretations of 2.2.14b.i respectively.

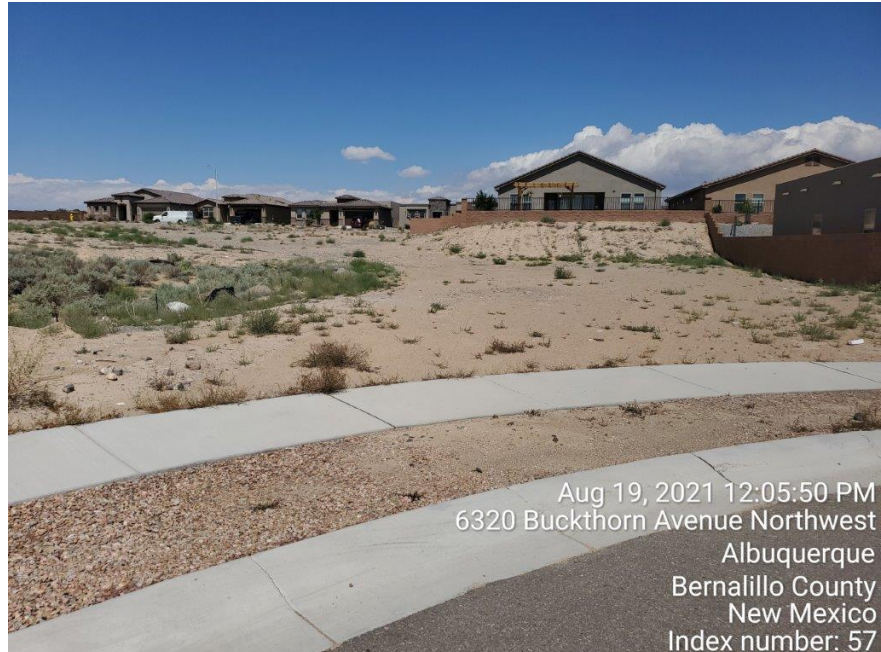
Tracts 1 and 2 of Unit 2 are adjacent to the Unit 1 HOA tract. The picture of Tract 1 below shows Tract 11 in the left background and remnants of a silt fence south of Tract 1 also on the left that should be removed. Tract 1 doesn't have any significant perennial vegetation or any rock cover. It is bare dirt. The 3:1 slope at the back of the tract has no significant cover and is eroding.

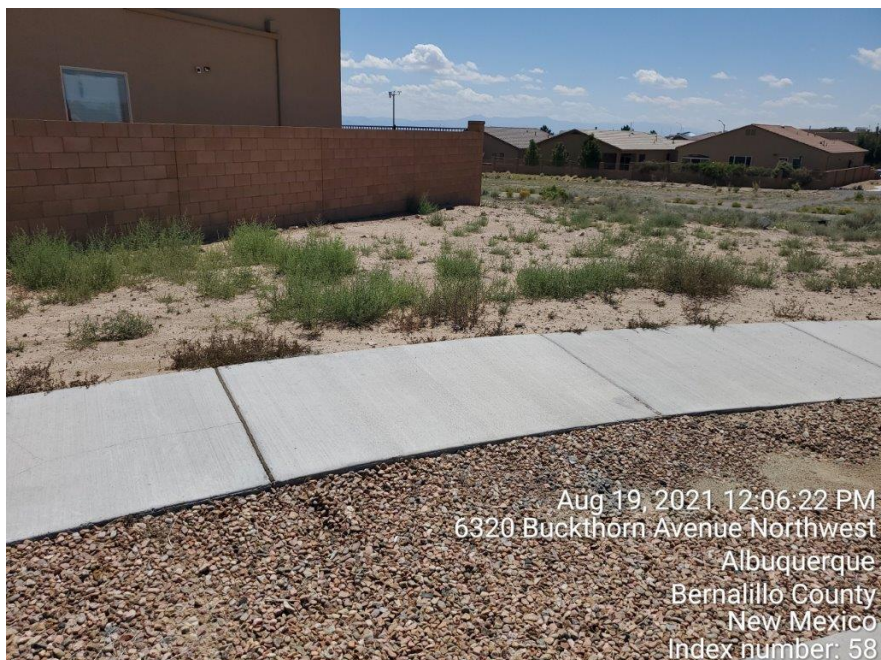
Tract 2

Similarly tract 2 has a few more rocks than Tract 1 but it is mostly bare dirt and tumble weeds satisfying neither the vegetation nor the rock criteria of CGP 2.2.14.b.

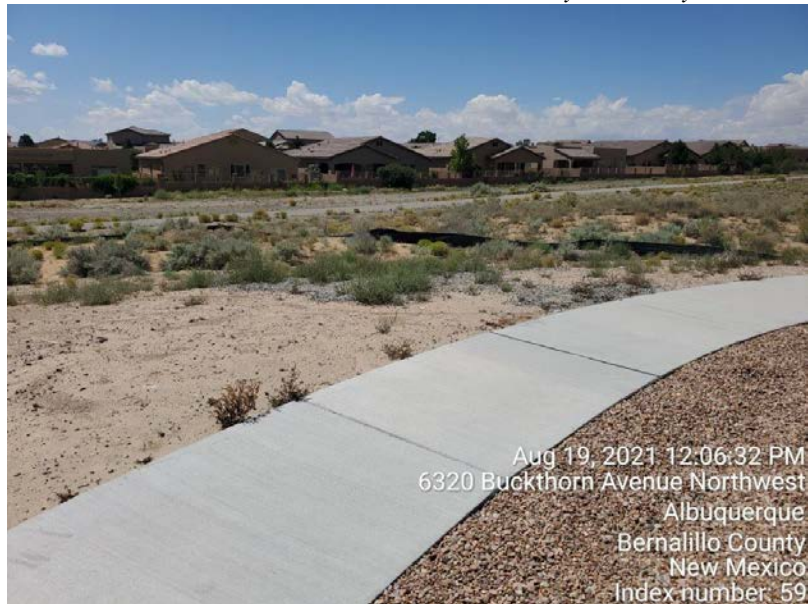
The silt fence south of Tract 2 (in the background of the photo to the right), is supposed to be removed after the disturbed area is stabilized.

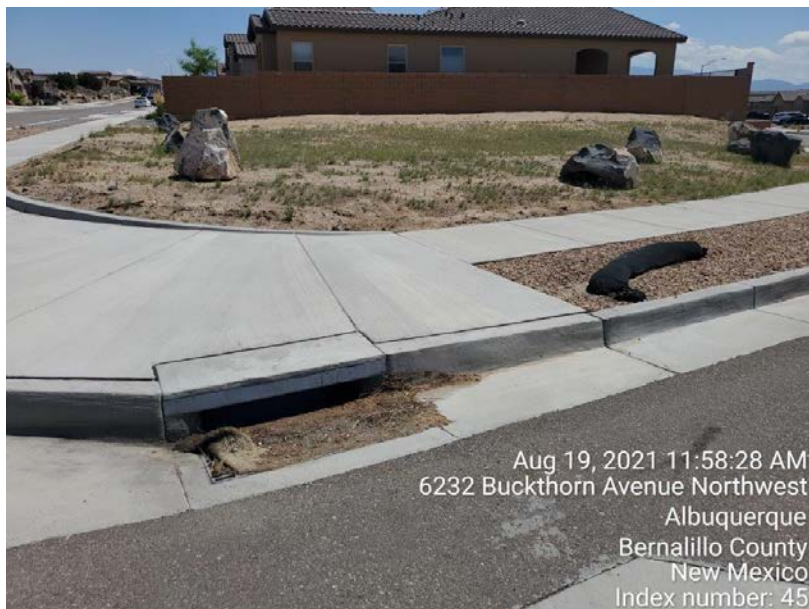
Twenty points were sampled from a single representative plot in Tract 3.

Dirt	6 points= 30%
Rock	0 points= 0%
Litter	10 points= 50%
Sage brush	1 points= 5%
<u>Grass</u>	<u>3 points= 15%</u>
Total	20 points=100%

Tract 3 satisfies both the strict and the loose interpretations of 2.2.14.b.i with 20% perennial vegetation, and 70% ground cover including the litter respectively.

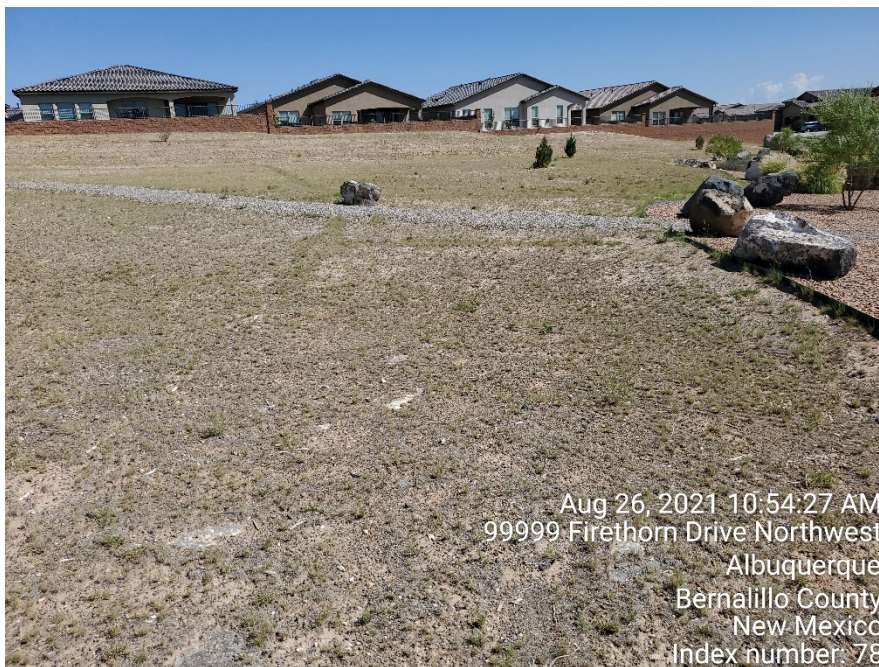
Tract 4 (mid)

Twenty points were sampled from two plots in Tract 4. One in the middle of the tract had these results.

Dirt	9 points= 45%
Rock	2 points= 10%
Litter	8 points= 40%
Sage brush	0 points= 0%
<u>Grass</u>	<u>1 points= 5%</u>
Total	20 points=100%

The middle plot in Tract 4 fails to satisfy the strict

interpretation of 2.2.14.b.i with only 5% perennial vegetation, but satisfies the loose interpretation with 55% ground cover including the rocks and

litter. About half of the litter appears to be a thin fibrous cover of remnant hydromulch and/or dead grass. The 2 points that were counted as rock did not meet the 3/4" minimum rock size but they were counted as rock because a cluster of small pebbles formed a shape that exceeded 3/4" in size. If the thin cover of the 4 litter points and the 2 clusters of small pebbles is counted as dirt the cover on this tract still exceeds the 23% needed to satisfy the loose interpretation of the final stabilization criteria 2.2.14.b.i.

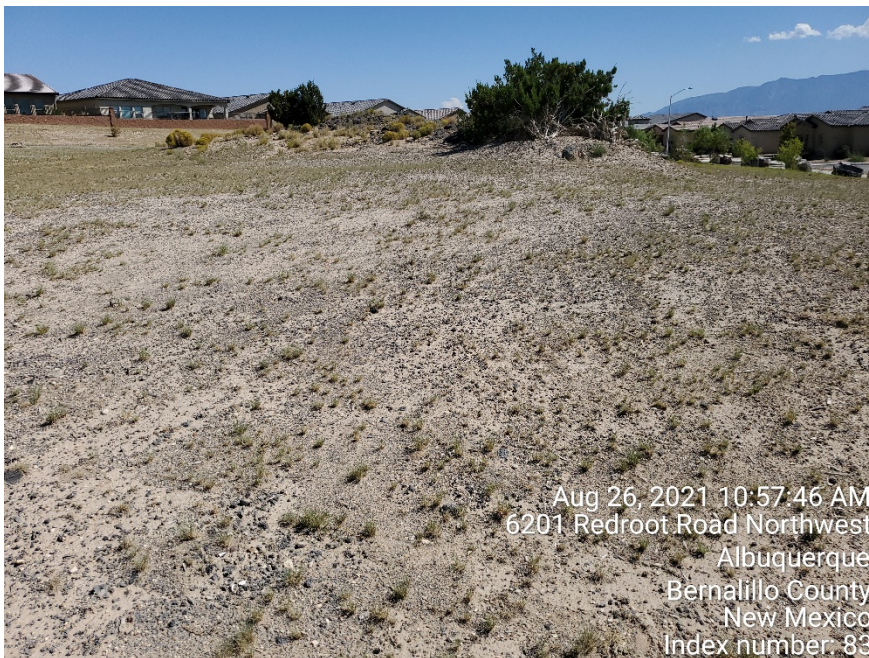
Tract 4 (east)

The plot on the east half of Tract 4 had these results.

Dirt	16 points= 80%
Rock	3 points= 15%
Litter	0 points= 0%
Sage brush	0 points= 0%
<u>Grass</u>	<u>1 points= 5%</u>
Total	20 points=100%

The east plot in Tract 4 fails to satisfy both the strict and the loose interpretations of 2.2.14.b.i with only 5% perennial vegetation, and 20% ground cover including rocks and litter respectively. The thin layer of tiny pebbles doesn't

compare to the 3/4" minimum thickness of aggregate mulch in Spec 1012.2.3.4 or other naturally

occurring rock cover in this vicinity of the desert. There weren't any thick clusters of pebbles like the middle plot above.

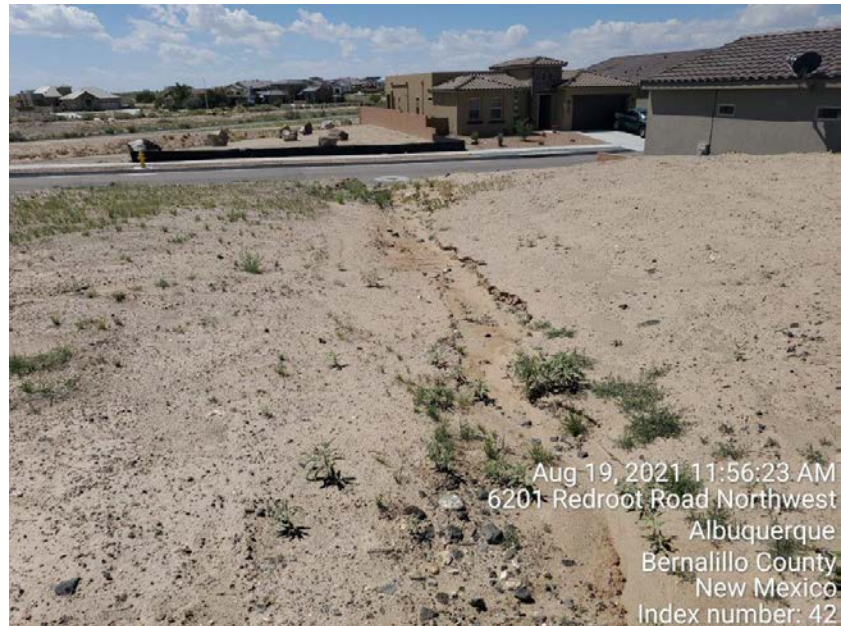
Tract 4 has at least one concentrated flow path that is highly erosive and should be stabilized, and there are several large bare spots as shown in the picture to the right.

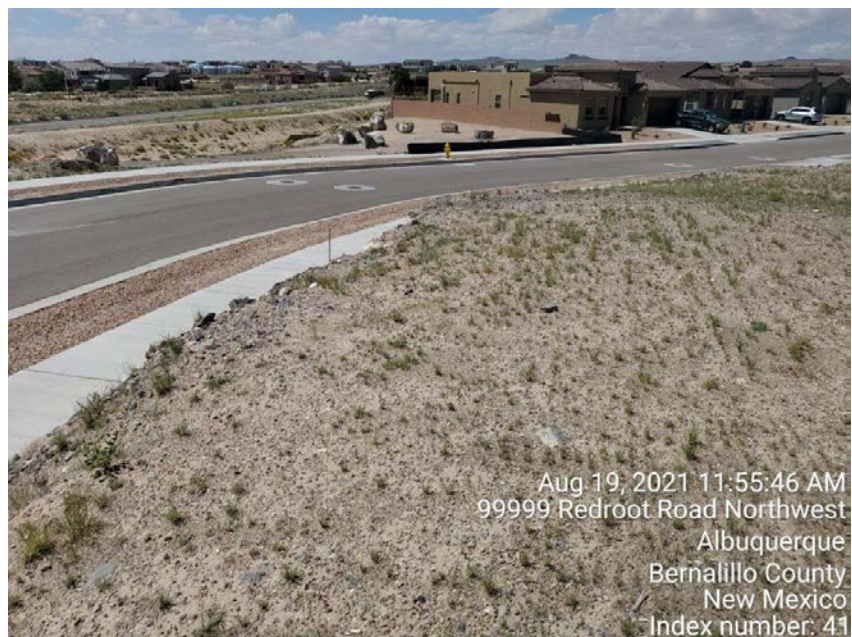
The west side of Tract 5 is in the background of both these photos.

Tract 4 in the foreground has been seeded last year and is irrigated resulting in sparse emergent grass.

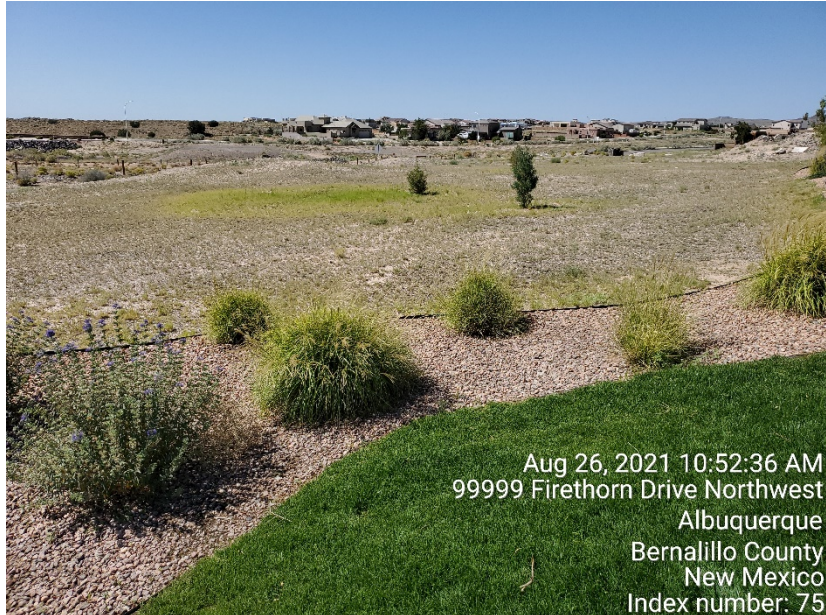
Tract 5 (east)

The far east side of Tract 5 has 100 % density cover with sod and gravel on filter fabric near the entrance off of Kimmick. West of that is an area that has been seeded and mulched and watered some. There is a green patch in the middle of that area that gets more water that has 45% perennial vegetation and 65% ground cover including the litter. The plot in the area with less water had these results.

Dirt	7 points= 35%
Rock	0 points= 0%
Litter	7 points= 35%
Sage brush	0 points= 0%
<u>Grass</u>	<u>6 points= 30%</u>
Total	20

The east plot in the area with less water in Tract 5 satisfies both the strict and the loose interpretations of 2.2.14.b.i with 30% perennial vegetation, and 65% ground cover including rocks and litter respectively.

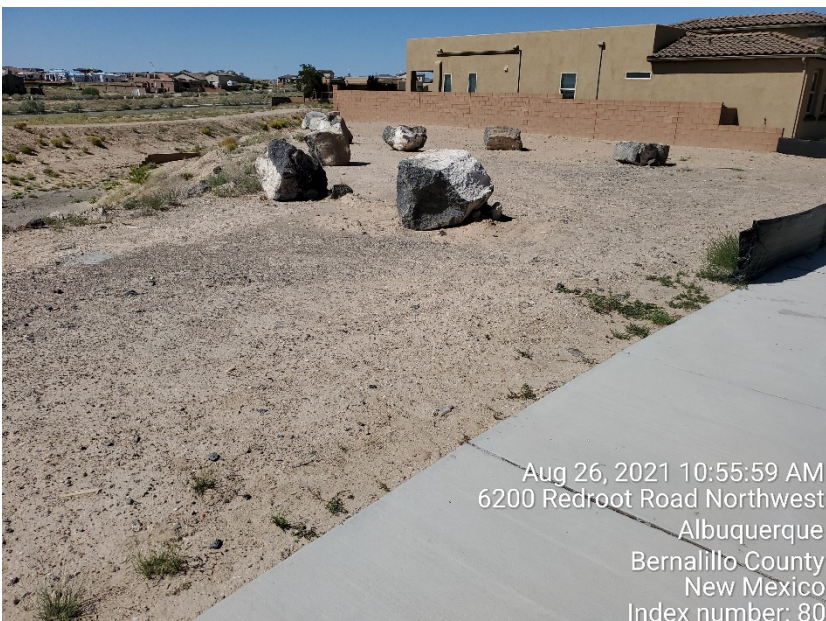
Tract 5 (west)

Has several large boulders on dirt with no measurable ground cover of any kind (<5%).

There is a small patch of concrete washout in the lower left corner of the picture and silt fence on the right side that is holding up well and should remain to prevent sediment from getting into the street until the area is stabilized.

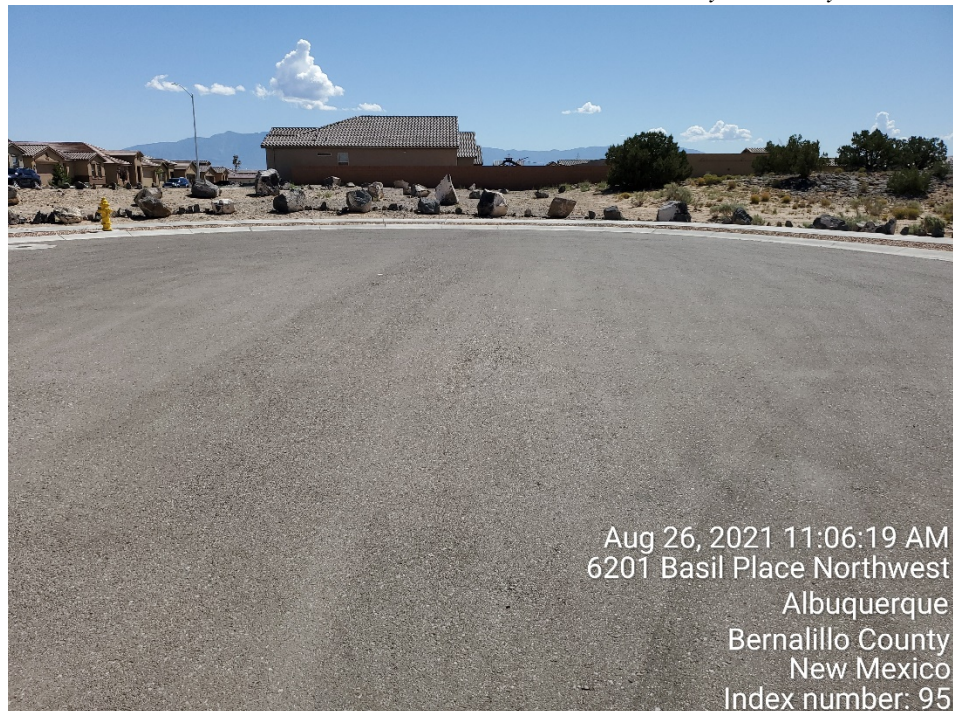
Tract 9 (West)

Boulder City has about 5% rock cover which doesn't satisfy any part of 2.2.14.b.

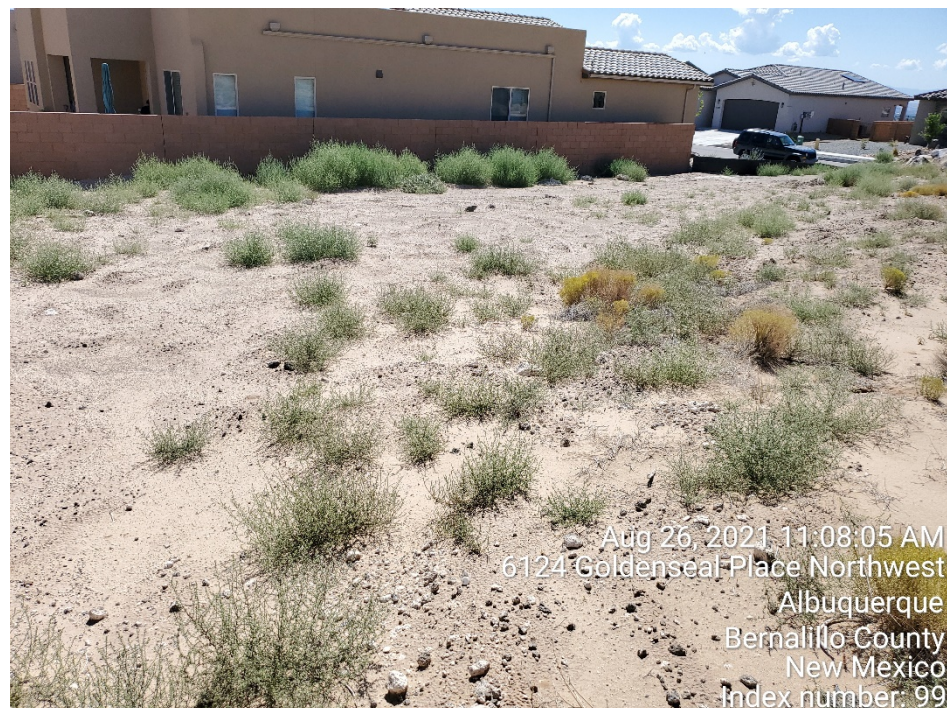
Tract 9 (North)

The north side of the arch site has a few tumble weeds and less than 5% rock cover so it doesn't satisfy the Final Stabilization Criteria in 2.2.14.b.

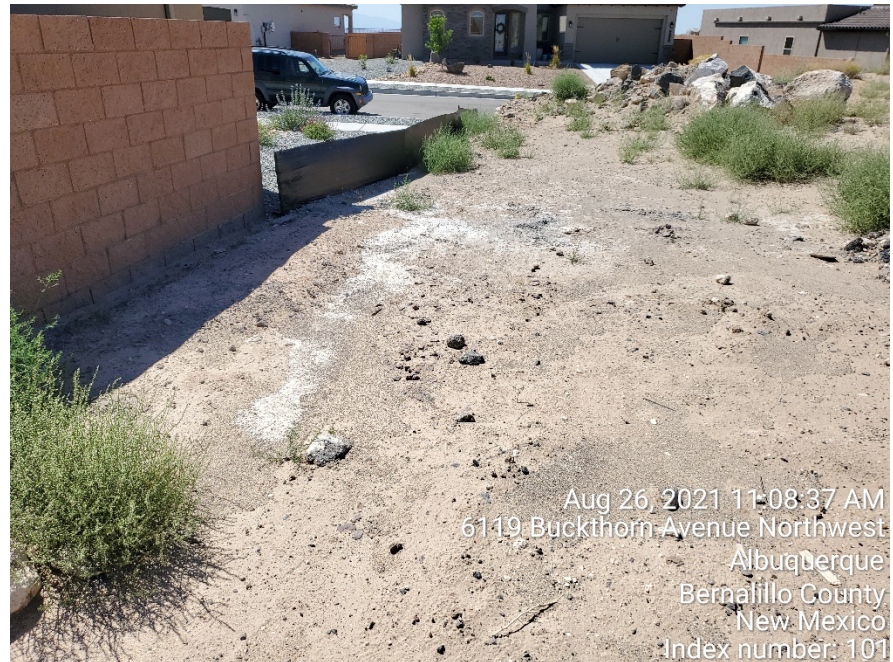
Tract 9 north also has concrete washout and a silt fence that is needed to keep the sediment from the north part of Tract 9 out of one of the resident's front yard landscaping.

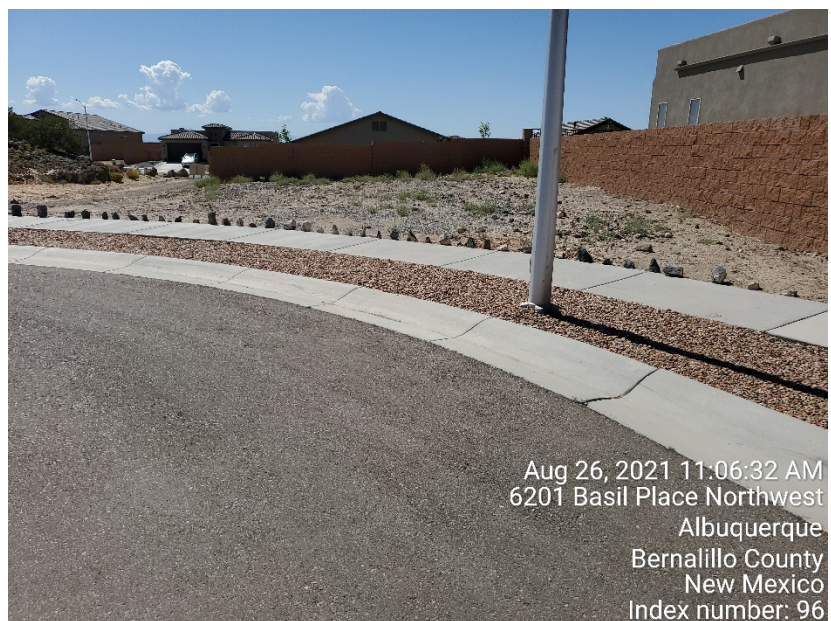
Tract 9 (southeast)

The plot in the southeast area had these results.

Dirt	13 points= 65%
Rock	7 points= 35%
Litter	0 points= 0%
Sage brush	0 points= 0%
Grass	0 points= 0%
Total	20 points=100%

The strict interpretations of 2.2.14.b.i is not satisfied because the only vegetation is annual tumble weeds with 0% perennial vegetation. However the 35% rock cover satisfies the loose interpretation.

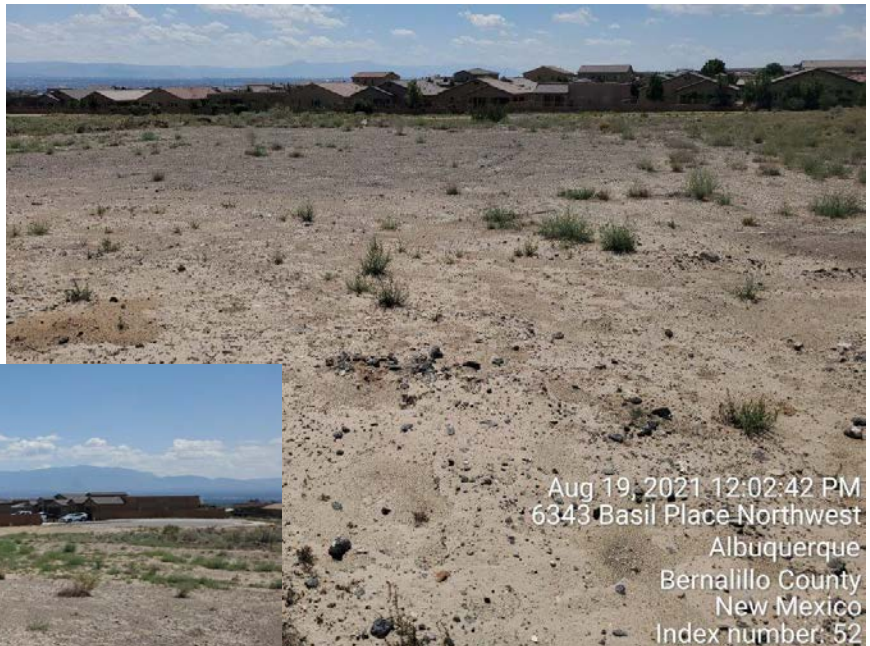
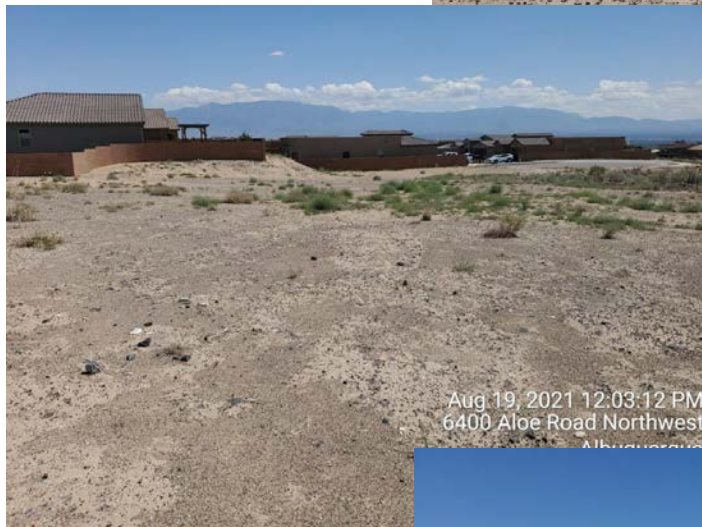
Tract 11 and the portion of Unit 1 HOA next to tract 11

On Tract 11, 20 points were sampled in a single representative plot with 0% perennial vegetation, 0% rock, and 0% litter. The tract has some sand and pebbles and some tumble weeds that are not included using this measurement method.

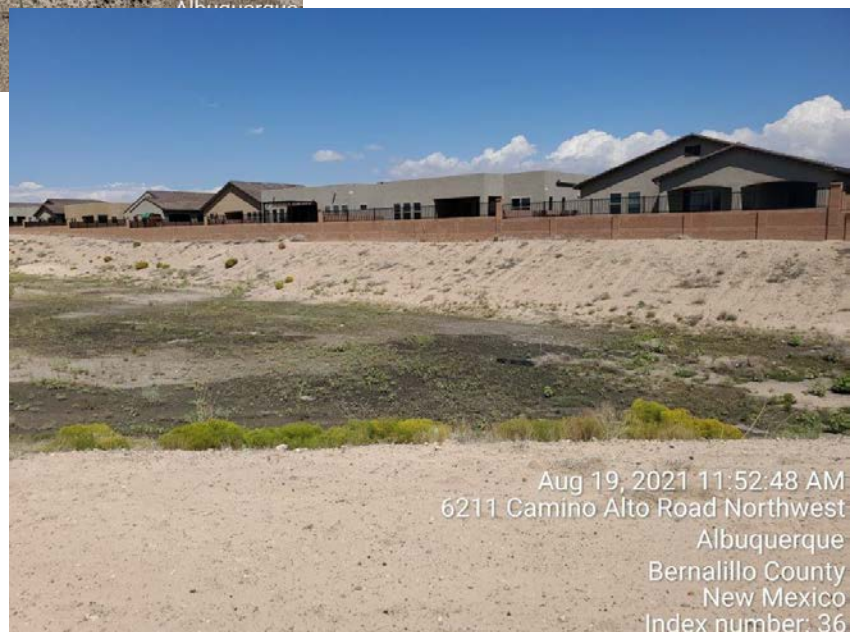
HOA Unit 1 Pond

The bottom of the pond received a lot of water and appears to have sufficient vegetation to satisfy the strict interpretation of the final stabilization criteria.

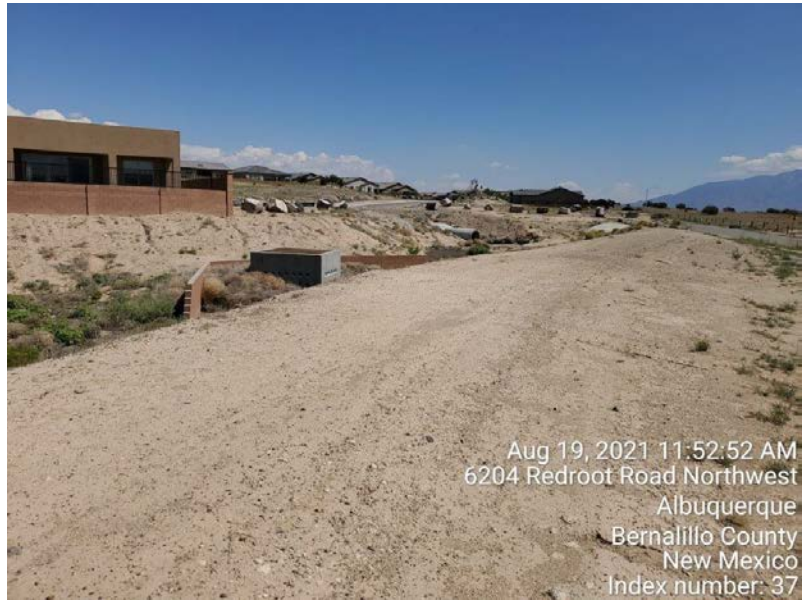
The pond side slopes are mostly bare dirt and will remain erosive until they are stabilized with rock armoring. The natural undisturbed condition of the land is flat and not very erosive, but the steep slopes require a lot more cover to stabilize.

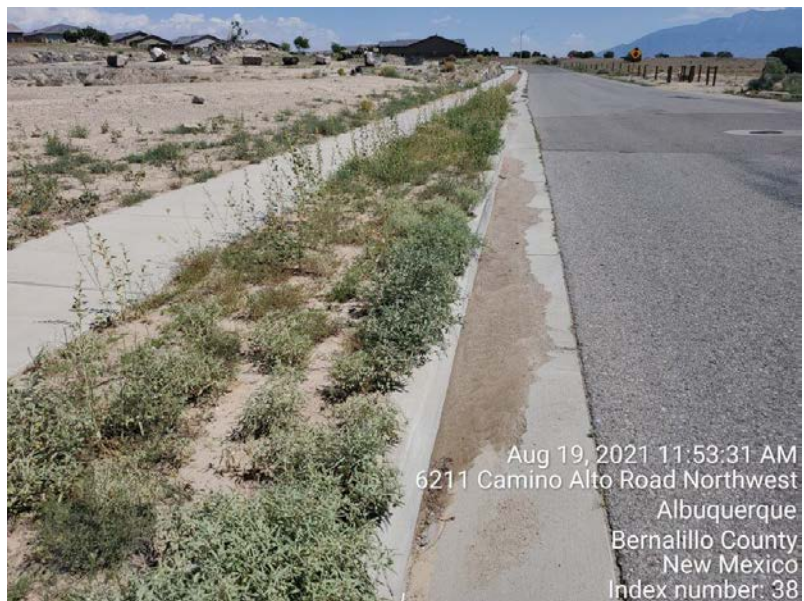
There is some sediment in the street on Kimmick Dr.

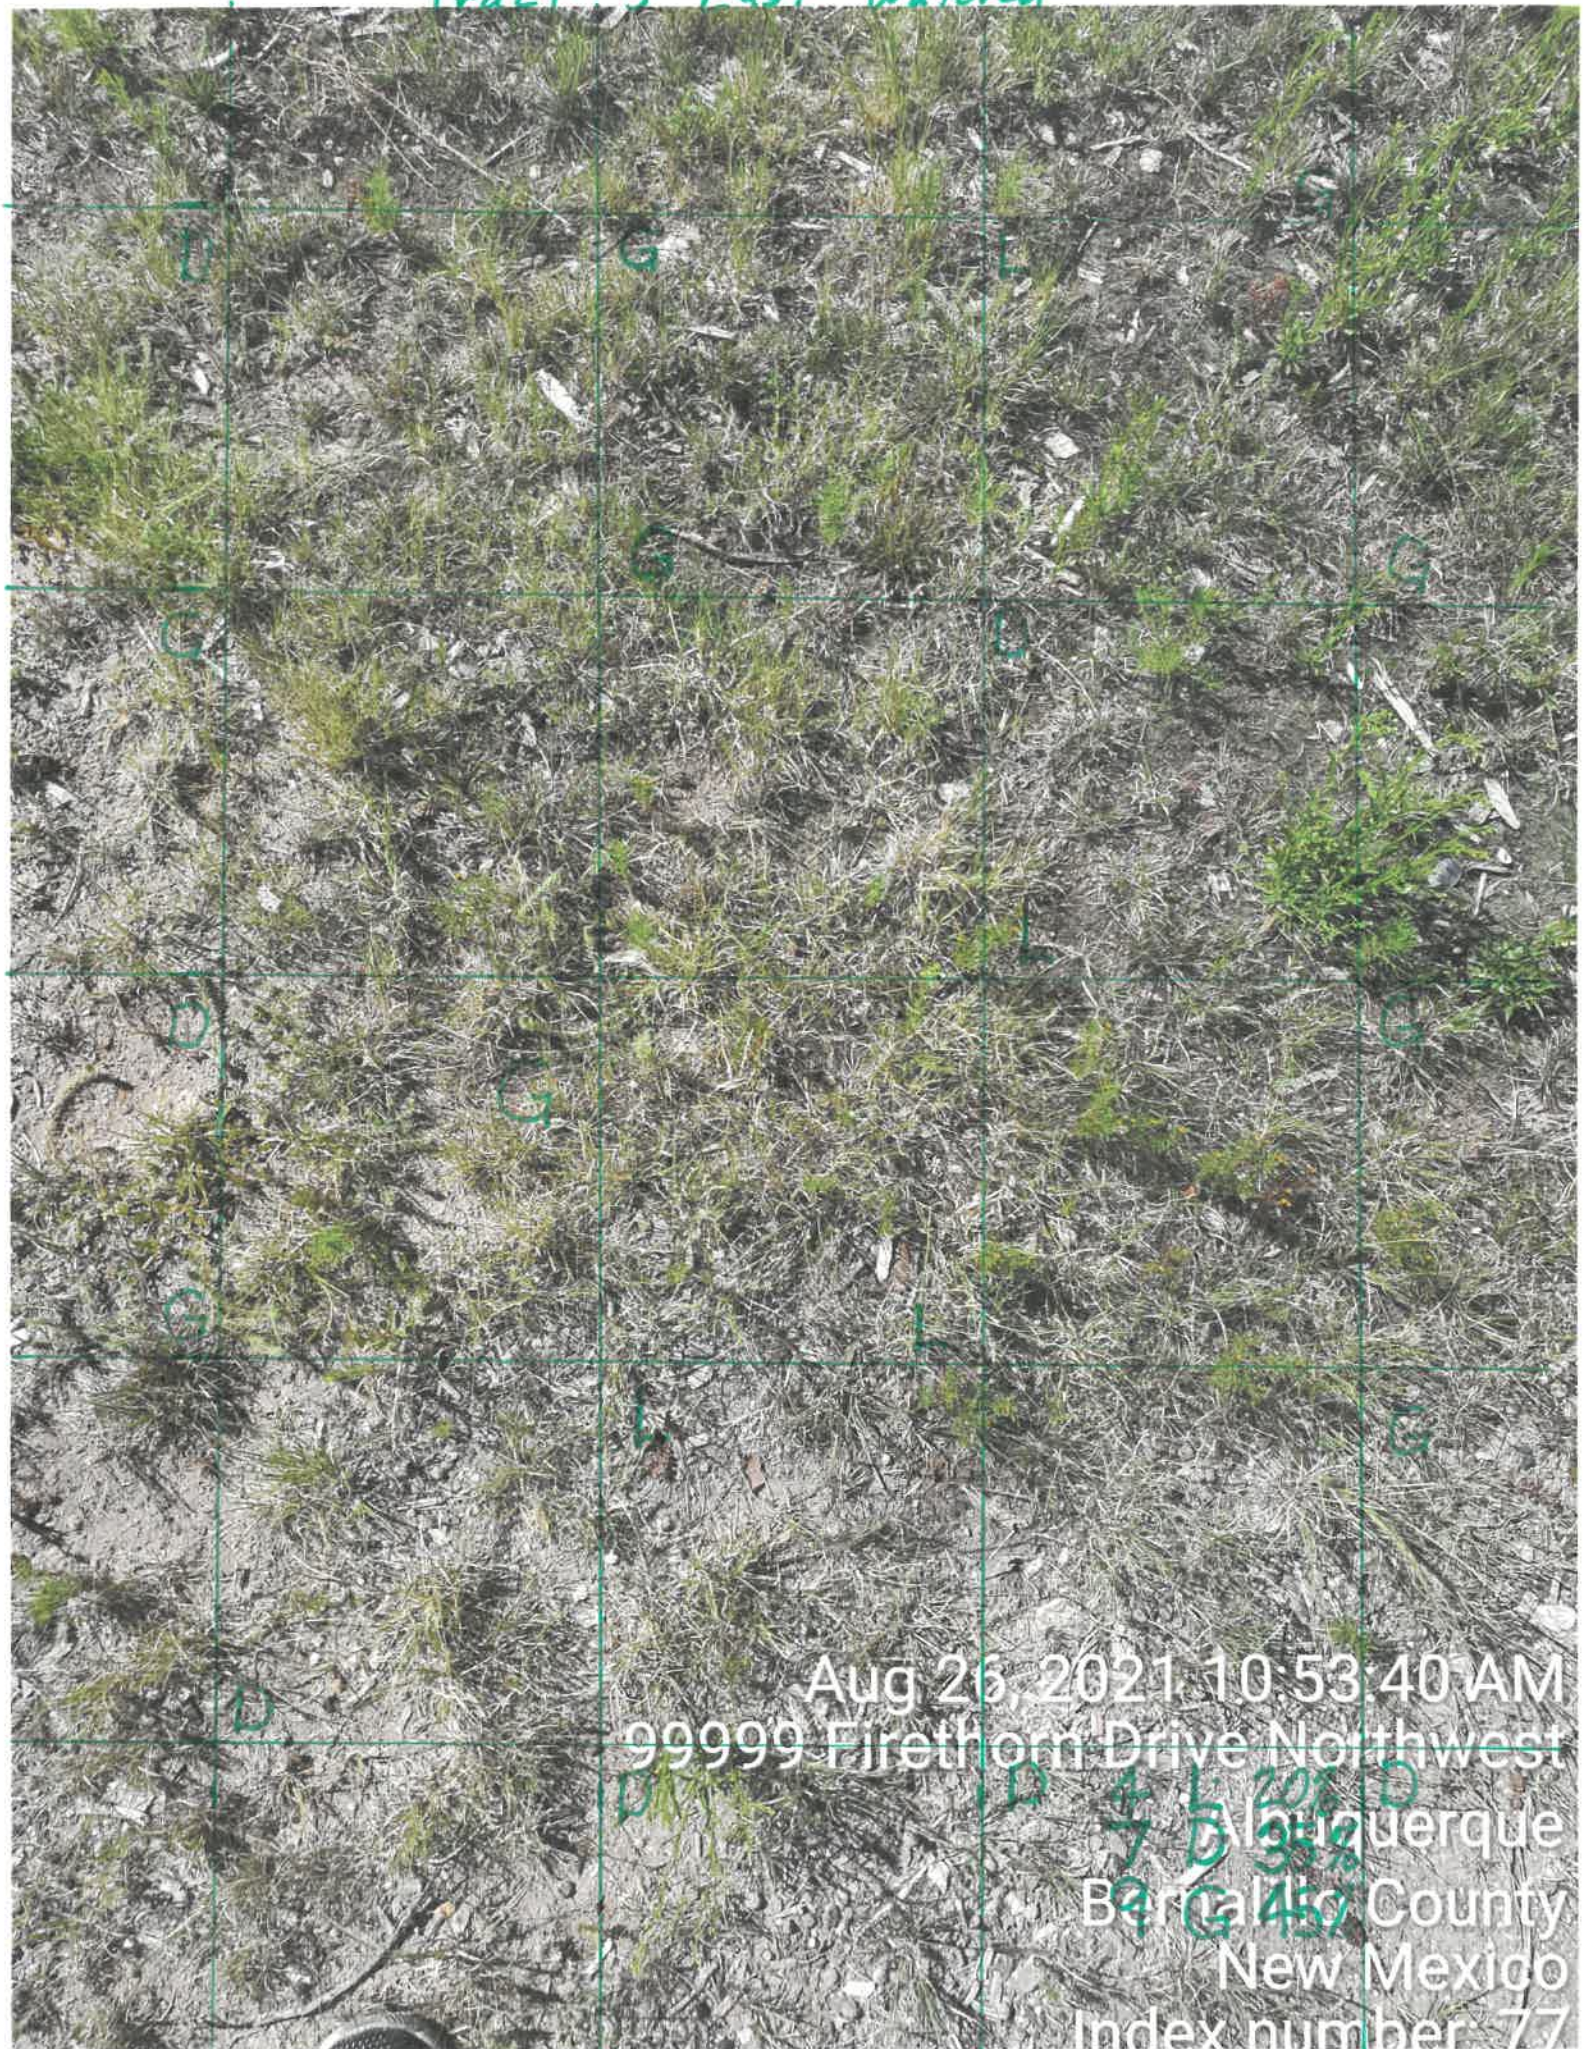
Aug 26, 2021 10:53:40 AM
99999 Firethorn Drive Northwest
Albuquerque
Bernalillo County
New Mexico
Index number 77

Tract 5 East
