Erosion Sediment Control Plan

Santa Monica Estates Subdivision

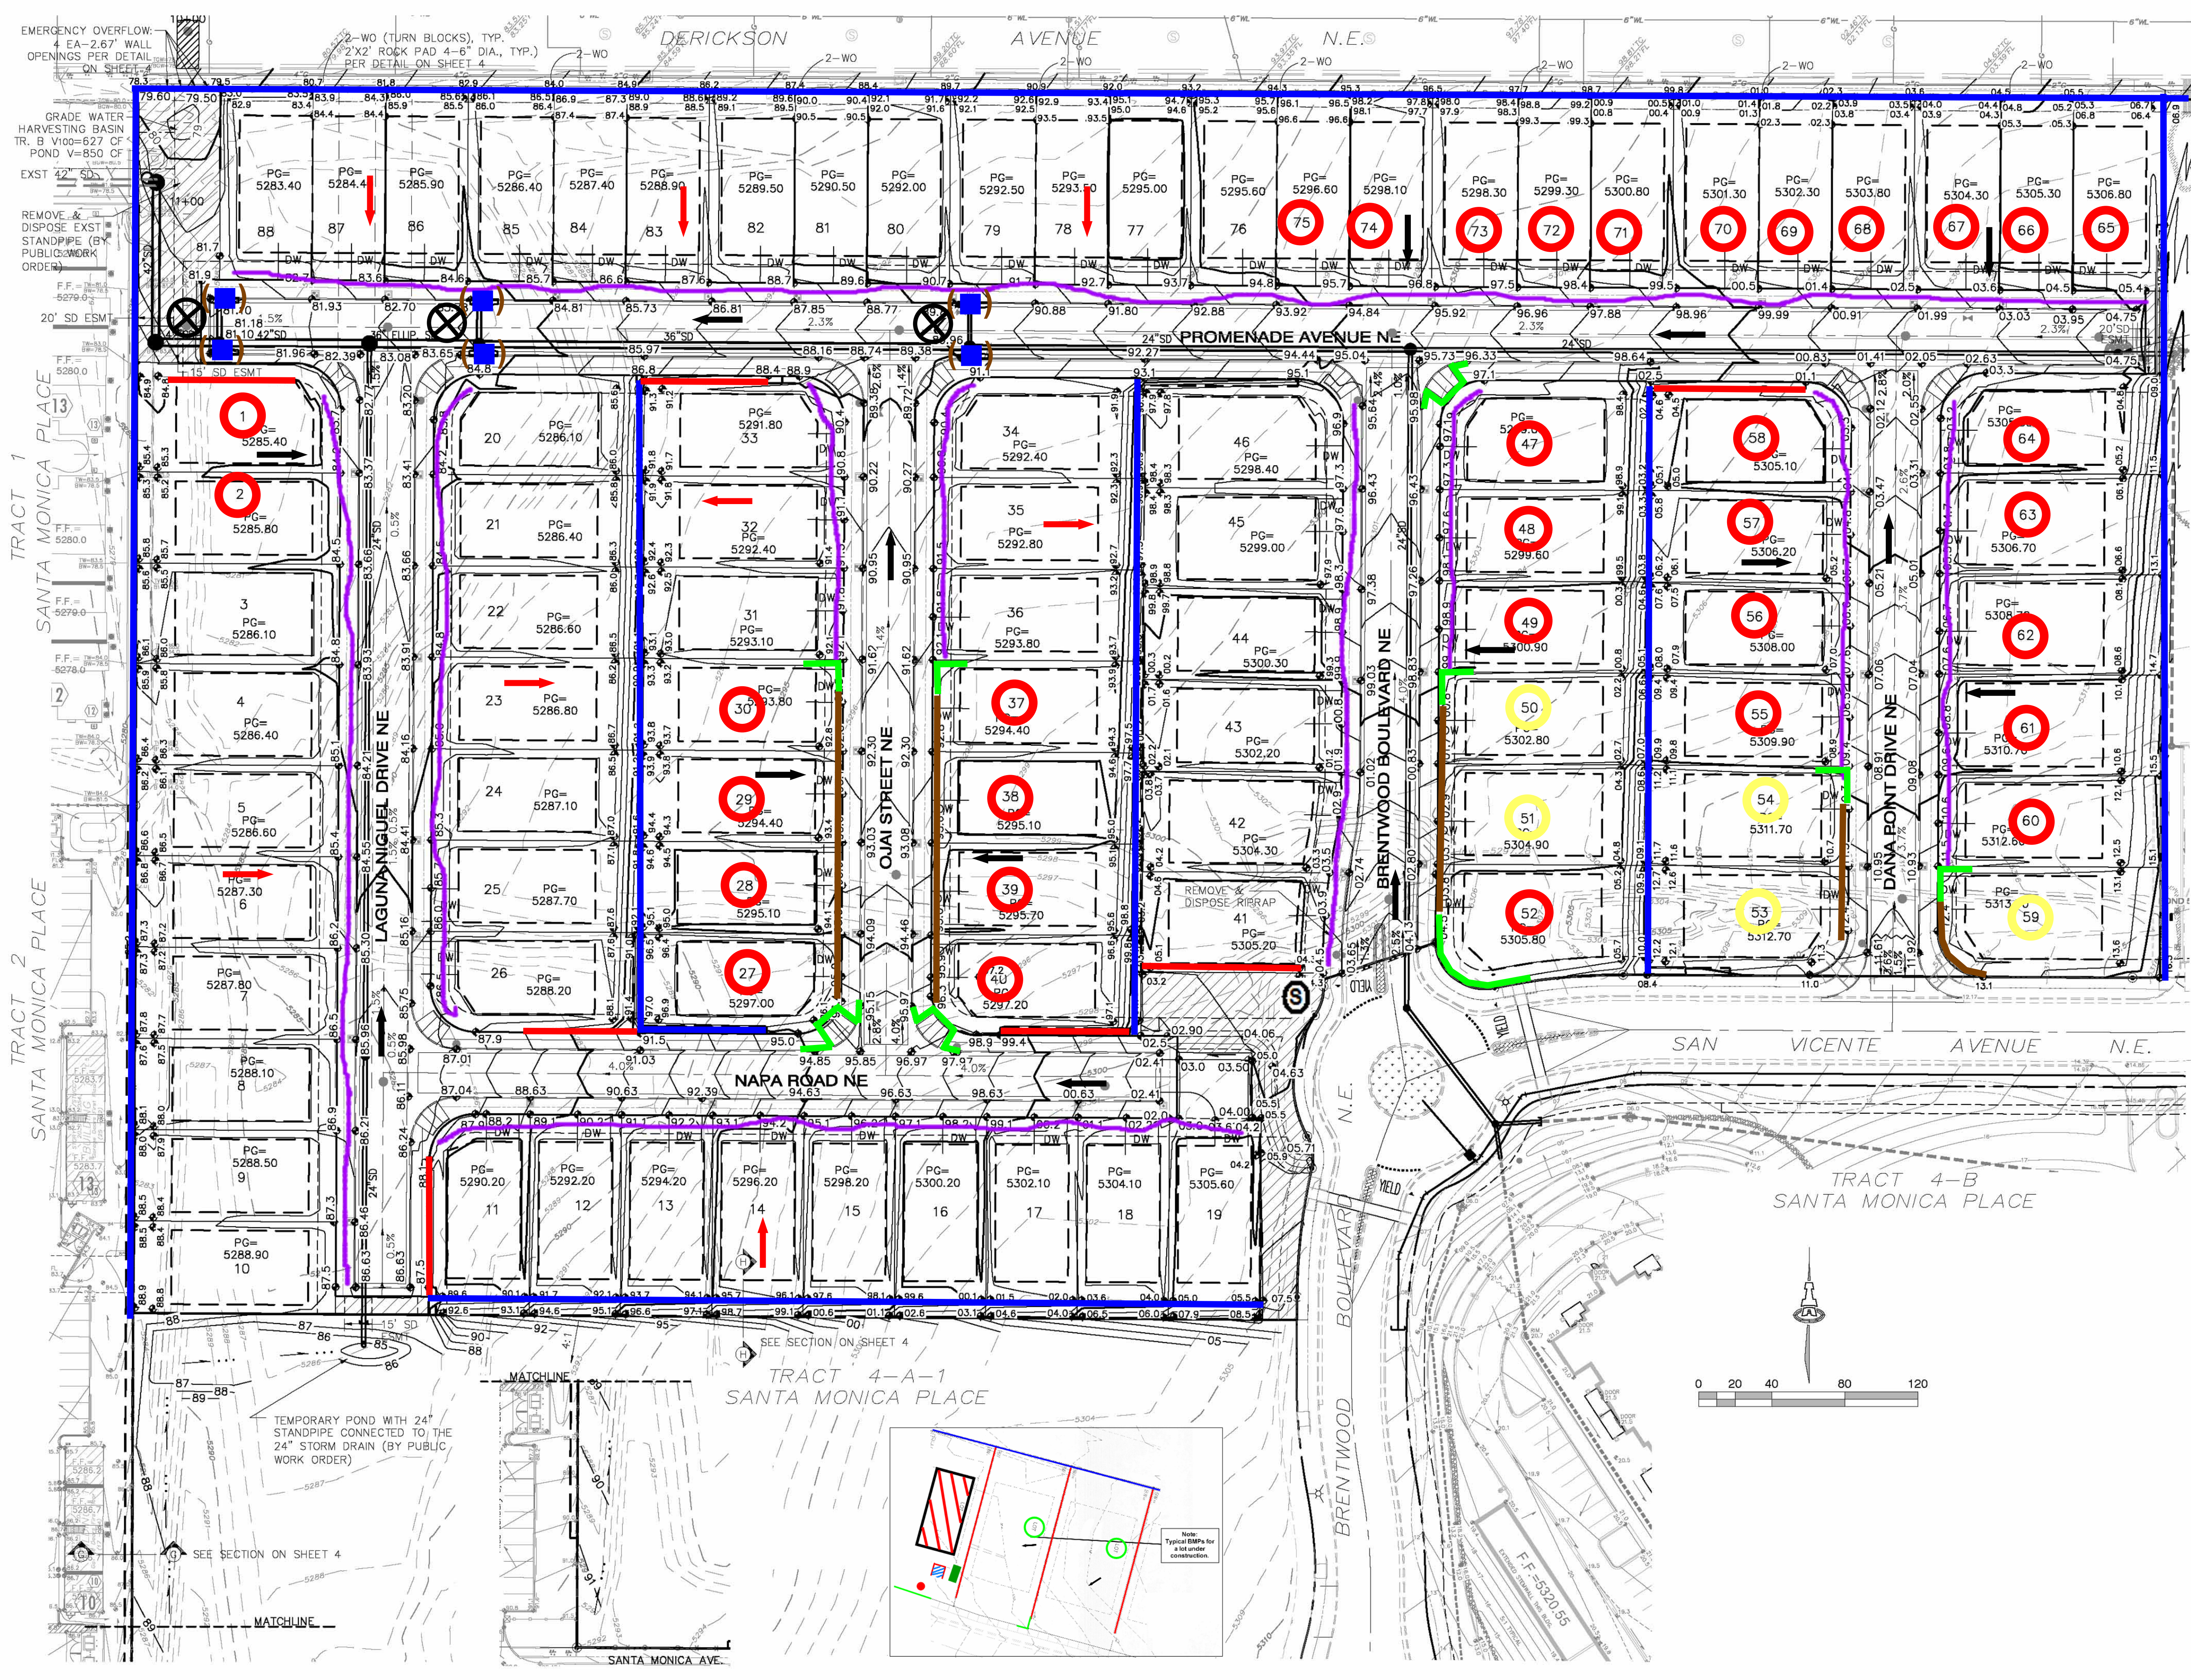
- Project Perimeter & Disturbed Area
- Silt Fence
- Pre Flow
- Flow
- Outfall
- Posting Sign
- Block Wall
- Retaining Wall
- Cut Back @ Curb
- Swale
- Inlet Protection
- Existing Curb Inlet with protection
- Available lots to purchase
- Lots in Plan (Note: Disturbed areas are lots under construction.)
- Construction completed

- Trash Receptacle
- Chemical Toilet
- Concrete Washout
- Staging Area

Receiving Waters and Critical Habitat: Rio Grande is located 5.4 miles to the NorthWest.

Grade: Before and After 1.5% to 4%
