Hydrologic Calculations - COA DPM 22.2											
Mesa View Church											
January 7, 2002											
Precipitation (in)	P60	P360	P1440	P4days	P10days	Six Hour Storm					
Zone 1	1.87	2.2	2.86	3.12	3.67	A	B	C	D		
Table 8	0.44	0.67	0.99	1.97		A	B	C	D		
Discharge (cfs/ac)	A	B	C	D		A	B	C	D		
Table 9	1.29	2.03	2.87	4.37		1.29	2.03	2.87	4.37		
Areas and Land Treatments:											
Land Treatments - Existing Conditions						Land Treatments - Fully Developed Conditions					
	A	B	C	D	Area (sf)	A	B	C	D	Area (sf)	
Subbasin 1	0	33,655	0	1,771	35,426	0	31,883	0	3,643	35,426	
Subbasin 2	0	17,472	21,840	4,368	43,680	0	4,368	0	39,312	43,680	
Subbasin 3	0	37,862	0	0	37,862	0	37,862	0	0	37,862	
Subbasin 4	37,555	0	0	0	37,555	0	5,633	0	31,922	37,555	
Subbasin 5	27,442	0	6,860	0	34,302	0	5,145	0	29,157	34,302	
Subbasin 6	0	2,523	0	14,300	16,823	0	2,523	0	14,300	16,823	
Subbasin 7	0	3,178	0	18,012	21,190	0	3,178	0	18,012	21,190

MESA VIEW CHURCH

GRADING AND DRAINAGE PLAN

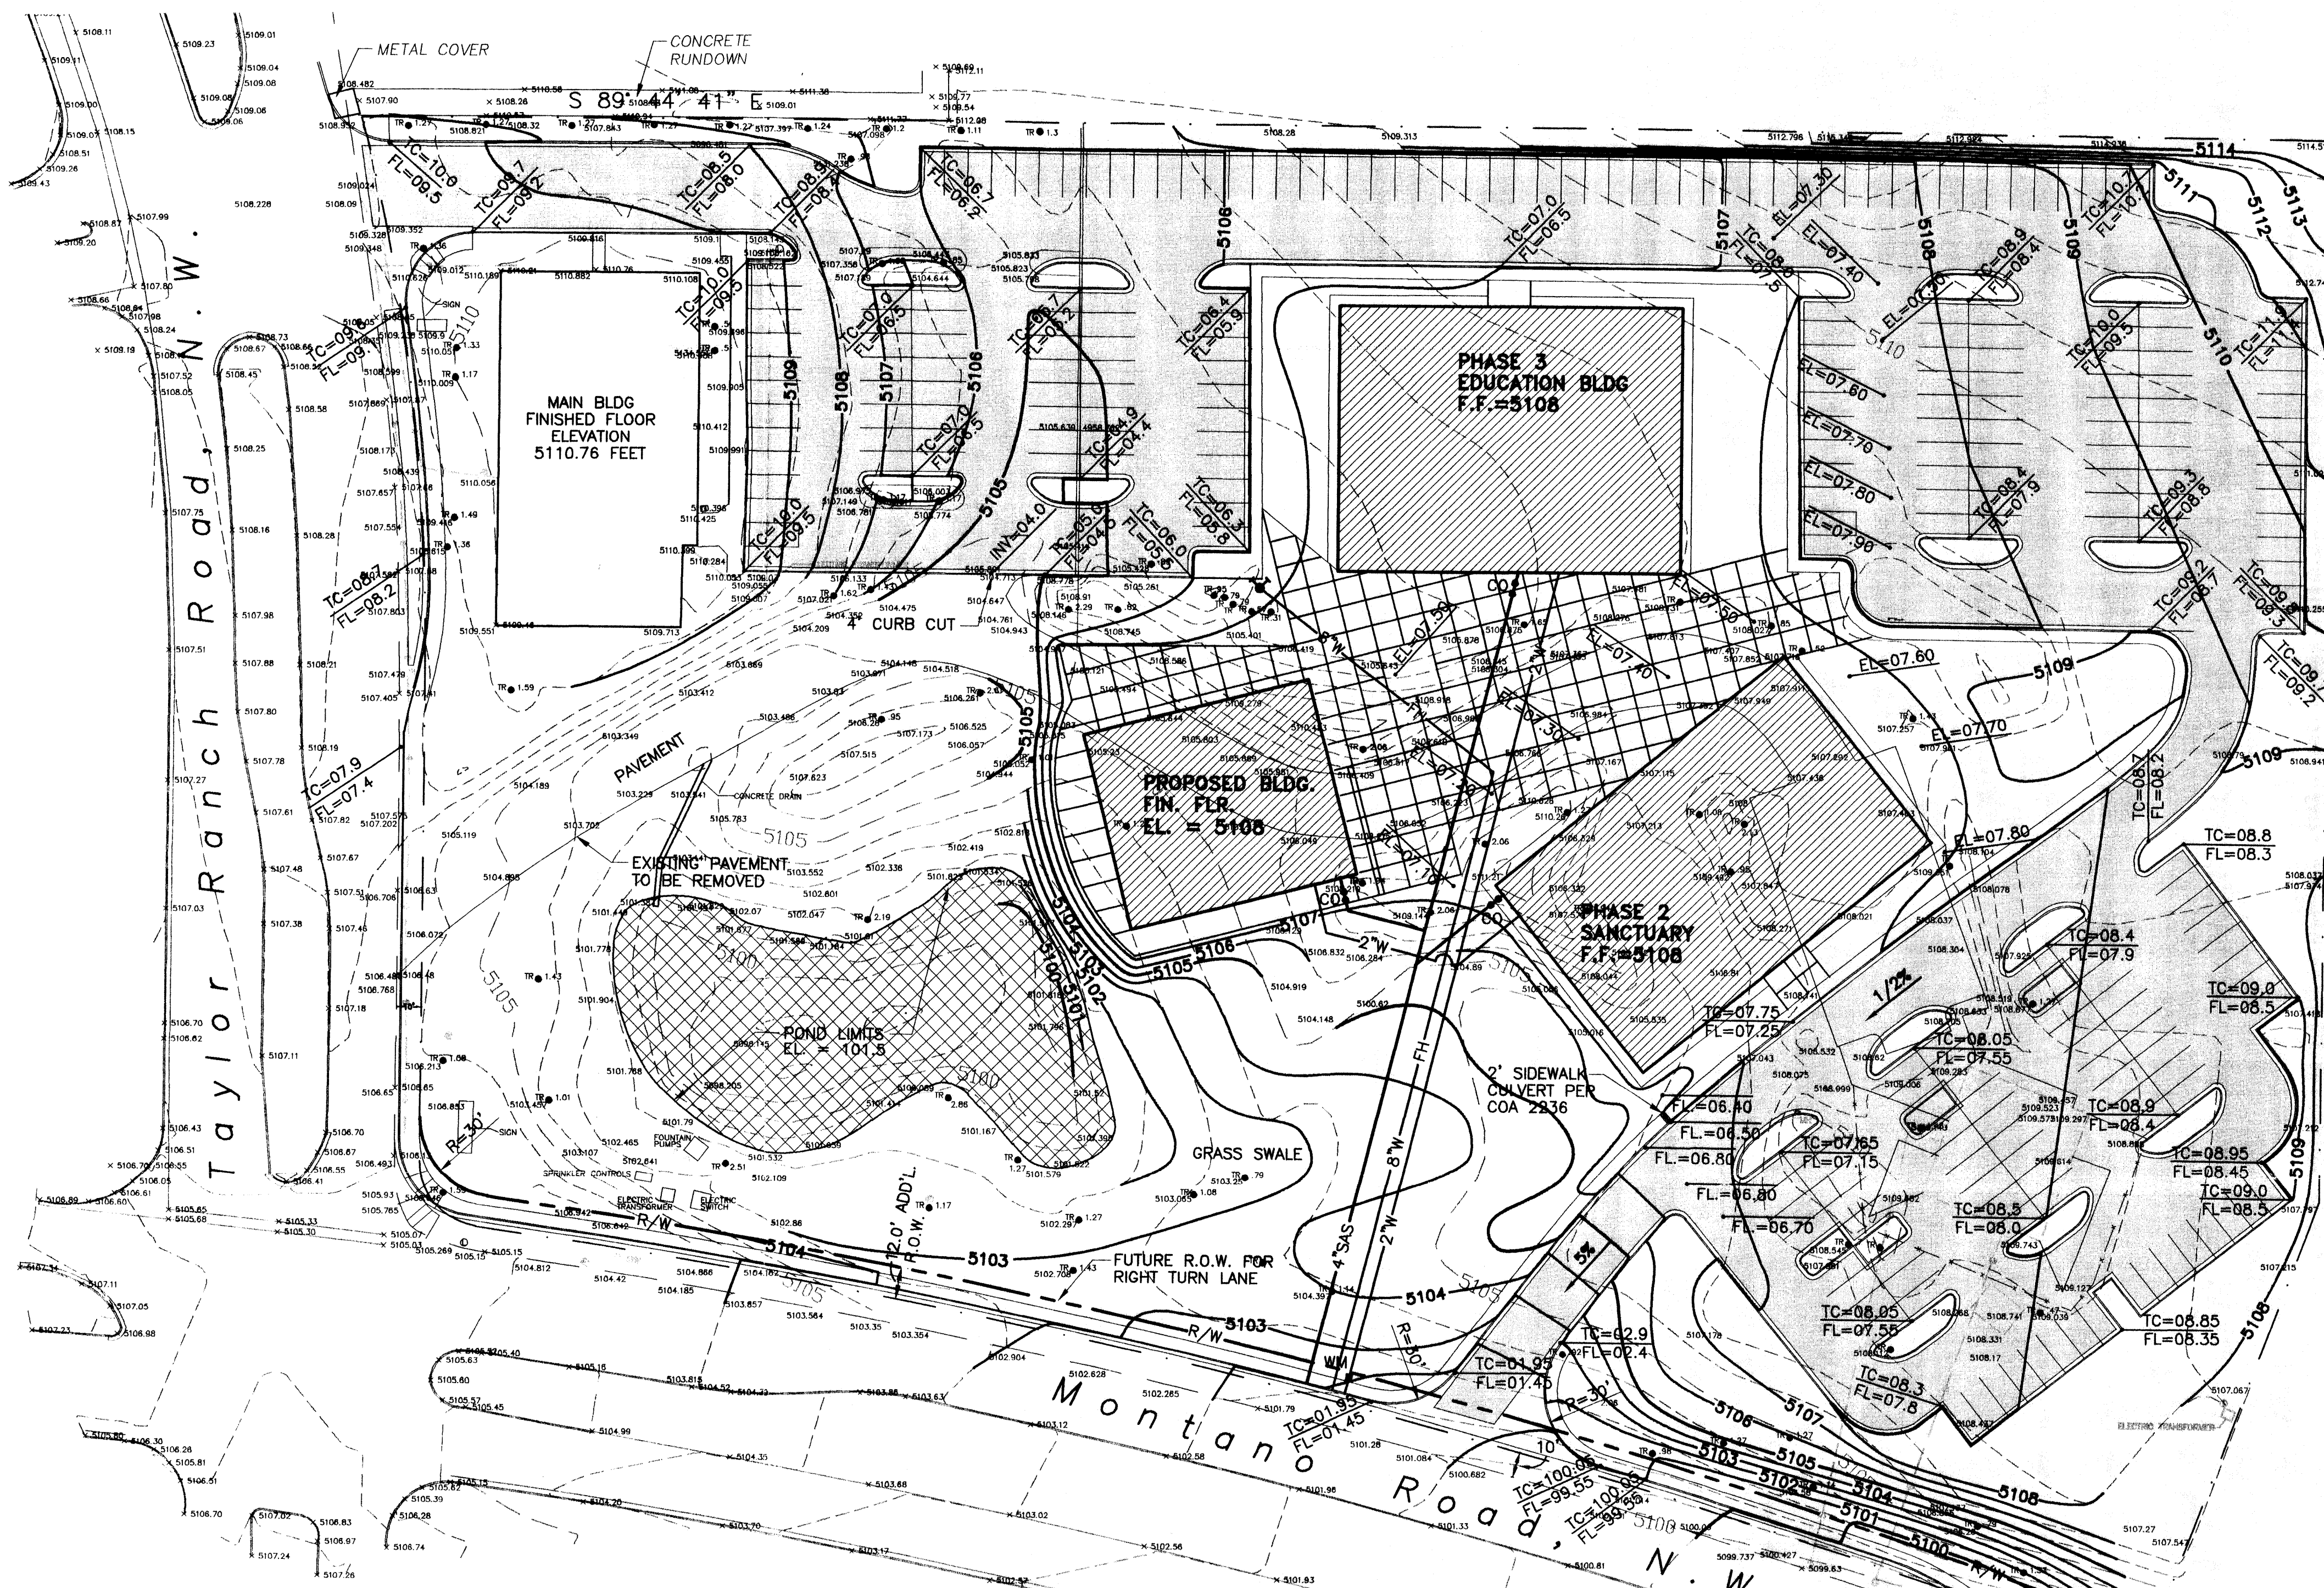
GRADING PLAN

Proposed Grading - The Grading and Drainage Plan shows 1) existing and proposed grades indicated by spot elevations and contours at one-foot intervals with continuity between existing and proposed grades; 2) the limit of existing and proposed improvements. The proposed building pads will be set to correspond to finish floor elevations of 5,108-feet to maintain positive drainage around the buildings. The additional northern parking area on both sides of the Phase Three building will be graded to drain from both ends to the proposed four-foot curb cut and then to the south across the grass-lined swale to the pond as shown on the plan. The grading of the site will maintain the drainage to the existing pond. The proposed condition 100-year rainfall runoff will generate approximately 76,195-cubic feet of volume in the pond at a maximum elevation of 5,102.35-feet. The increase in water surface elevation due to the proposed construction was estimated to be less than five-inches. This will leave about 0.65-foot of freeboard constituting 39,278 cubic-feet of additional storage volume before overtopping.

The Phase Two construction will include the construction of the additional driveway as shown on the Plan. The runoff from this parking facility will discharge through a sidewalk culvert into the pond. The increase in discharge to Montano Road was estimated to be approximately 0.11-cfs.

Existing Conditions - Currently, the properties to the north and east of the project site drain to either Taylor Ranch Drive or Montano Road. No offsite runoff impacts the site. The street slopes are on the order of one-percent and support adequate capacity to carry the fully developed 100-year design flood from the site. The existing pond on the project site acts as a retention facility during significant rainfall events. Most of the subject property discharges through the park area into the pond. The normal water surface of the pond is maintained at elevation 5,101-feet storing approximately 35,247 cubic-feet of water. The maximum capacity of the pond before overtopping occurs was estimated as 115,473 cubic-feet of water at elevation 5,103 feet. All overflow will discharge to Montano Road. The existing 100-year runoff was estimated as 64,405 cubic-feet at an elevation of 5,101.96-feet.

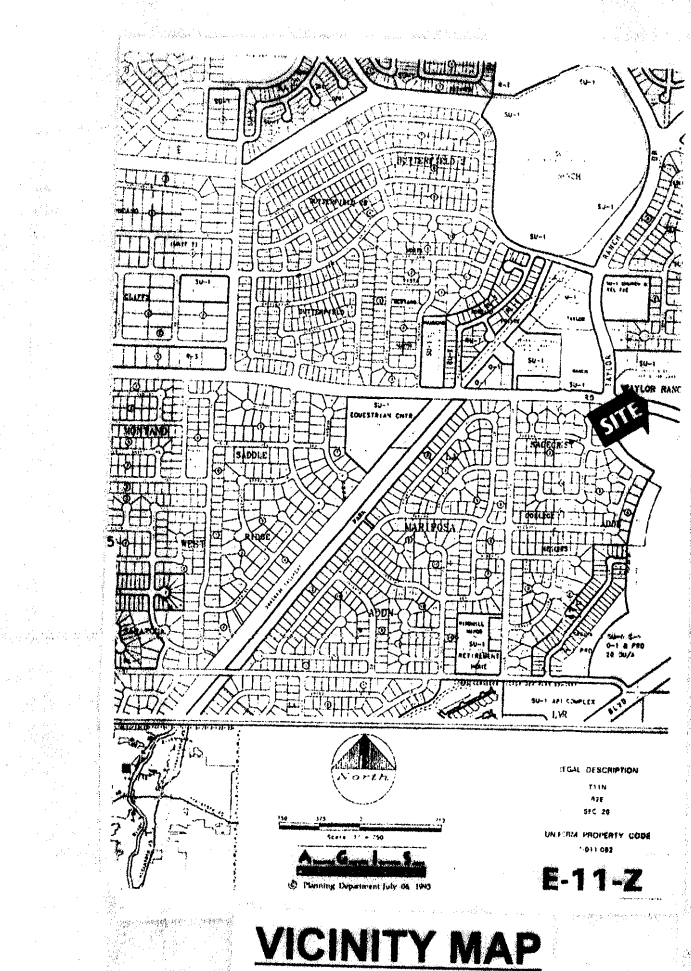
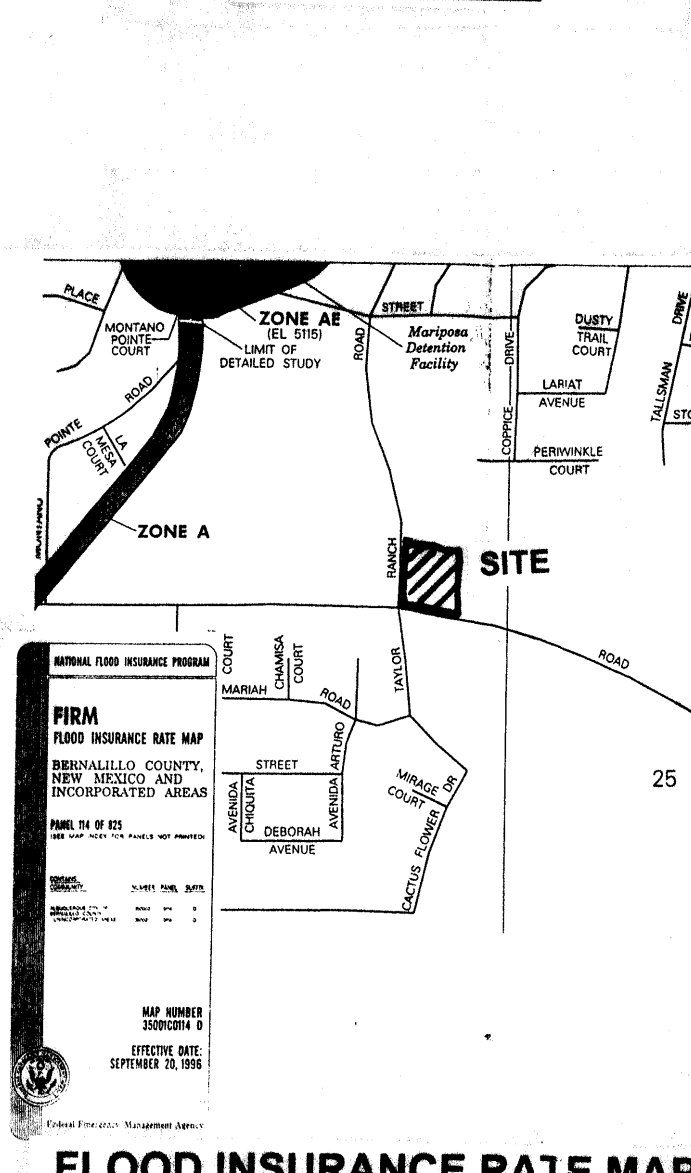
SCALE: 1" = 40'

Hydrologic Methods - The drainage basin map shows twelve separate subbasins 1 through 12 to assess peak flow rates at various points around the project site culminating at the pond or Montano Road. The spreadsheet calculations analyze both the existing and developed conditions for the 100-year, 6-hour rainfall event. The process outlined in the DPM, Section 22.2 was used to quantify the peak flow rates and volumes. As shown by these calculations, the fully developed commercial improvements will result in a minimal increase in runoff generated by the site. Also, by draining the majority of the site toward the existing pond, only a minimal increase in runoff to Montano Road will be found due to the proposed improvements to the site. As noted on the Plan, only subbasin one will continue to discharge onto Montano Road as is the case under current conditions.

The subject property improvements increase the existing peak runoff by about six cubic feet per second and about 12,000 cubic feet of volume in the Pond as shown on the calculations. A spreadsheet for Precipitation Zone 1 is included on this plan. This spreadsheet outlines the peak runoff and volume generated for each subbasin for existing and proposed fully developed conditions.

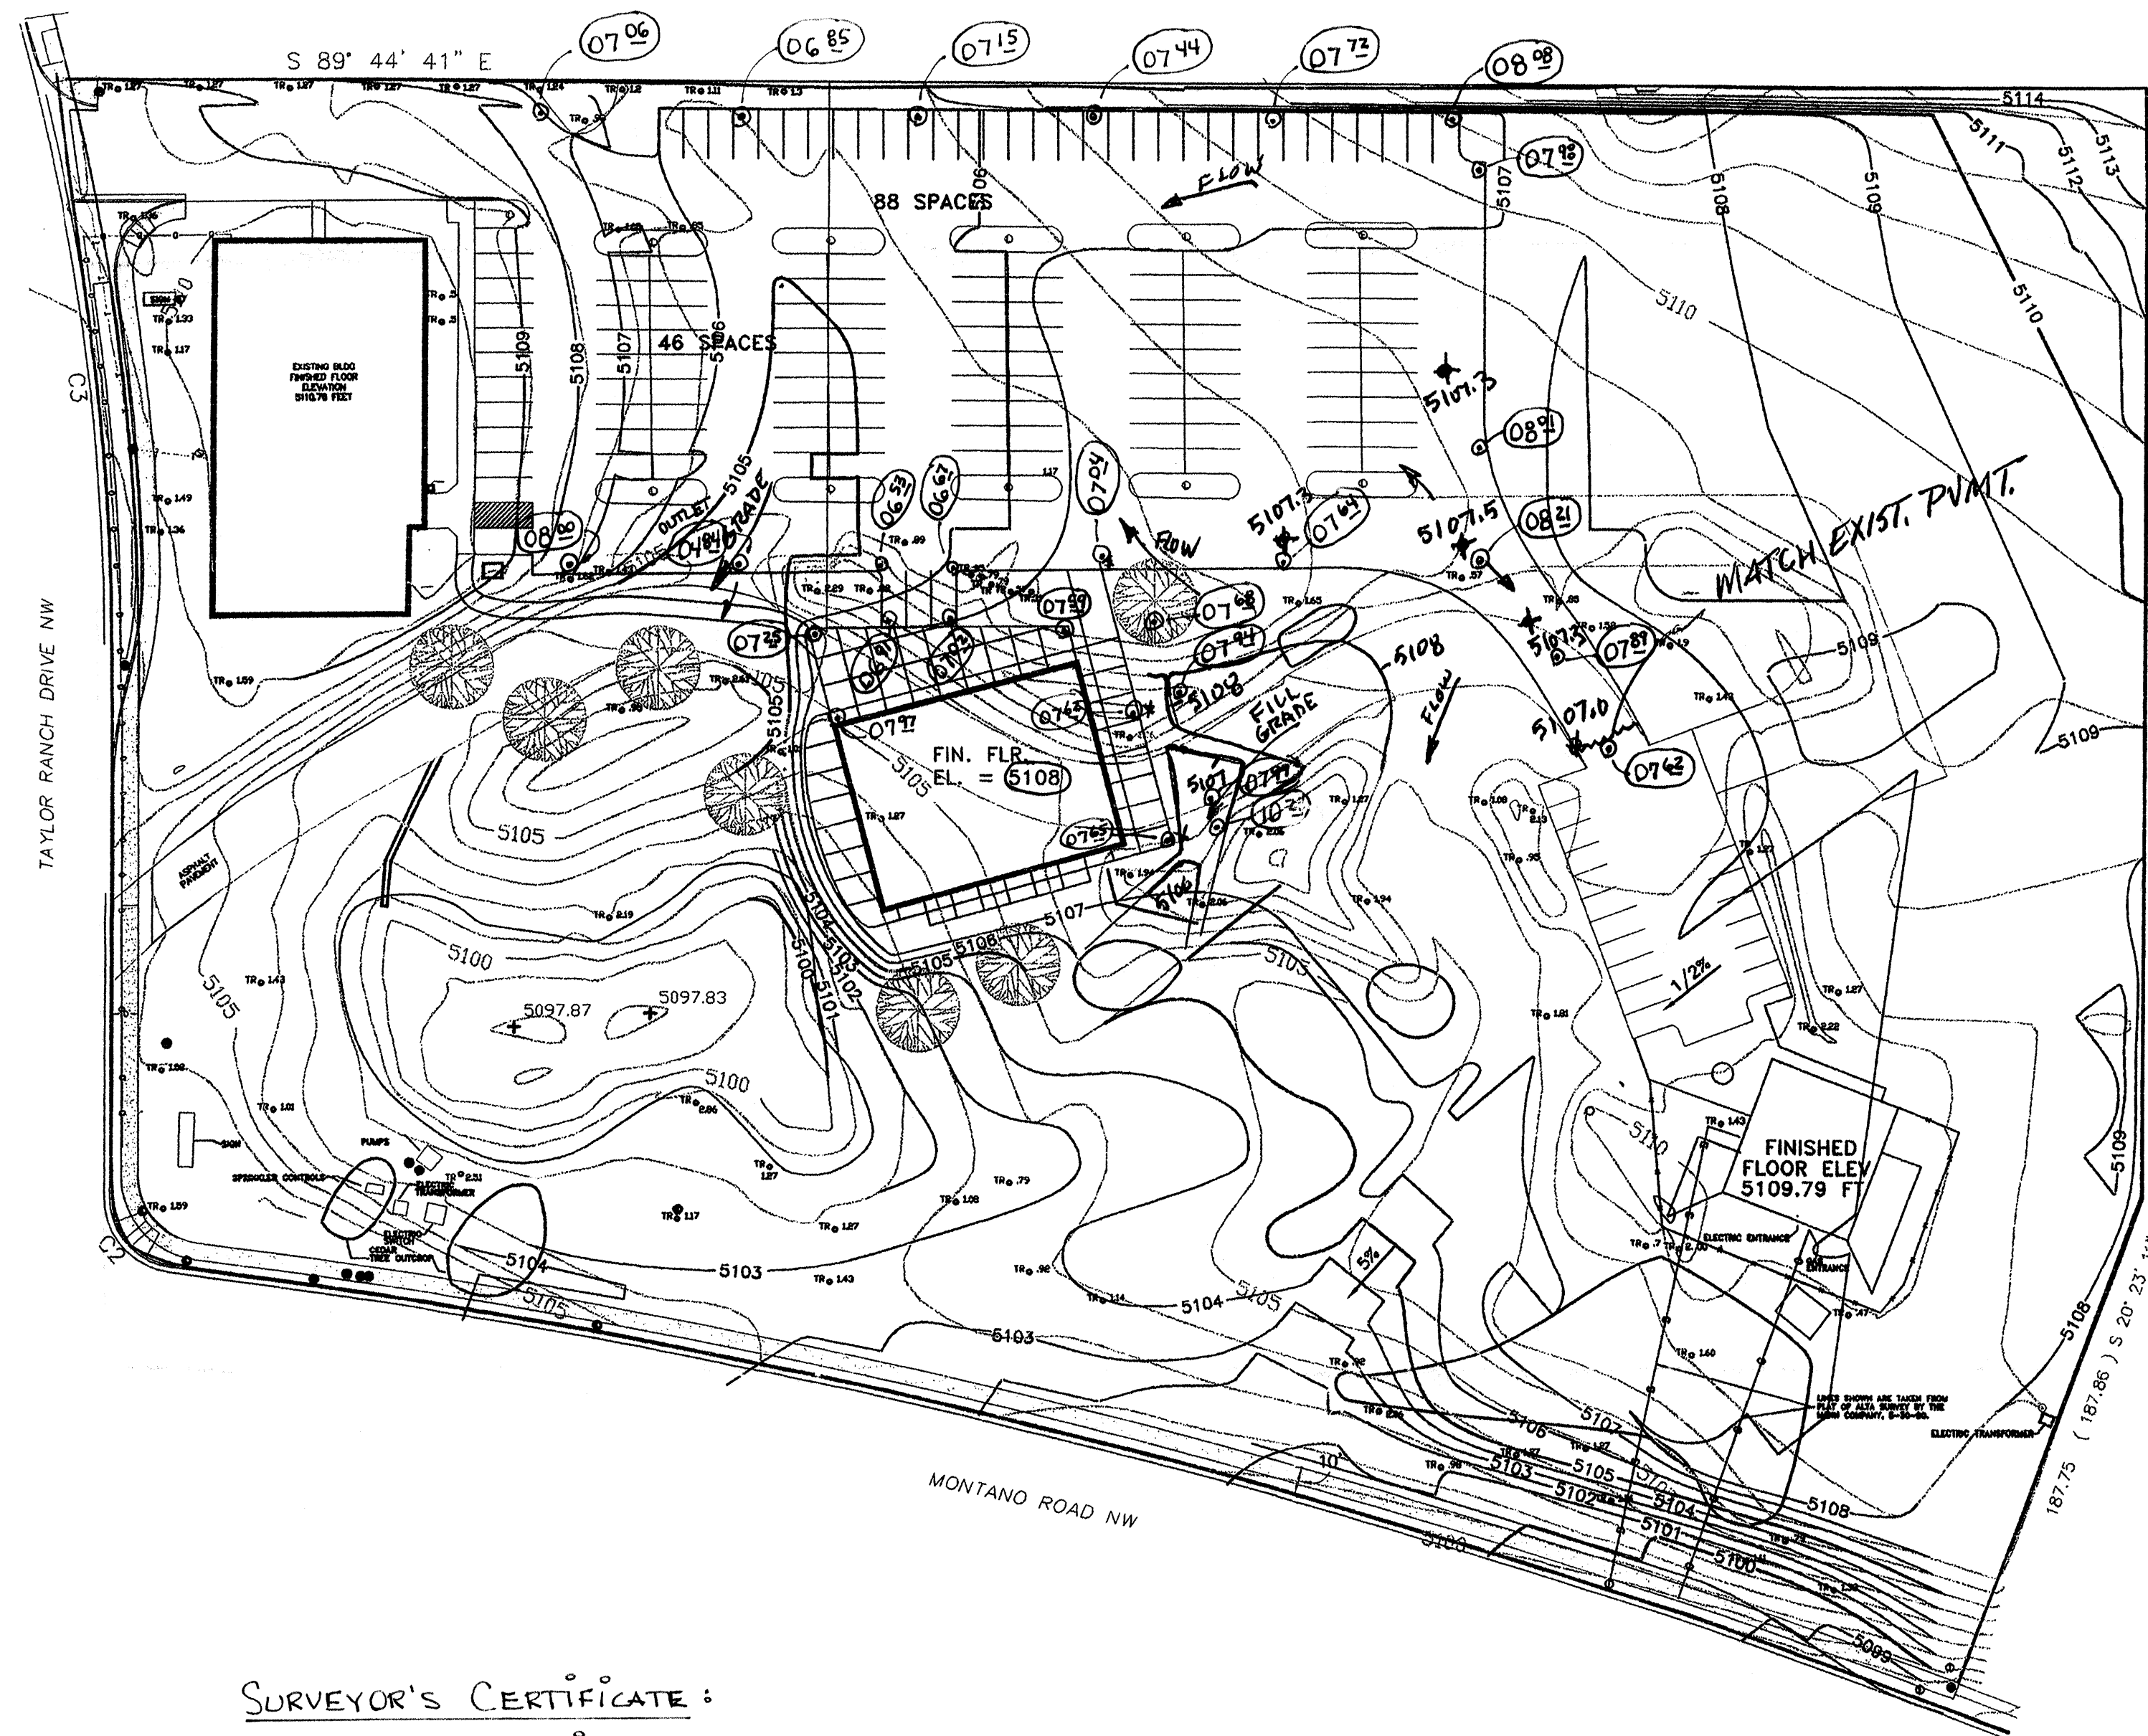
THE ASBUILT ELEVATIONS, SHOWN HEREON BY THE CIRCLED NUMBERS, WERE TAKEN IN THE FIELD ON NOVEMBER 22ND, 2002. THE ELEVATIONS SHOWN ARE BASED OFF THE BUILDING F/F ELEVATION OF 5108.00 AND ARE TRUE AND CORRECT TO THE BEST OF MY KNOWLEDGE AND BELIEF.

Engineer's Certification	
Mesa View Church Addition - Phase One	
This site was surveyed on November 22, 2002 by Brian K. McClintock, NMPS No. 11597 to confirm post-construction design elevations and drainage for the project's first phase. I, Mark H. Burak, P.E. have assessed the "as constructed" conditions and have found the site to be in substantial compliance with the approved plan stamped 01/08/02.	
<i>Mark H. Burak</i> Mark H. Burak, P.E. # 10987	December 1, 2002
