Enterprise Builders: First NMR1002LX, NMR1002M0 Financial Credit Union

Storm Water Compliance Inspection Form

Inspection Type: Routine	Date: 08-25-2020	Time: 12:42 PM		
Permit Tracking #: NMR1002LX, NMR1002M0	Inspector Name: Matt Vallejos	Qualifications: CPESC, CISEC		
Current Weather Conditions: Sunny	Date and Amount of Last Recordable Storm Event: 03-13-2020 .50

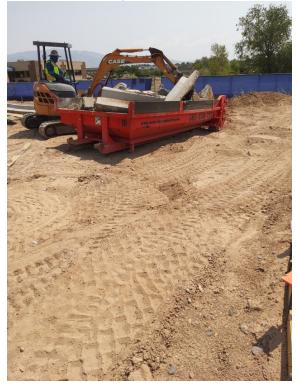
Name Signature Date Site Walk Deficiency Photos - Concrete washout

Location	Action Type	Action Required	Date Noted	Date Completed	Initials
Concrete washout	Maintenance	Concrete washout roll off container is full.	08-25-2020
