Inspections Plus, Inc.

Fairfield Suites

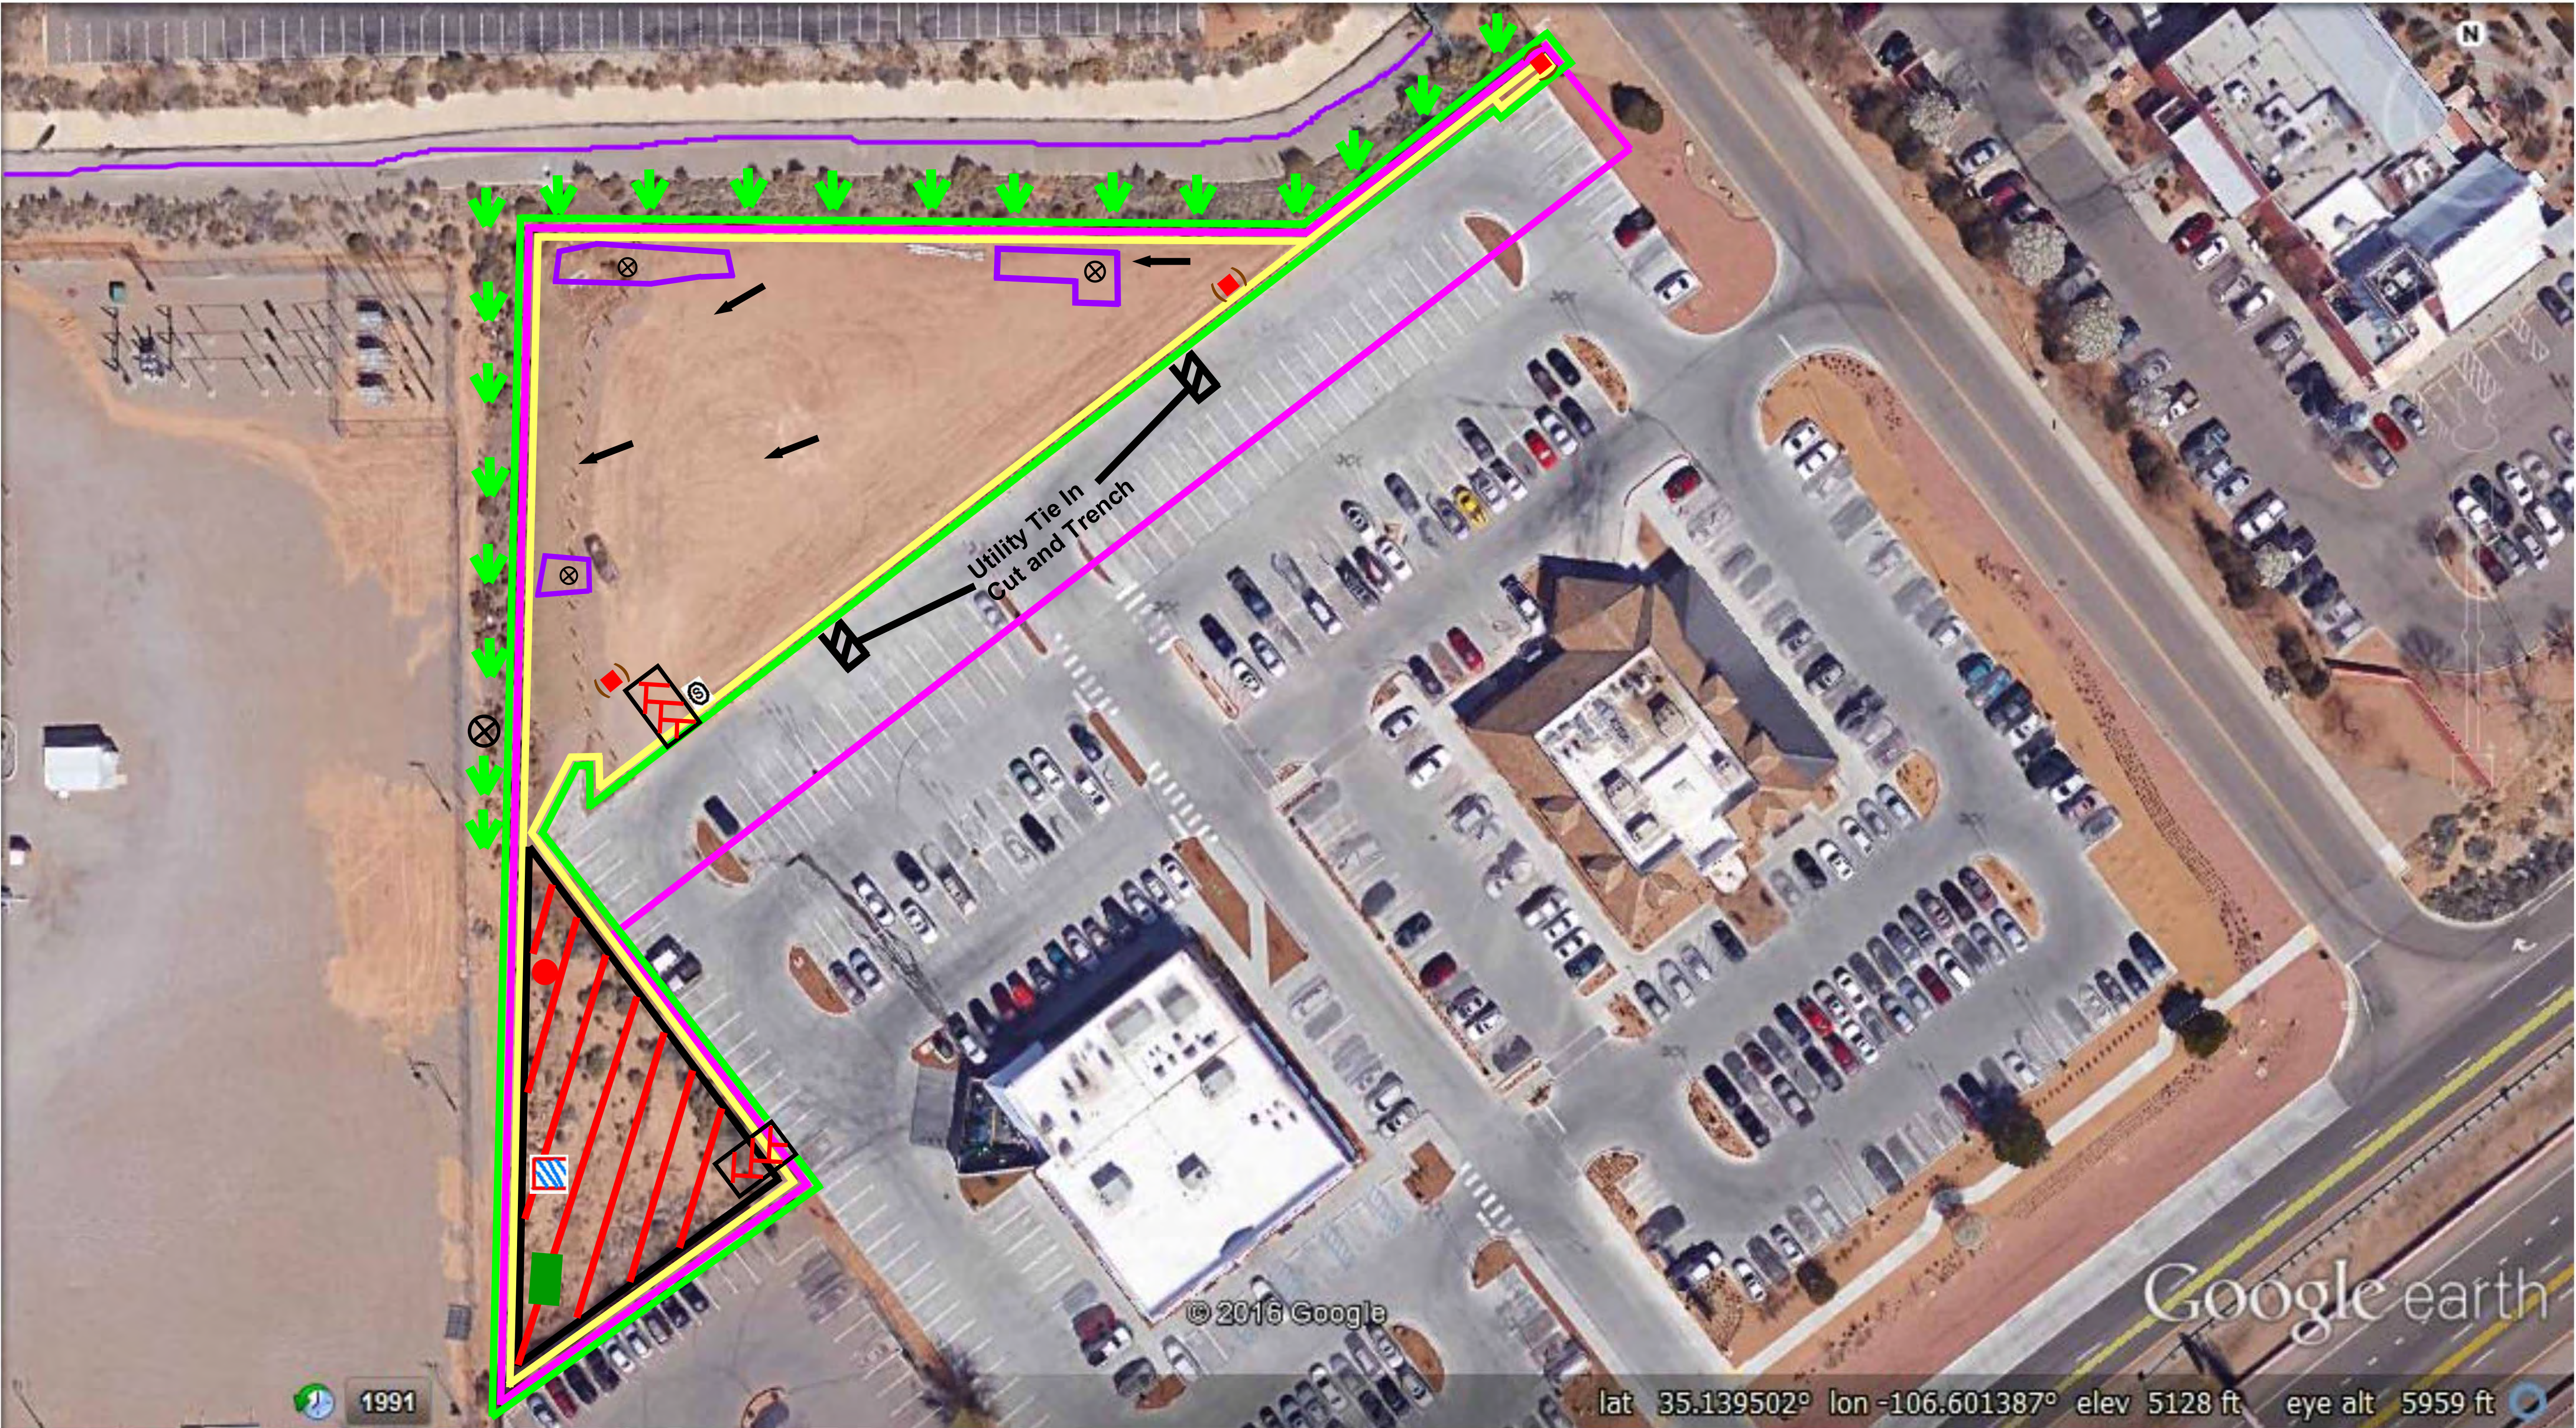
Receiving Waters and Critical Habitat: Rio Grande is located 4.2 miles to the West.

Impairments: E. coli, Dissolved Oxygen, PCBs in Fish Tissue, Water Temperature

Grade: Before and After 0.5%
