Appendix 1

Photograph Log

UNITED STATES ENVIRONMENTAL PROTECTION AGENCY

Location: Tru by Hilton		
City: Albuquerque	County/Parish: Bernalillo	State: New Mexico

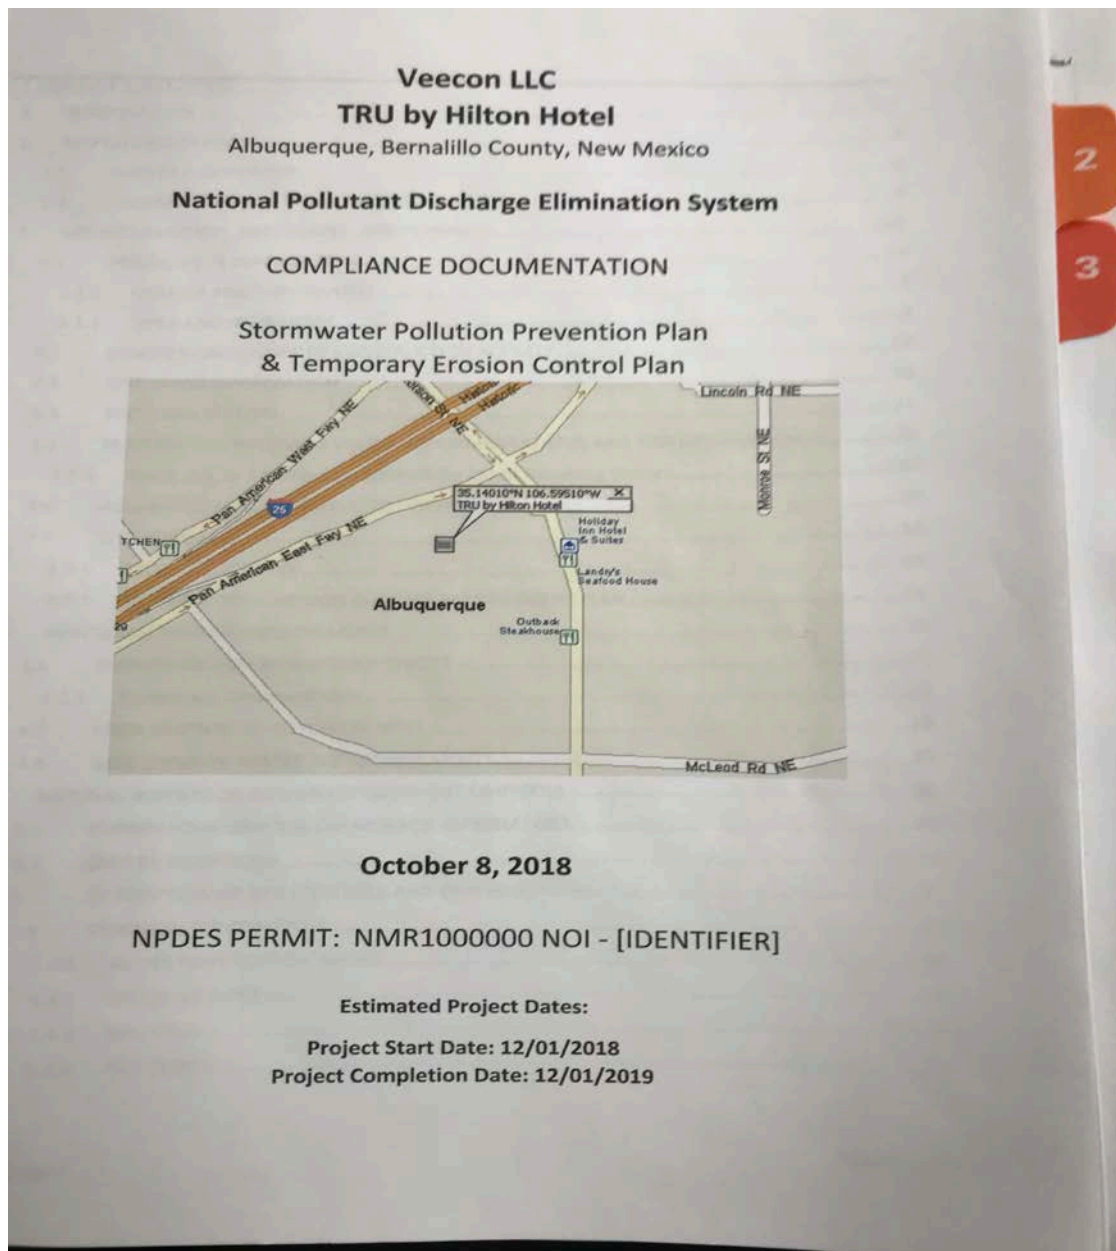
Photo No. 1

Picture of on-site SWPPP coversheet. January 29, 2020 10:37 AM (IMG_0151}). Photographed by D. Esparza.

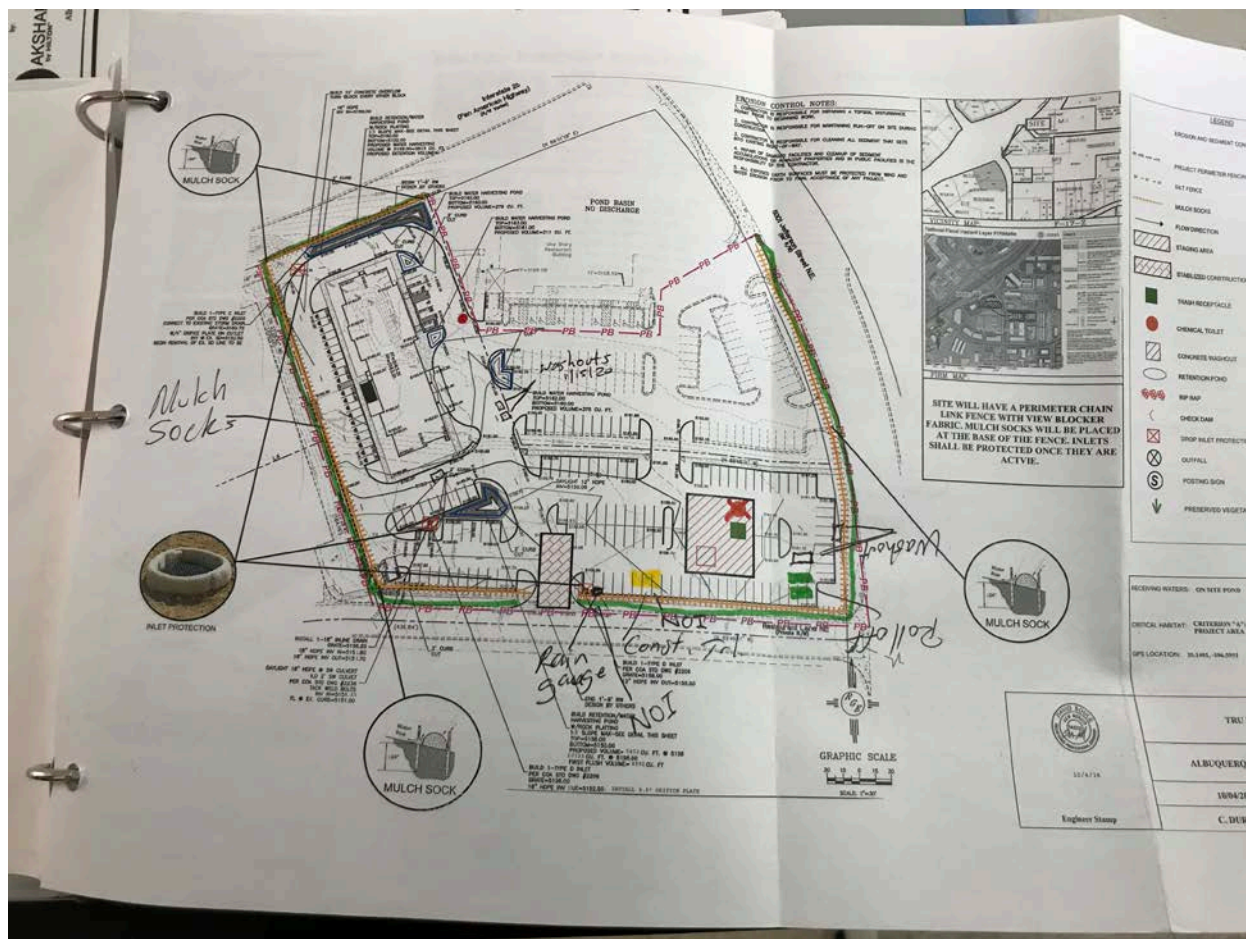
Photo No. 3

Picture of the on-site "as built" site plan sheet indicating locations of BMP structures and SWPPP ancillary appurtenances. January 29, 2020 10:38 AM (IMG_0153). Photographed by D. Esparza.

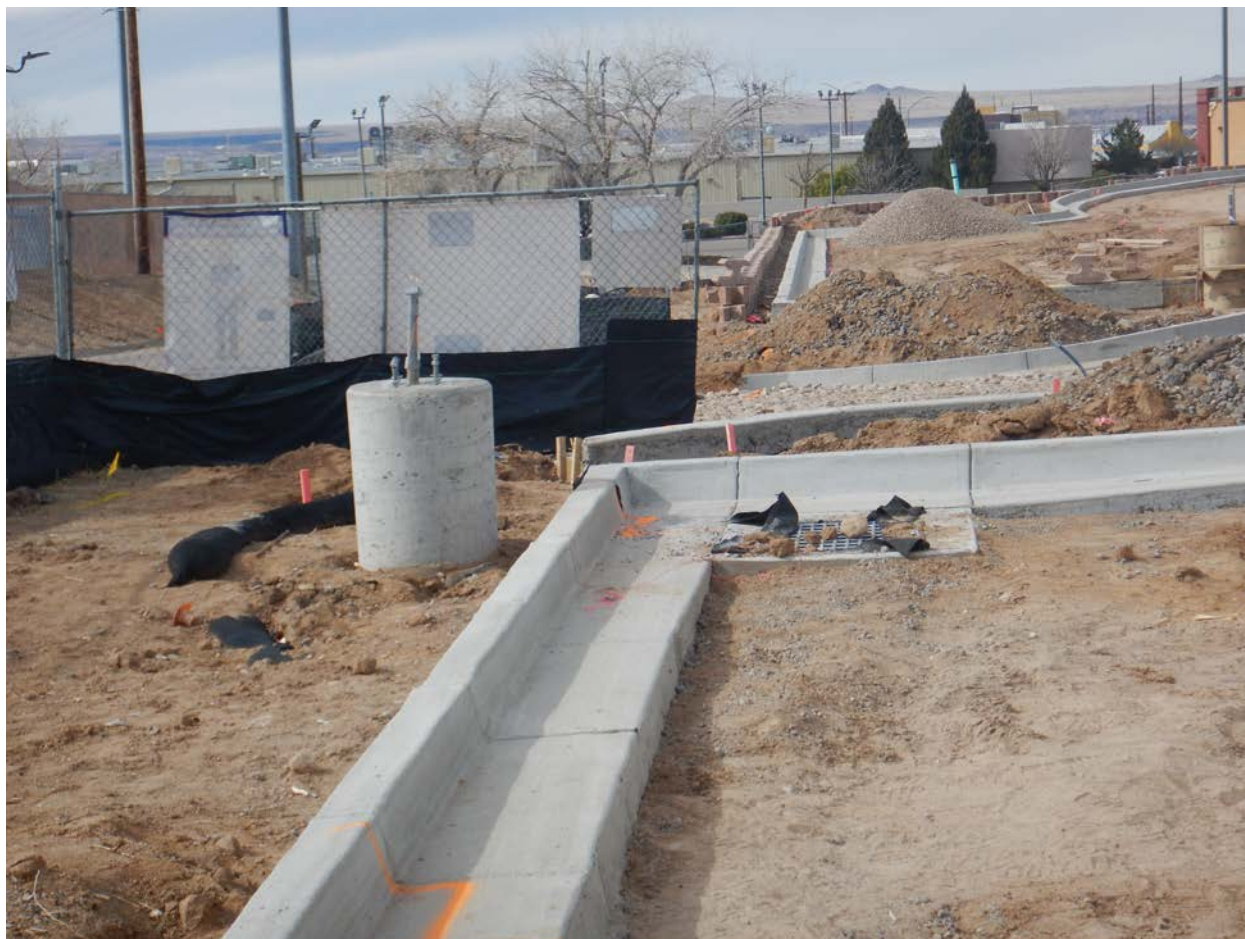
Photo No. 4

Picture of the drop drain located at the approximate northeast corner of the site entrance and lighting stanchion. January 29, 2020 12:49 PM (DSCN 1690). Photographed by D. Esparza.

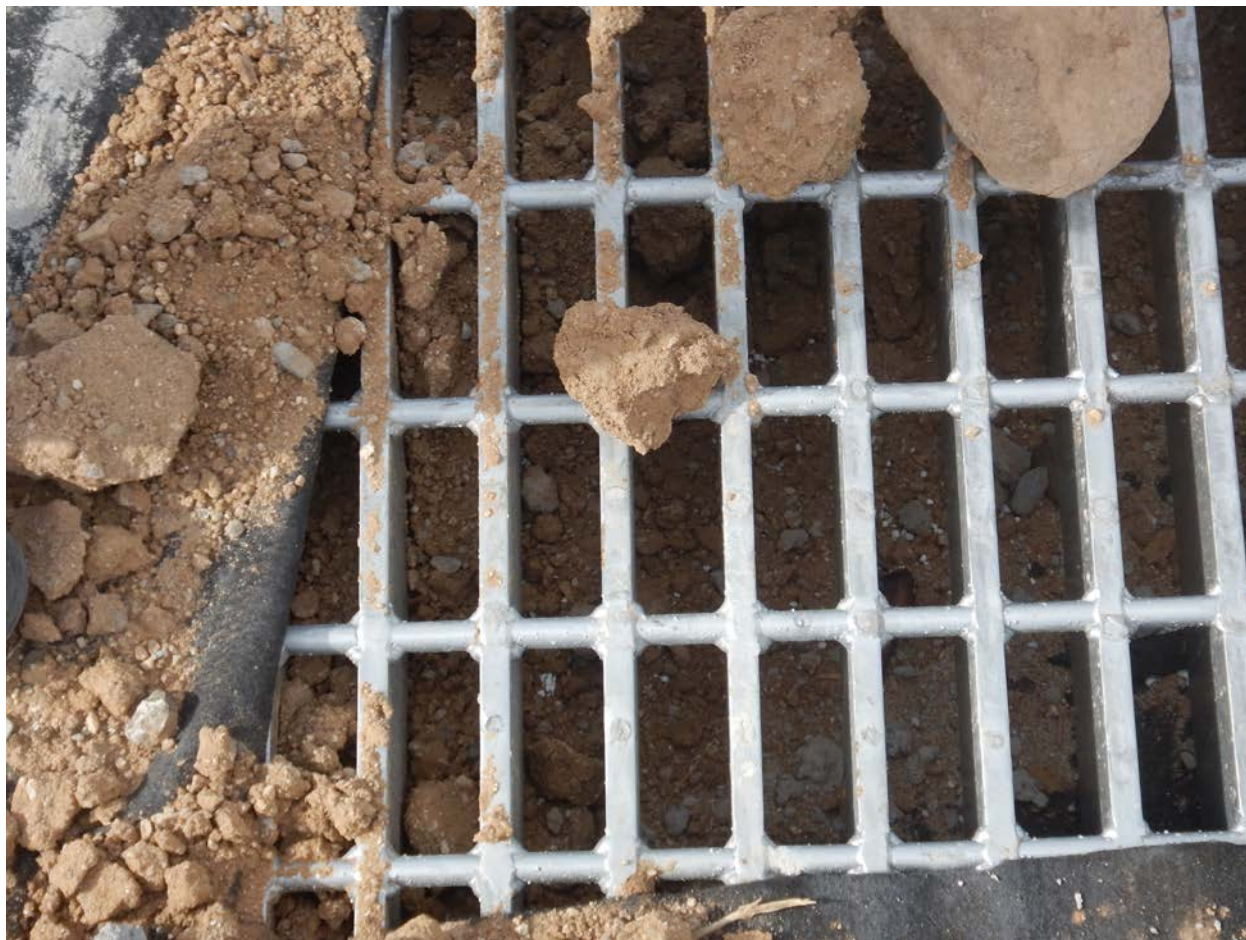
Photo No. 5

Close up picture of the drop drain (location described above). Note: cloth type fabric negating drainage, allowing accumulation of earthen debris. January 29, 2020 12:50 PM (DSCN 1693). Photographed by D. Esparza.

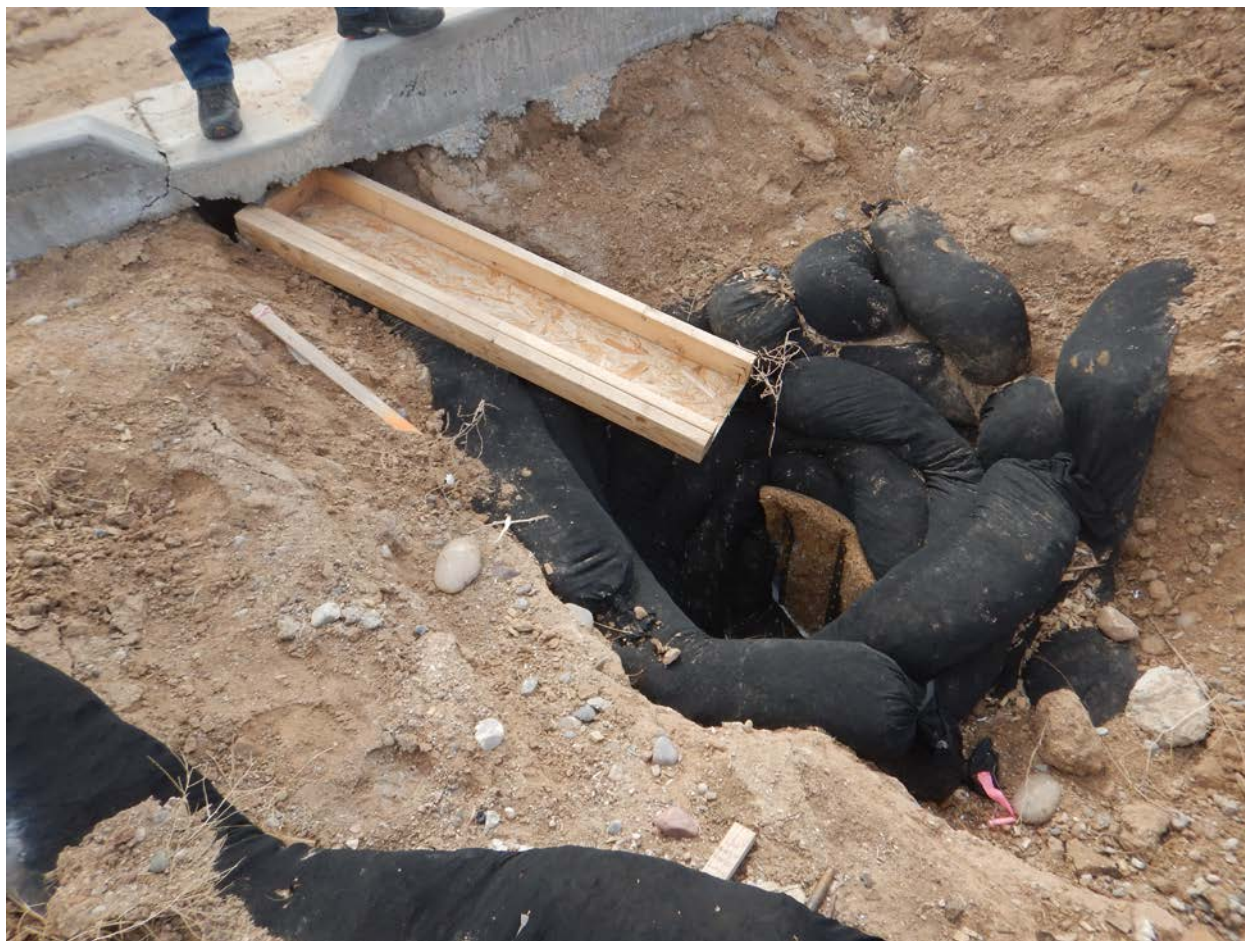
Photo No. 6

Picture of wattle lined drainage structure located at the approximate southwest corner of the building and outside the curb and gutter. January 29, 2020 1:03 PM (DSCN 1708). Photographed by D. Esparza.

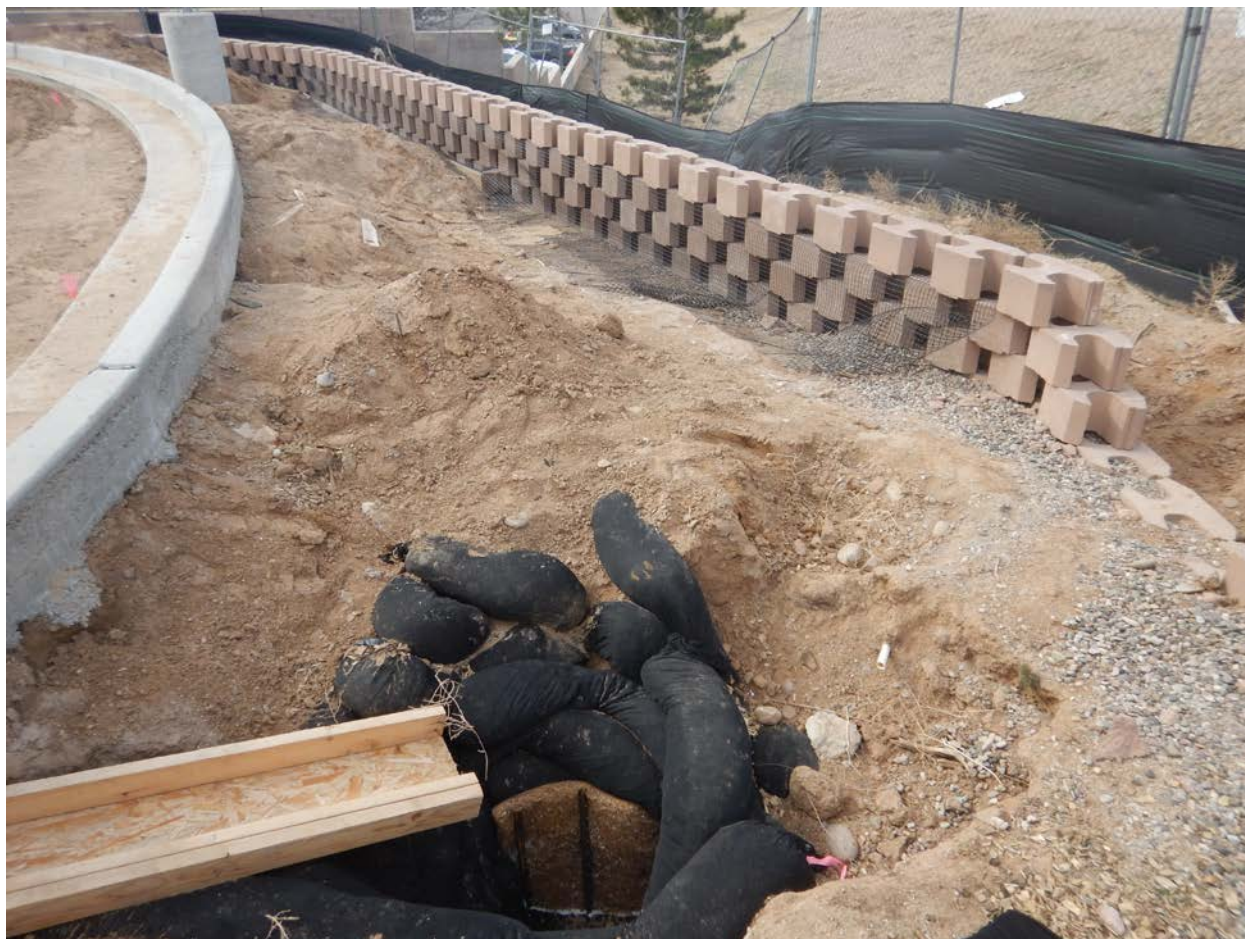
Photo No. 7

Another view of wattle lined drainage structure located at the approximate southwest corner of the building and outside the curb and gutter. January 29, 2020 1:03 PM (DSCN 1709). Photographed by D. Esparza.

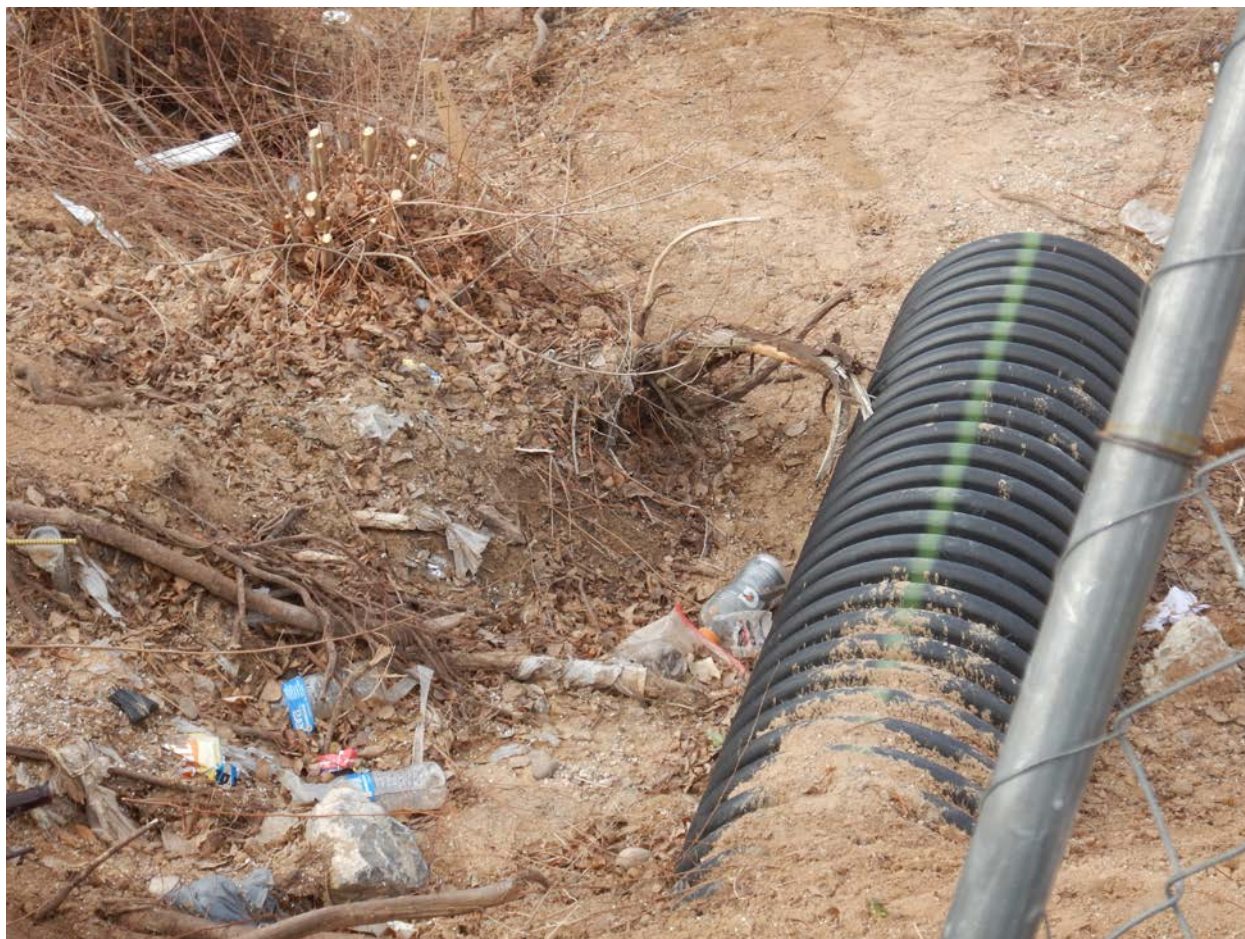
Photo No. 8

View of HDPE corrugated pipe that exits the above described wattle lined structure into an unlined arroyo adjacent to I-25 and the off ramp to Jefferson Street. Note: the HDPE pipe is outside the site perimeter fencing and the accumulated debris. January 29, 2020 1:02 PM (DSCN 1706). Photographed by D. Esparza.

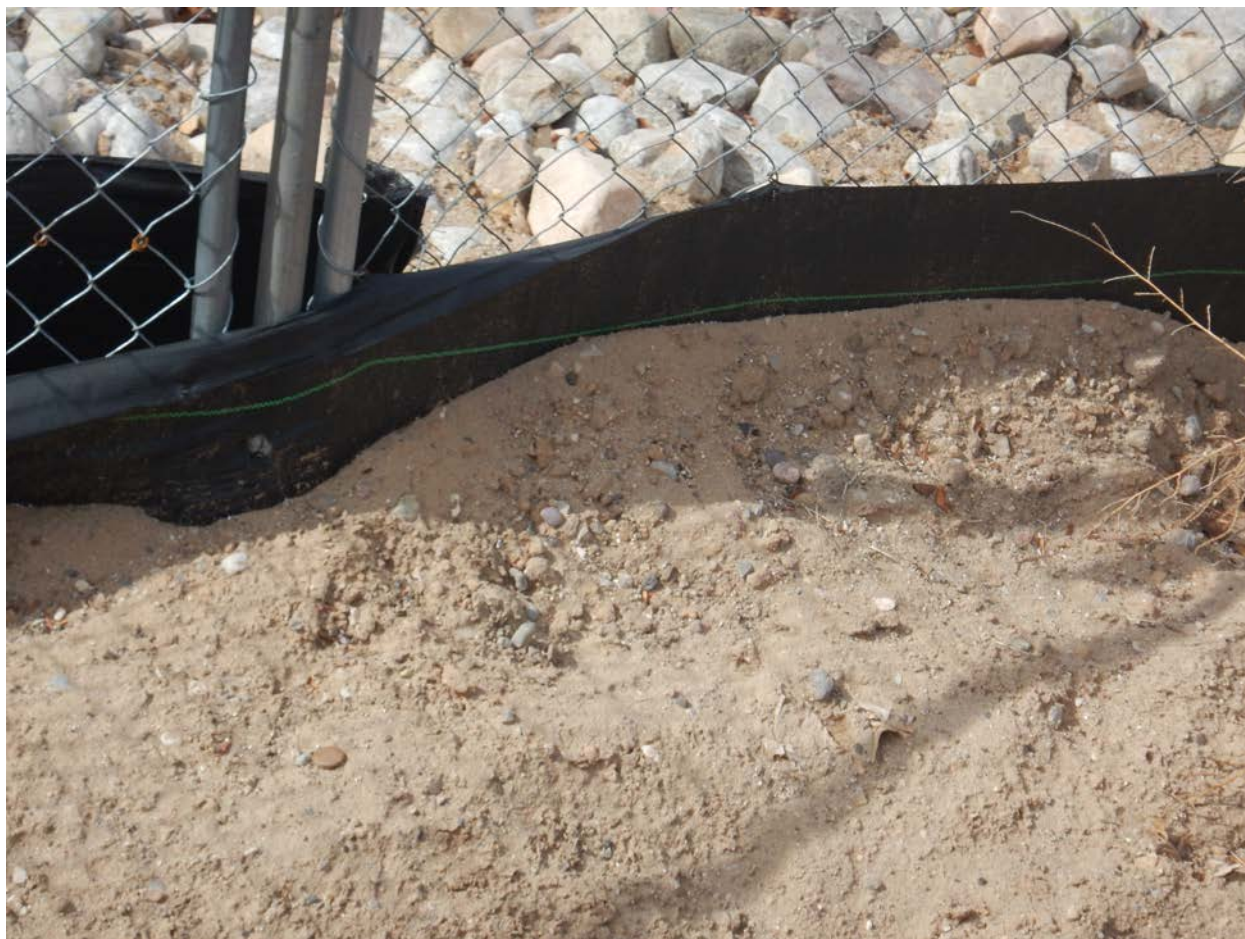
Photo No. 10

View of accumulated earthen material against existing silt fencing. January 29, 2020 12:56 PM (DSCN 1696). Photographed by D. Esparza.

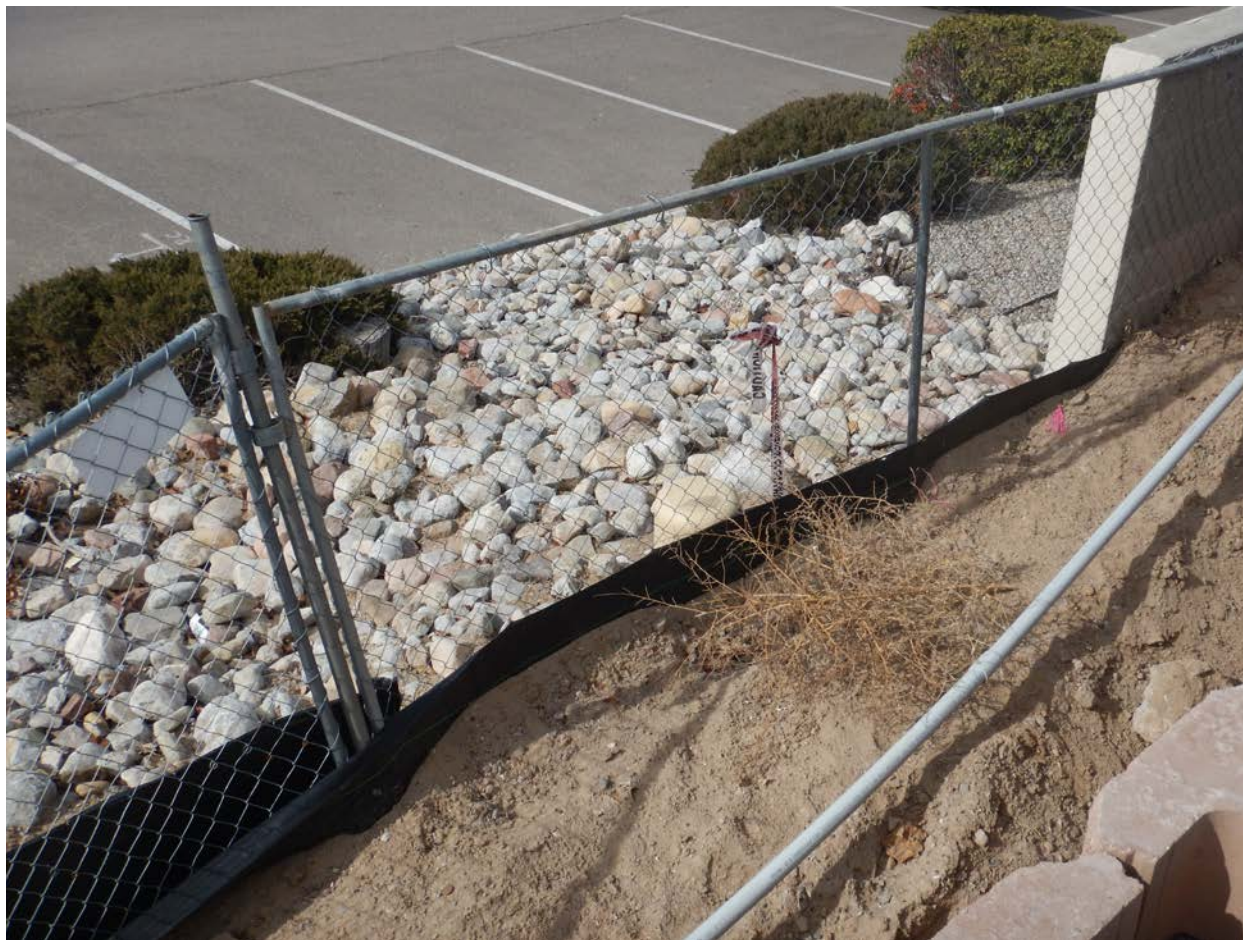
Photo No. 11

View of accumulated earthen material against existing silt fencing. Note: this picture and the picture above are located along the west side of the site. January 29, 2020 12:56 PM (DSCN 1700). Photographed by D. Esparza.

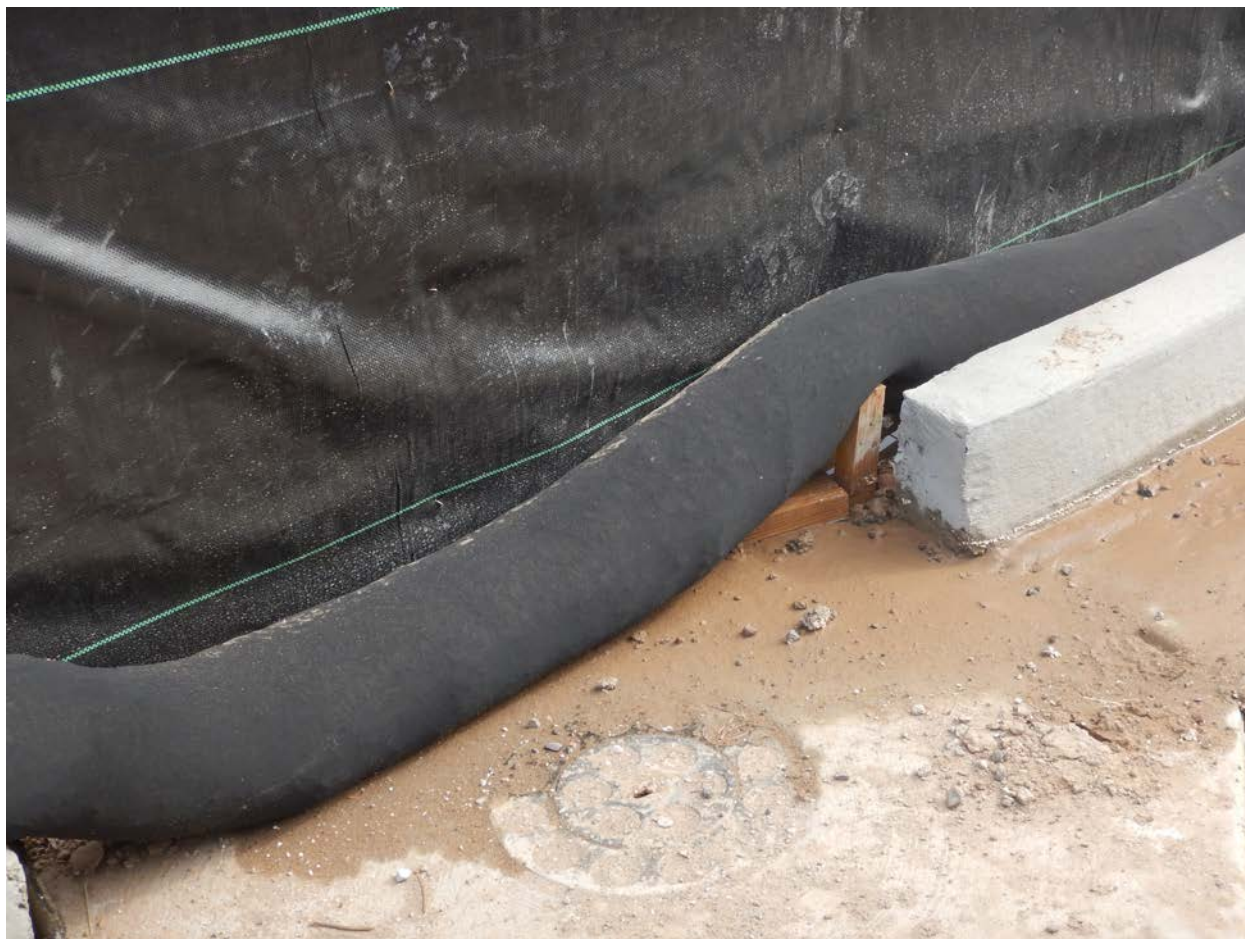
Photo No. 12

View of potential run-on location from adjacent up gradient property. January 29, 2020 1:06 PM (DSCN 1711). Photographed by D. Esparza.

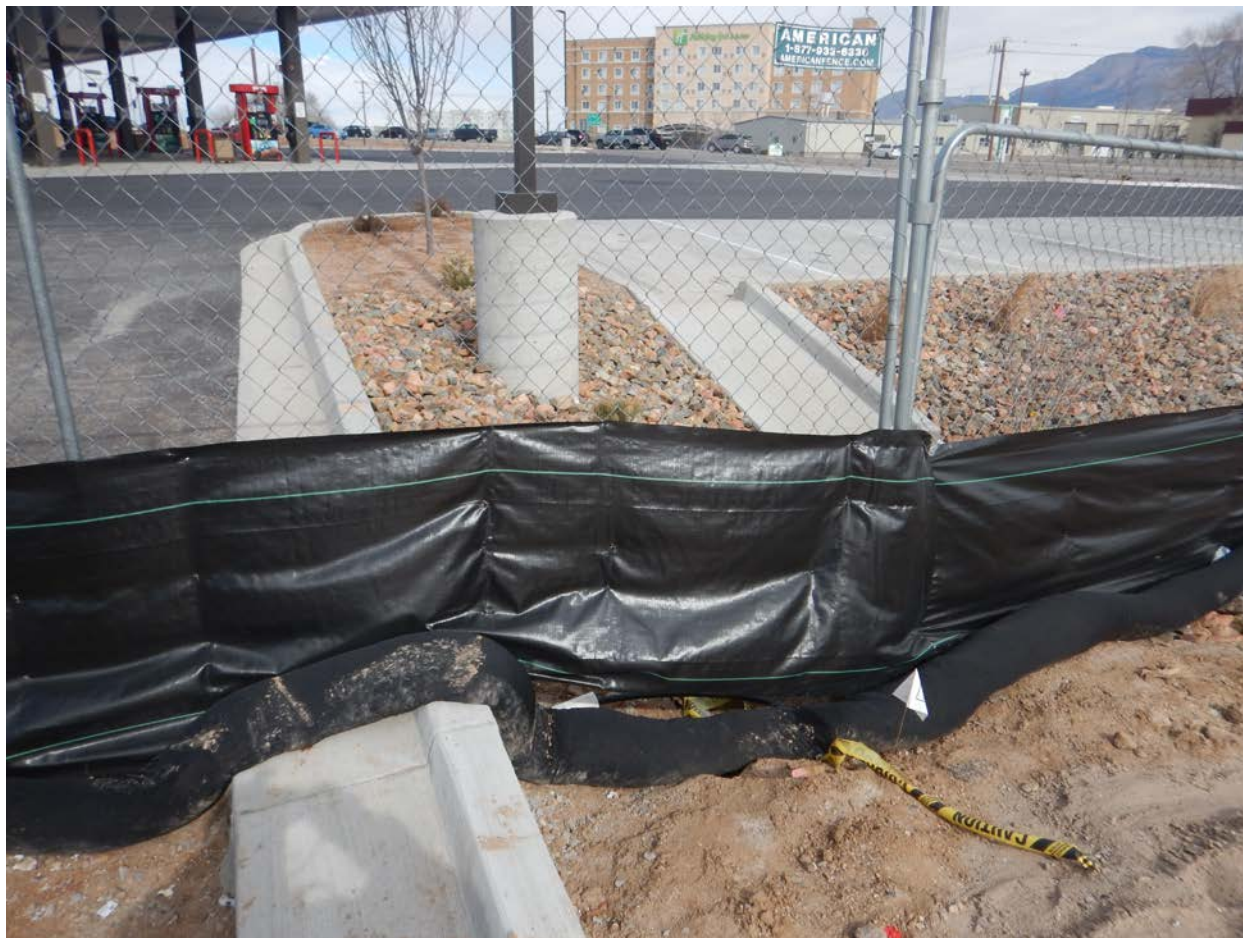
Photo No. 13

View of potential run-on location from adjacent up gradient property. January 29, 2020 1:11 PM (DSCN 1713). Photographed by D. Esparza.
