2200 VISTA ORIENTE

ALBUQUERQUE, NM

TEMPORARY EROSION AND SEDIMENT CONTROL PLAN

PAGE INDEX	
1	TITLE PAGE
2	SWPPP INFO AND NOTES
3	DETAILS
4	TEMPORARY EROSION CONTROL PLAN

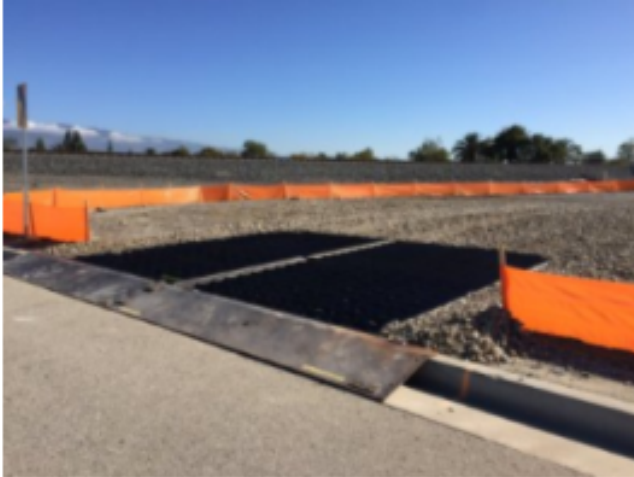
SEDIMENT TRACK OUT CONTROL

- BMP Objectives**
- Sediment Control

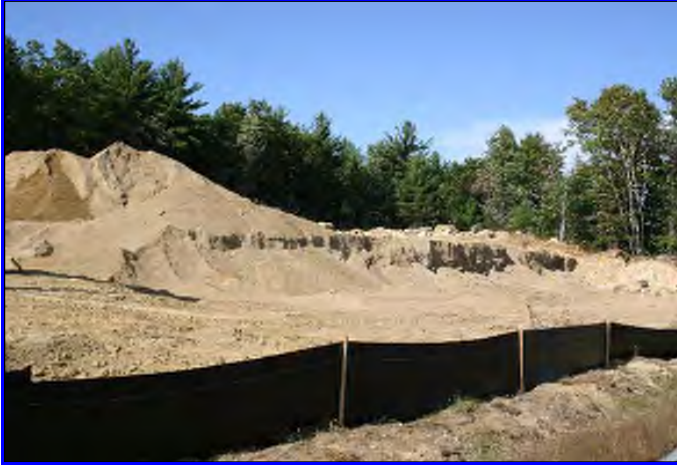
SILT FENCE

- BMP Objectives**
- Sediment Control
 - Sheet Flow Runoff Control
 - Wind Erosion Control

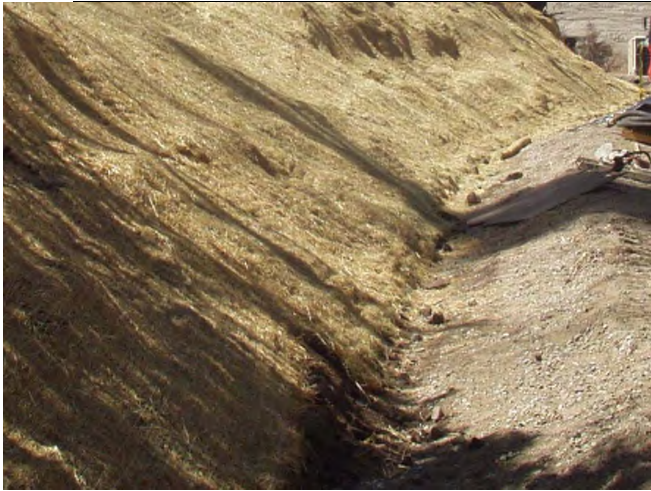
BERMS AND SWALES

- BMP Objectives**
- Runoff Control
 - Run-on Diversion

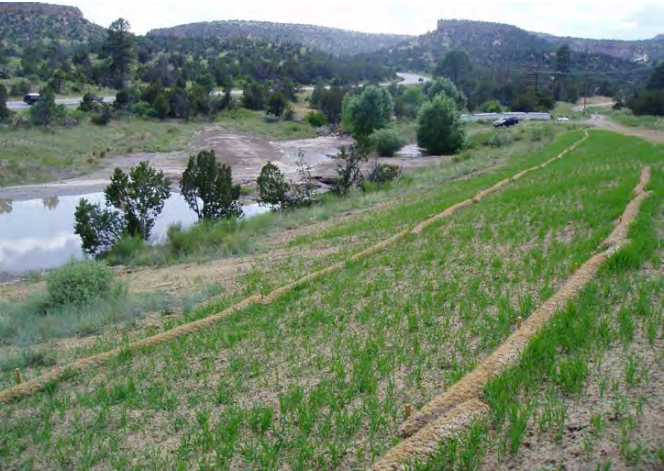
MULCH SOCK/STRAW WATTLE

- BMP Objectives**
- Sediment Control
 - Reduce Runoff Velocity
 - Inlet Protection

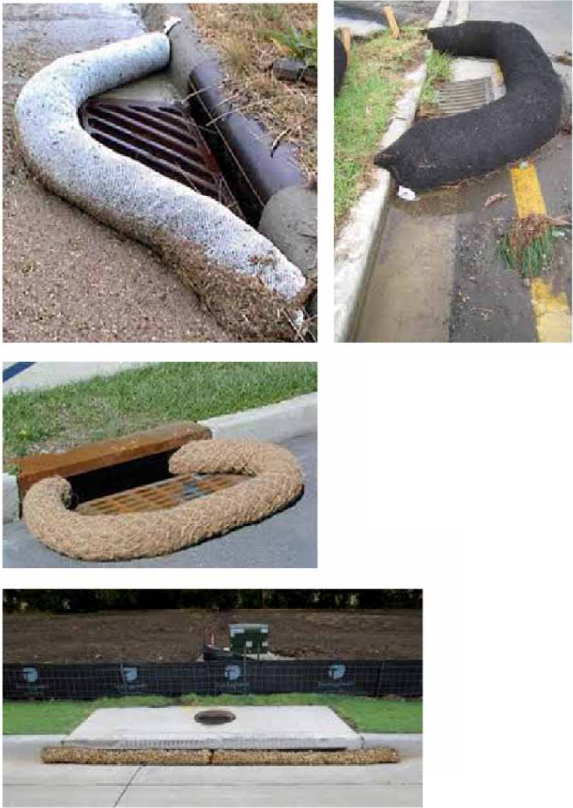
INLET PROTECTION

- BMP Objectives**
- Sediment Control
 - Sheet Flow Runoff Control
 - Wind Erosion Control
