# Site Traffic Analysis for Fortuna Rd Coffee Shop

## Final Report

March 2020

Prepared for:  
Accelerated Development Services

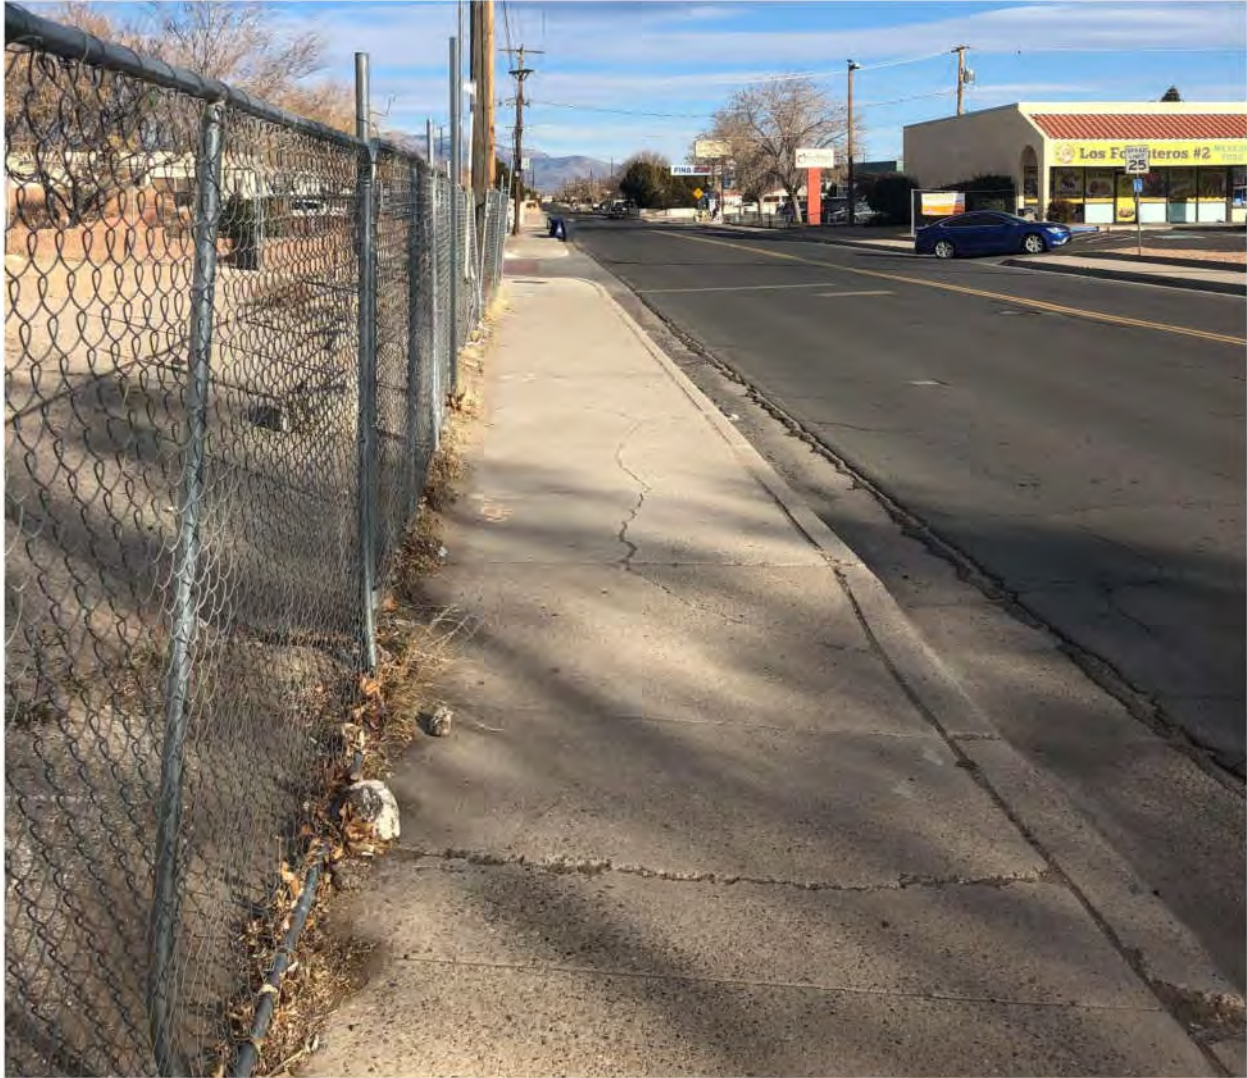
*Figure 7: Right Turn Sight Distance Field Review*

A field review of sight distance was performed for the site driveway on Fortuna Rd. Figure 7 and Figure 8 show available sight distance for right turns and left turns from the driveway. At the time of the review, a chain-link fence around the site prohibited a traditional sight distance review where the reviewer is placed 14.5 feet back from the edge of curb. Therefore, it is noted that true sight distance provided may vary. As measured under current field conditions, approximate sight distance was measured to be as follows:

| Turning Direction | Field Measured Sight Distance |
|---|---|
| Right Turn | Approx. 335 feet to next intersection (Estancias Dr) |

Although the site plan is currently in the preliminary stages, pending the position of the site’s access driveway as detailed in a subsequent section, it is recommended that all development driveways adhere to the sight distance provisions detailed in the AASHTO “Green Book”. An area bounded by the above sight distances with the decision point placed 14.5 feet back from the edge of the shoulder midway between the outbound driving lane should be maintained clear of any obstructions. Due to the proximity of Coors Blvd, it is recommended that existing sight distance to the west be maintained.

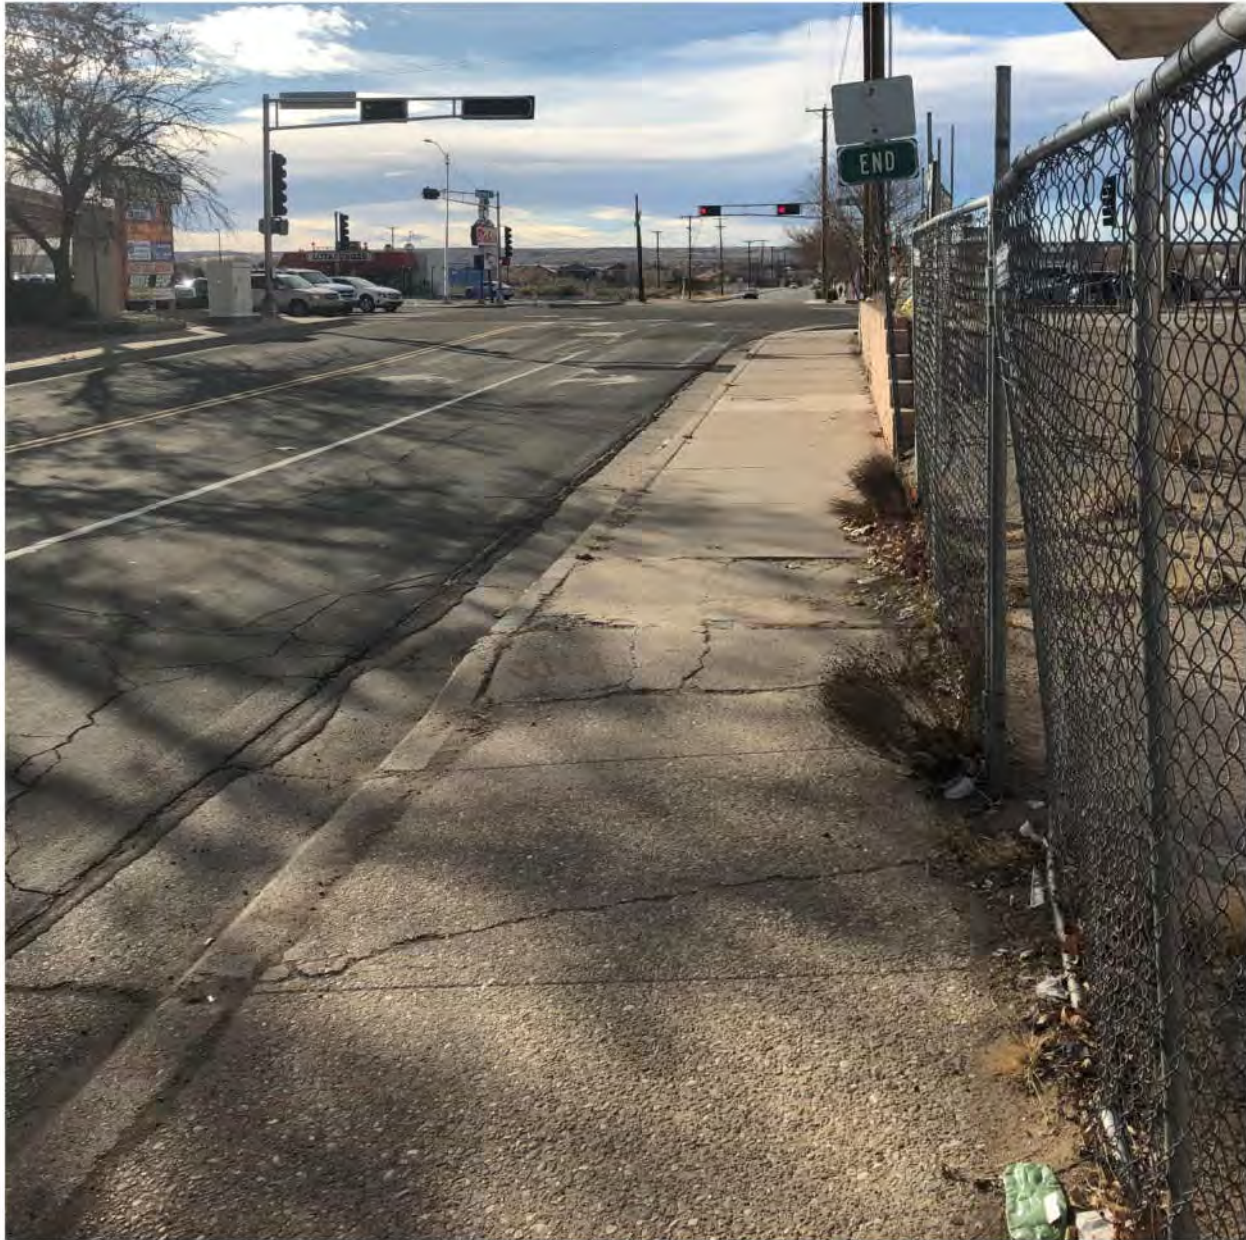
*Figure 8: Left Turn Sight Distance Field Review*

| Turning Direction | Field Measured Sight Distance |
|---|---|
| Left Turn | Approx. 165 feet to next intersection (Coors Blvd) |
