Site Traffic Analysis for Fortuna Rd Coffee Shop

Final Report

March 2020

Prepared for:
Accelerated Development Services

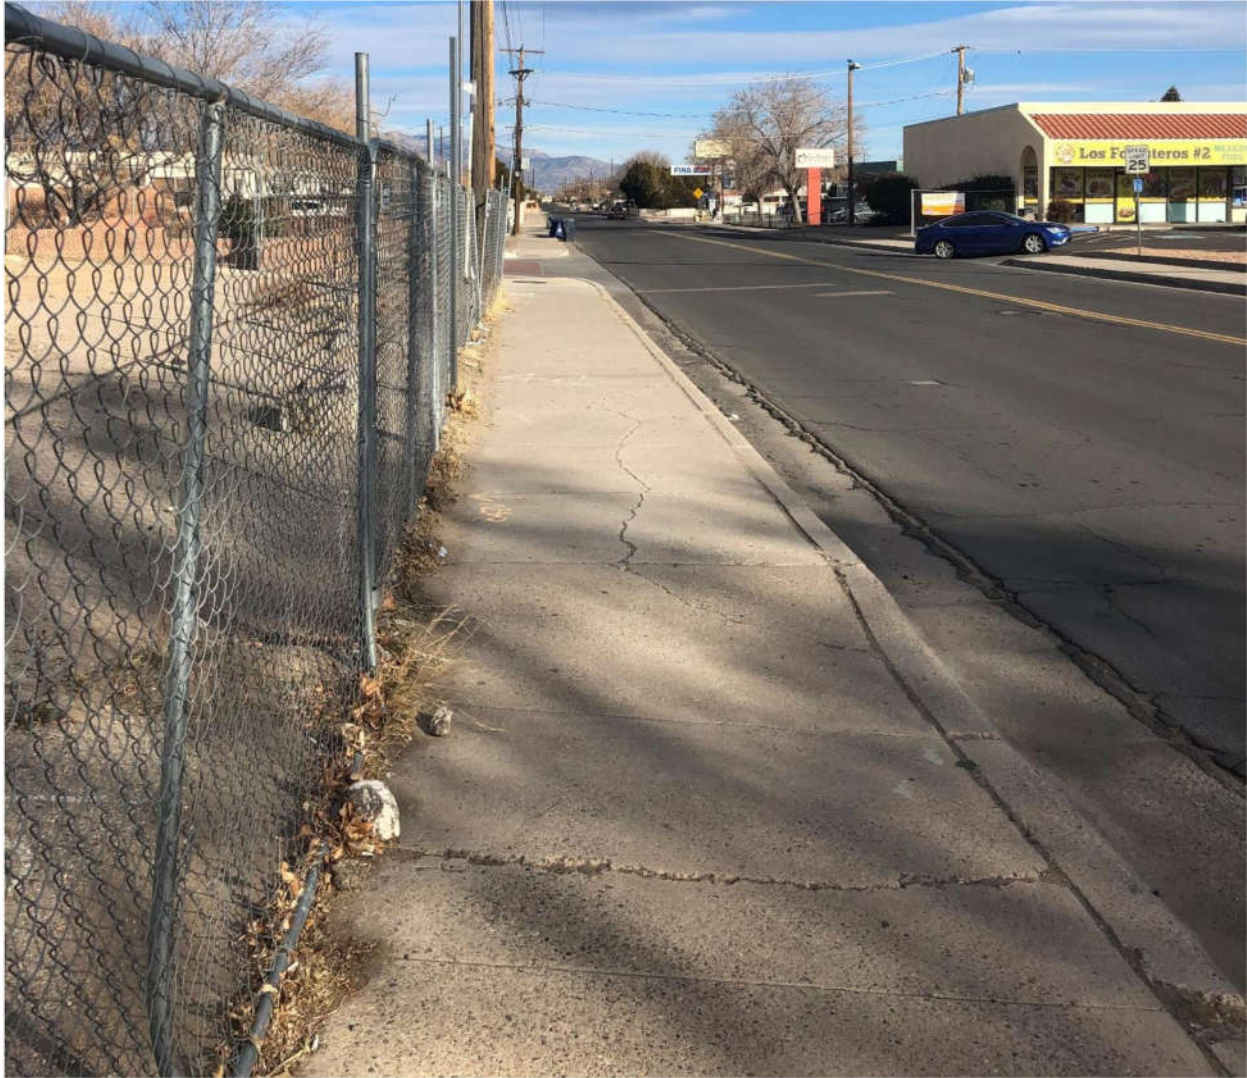
Figure 7: Right Turn Sight Distance Field Review

A field review of sight distance was performed for the site driveway on Fortuna Rd. Figure 7 and Figure 8 show available sight distance for right turns and left turns from the driveway. At the time of the review, a chain-link fence around the site prohibited a traditional sight distance review where the reviewer is placed 14.5 feet back from the edge of curb. Therefore, it is noted that true sight distance provided may vary. As measured under current field conditions, approximate sight distance was measured to be as follows:

Turning Direction	Field Measured Sight Distance
Right Turn	Approx. 335 feet to next intersection (Estancias Dr)
Left Turn	Approx. 165 feet to next intersection (Coors Blvd)

Although the site plan is currently in the preliminary stages, pending the position of the site’s access driveway as detailed in a subsequent section, it is recommended that all development driveways adhere to the sight distance provisions detailed in the AASHTO “Green Book”. An area bounded by the above sight distances with the decision point placed 14.5 feet back from the edge of the shoulder midway between the outbound driving lane should be maintained clear of any obstructions. Due to the proximity of Coors Blvd, it is recommended that existing sight distance to the west be maintained.
