Development & Commercial Stormwater Construction Site Inspection Report

Site: Garcia Honda

Re: Drainage Ordinance (14-5-2-1) Violations for Erosion and Sediment Control

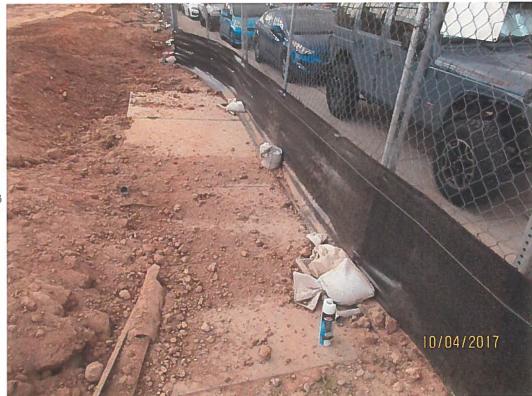
1. The silt fence is not sealed/buried along the western edge of the site.

Silt fence not sealed on concrete surface.

- 1. A filter sock/wattle is required where the silt fence is installed over concrete surfaces.
- 2. The silt fence is to be buried or a filter sock/wattle placed at the bottom of the silt fence where the grade on site adjacent to the curb is 3 inches or less below the top of curb (e.g. if on site grade is 6 inches below the top of curb then can leave installation as is in these areas, with the condition that sediment does not leave the site in these areas).

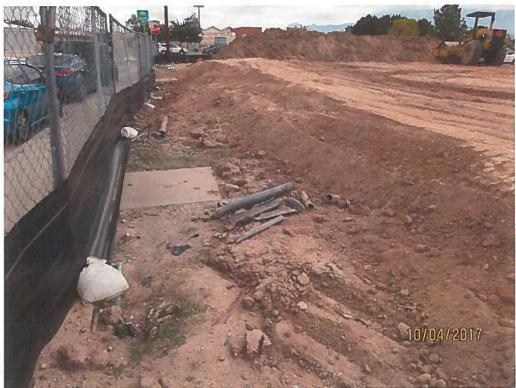
Silt fence not buried/sealed.
