FIESTA SUBARU CAR DEALERSHIP

TEMPORARY EROSION AND SEDIMENT CONTROL PLAN

PAGE INDEX	
1	TITLE PAGE
2	SWPPP INFO AND NOTES
3	DETAILS
4	TEMPORARY EROSION CONTROL PLAN

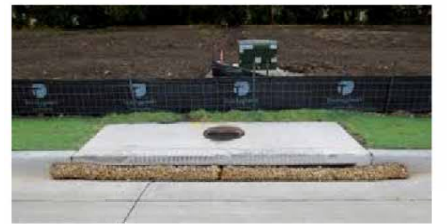
- Sediment Control
- Sheet Flow Runoff Control
- Wind Erosion Control

- Sediment Control
- Reduce Runoff Velocity
- Inlet Protection

- Runoff Control
- Run-on Diversion
