PRELIMINARY REPORT

**ALBUQUERQUE STORM WATER PUMPING STATIONS
REHABILITATION STUDY - PHASE I
STATIONS : 26, 27, 32, 34, 35, 36, 37,
AND ALCALDE (PROPOSED)**

BOVAY ENGINEERS, INC.

BELL/COMMERCIAL S.E. STATION NO. 37

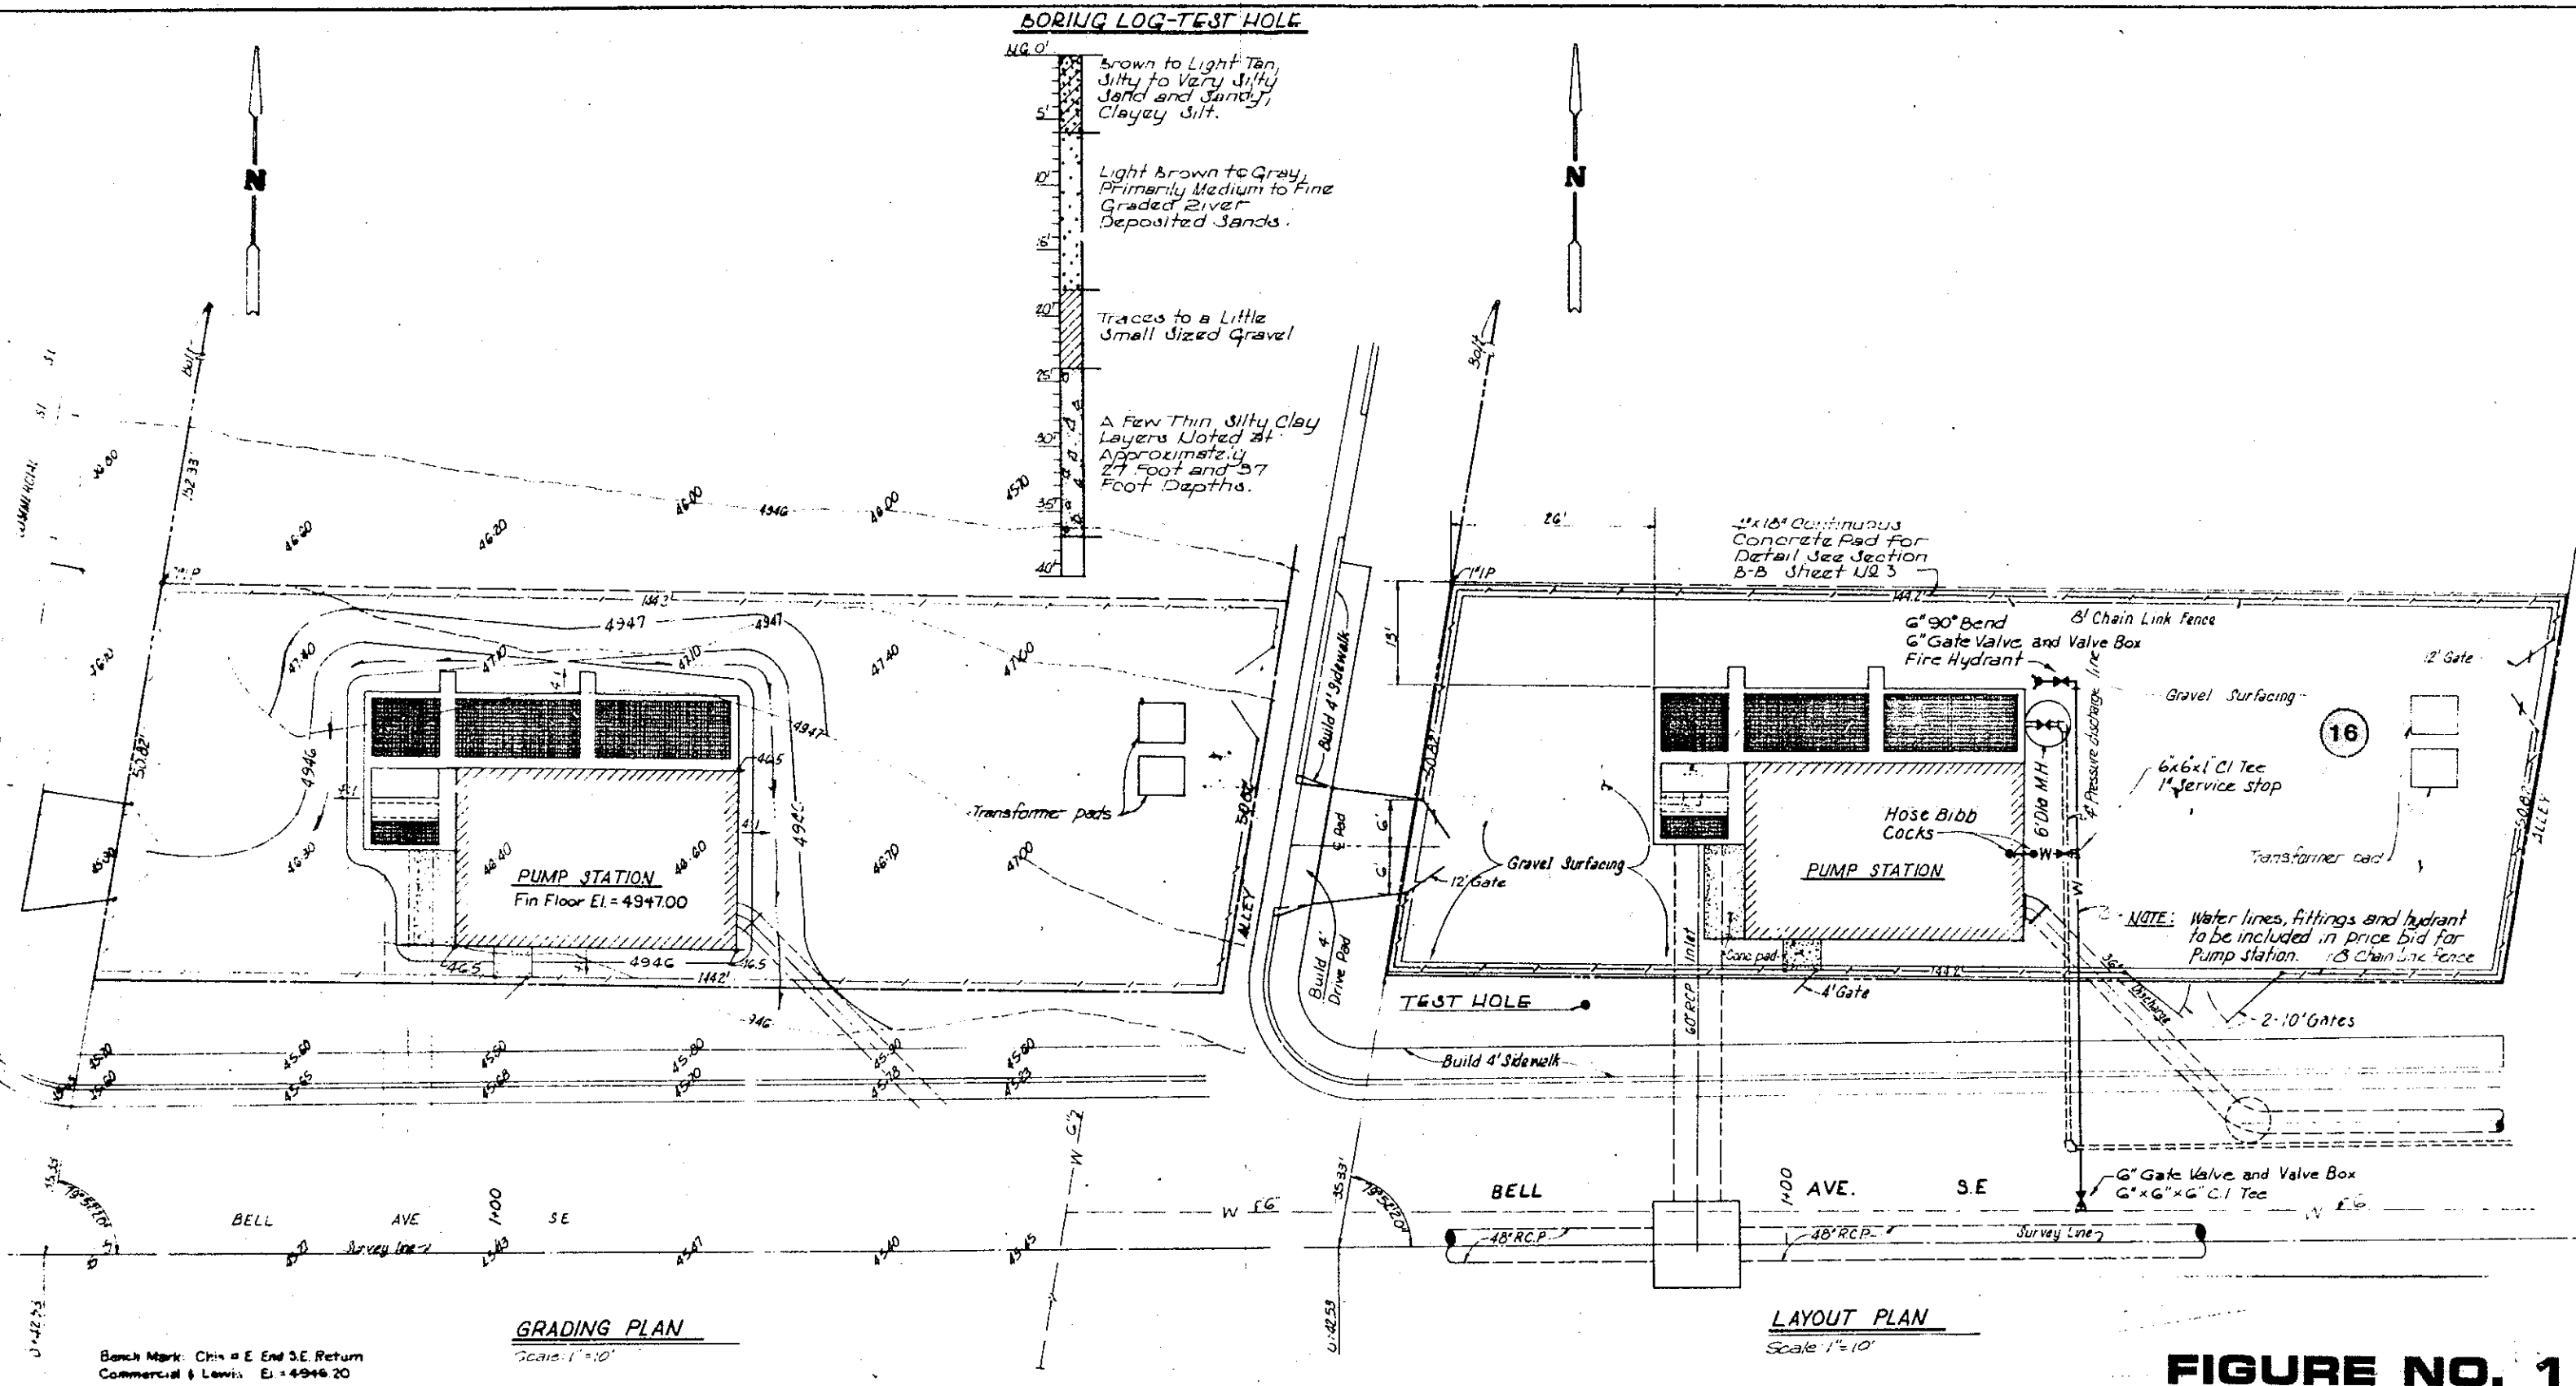
KEY TO FIGURES 1 & 2
BELL/COMMERCIAL STATION NO. 37

1. All motors line shaft protective guards at intermediate level.
2. Safety-climb devices added; split level ladder run modification.
3. Second dry well exit ladder added with safety provisions.
4. Extension added to ladders; toeboards additions to platforms.
5. Intermediate railings added at platforms.
6. Floor conduit yellow safety painting/markings.
7. All pumps - control valves repair/overhauls, replace seals/repacking.
8. Pumps 2 & 3 - isolation valves added (knife gate valves).
9. Sump pumps - overhauling/renovating.
10. All equipment markings, identification with vinyl markers.
11. All gauges/recorders testing/recalibrating.
12. Running time meters added for motors 2 & 3.
13. Back up duplicate air compressor.
14. Overhead hoists/crane extension
15. Dry well - floor level mechanical jack and gantry crane.
16. Power supply back up to station.
