STRUCTURAL, SITE WORK, AND INTERIOR / EXTERIOR REPAIRS TO: CHILDREN, YOUTH, & FAMILIES DEPARTMENT OF THE STATE OF N.M. 1031 LAMBERTON PLACE NE ALBUQUERQUE, NM 87107

Sheet Title: **GRADING NOTES** 07905 ÅNW Drawn By: Project No FCA 06.27.14 Checked By: Date:

GRADING PLAN & DETAILS

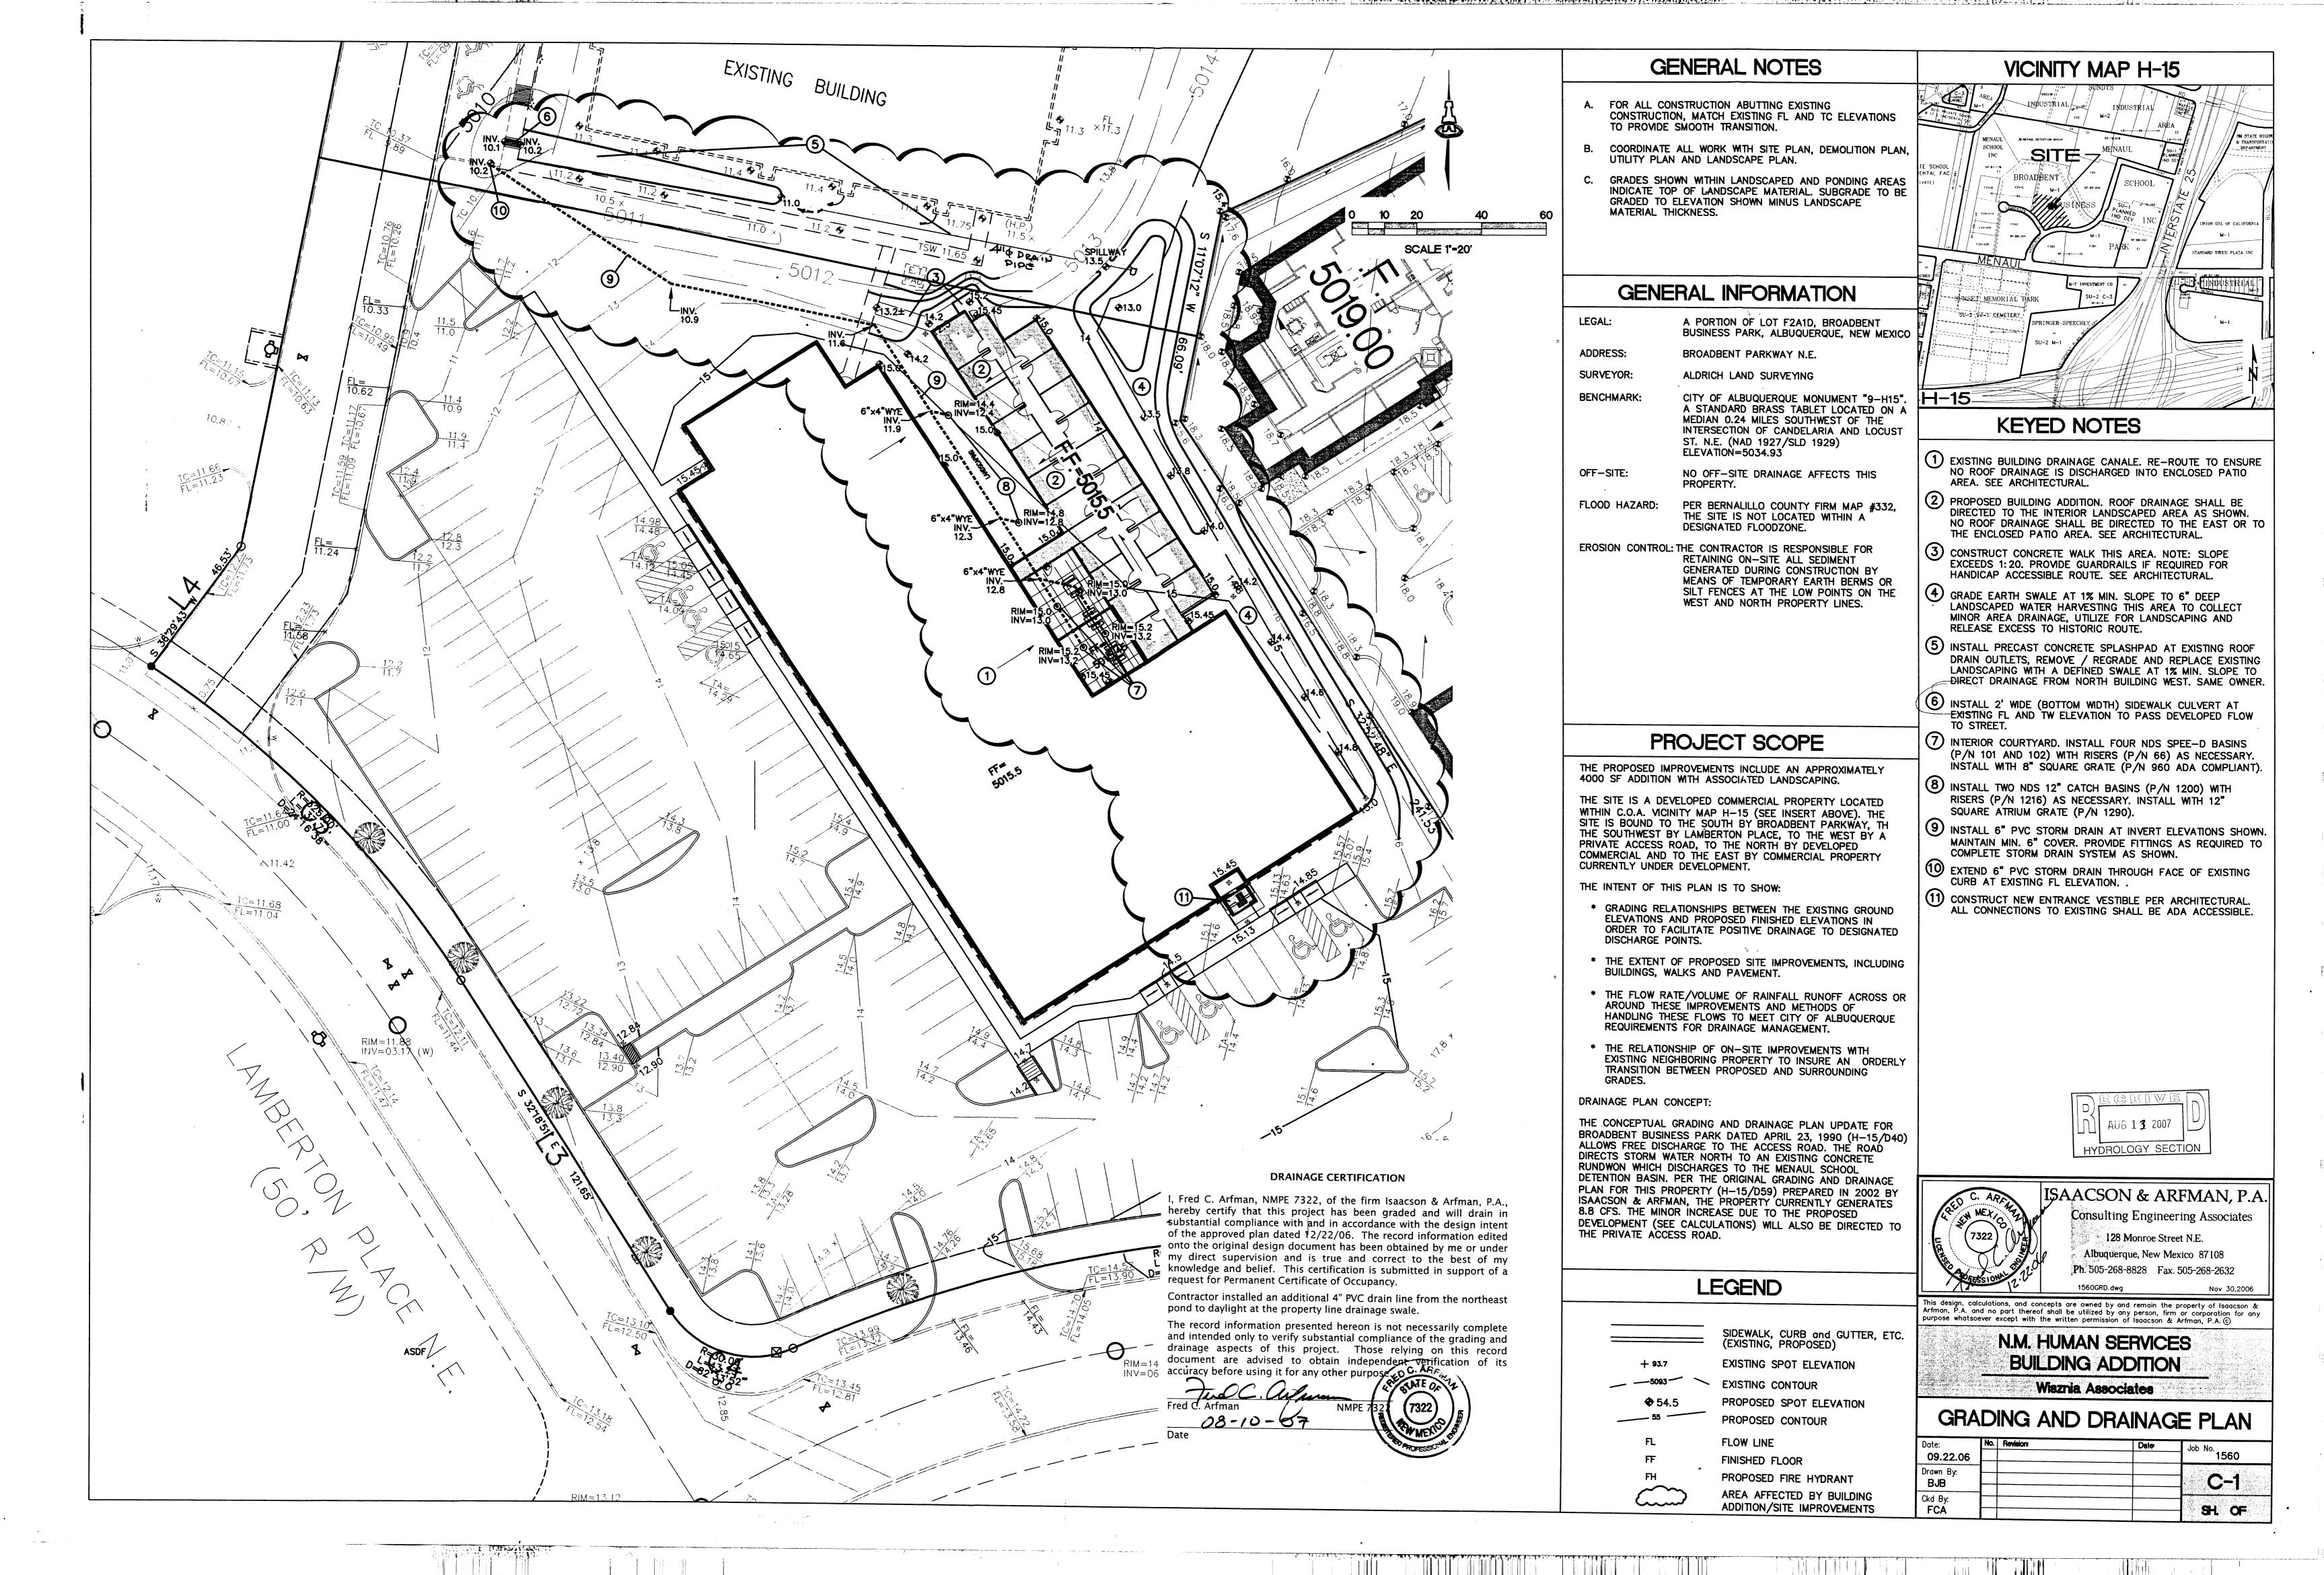
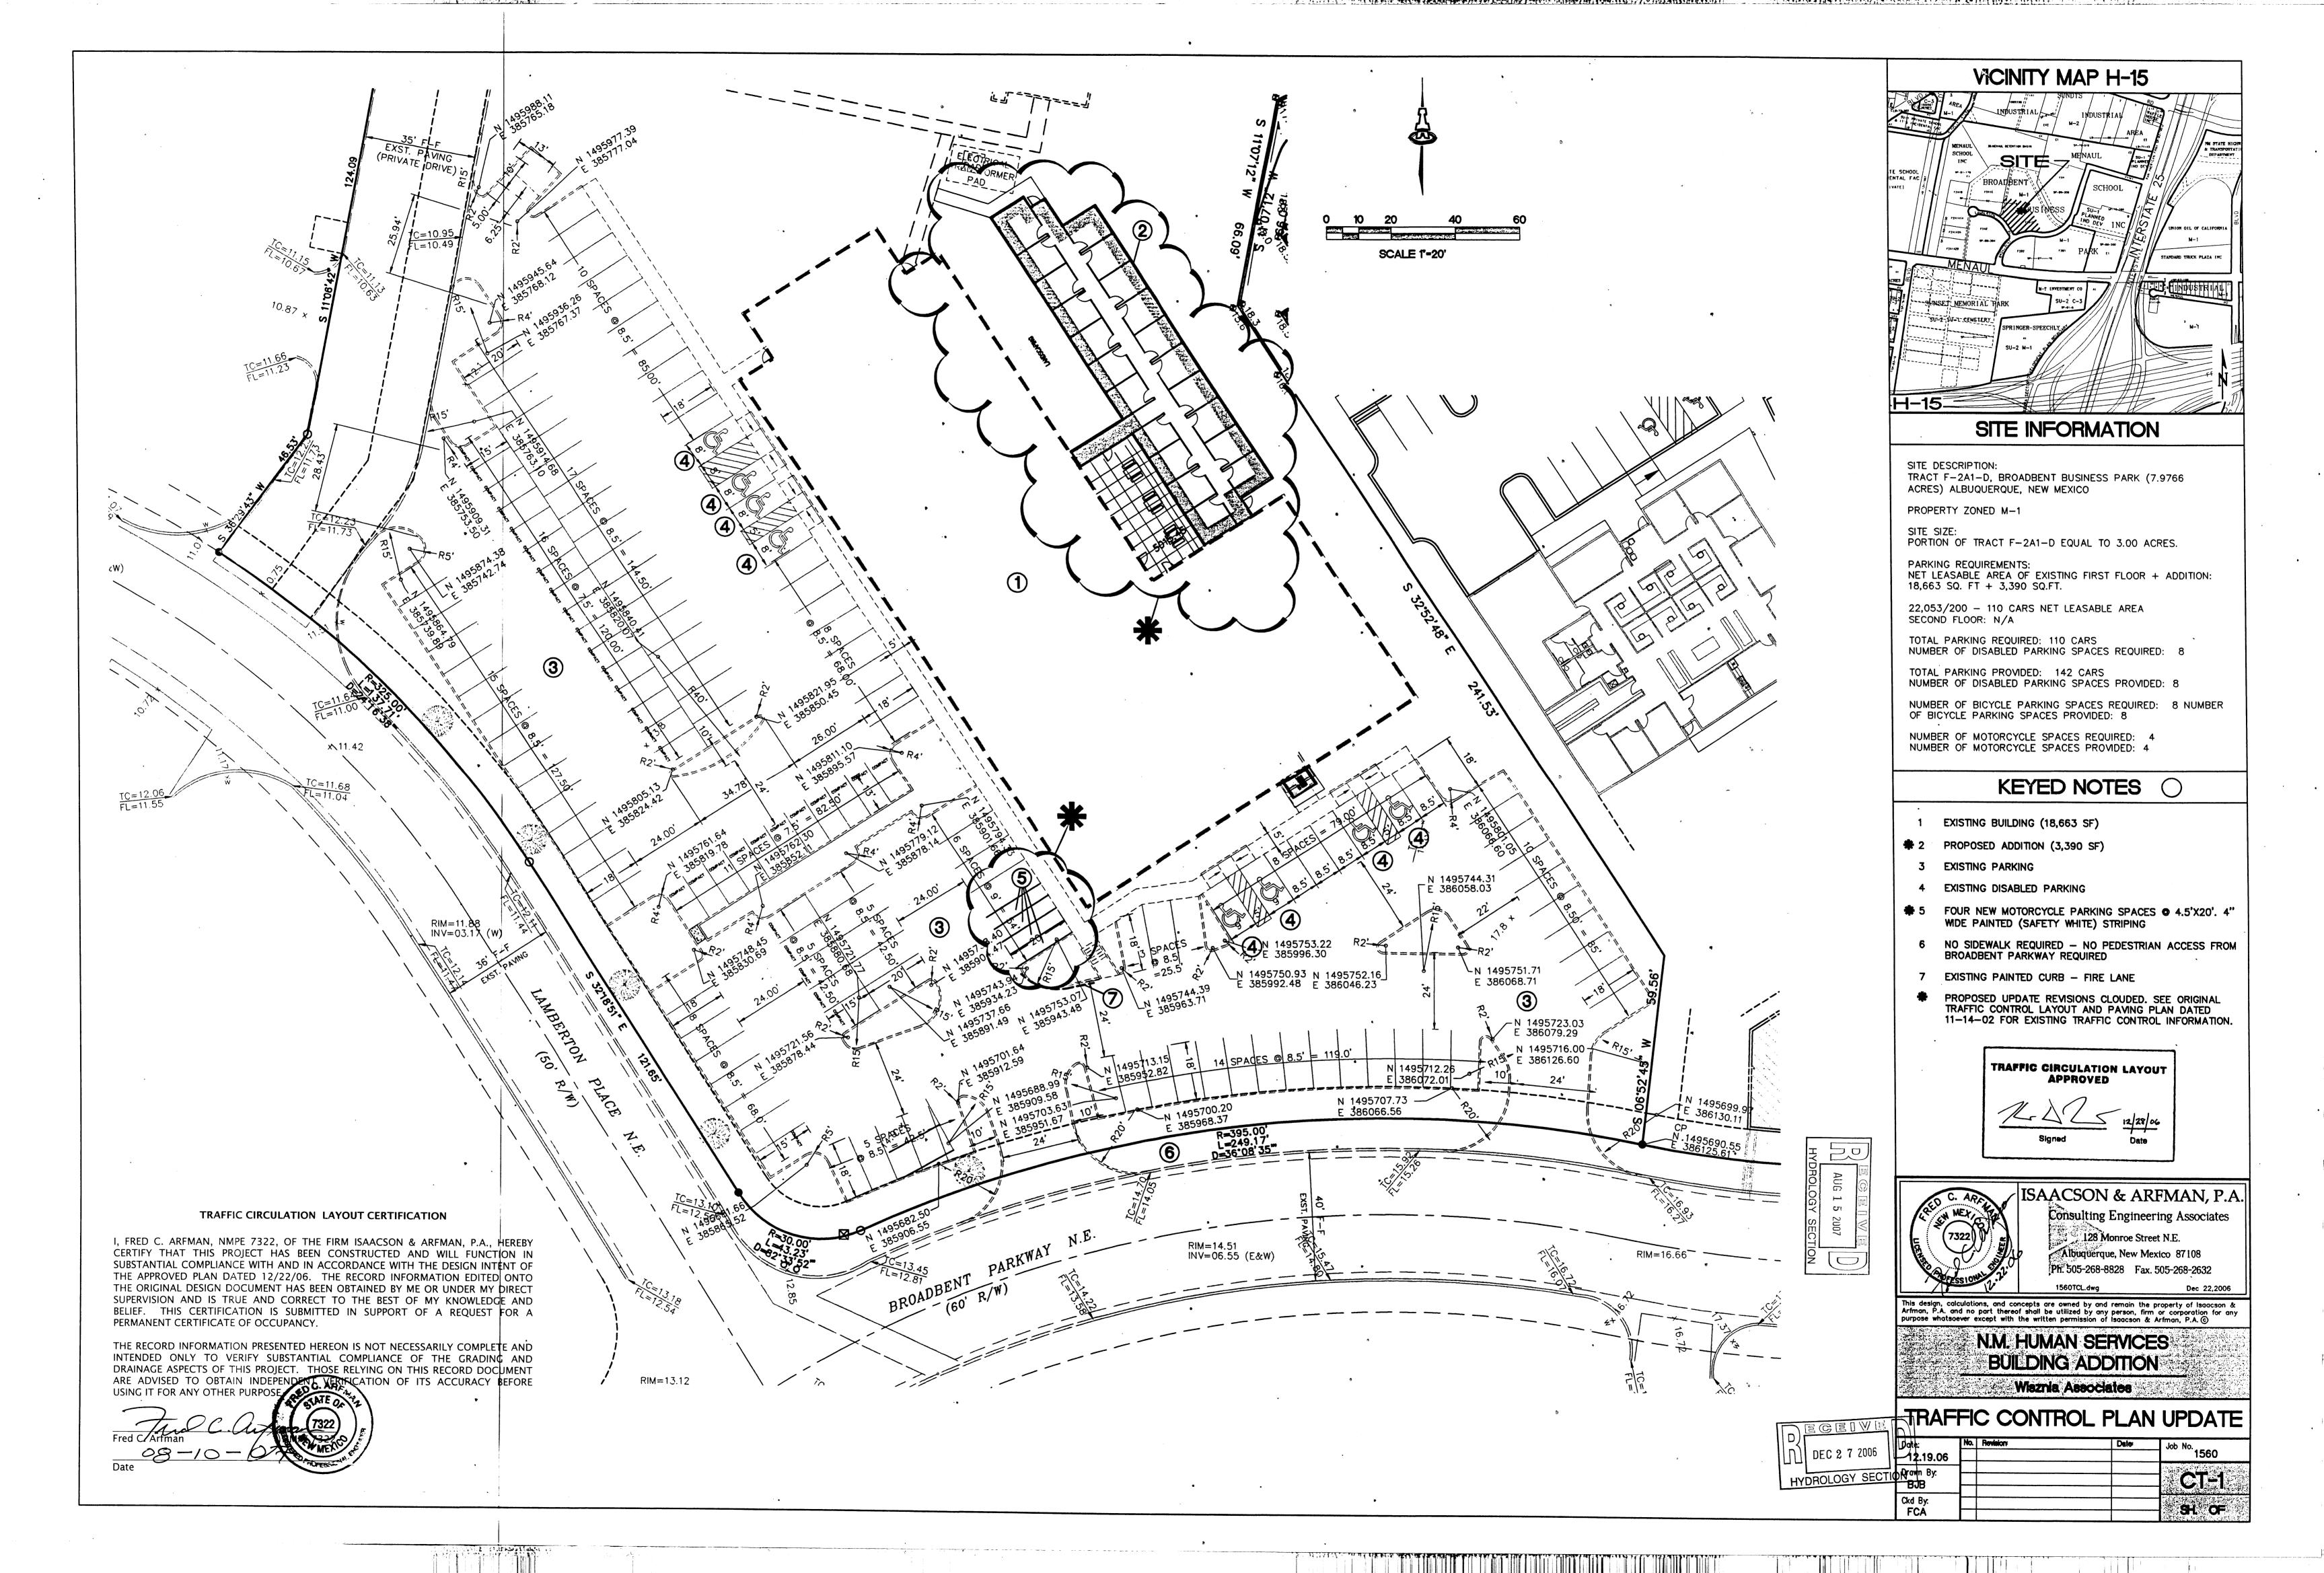
THE ORIGINAL GRADING PLAN (2002) DID NOT INDICATE A SIDEWALK TO THE EAST OF THE BUILDING DOORWAY. THE SIDEWALK IS INSTALLED HIGHER THAN THE GRADE AT THE BUILDING, SO WATER FROM THE THREE ROOF DRAINS IS TRAPPED BETWEEN THE BUILDING AND THE SIDEWALK.

THE ORIGINAL GRADING PLAN SHOWED A SWALE FROM THE SOUTHEAST BUILDING CORNER TO A CURB OPENING EAST OF THE NORTHEAST BUILDING CORNER. THE AS-BUILT GRADE AT THE CURB OPENING IS HIGHER THAN WHAT WAS SHOWN ON ORIGINAL GRADING PLAN SO THE SWALE DOES NOT FUNCTION. CURRENTLY, WATER IS BEING PONDED ADJACENT TO THE BUILDING.

THE GRADES AT THE SOUTHEAST CORNER OF THE SITE ARE HIGHER THAN THE BUILDING. THERE ARE TWO ROOF DRAINS AT THE SOUTH SIDE OF THE BUILDING WHERE THE SOIL HAS ERODED SIGNIFICANTLY.

THE GRADES ALONG THE WEST SIDE OF THE BUILDING APPEAR TO HAVE SUFFICIENT SLOPE TO THE WEST. THERE IS A SMALL HOSE BIB IN THE WALL SOUTH OF THE BUILDING ENTRANCE THAT APPEARS TO HAVE LEAKED CAUSING DAMAGE TO THE WALL. ADDITIONAL AREAS OF BUILDING CRACKING AND STAINING WERE OBSERVED.

INSTALL 12" SIDEWALK DRAINS AT ROOF DRAIN LOCATIONS (2) TOTAL) AND INSTALL AN IMPERMEABLE LINER IN LANDSCAPE AREAS. TO CAPTURE WATER DURING SNOWMELT AND MINIMIZE ICE FORMING ON SIDEWALK AND PAVEMENT, SIDEWALK DRAIN OUTLETS SHALL CONNECT TO A NEW 8" STORM DRAIN MAIN EXTENDING TO A NEW BUBBLE UP INLET IN THE NORTHWEST MEDIAN. DURING LARGER STORM EVENTS, THE WATER NOT CAPTURED BY THE SIDEWALK DRAIN DOWN PIPES WOULD CONTINUE TO BE DIRECTED TO THE NORTH PARKING LOT THROUGH THE SIDEWALK DRAIN CURB OPENING AND OVER THE SIDEWALK.

REGRADE THIS AREA TO ESTABLISH POSITIVE DRAINAGE AWAY FROM THE BUILDING AND GRADE A WATER HARVESTING BASIN WITH A PERCOLATION PIT AND SURFACE OVERFLOW TO THE EXISTING CURB OPENING.

CONTRACTOR SHALL PROVIDE AN ITEMIZED PROPOSAL FOR ALL WORK/REPAIRS REQUIRED PER THE ASSESSMENT.
