CITY OF ALBUQUERQUE

Site: Inspiration Subdivision at Arroyo Vista Blvd/ 118th St. NW – J08E005

Re: Drainage Ordinance (14-5-2-11) Violations for Erosion and Sediment Control

This Notice of Violation #2 pertains to observation during City Follow-up inspections on 9/1/22 and 9/15/22.

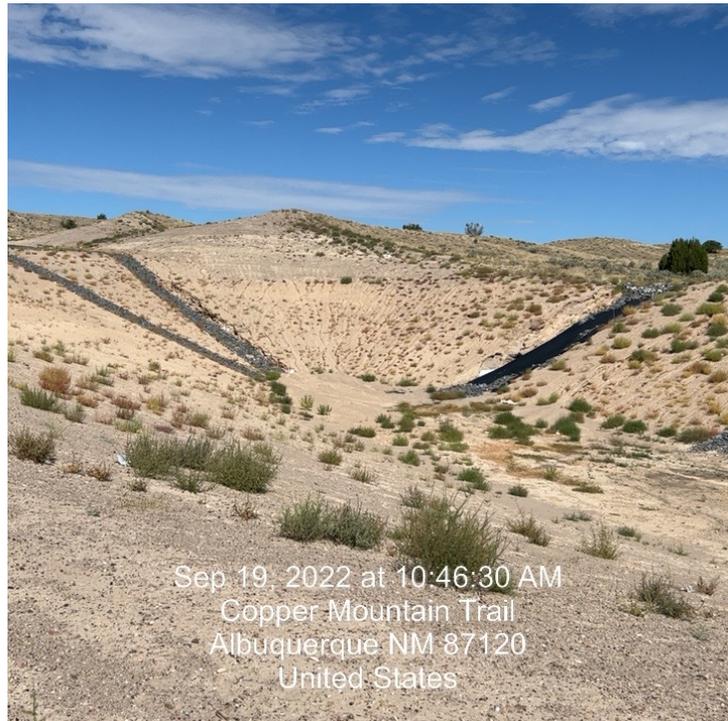
Two sediment basins are identified on the SWPPP map, but the SWPPP doesn't provide any criteria for inspection or a maintenance schedule for these BMPs, as required by CGP 9.6.1.c.i, so it isn't clear how to remedy the waste floating on top of the brackish water the First Flush Pond in the south east corner of the subdivision. It has an as-built retention volume of 0.93 ac-ft which is less than 1/3 of the volume required for Sediment Basins

by CGP 2.2.12. The pond has had standing water in it during every inspection since 7/6/22. Infiltration is prevented by shotcrete lined sides and a dirt bottom that is sealed with fine sediment. The pond owner, Inspiration Community Association Inc., doesn't have an NOI. They also own another dirt pond on a 1.1 acre tract along the north edge of the subdivision that needs to be stabilized per CGP 2.2.14. So permit coverage is required for the Association and the transfer must be shown on Pulte's SWPPP. Severe erosion at two of the rip-rap rundowns needs repaired and the tumble weeds in the picture to the right violate the City's weed control ordinance § 9-8-4 https://codelibrary.amlegal.com/codes/albuquerque/latest/albuquerque_nm/0-0-0-97141 which prohibits weeds wider or taller than 4".

- c. Repair and prevent erosion at the 118th St. discharge point on Arroyo Vista Blvd. per CGP 2.2.11. This shouldn't be a discharge point.
 - d. Inspect and maintain the sediment basins in accordance with standard procedures and modify the SWPPP accordingly.
