# ***Calabacillas Watershed Park Management Plan***

***February 2015***

***Southern Sandoval County  
Arroyo Flood Control Authority***

# ***INTERIM Calabacillas Watershed Park Management Plan (CAWMP)***

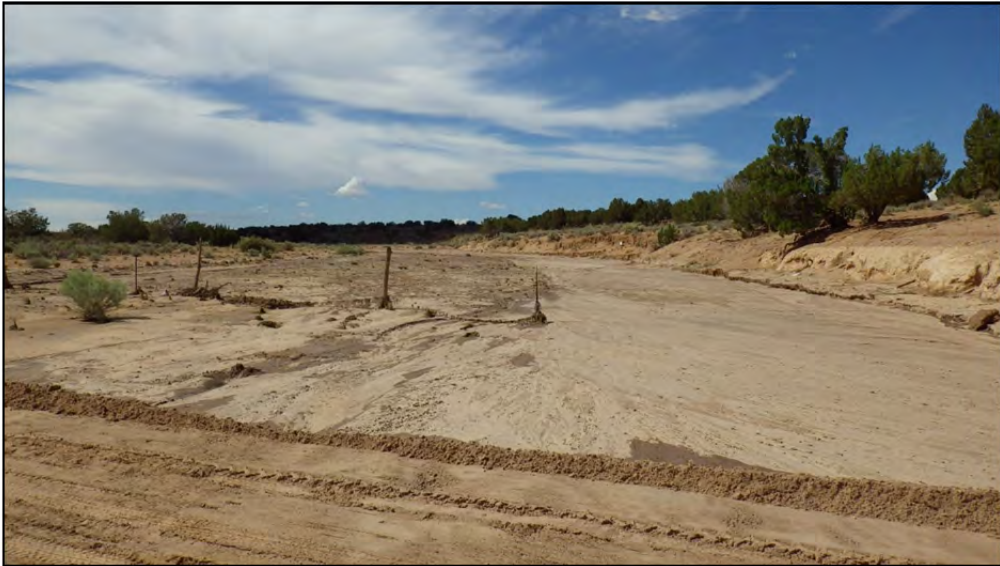
Photo 2: Calabacillas Arroyo looking upstream from 29<sup>th</sup> Ave; the width of the arroyo in this location is approximately 70 feet.

The main stem of the Calabacillas Arroyo between King Blvd. and Unser Blvd. is approximately 12 miles in length; the arroyo ranges from 40 to over 300 feet in width, with an average width of about 130 feet.

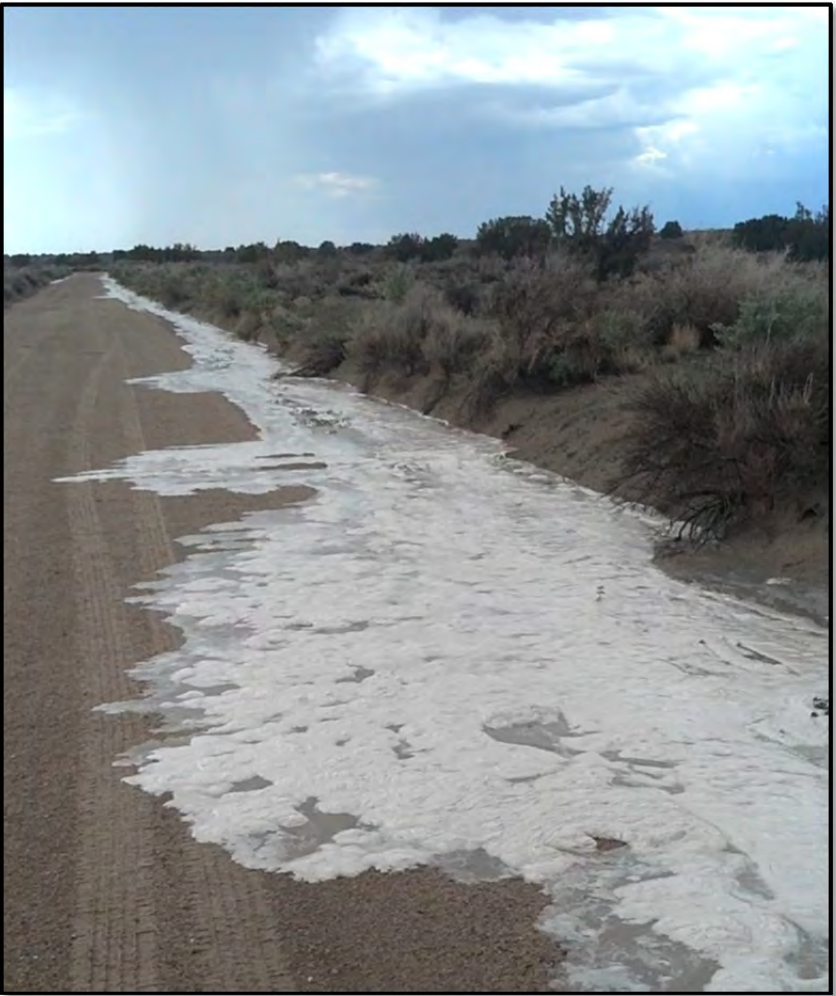
Photo 3: Picture showing a graded dirt road in the Calabacillas Watershed acting as a channel after a small storm event in August of 2013.

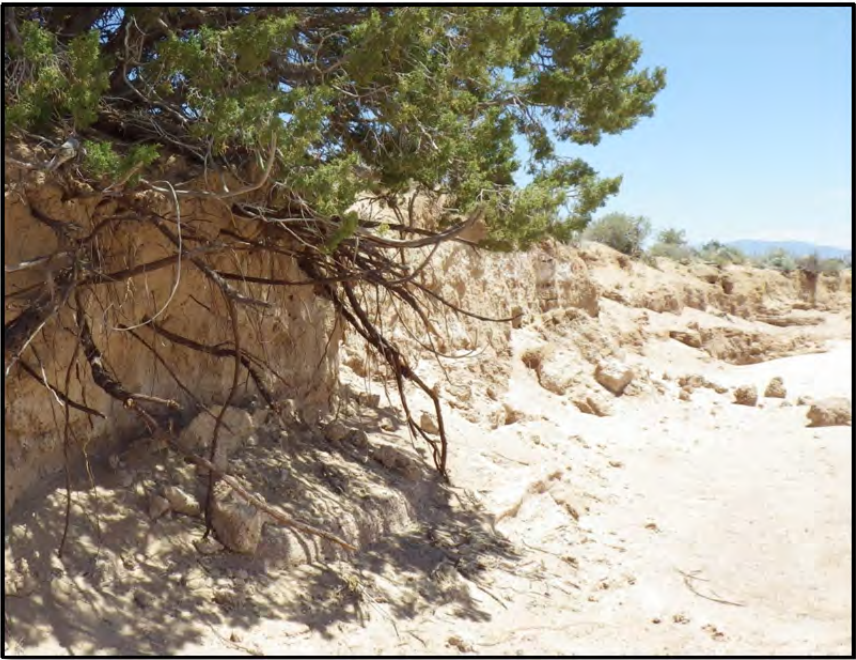
Photo 4: Bank erosion along the Calabacillas Arroyo.

In general, soils found throughout the Upper Calabacillas can be characterized as highly erosive. Photo 4 shows roots of a juniper that were recently exposed when flood waters moving through the Calabacillas Arroyo eroded several feet of bank.

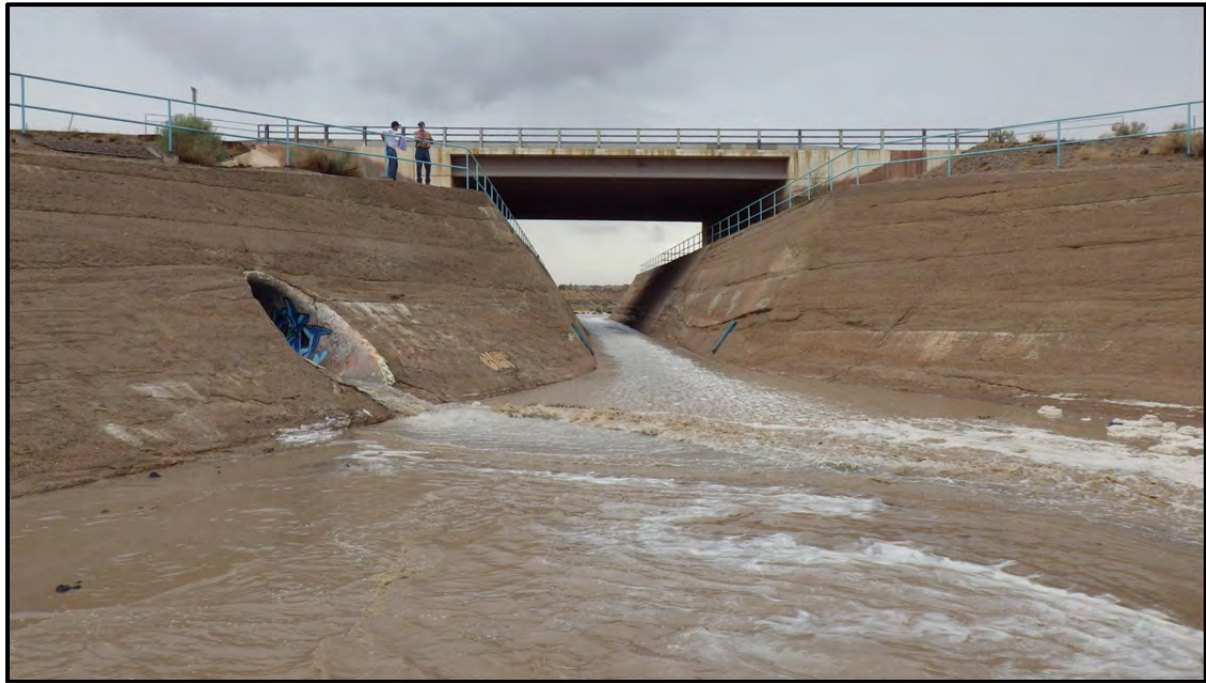
Photo 5: Swinburne Dam, looking upstream at the outlet structure.

Swinburne Dam. Located at the downstream end of the Upper Calabacillas where Unser Blvd crosses the Calabacillas Arroyo, Swinburne Dam was built by AMAFCA in 1990. The dam embankment has a maximum height of 34 feet, and the roadway (Unser Blvd) acts as the emergency spillway. The principal spillway consists of a trapezoidal soil cement channel with a bottom width of 12 ft. At the emergency spillway crest, the dam has a storage capacity of approximately 920 acre-feet.

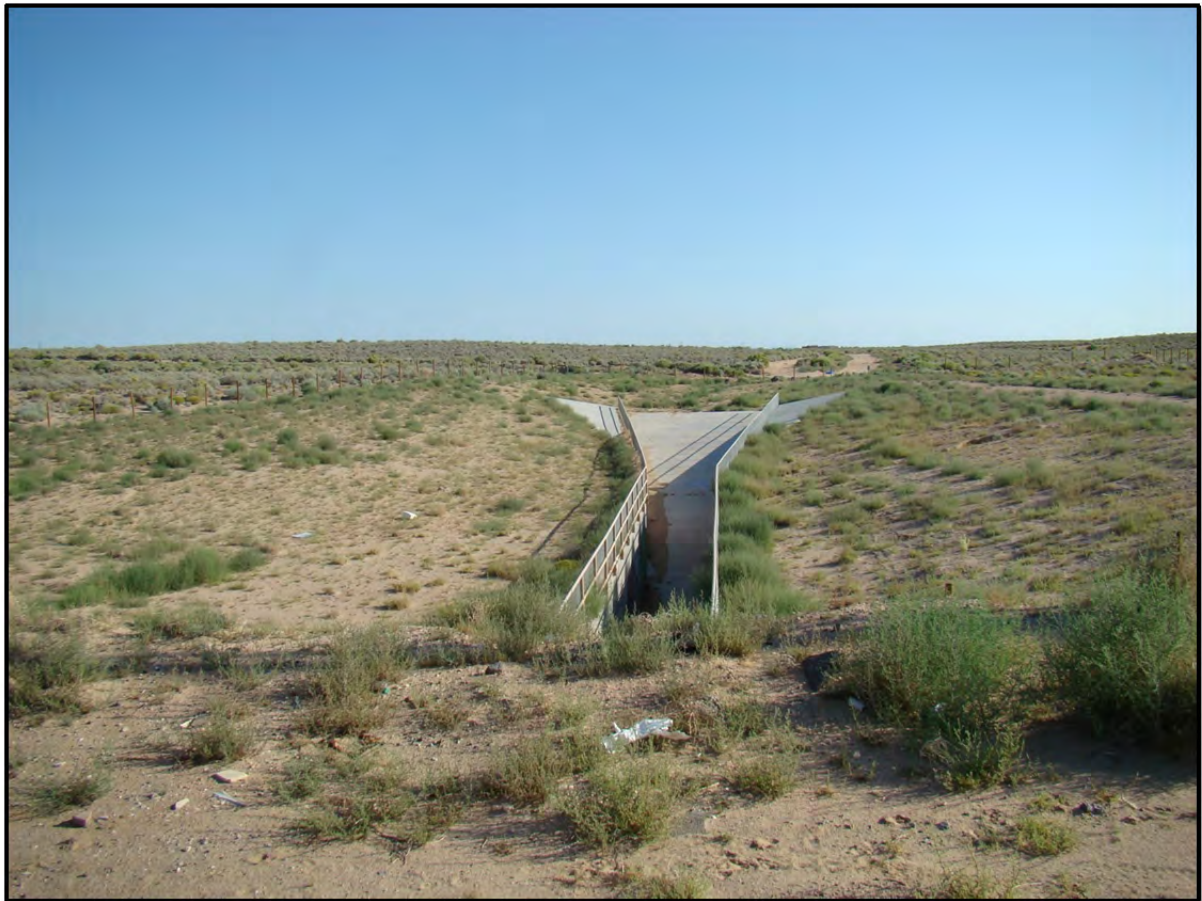
Photo 6: Inlet to the Saltillo storm drain.

The Saltillo storm drain captures all runoff from the Rainbow Tributary north of the Sandoval/Bernalillo county line and conveys it through approximately 2000 feet of 102” reinforced concrete pipe to the Calabacillas Arroyo just downstream of McMahon Blvd.

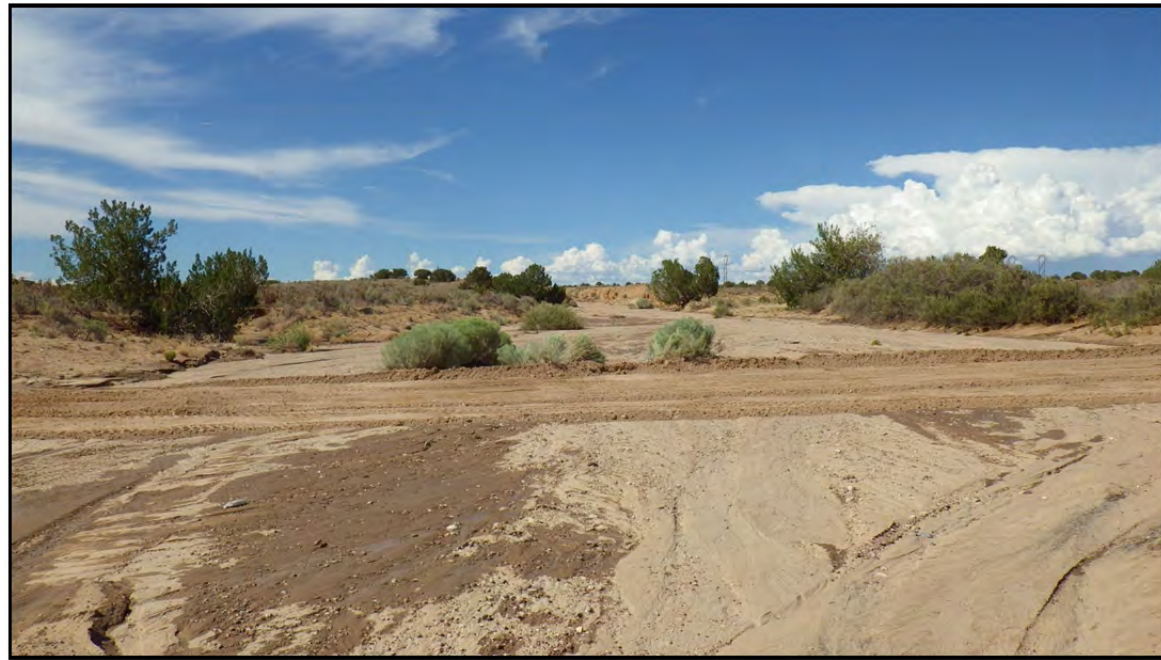
Photo 7: Typical at-grade road crossing (King Blvd & Calabacillas Arroyo, looking upstream)

Most roads in the Upper Calabacillas are unpaved dirt roads and cross arroyos at grade. Only two crossing structures exist along the main stem of the Calabacillas Arroyo upstream of Swinburne Dam:

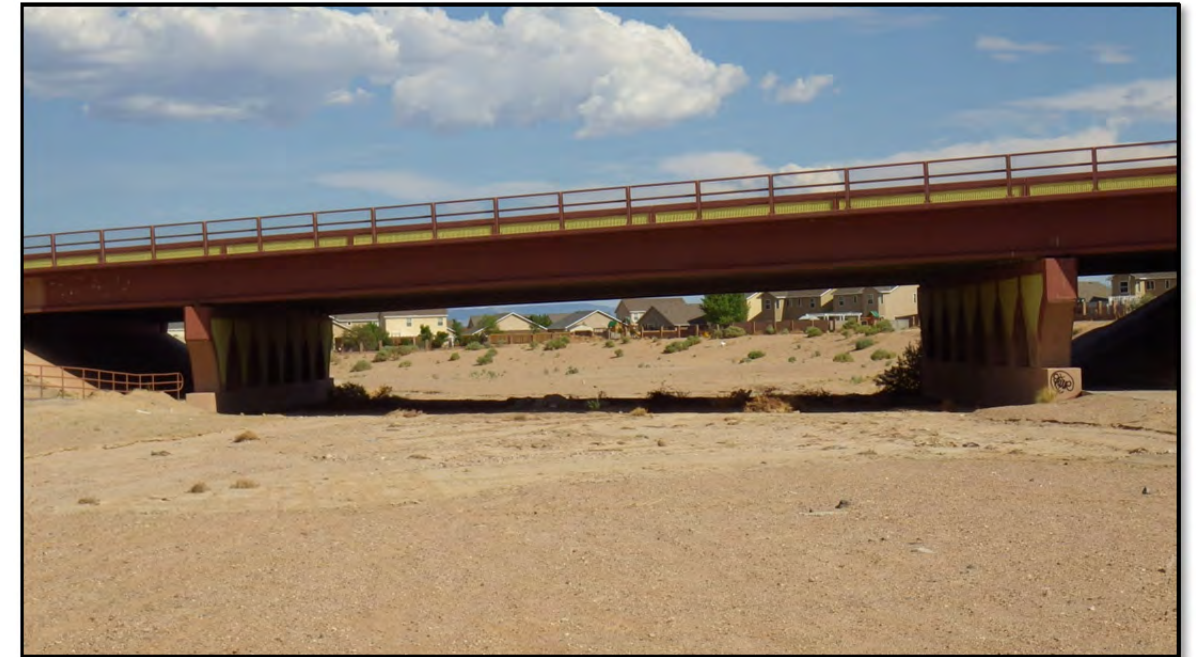
Photo 8: McMahon Blvd Bridge crossing of the Calabacillas Arroyo, looking upstream.

McMahon Blvd crosses the arroyo over a bridge, and Southern Blvd features a set of five 8ft W x 6ft H concrete box culverts. Some smaller culvert crossings exist along Northern Blvd and Southern Blvd, and within the Rainbow Tributary between Tulip Rd and Southern Blvd.

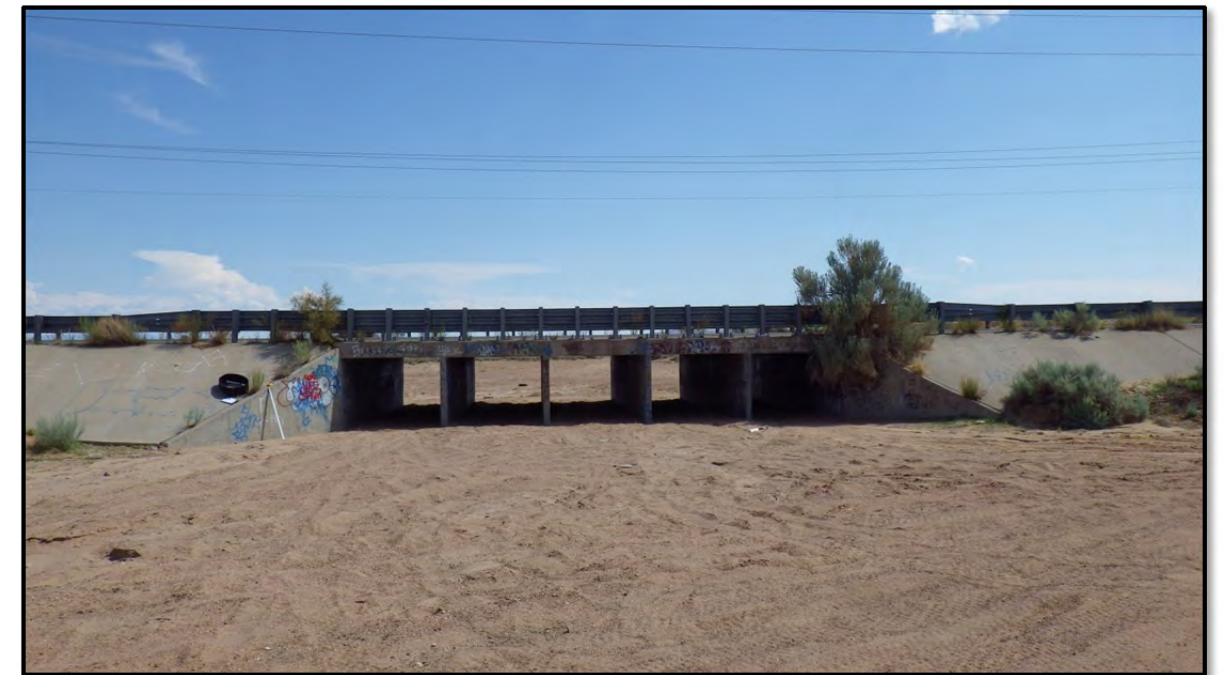
Photo 9: Concrete box culverts at Southern Blvd, looking downstream.

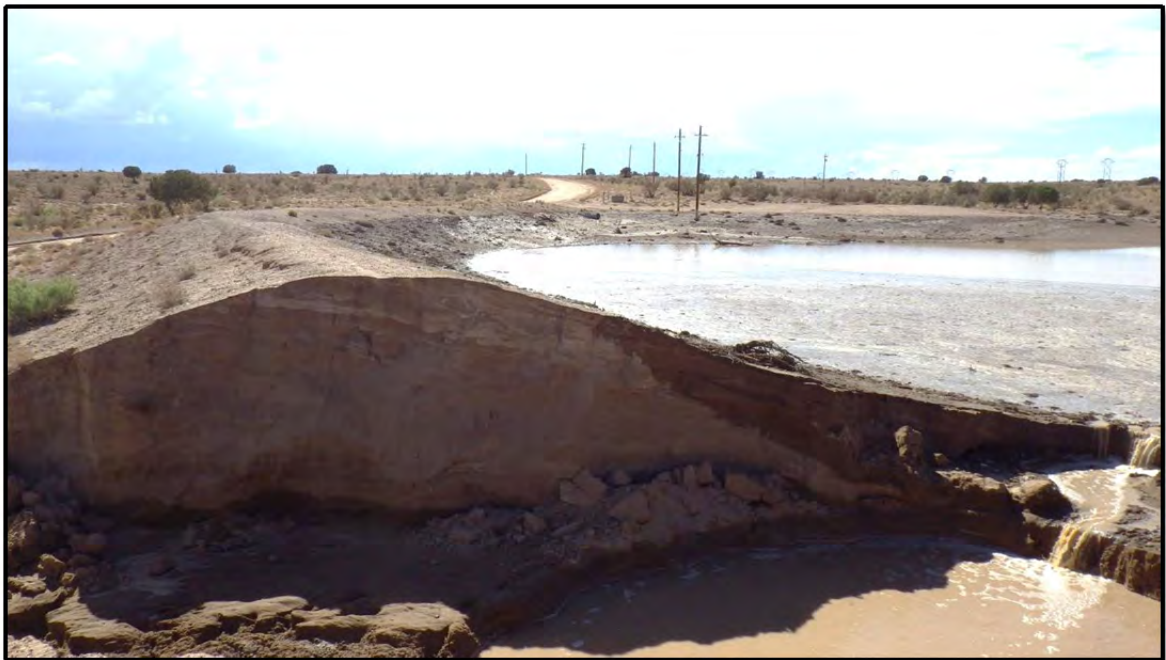
**Photo 10:** Stock pond north of King Blvd in Tributary N; the breach in the embankment caused by the storm of August 4, 2013 is evident in the foreground.

Photo 10 shows the stock pond just north of King Blvd on Tributary N. During the storm of August 4, 2013, the pond filled to the top of the earthen embankment, retaining an estimated 20 acre-feet of runoff. Several hours after the storm, the embankment failed and sent a flood wave down the arroyo.

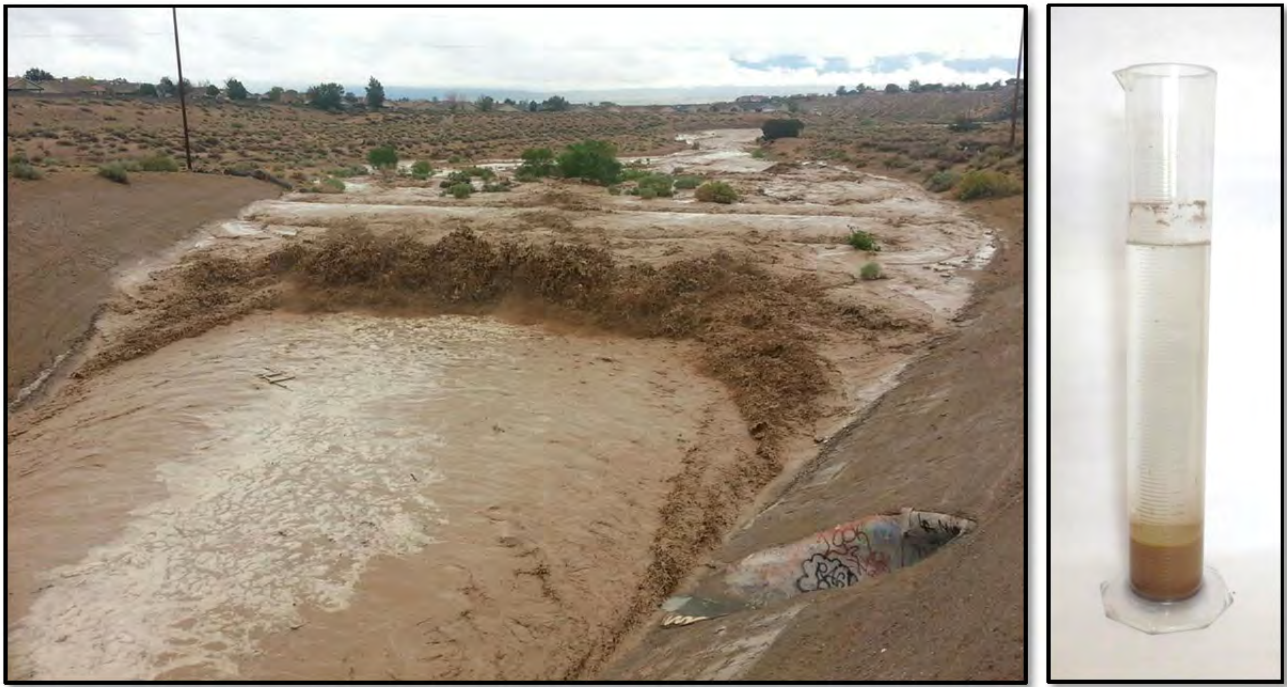
Photo 12: Sediment-laden stormwater runoff in the Calabacillas Arroyo downstream of Swinburne Dam (left), and a graduated cylinder showing the amount of sediment in a stormwater sample (right).

Sediment bulking factors of 18 percent for undeveloped areas and six percent for developed areas were added as flow ratios to the clearwater discharge in HEC-HMS to account for the increase in runoff volume due to suspended sediment in storm flows. Area averaged bulking factors were used for subbasins containing both developed and undeveloped areas.

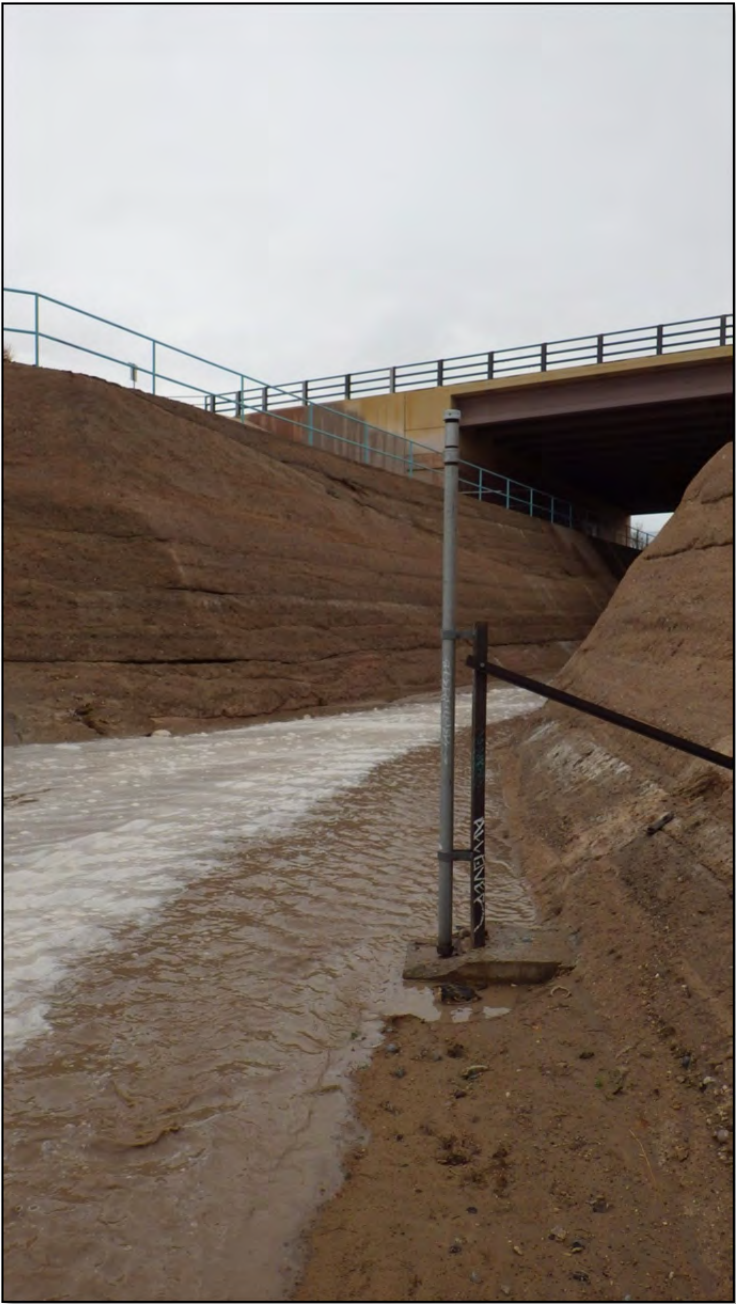
Photo 13: Stream gauging station at the outlet structure of Swinburne Dam; the gauge is located in the 2-inch galvanized steel pipe on the right.

After completion of the preliminary hydrology, an effort was undertaken to compare model results to measured storm flows. Discharge data was obtained from a stream gauging station located at the outlet structure of Swinburne Dam (see Photo 13), at the downstream end of the Upper Calabacillas. The gauging station has been in operation since 1991. Between 1991 and 2011, the site was equipped with a crest-stage gauge located in a 2-inch galvanized steel housing. Crest-stage gauges record only the peak stage of a flow event; they provide no information regarding the timing of the peak or the rest of the hydrograph and therefore have limited usefulness for model calibration efforts. In 2011, the site was retrofitted with a pressure transducer. The probe measures stage (or depth of flow) in 5-minute increments; stage measurements are converted to discharge by using a rating curve developed for the location of the gauge.

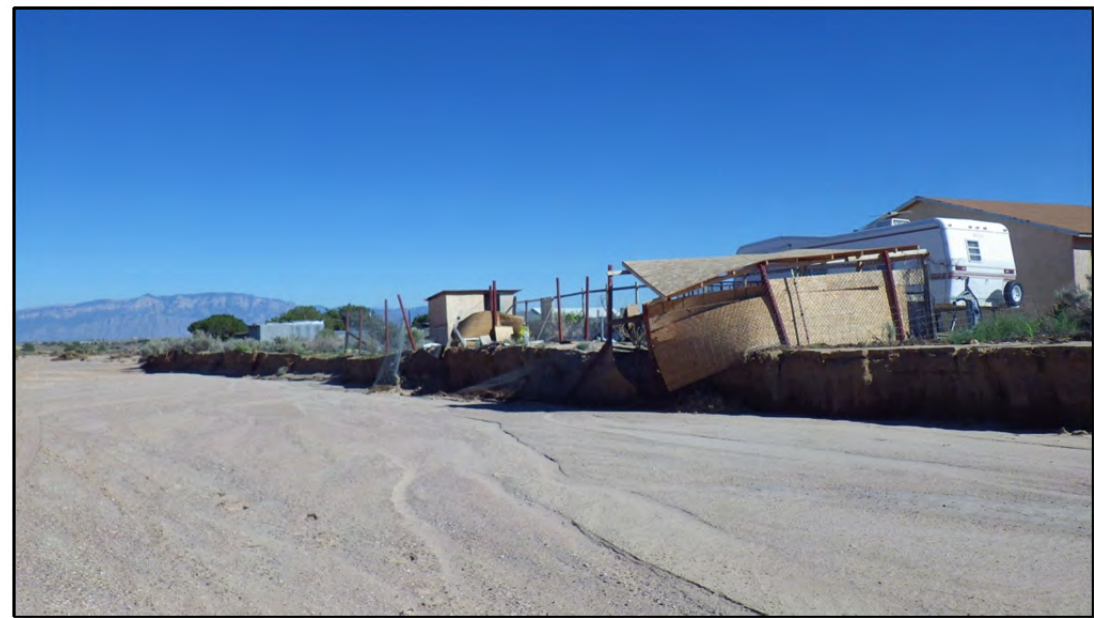
Photo 14 shows a house built adjacent to the Calabacillas Arroyo and within the Lateral erosion Envelope. In less than three hours, the flood of September 13, 2013 eroded approximately 40 feet of bank on the south side of the arroyo.

Photo 14: House built within the lateral erosion envelope of the Calabacillas Arroyo (looking east towards the Sandia Mountains in the background).

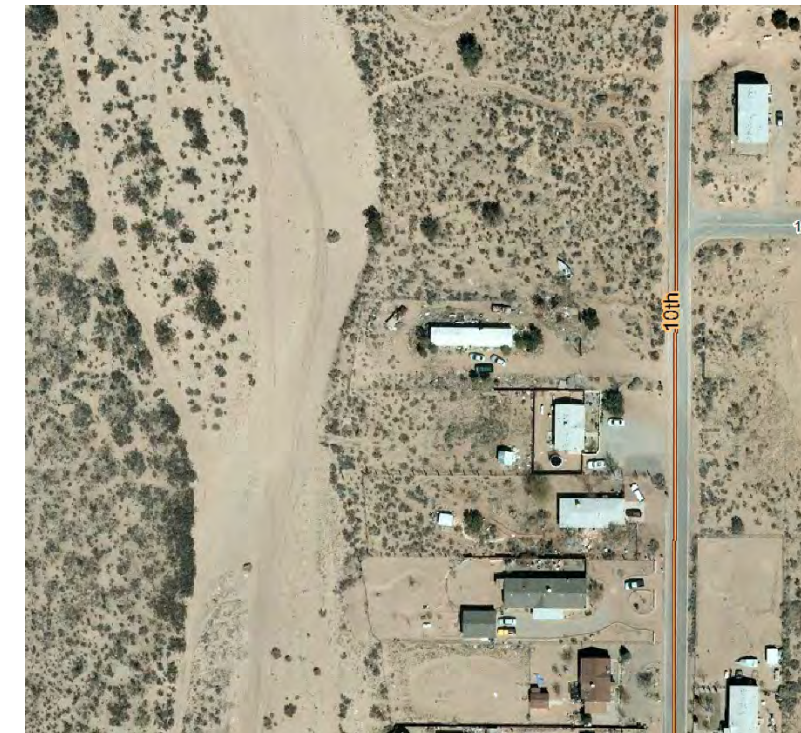
Figure 22: Partially developed area just north of Northern Blvd 2012.

**Lateral Migration/Bank Erosion.** Following the 2013 monsoon season, SSCAFCA determined (based on a comparison of pre- and post-monsoon aerial imagery) that some banks along the main stem of the Calabacillas Arroyo moved in excess of 70 feet. An example of how lateral migration has affected semi-developed areas, see Figure 22 and Figure 23. The arroyo bank migrated approximately 50 feet at this location as a result of just one monsoon season. For additional information on lateral migration & erosion, see Section III.B.4 above.

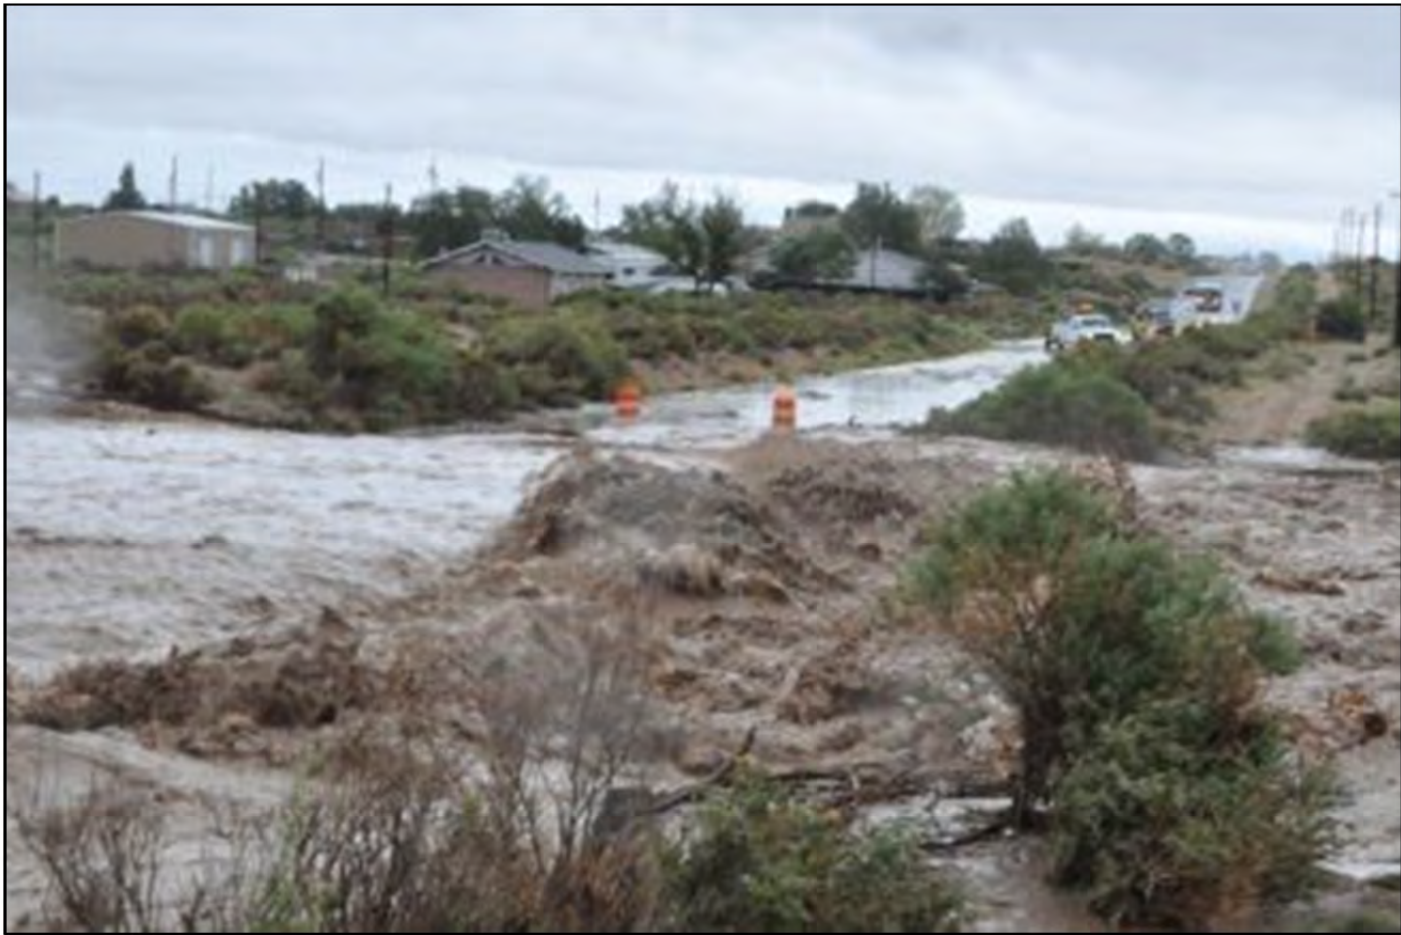
Photo 15: Flood waters crossing Northern Blvd during the storm of September 13, 2013 (Source: KOB News).

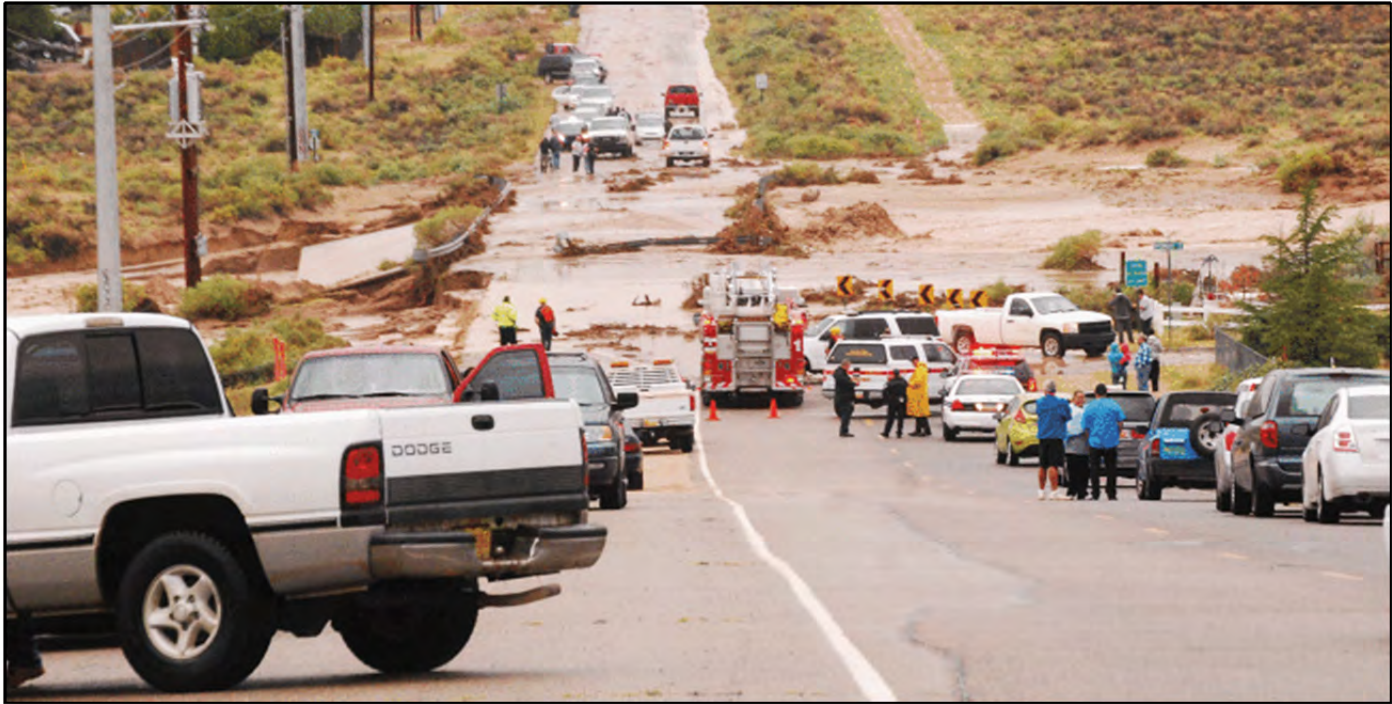
Photo 16: Storm flows in the Calabacillas Arroyo overtopping Southern Blvd during the September 13, 2013 storm (Source: KOAT News).

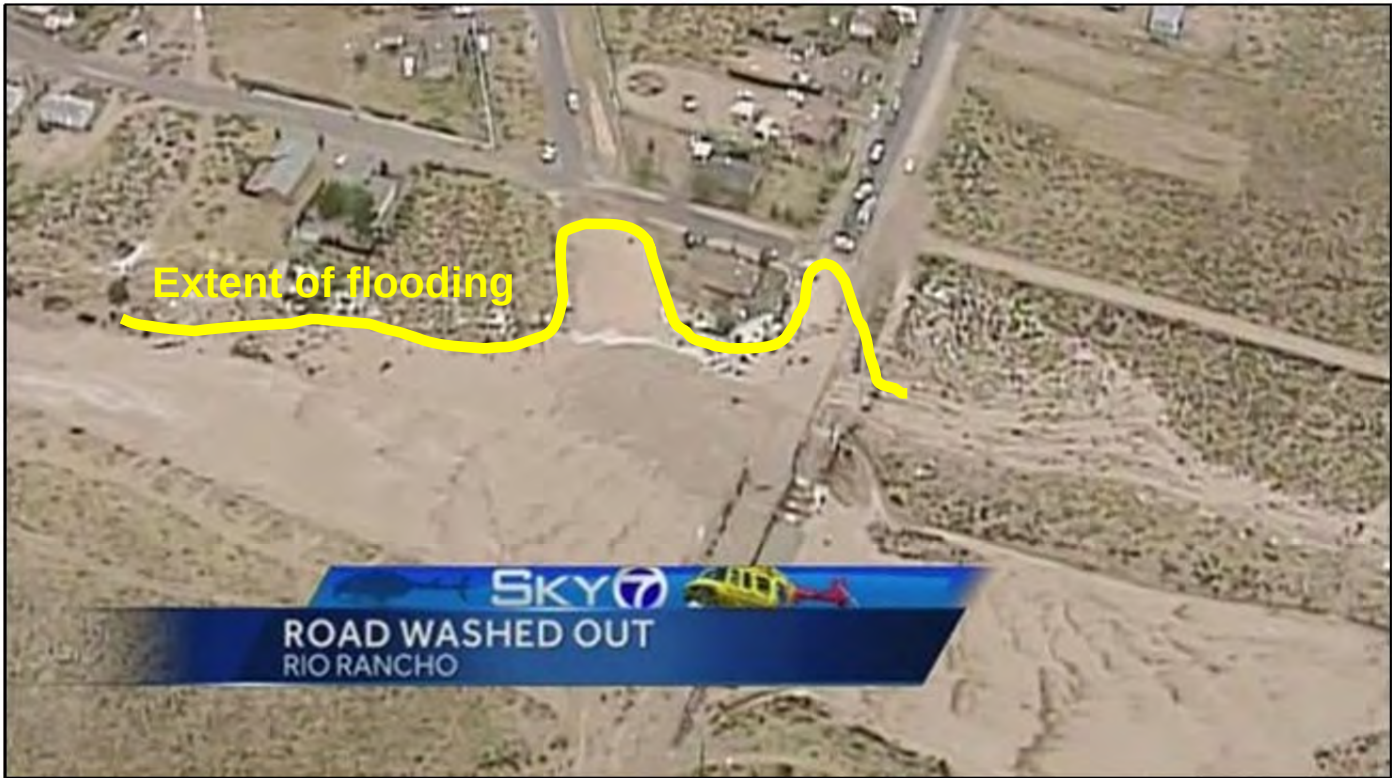
Photo 17: Extent of flooding upstream of Southern Blvd during the storm of September 13, 2013 (Source: KOAT News).

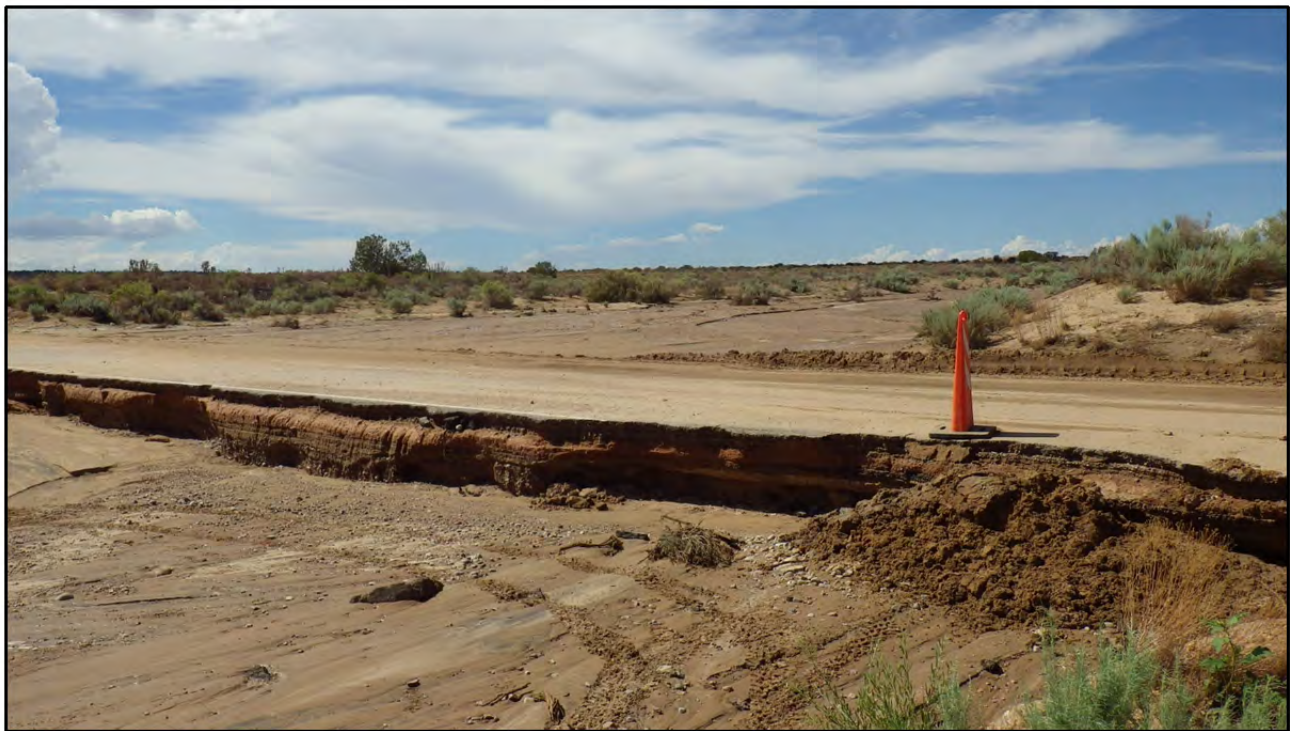
Northern Blvd crosses the Calabacillas Arroyo at grade. Any storm flows in the arroyo have to cross the roadway, and no signage currently exists to warn motorists of the potential dangers of crossing flowing water. Storm flows also frequently cause damage to the road surface as can be seen in Photo 18 and Photo 19. Scour on the downstream side of the crossing undermined the asphalt, which subsequently collapsed.

**Photo 18: Damage to Northern Blvd caused by the August 4, 2013 storm.**

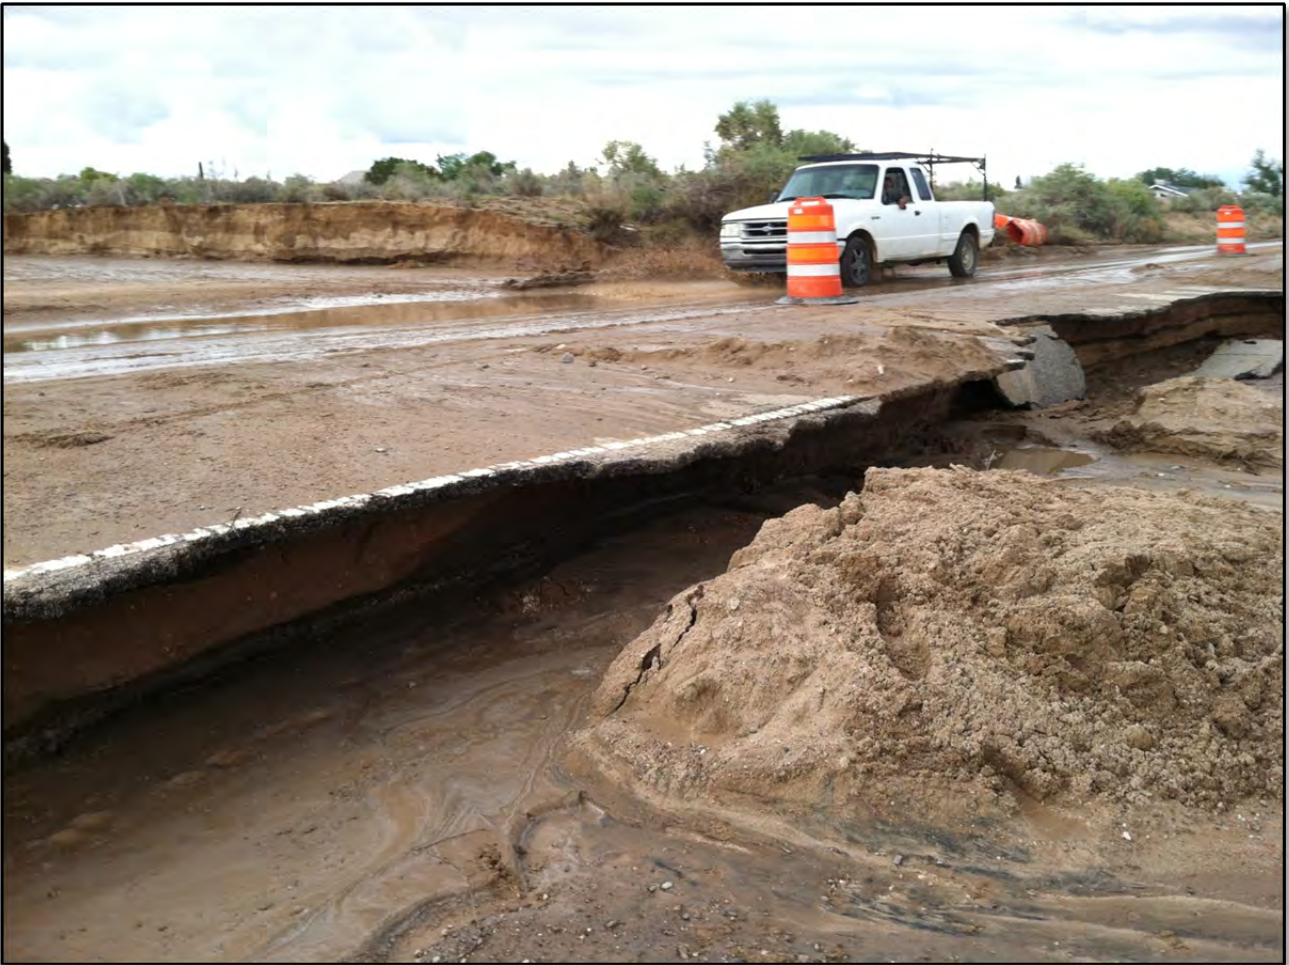
**Photo 19: The south lane of Northern Blvd is partially undermined following the storm of September 13, 2013.**

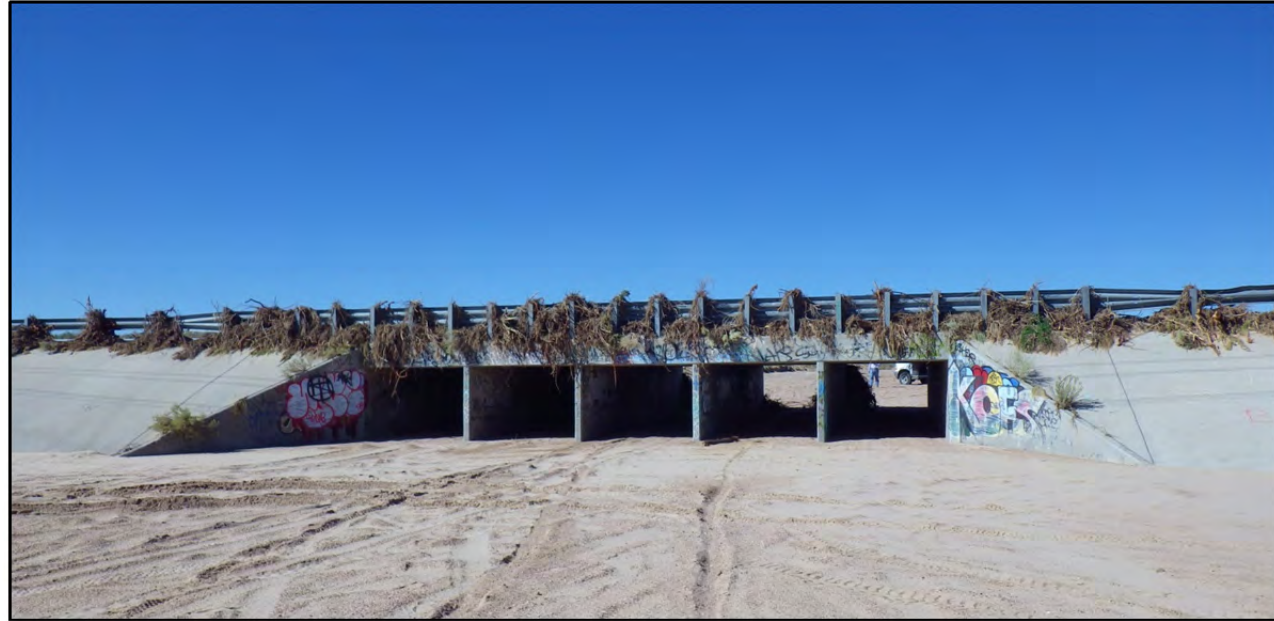
The road crossing of the Calabacillas Arroyo at Southern Blvd consists of a five 8-ft wide by 6-ft high concrete box culverts (see Photo 20).

Photo 20: Southern Blvd. Crossing of the Calabacillas Arroyo, looking upstream.

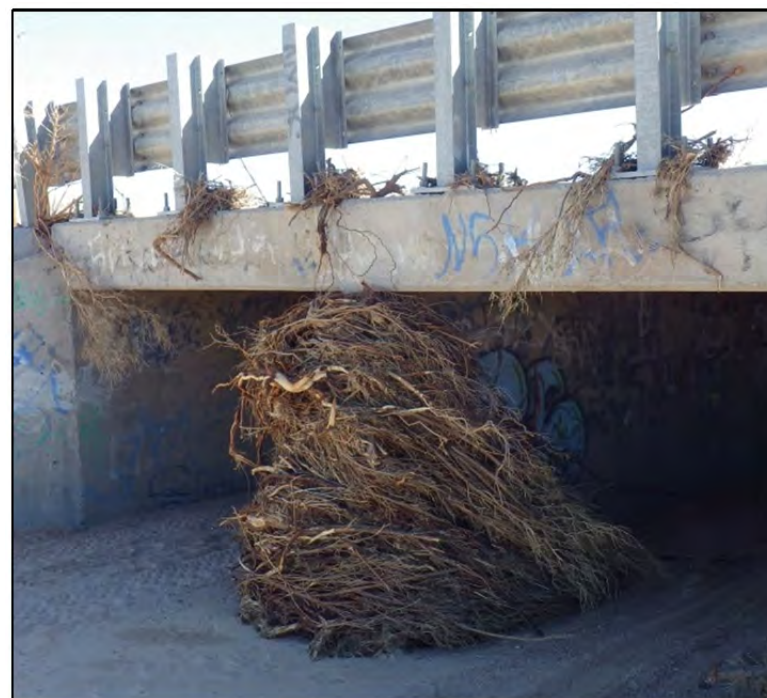
Photo 21: Debris accumulated on the upstream side of the Southern Blvd crossing following the 9/13/2013 flood.

due to sediment accumulation in the culvert. During large storm events, the debris getting caught at the entrance to the culvert can further reduce the capacity of the crossing (see Photo 21).

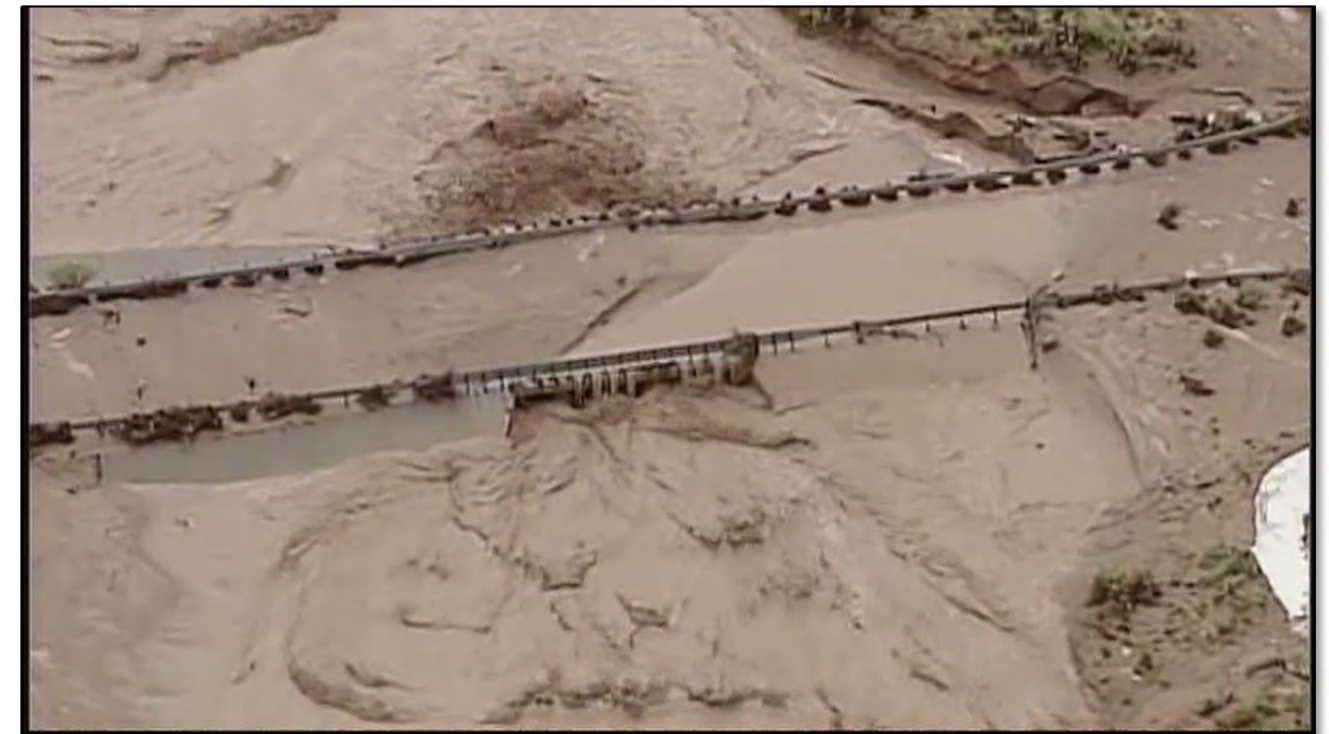
Following the storm of September 13, 2013, storm flows overtopped Southern Blvd (see Photo 22). This resulted in localized flooding upstream of the crossing structure due to the ponding effect of the road embankment, and to erosion downstream of the crossing.

The flow gaging station further downstream at Swinburne Dam indicated peak flows of approximately 1,300 cfs during the storm event. The crossing at Southern Blvd likely overtopped due to a combination of sediment accumulation in the culvert and debris caught on the upstream side.

Photo 22: Storm flows overtopping Southern Blvd during the flood of September 13, 2013. (Source: KOAT News).

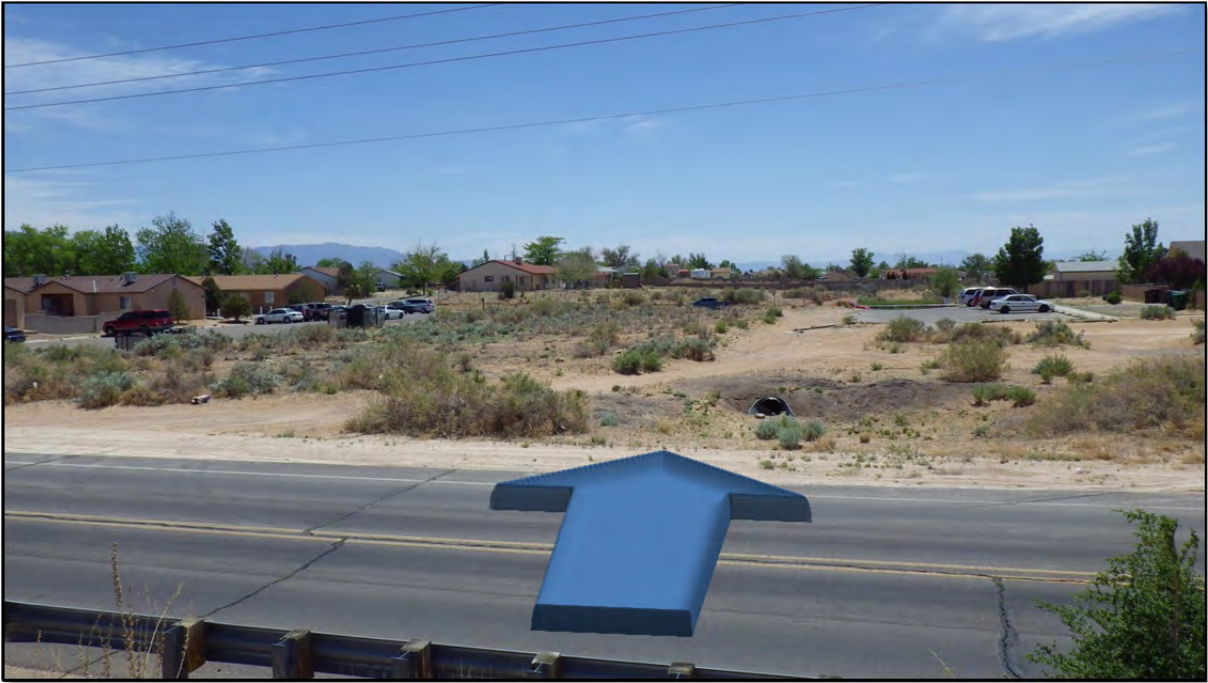
Photo 23: Looking south from Tulip Road. Except for one 18" CMP culvert, no drainage infrastructure exists between Tulip and Vancouver Roads.; apartment buildings on both sides are in the 100-year floodplain

The Rainbow Tributary upstream of Tulip Road (approximately one square mile) drains to a shallow playa just north of Tulip Road; runoff then cross the road through a set of three 18-inch corrugated metal pipes (CMP) which daylight south of the road and transition into one 18-inch CMP culvert; this pipe in turn daylights upstream of Vancouver Road. Stormwater runoff exiting the pipe crosses Vancouver Road and flows into an existing earthen channel.

The drainage infrastructure between Tulip Road and the start of the channel is grossly inadequate to convey the 100-year peak flows, both under EXISTING and DEVEX conditions. Flood waters will overtop Tulip Road and surface-flow south to Vancouver Road, potentially causing damage to houses and other private property located in the flow path. The area in question is designated as a 100-year FEMA floodplain (see Figure 25). Please note that the peak flow rates reported in Figure 25 stem from model runs using rainfall input without depth-area reduction factors, since the contributing drainage area is less than two square miles in size (see also discussion in Section III.A.5 above).

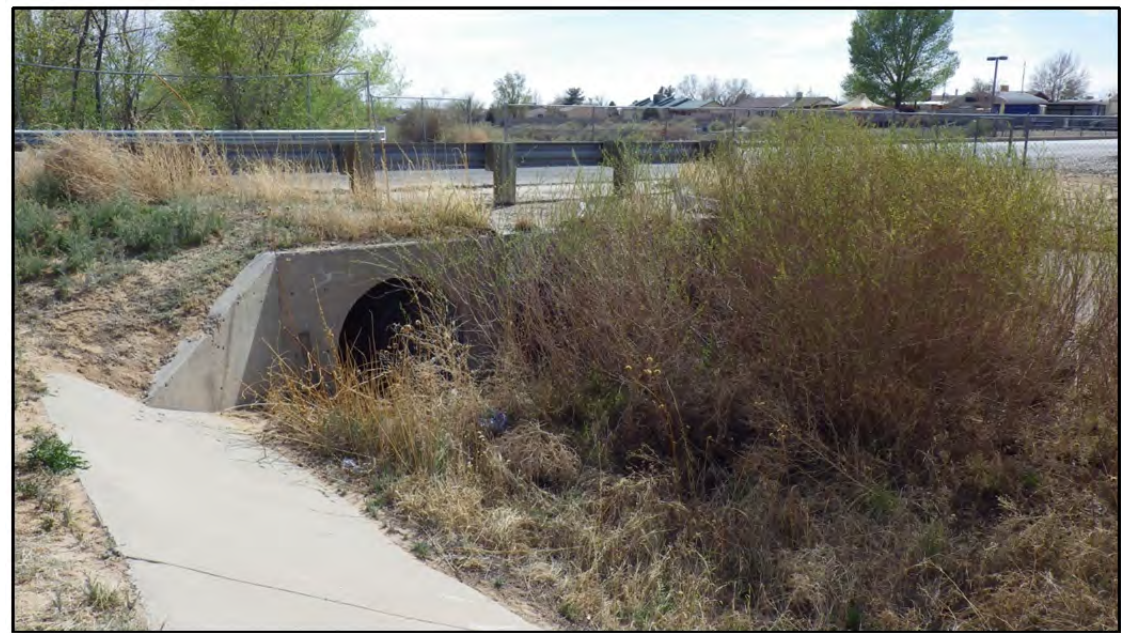
Photo 24: Rainbow Tributary crossing at Pecos Loop (4 – 48” CMP, capacity ≈ 333 cfs).

The crossing structures further downstream at Pecos Loop and Southern Blvd are also undersized for EXISTING and DEVEX conditions and could lead to localized flooding due to temporary ponding upstream of the road crossings.

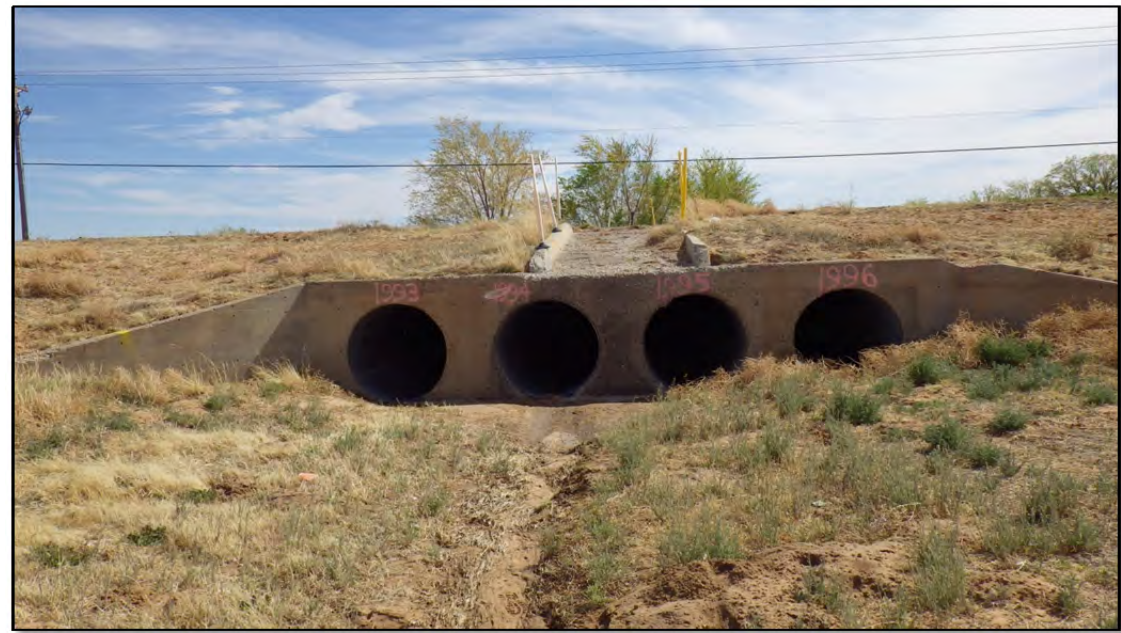
Photo 25: Rainbow Tributary crossing at Southern Blvd (4 – 48” CMP, capacity ≈ 438 cfs).
