# ***Calabacillas Watershed Park Management Plan***

***February 2015***

***Southern Sandoval County  
Arroyo Flood Control Authority***

# ***INTERIM Calabacillas Watershed Park Management Plan (CAWMP)***

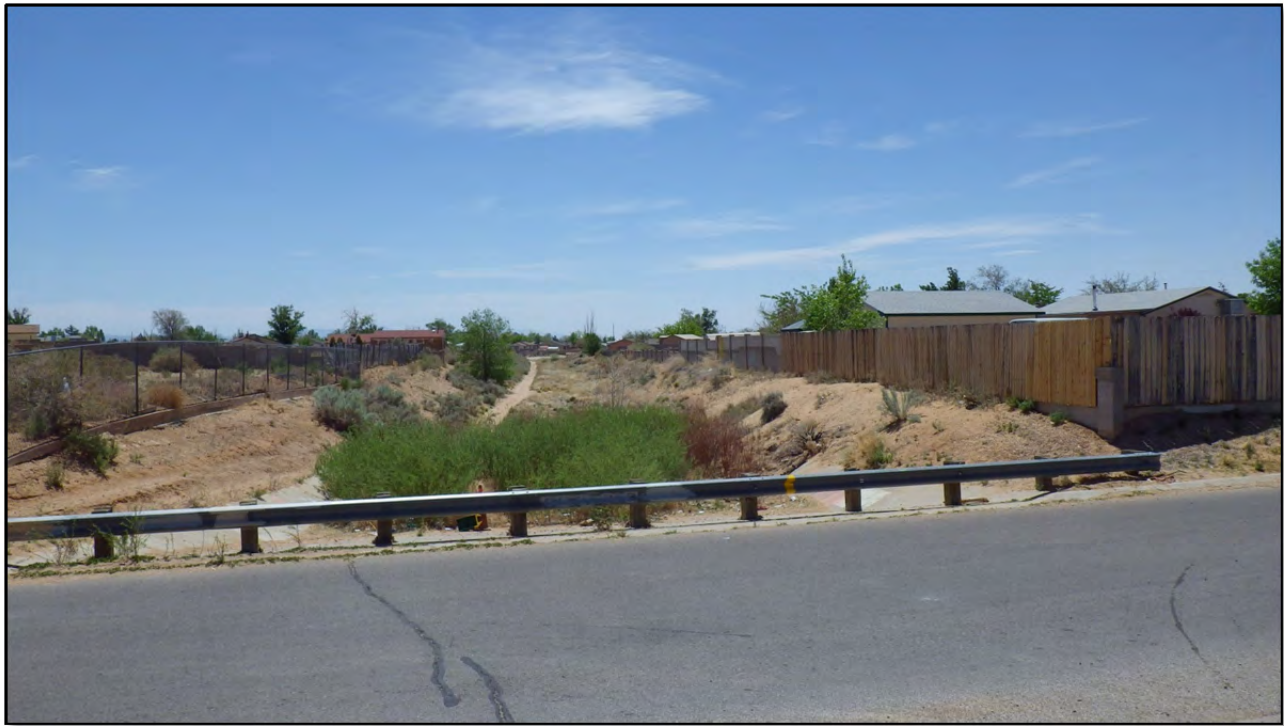
Photo 26: Looking south from Vancouver Road down the existing earthen channel.

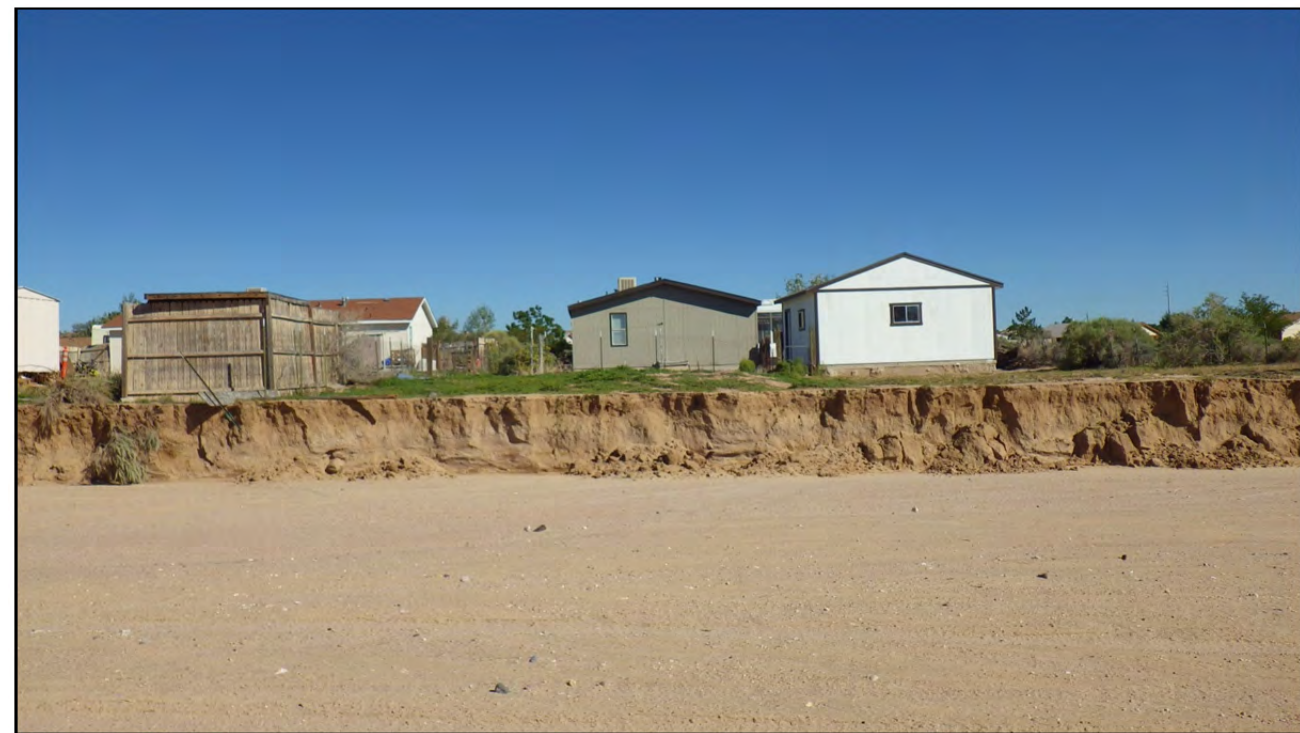
Photo 28: Houses on the east bank of the Calabacillas Arroyo north of Southern Blvd threatened by bank erosion.

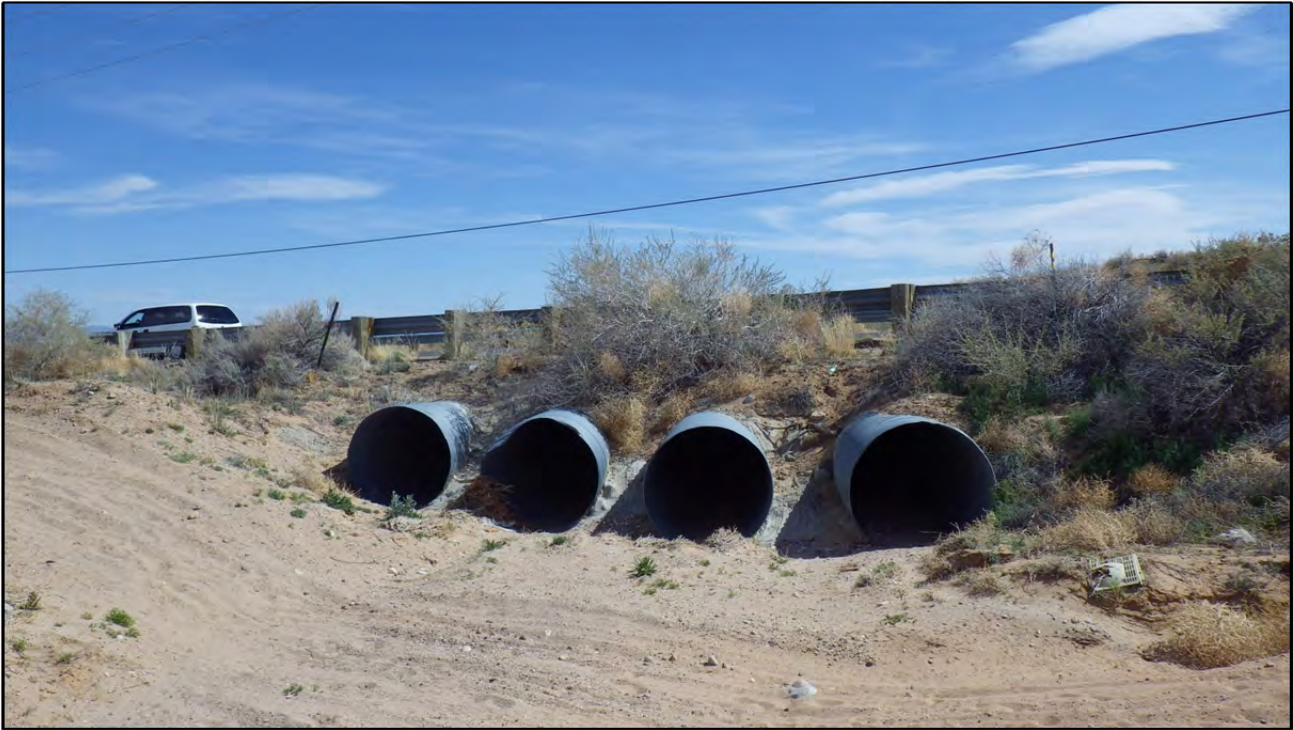
Photo 29: Tributary B crossing at Southern Blvd (4 – 48” CMP, capacity ≈ 232 cfs).

The crossing structure has an estimated capacity of 232 cfs, and is therefore undersized under EXISTING, DEVEX, and ULTIMATE conditions. Flows in excess of the culvert capacity will overtop the roadway, and a portion of the runoff may flow eastward along Southern Blvd, causing erosion along the road and exacerbating the conveyance deficiency that already exists downstream (see Section V.A.7 below).

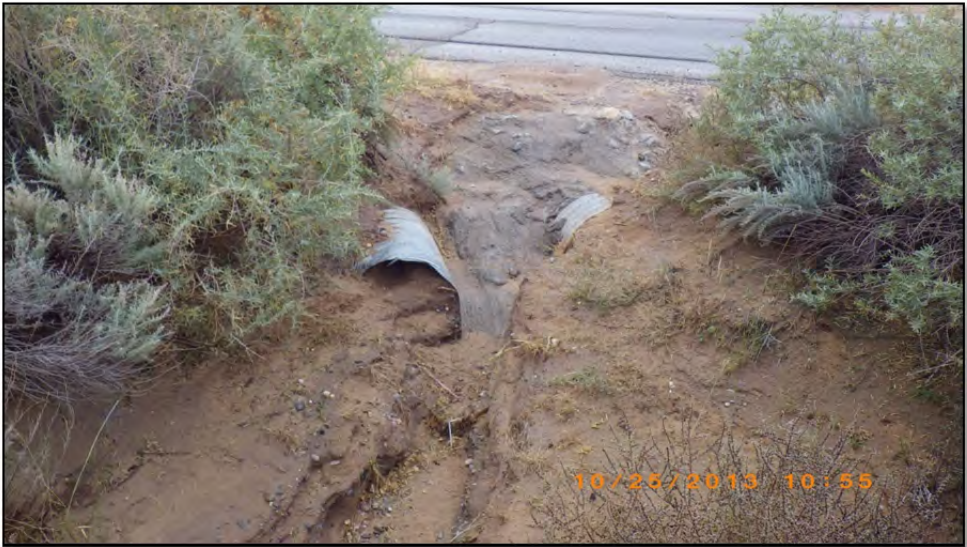
Photo 30: Culverts at Southern Blvd & Tributary C filled completely with sediment (capacity = 0 cfs).

The historic flow path of Tributary C has been cut off by Southern Blvd; culverts that used to convey some flows under Southern are now completely filled with sediment (Photo 30). Additionally, houses have been constructed in the former flow path south of Southern. Runoff from Tributary C will now flow eastward along Southern Blvd for approximately 1,500 feet to the Calabacillas Arroyo; during large storm events, some flow may cross the roadway and cause flooding and erosion downstream.

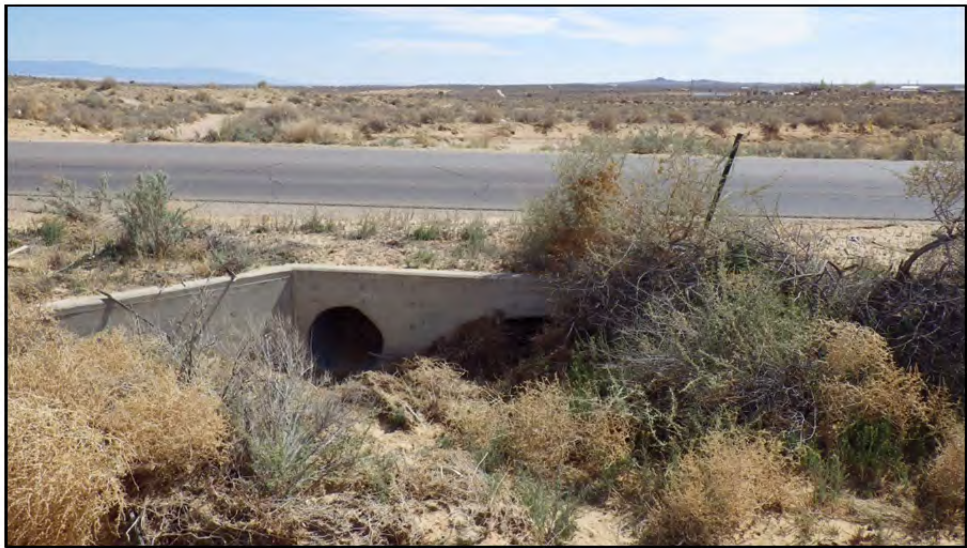
Photo 31: Culverts at Southern Blvd & Tributary D (2 – 24” CMP, capacity ≈ 24 cfs).

Tributary D intersects Southern Blvd just west of the Calabacillas Arroyo; the crossing structure has a capacity of 24 cfs and is therefore grossly undersized to convey the EXISTING or DEVEX conditions peak flows (2,031 cfs and 3,540 cfs, respectively). Runoff in excess of the culvert capacity will flow east into the Calabacillas Arroyo. Please note that these peak flow rates stem from model runs using rainfall input with depth-area reduction factors appropriate for the area of Tributary C (4 square miles) and Tributary D (3 square miles) upstream of Southern Blvd (see also discussion in Section III.A.5 above).

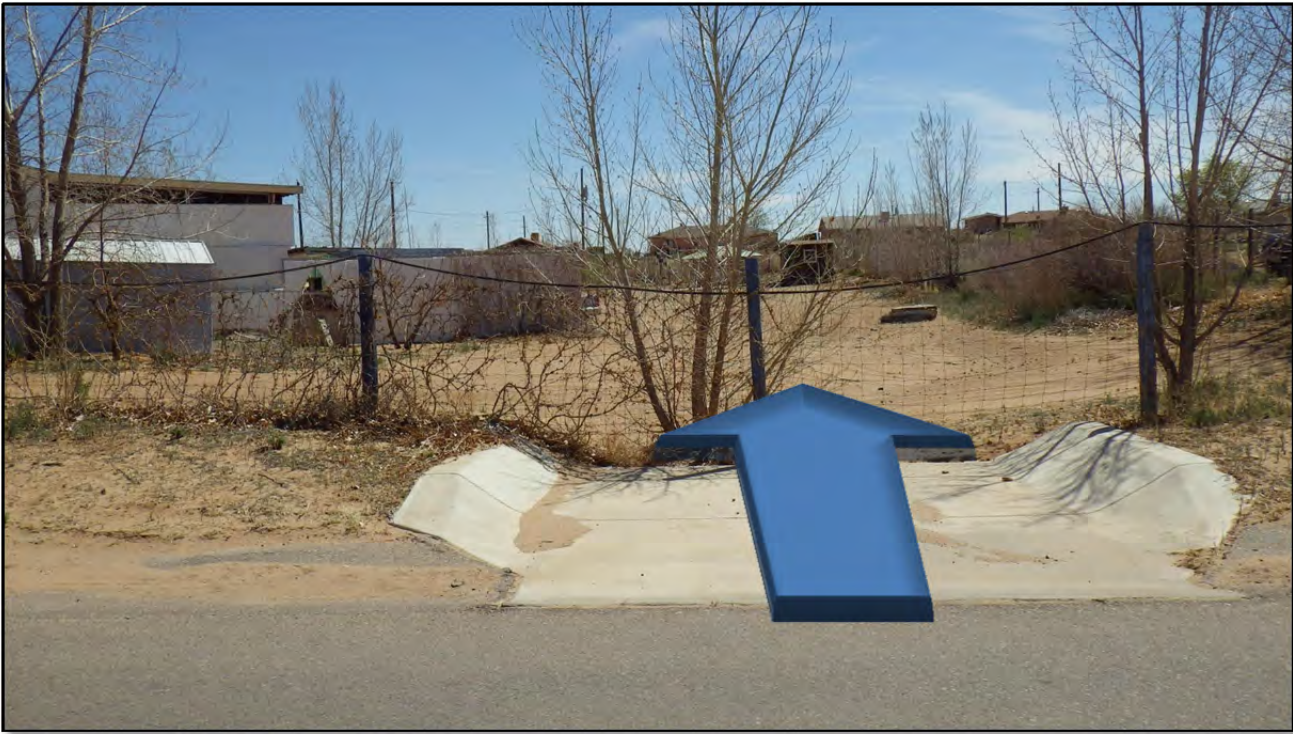
Photo 32: Looking south from 10<sup>th</sup> Ave: the flow path of Tributary P crosses residential properties.

In the lower portion of the reach between approximately 13<sup>th</sup> Ave and Northern Blvd, a number of residential homes have been built in the flow path (see Photo 32 and Photo 33). This poses a danger for properties and residents, potentially even from storms much smaller than the 100-year event.

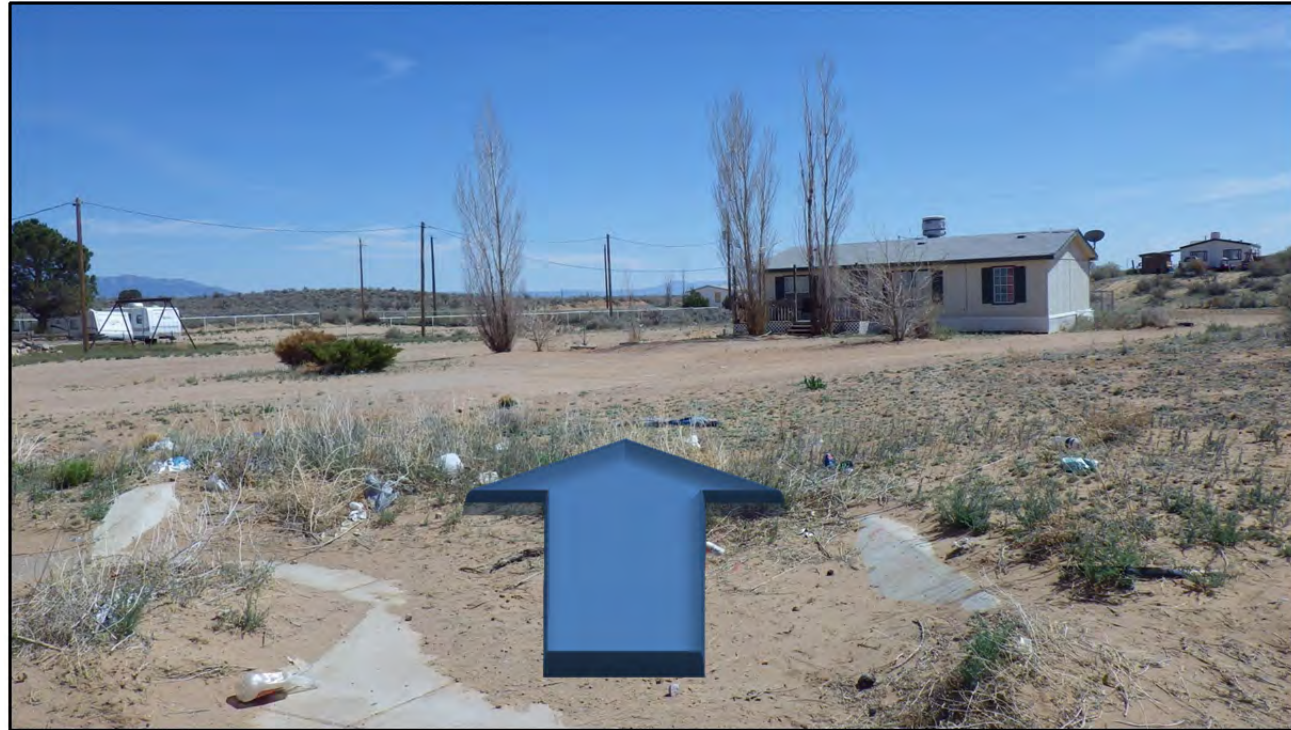
**Photo 33: Looking south from 11<sup>th</sup> Ave: the flow path of Tributary P crosses residential properties.**

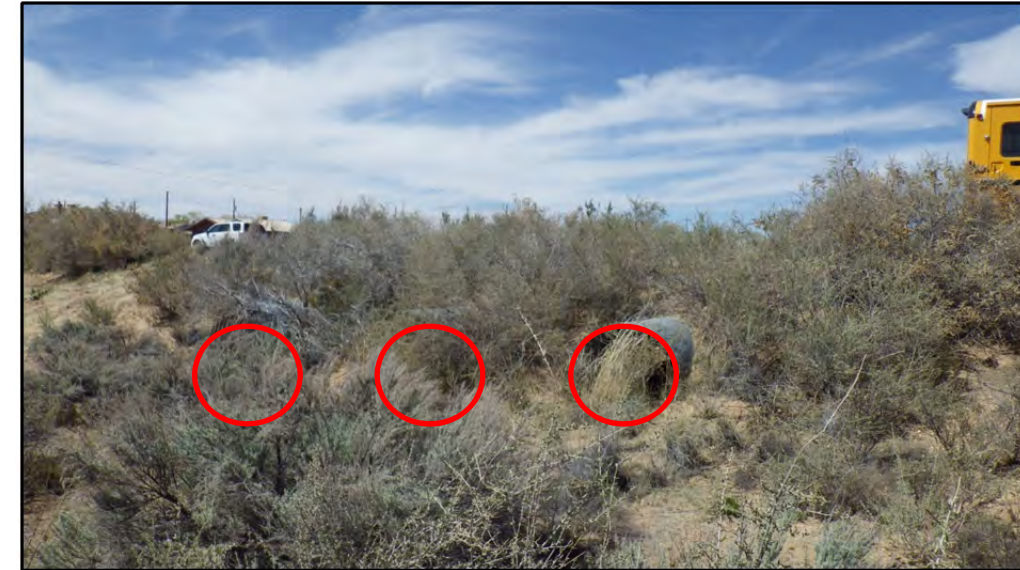
**Photo 34: Looking upstream at the Tributary P crossing at Northern Blvd (3 – 48" CMP, capacity ≈ 258 cfs).**

The crossing of Tributary P and Northern Blvd consists for three 48" corrugated metal pipes (see Photo 34 and Figure 41). Under ideal conditions, the estimated total capacity of the crossing is 258 cfs. The actual capacity may be significantly less due to heavy vegetation at the inlet of all three pipes. Even under ideal conditions, the crossing structure is insufficient to convey the EXISTING or DEVEX conditions flows (1,092 cfs and 1,699 cfs, respectively).

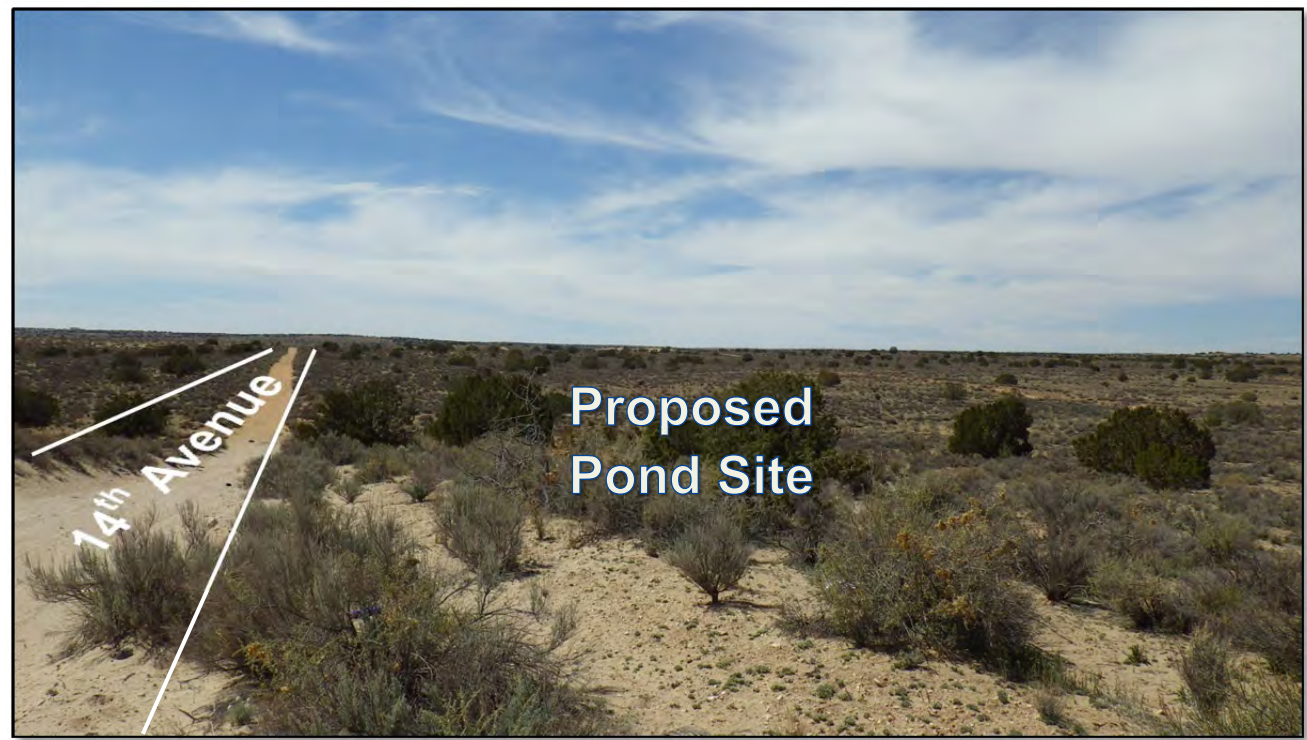
Photo 35: Looking west along 14<sup>th</sup> Ave towards the site of proposed pond CA\_09P.

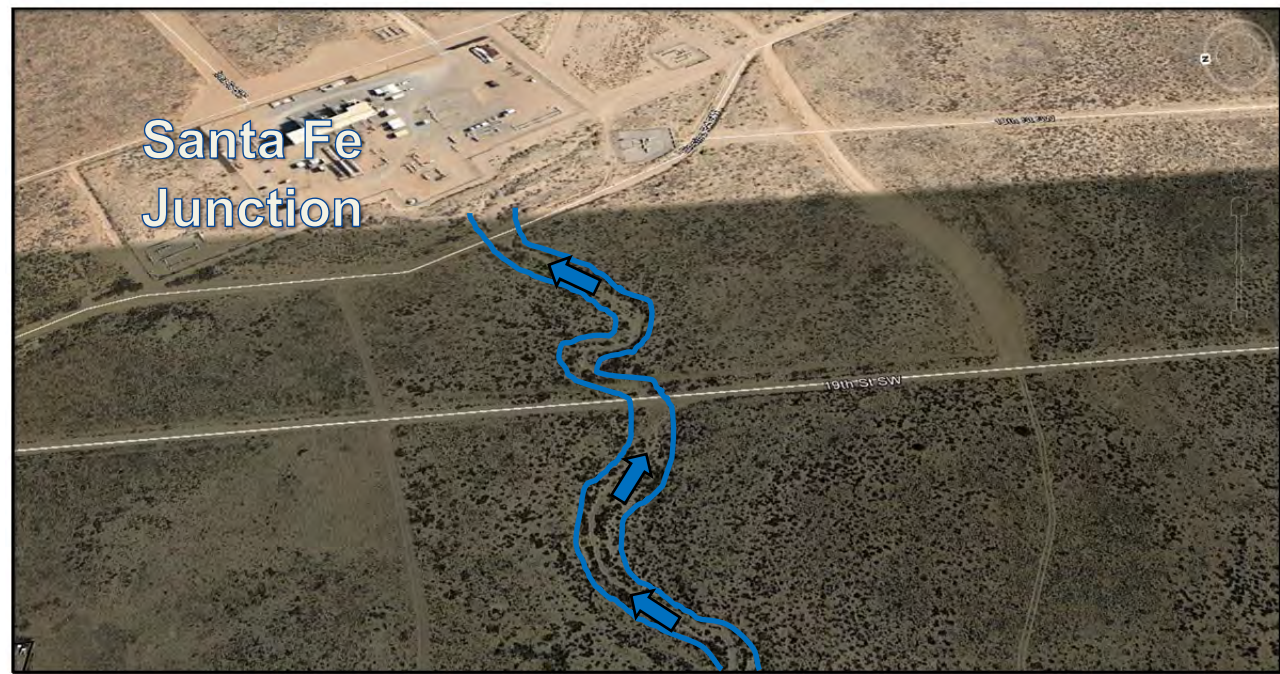
Figure 45: Looking east along the arroyo toward the Santa Fe Junction (source: Google Earth).

The Santa Fe Junction, a facility owned and operated by the New Mexico Gas Company, is located at the intersection of Encino Rd and Idalia Rd in Tributary B. The facility, which compresses and delivers natural gas to the entire State of New Mexico, has been constructed in the former flow path of an arroyo with an upstream drainage area of approximately 2 square miles (see Figure 46). The facility is also partially located within FEMA Flood Zone A.

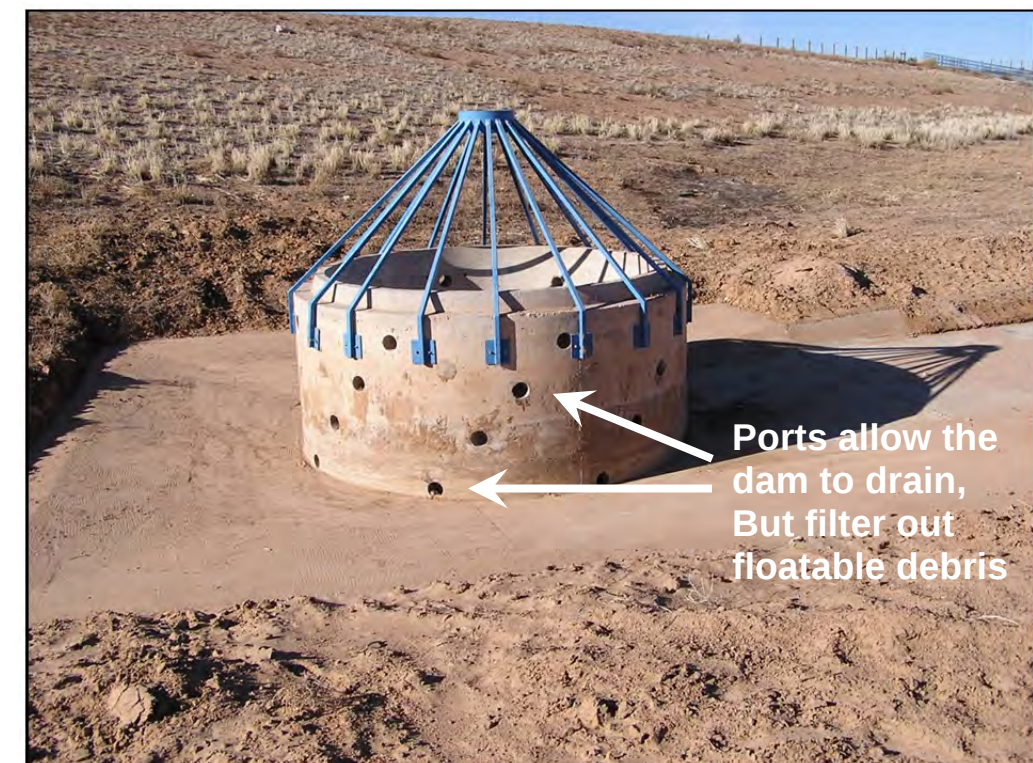
- Water quality treatment mechanisms will be incorporated in the design of all regional stormwater detention facilities (see Photo 37).
- SSCAFCA, in cooperation with the CoRR, has implemented a policy that requires residential, commercial and industrial developments to provide operation and maintenance of on-site stormwater quality facilities to treat the runoff from a 0.6", 6-hour storm event prior to discharge to a public facility. See the SSCAFCA/CoRR Development Process Manual.
- Naturalistic channel treatments (unlined channels, stabilized with bank protection and drop structures where necessary) will be utilized wherever feasible to slow down the velocity of stormwater runoff and promote infiltration into the soil.

**Photo 37: Water Quality outlet structure in one of SSCAFCA's flood control dams; the ports in the standpipe let water drain, but filter out floatable debris.**

Photo 37: Water Quality outlet structure in one of SSCAFCA’s flood control dams; the ports in the standpipe let water drain, but filter out floatable debris. ....51

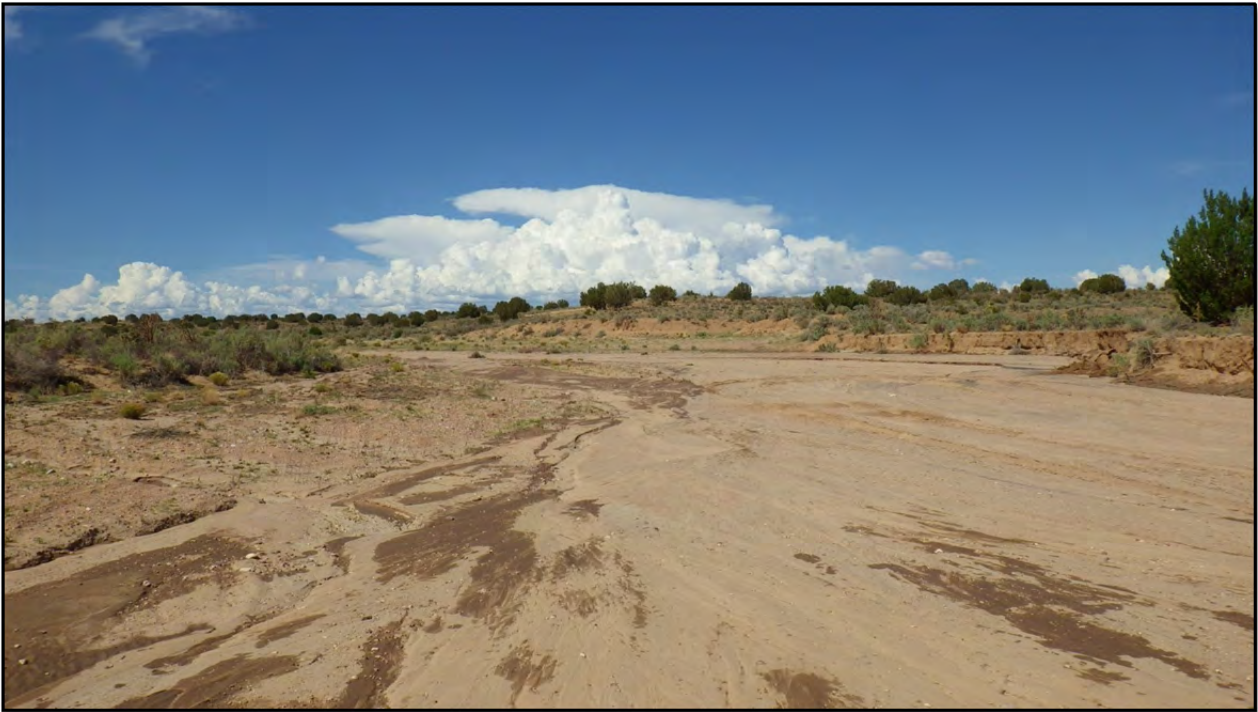
The Calabacillas Watershed Park is the largest drainage basin in SSCAFCA’s jurisdiction. Most of the watershed is undeveloped, and the Calabacillas Arroyo and its mayor tributaries have not been lined or modified (see Photo 38).

Photo 38: Calabacillas Arroyo, looking upstream from King Blvd.

Photo 38: Calabacillas Arroyo, looking upstream from King Blvd. ....52
