EROSION STUDY  
NORTH DOMINGO BACA ARROYO  
AT  
NOR ESTE MANOR, BLOCK F AND TRACT "B"

PRESLEY COMPANY OF NEW MEXICO  
1909 CARLISLE BOULEVARD NE  
ALBUQUERQUE, NEW MEXICO 87106

ADDENDUM NO. 1  
TO THE  
EROSION STUDY  
NORTH DOMINGO BACA ARROYO  
AT  
NOR ESTE MANOR, BLOCK F AND TRACT "B"

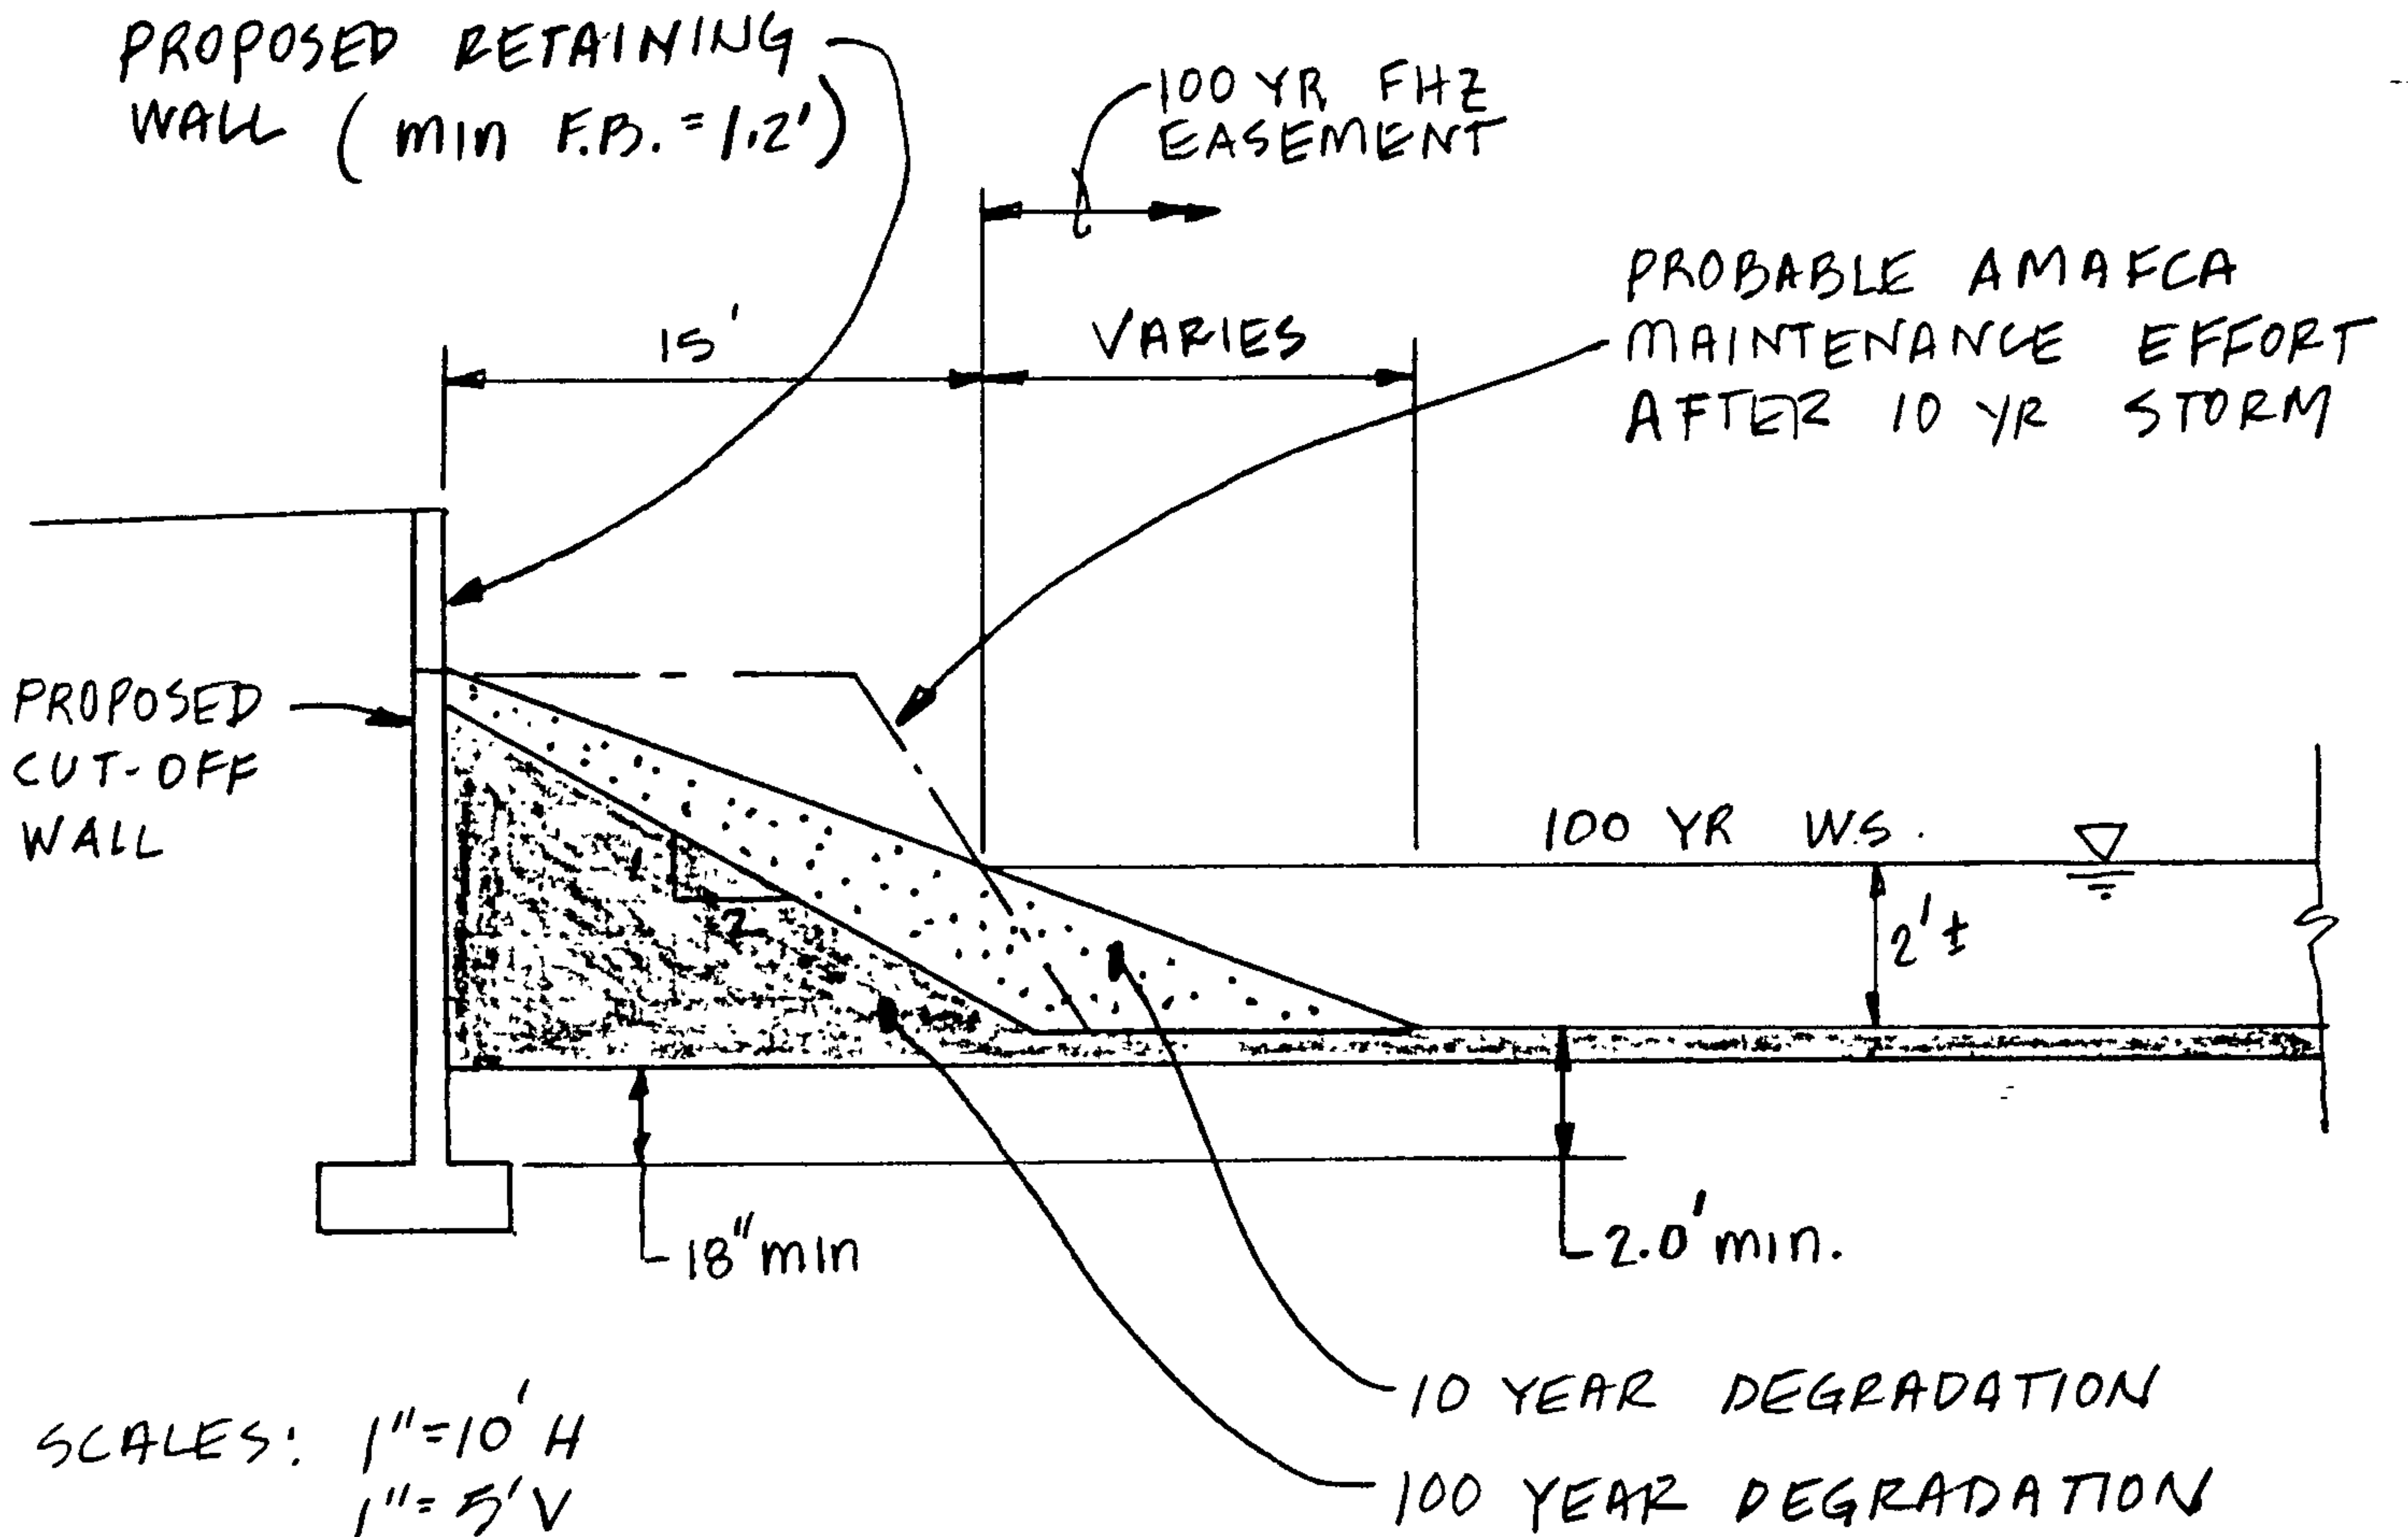
### TYPICAL SECTION - SEGMENT 1

TYPICAL DEGRADATION VALUES - TAKEN AT SECTION 16 (WORST CASE)

Segment 1 represents a rather straight reach of the arroyo where a retaining wall is proposed by the Nor Este Manor development. Degradation resulting from the 10-year storm is estimated to expose approximately 6 inches of the cut-off wall. The following 100-year storm is estimated to expose approximately 5.5 feet of the wall. The wall footing will be located 2.0 feet below the existing arroyo bottom which will provide adequate bury for protection from consecutive 10-year and 100-year storms.

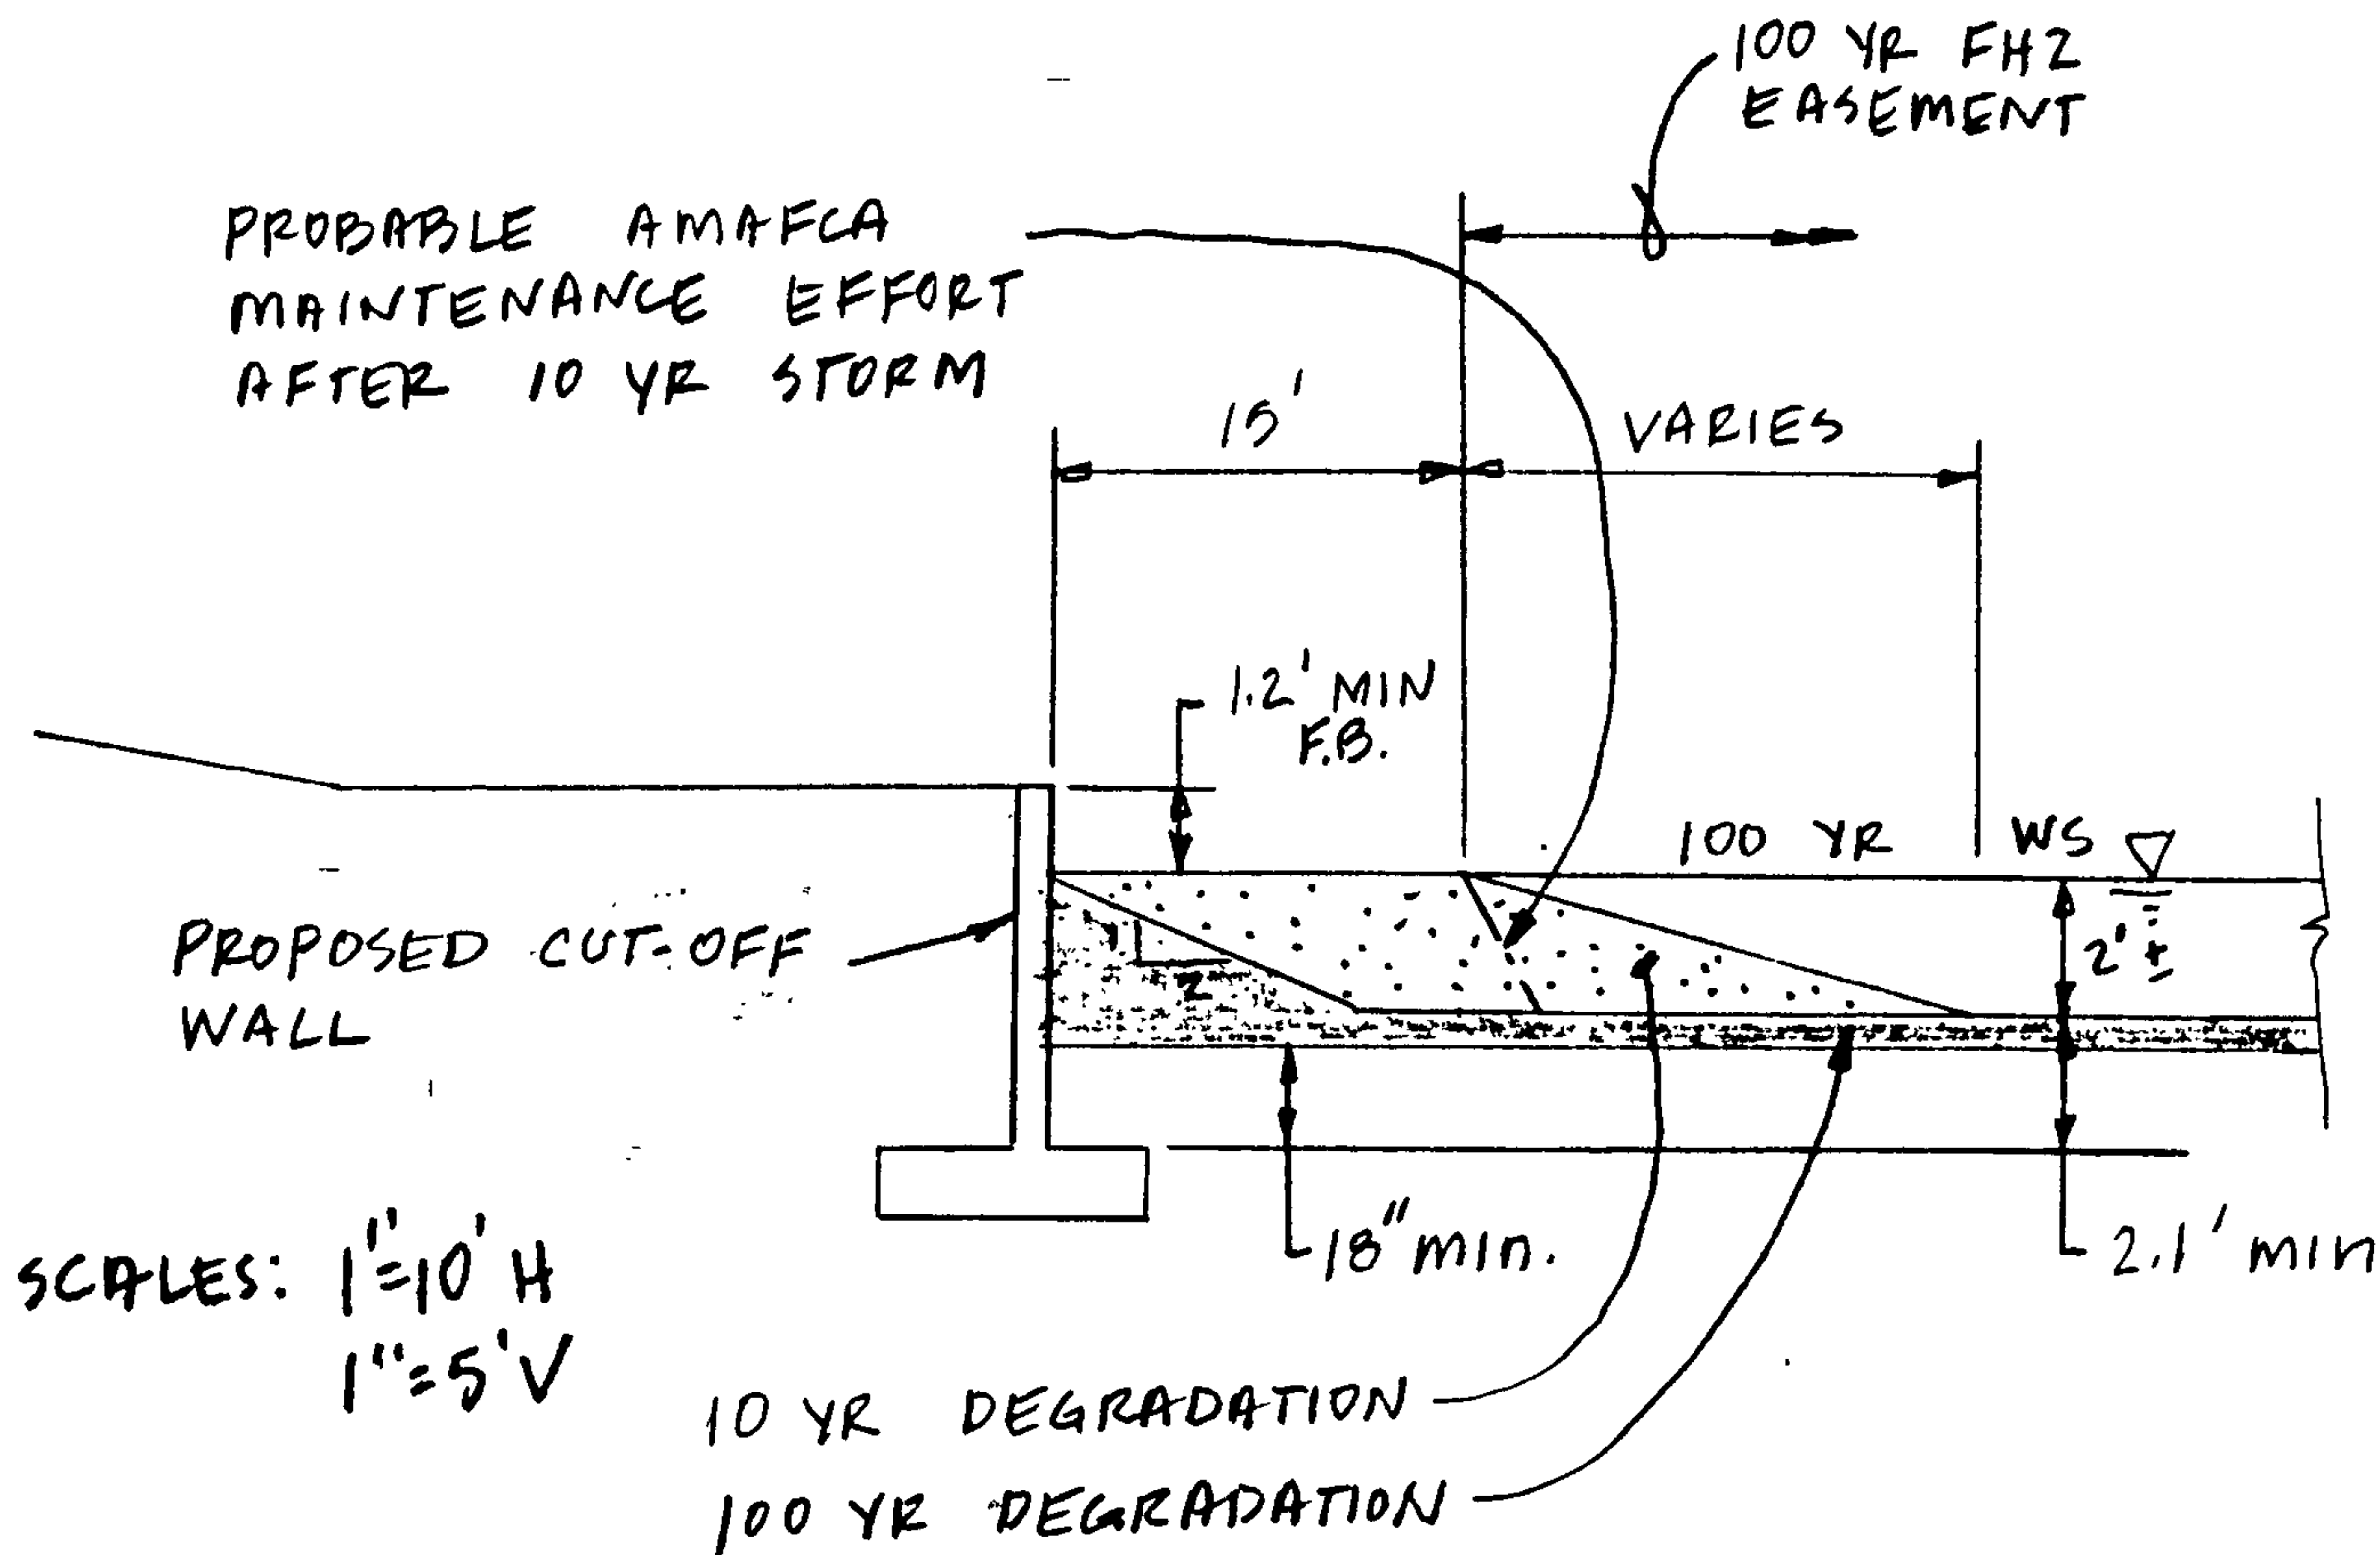
### TYPICAL SECTION - SEGMENT 2

TYPICAL DEGRADATION VALUES - TAKEN AT SECTION 20 (WORST CASE)

100 YEAR :  $d = -0.59'$   
 BW = 262' VOL SED = 155 CF

Segment 2 is located on the inside of the arroyo curvature in a section where large building setbacks occur.? In this segment the arroyo cross-section can withstand degradation by the 10-year storm without exposing the cut-off wall. The following 100-year storm is estimated to expose approximately 2.5 feet of the cut-off wall. The footing will be located 2.1 feet below the existing arroyo bottom which will provide adequate bury for protection from consecutive 10-year and 100-year storms. How

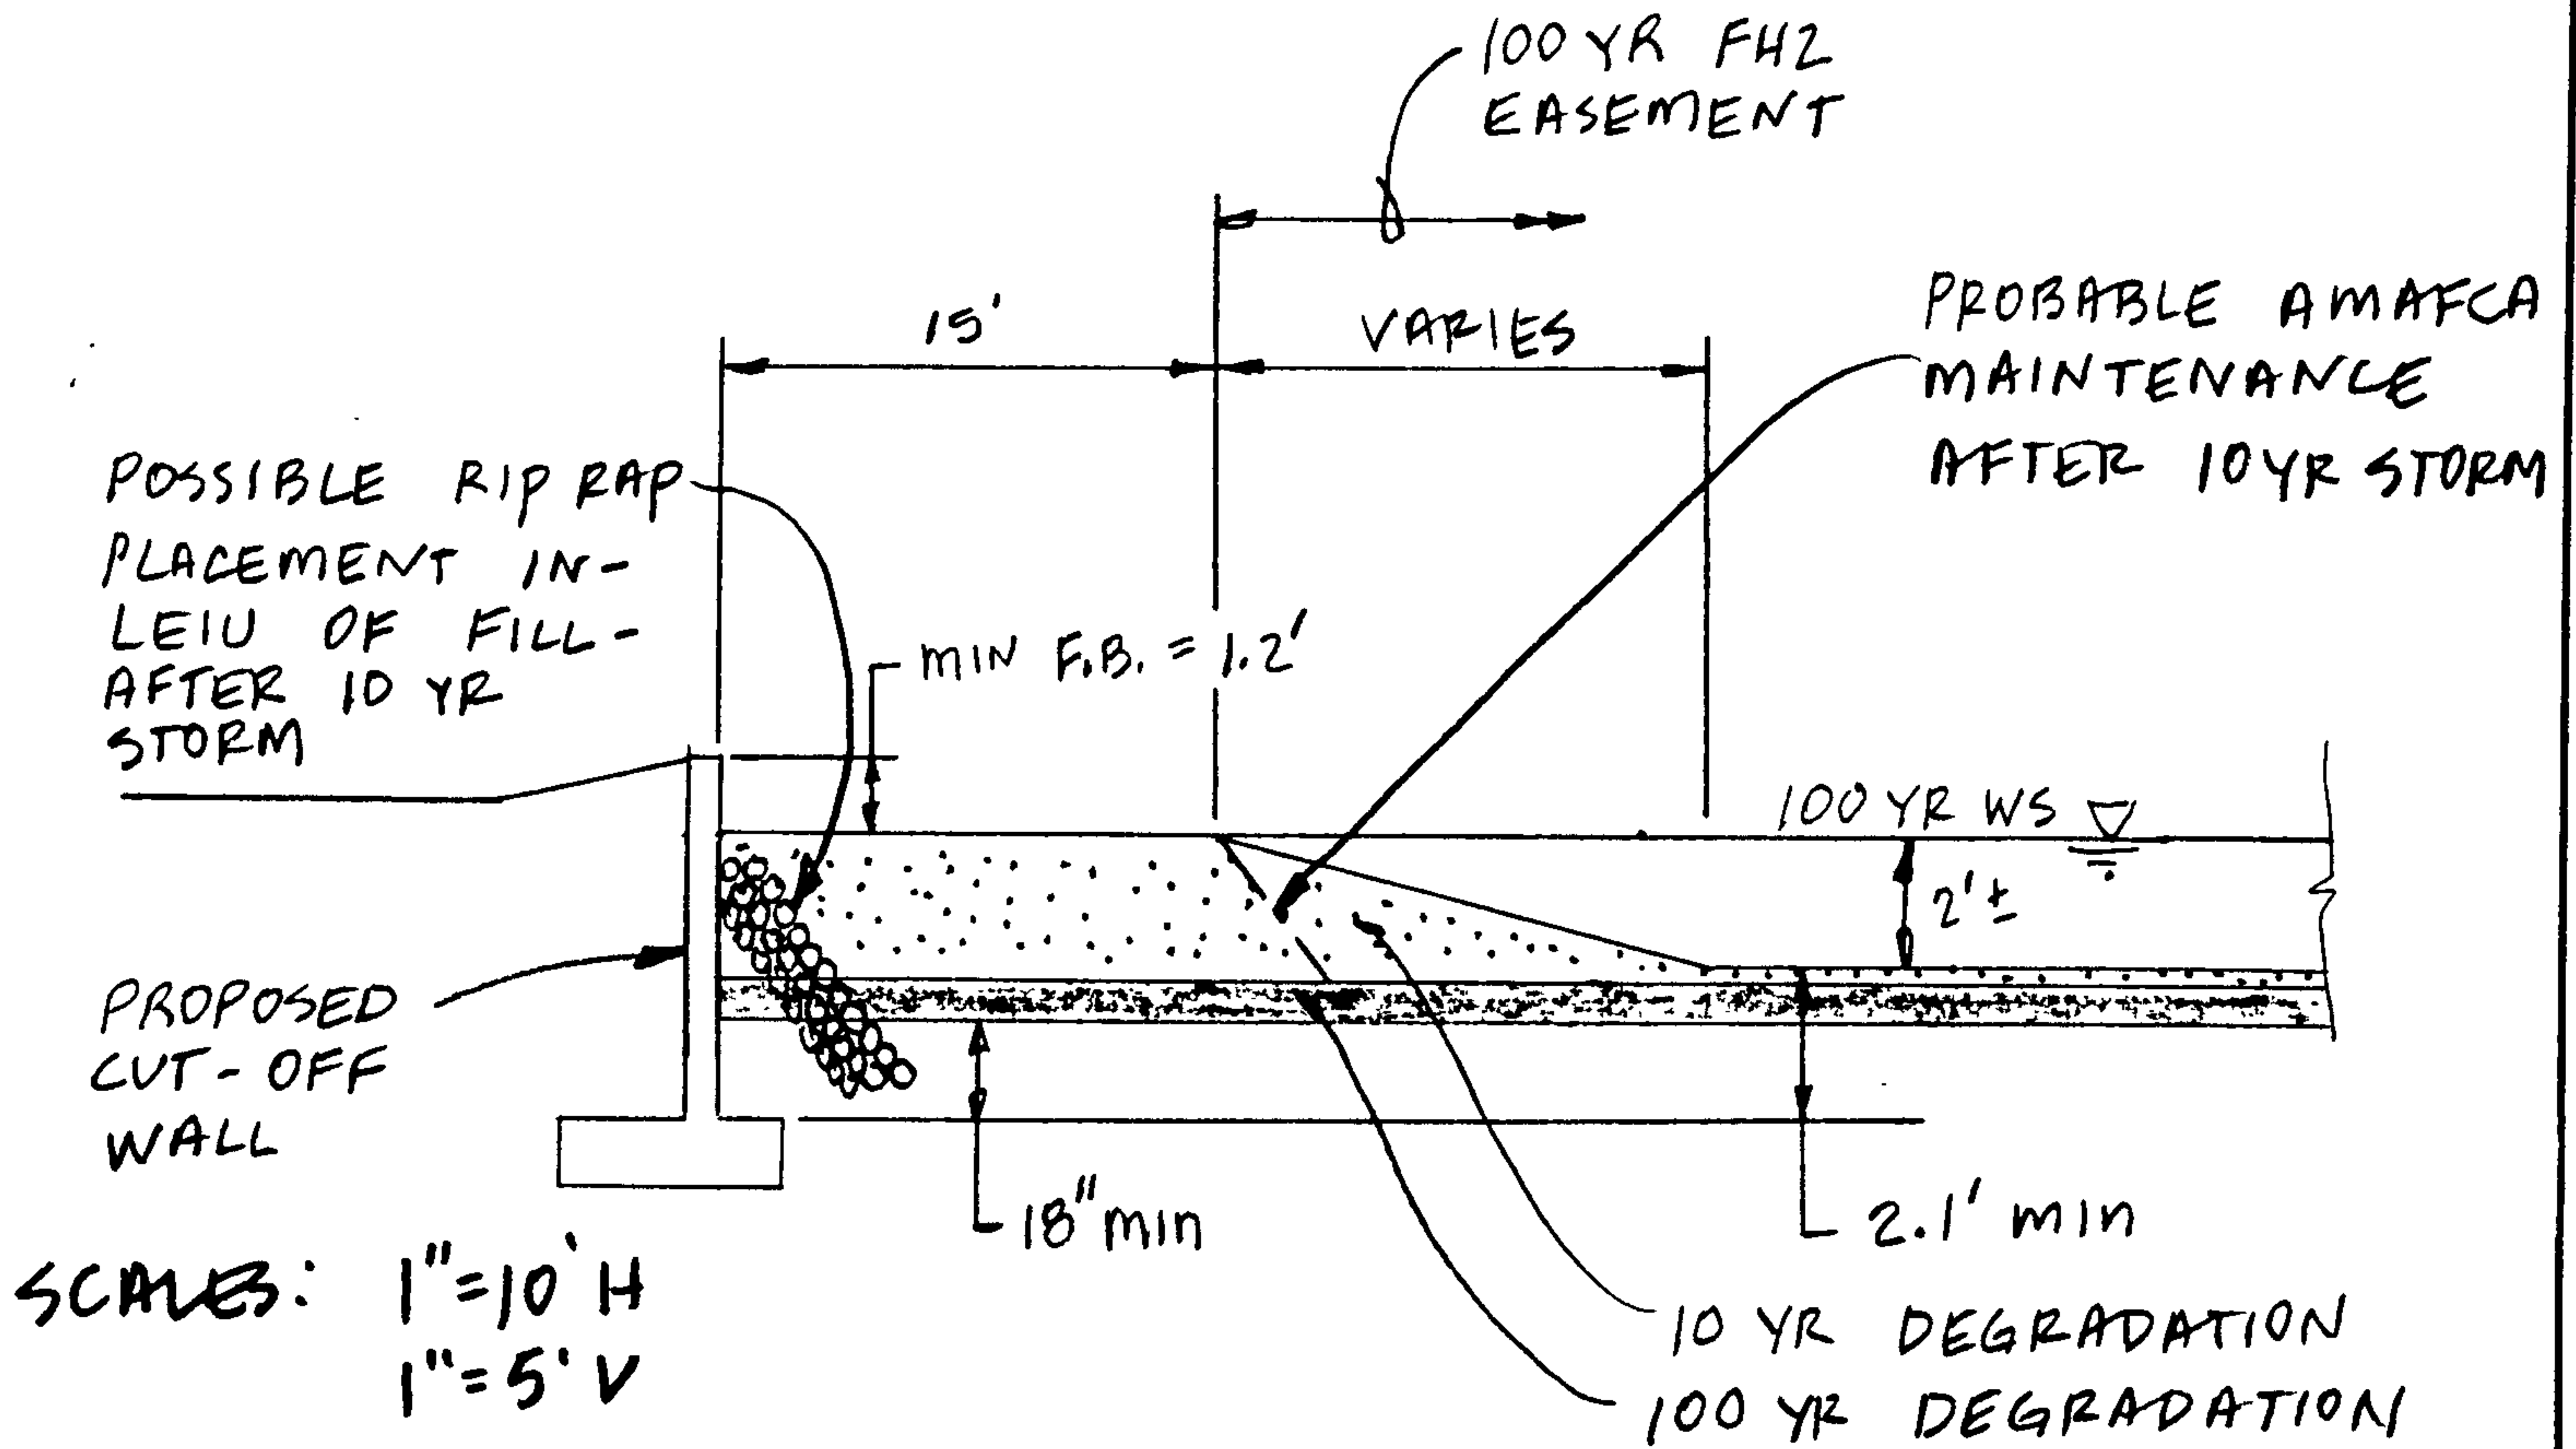
### TYPICAL SECTION - SEGMENT 3

TYPICAL DEGRADATION VALUES - TAKEN AT SECTION 26  
 (WORST CASE)

FOR PAD  $FB = 2.0 + 0.7 [0.025 (6.2) (2.35)^{1/3}] = 1.54 \text{ FT}$

⇒ FOR PAD USE 2.2 FT (1' MIN ABOVE  
 TOP OF WALL PER PRE-DESIGN CRITERIA)

It will be necessary to wrap the cut-off wall around Lot 4 along the Barstow frontage to provide protection from flows topping Barstow. The wall design will be consistent with Segment 3 criteria. However, it is not anticipated to be as maintenance intensive.

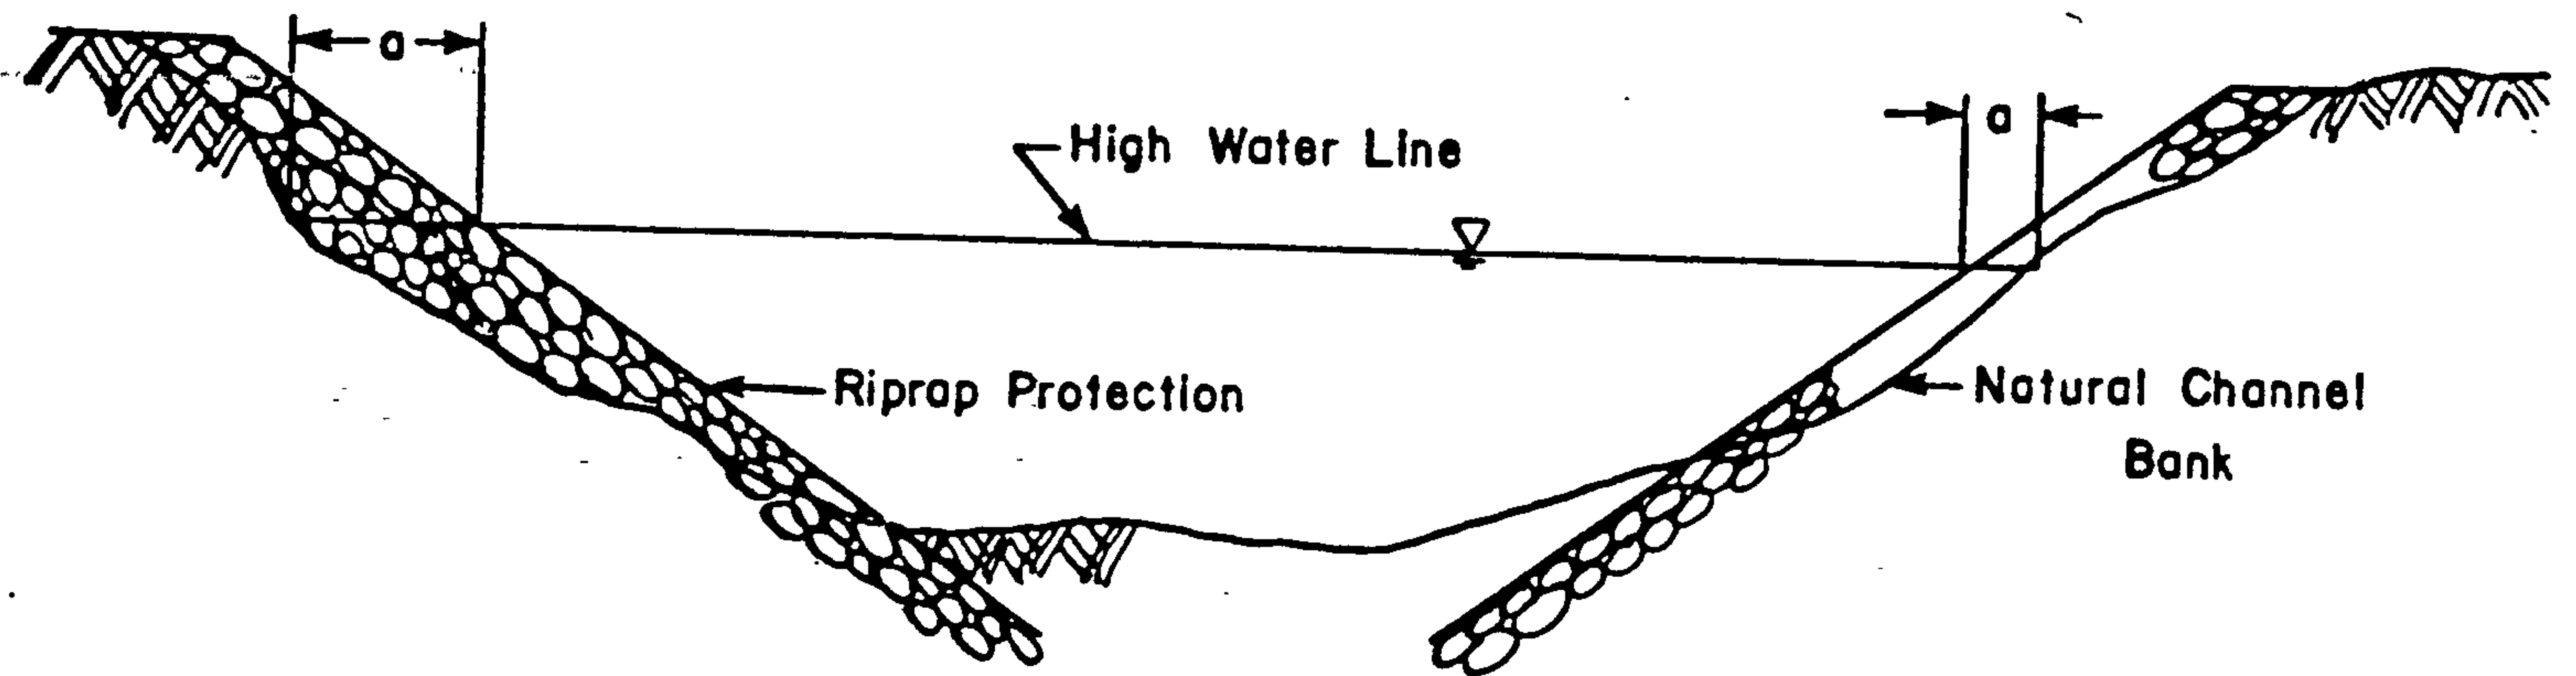
Figure 3-2. The embankment length measured normal to the flow.

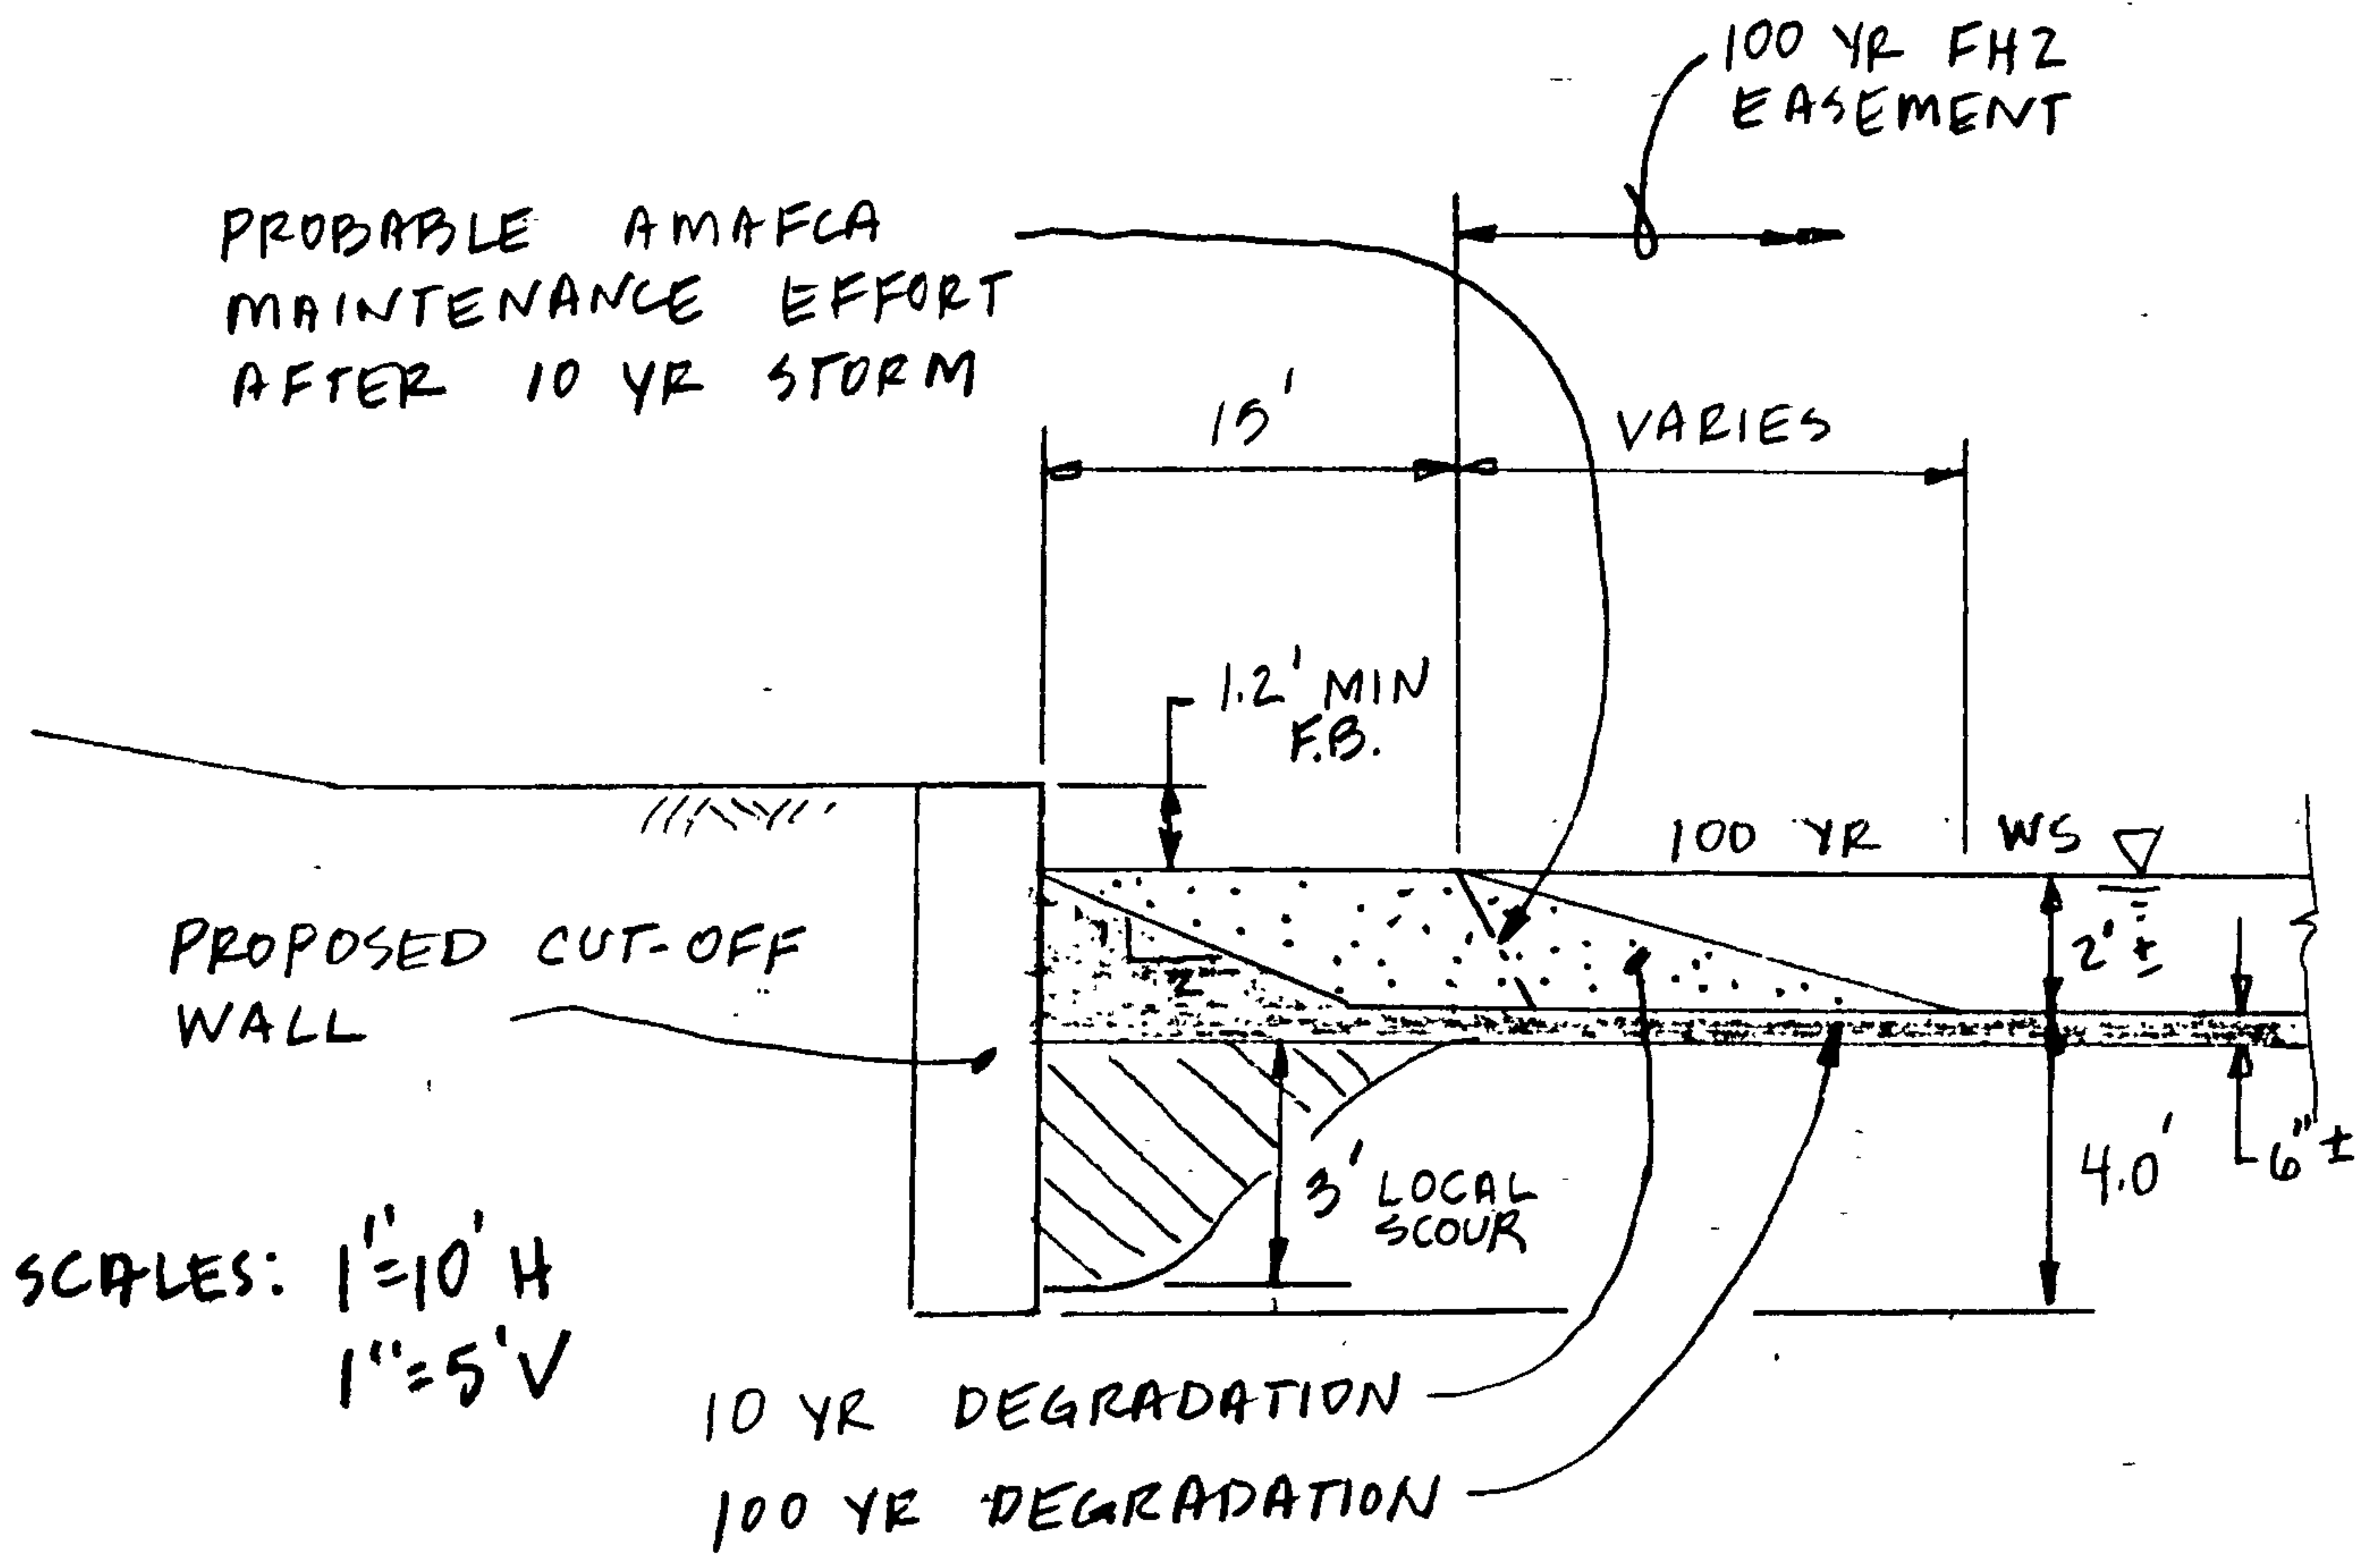
### TYPICAL SECTION - SEGMENT 2

SCALES: 1" = 10' H  
 1" = 5' V

TYPICAL DEGRADATION VALUES - TAKEN AT SECTION 20 (WORST CASE)

100 YEAR :  $d = -0.59'$  VOL SED = 155 CF  
 BW = 262'

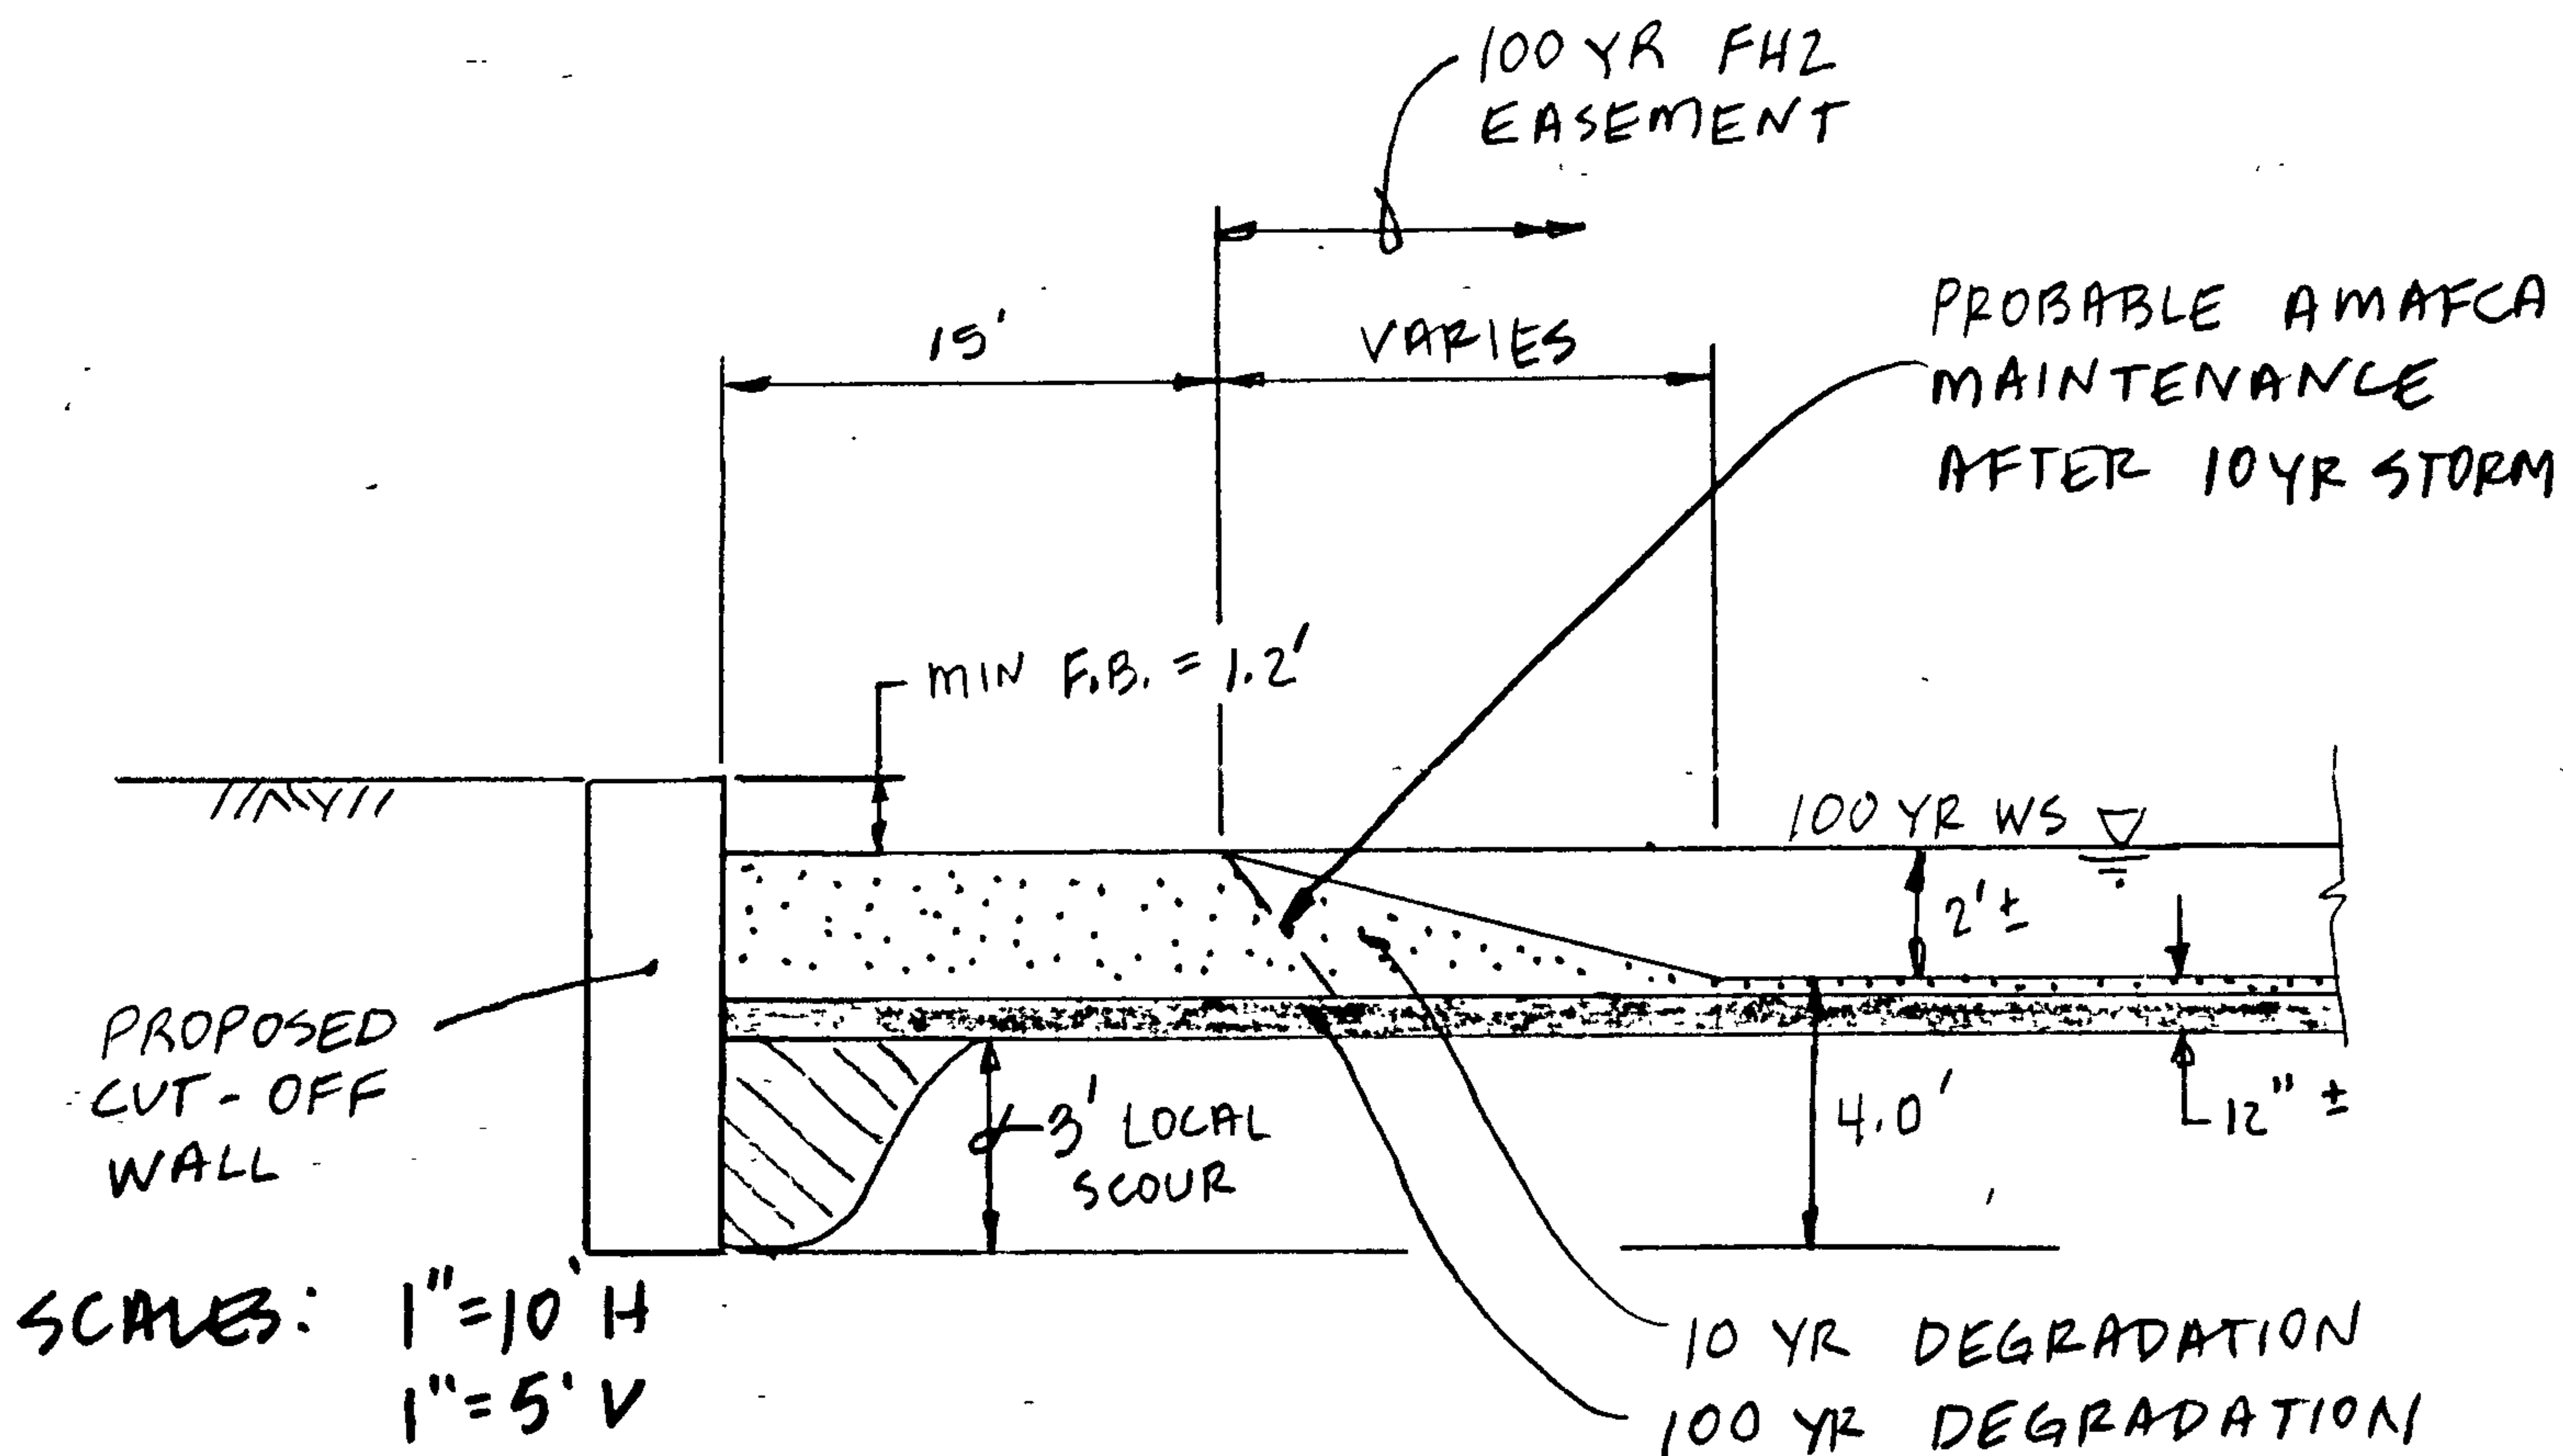
TYPICAL SECTION - SEGMENT 3

TYPICAL DEGRADATION VALUES - TAKEN AT SECTION 26 (WORST CASE)
