EROSION STUDY  
NORTH DOMINGO BACA ARROYO  
AT  
NOR ESTE MANOR, BLOCK F AND TRACT "B"

PRESLEY COMPANY OF NEW MEXICO  
1909 CARLISLE BOULEVARD NE  
ALBUQUERQUE, NEW MEXICO 87106

ADDENDUM NO. 1  
TO THE  
EROSION STUDY  
NORTH DOMINGO BACA ARROYO  
AT  
NOR ESTE MANOR, BLOCK F AND TRACT "B"

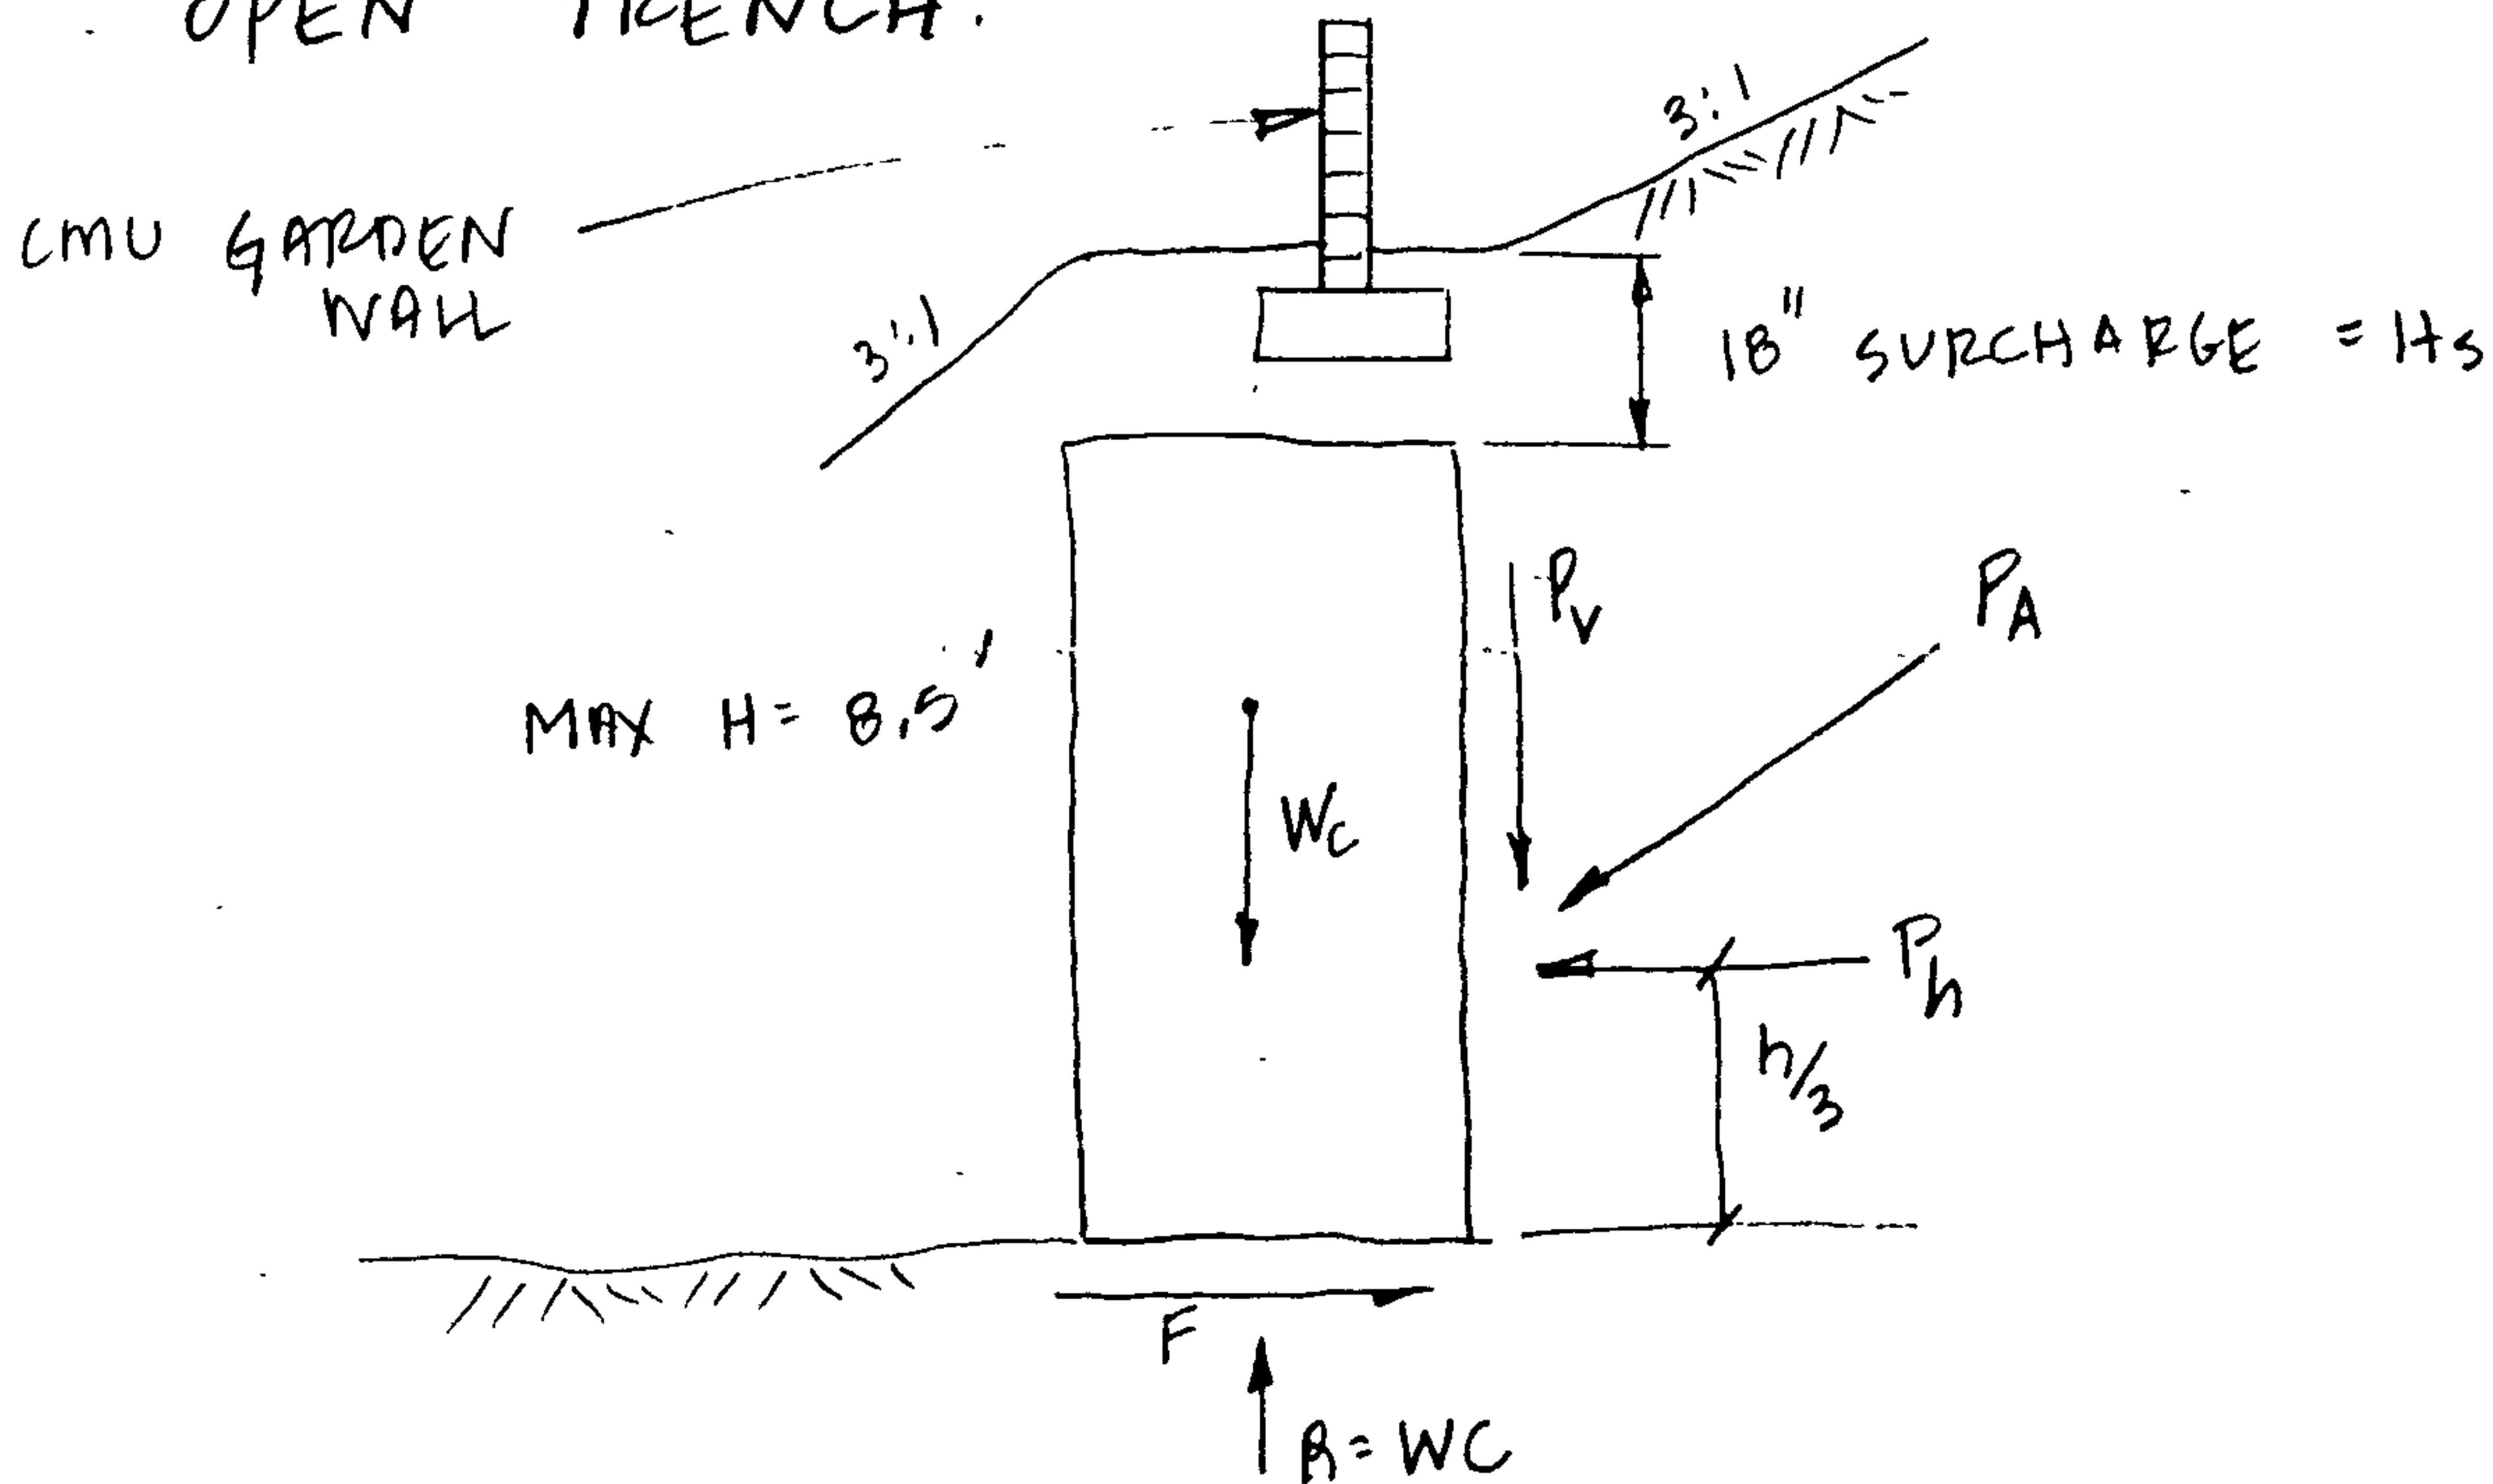
## CUT-OFF WALL DESIGN

DESIGN WALL AS GRAVITY TYPE RETAINING WALL TO BE MONOLITHICALLY POURED IN AN OPEN TRENCH:

$$\gamma_c = 150 \text{ PCF}$$

$$\gamma_s = 130 \text{ PCF}$$

$$P_B (\text{ALLOW}) = 2500 \text{ PSF}$$
