**RE: ENGINEER'S CERTIFICATION FOR LOTS 15 AND 16, BLOCK 3,
TRACT 2, UNIT 1, NORTH ALBUQUERQUE ACRES,(C22/D38)(PWD-94-
38), ENGINEER'S STAMP DATED 9/26/95.**

LEGAL DESCRIPTION
LOTS 15 AND 16, BLOCK 3, TRACT 2, UNIT 1, NORTH ALBUQUERQUE ACRES,
BERNALILLO COUNTY, NEW MEXICO

GRADING AND DRAINAGE PLAN
LOTS 15 & 16 BLOCK 3, TRACT 2,
UNIT 1, NORTH ALBUQUERQUE ACRES
11900 EAGLE ROCK AVENUE

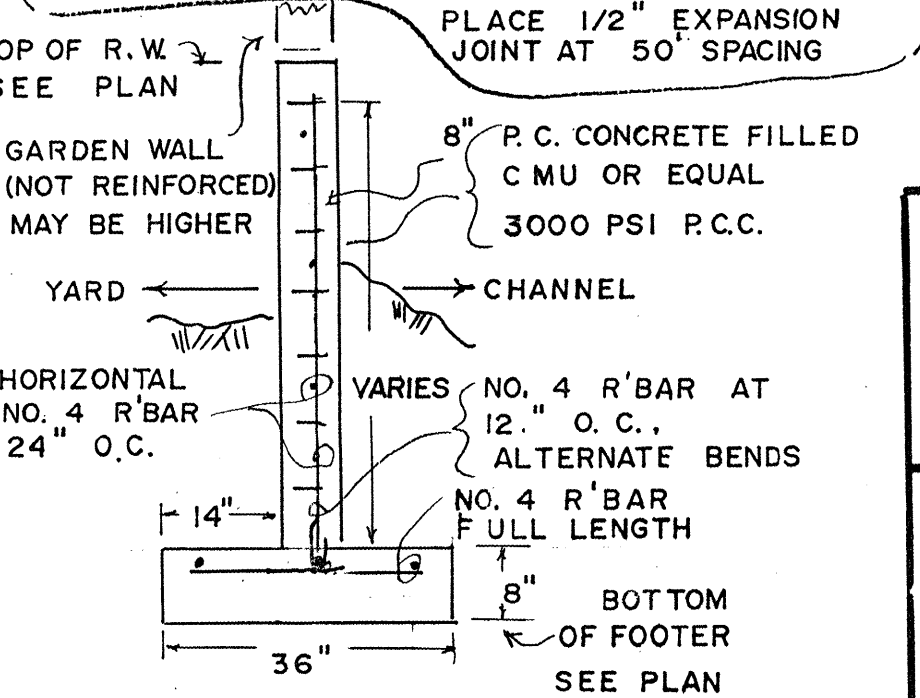
ALL R'BAR 40,000 PSI MIN.

ALTERNATIVE WALL SECTION
6" FOAM FORM FILLED WITH 3000 PSI P.C.
NO. 4 R'BAR AT 12" O.C. VERTICAL, 24" HORIZONTAL

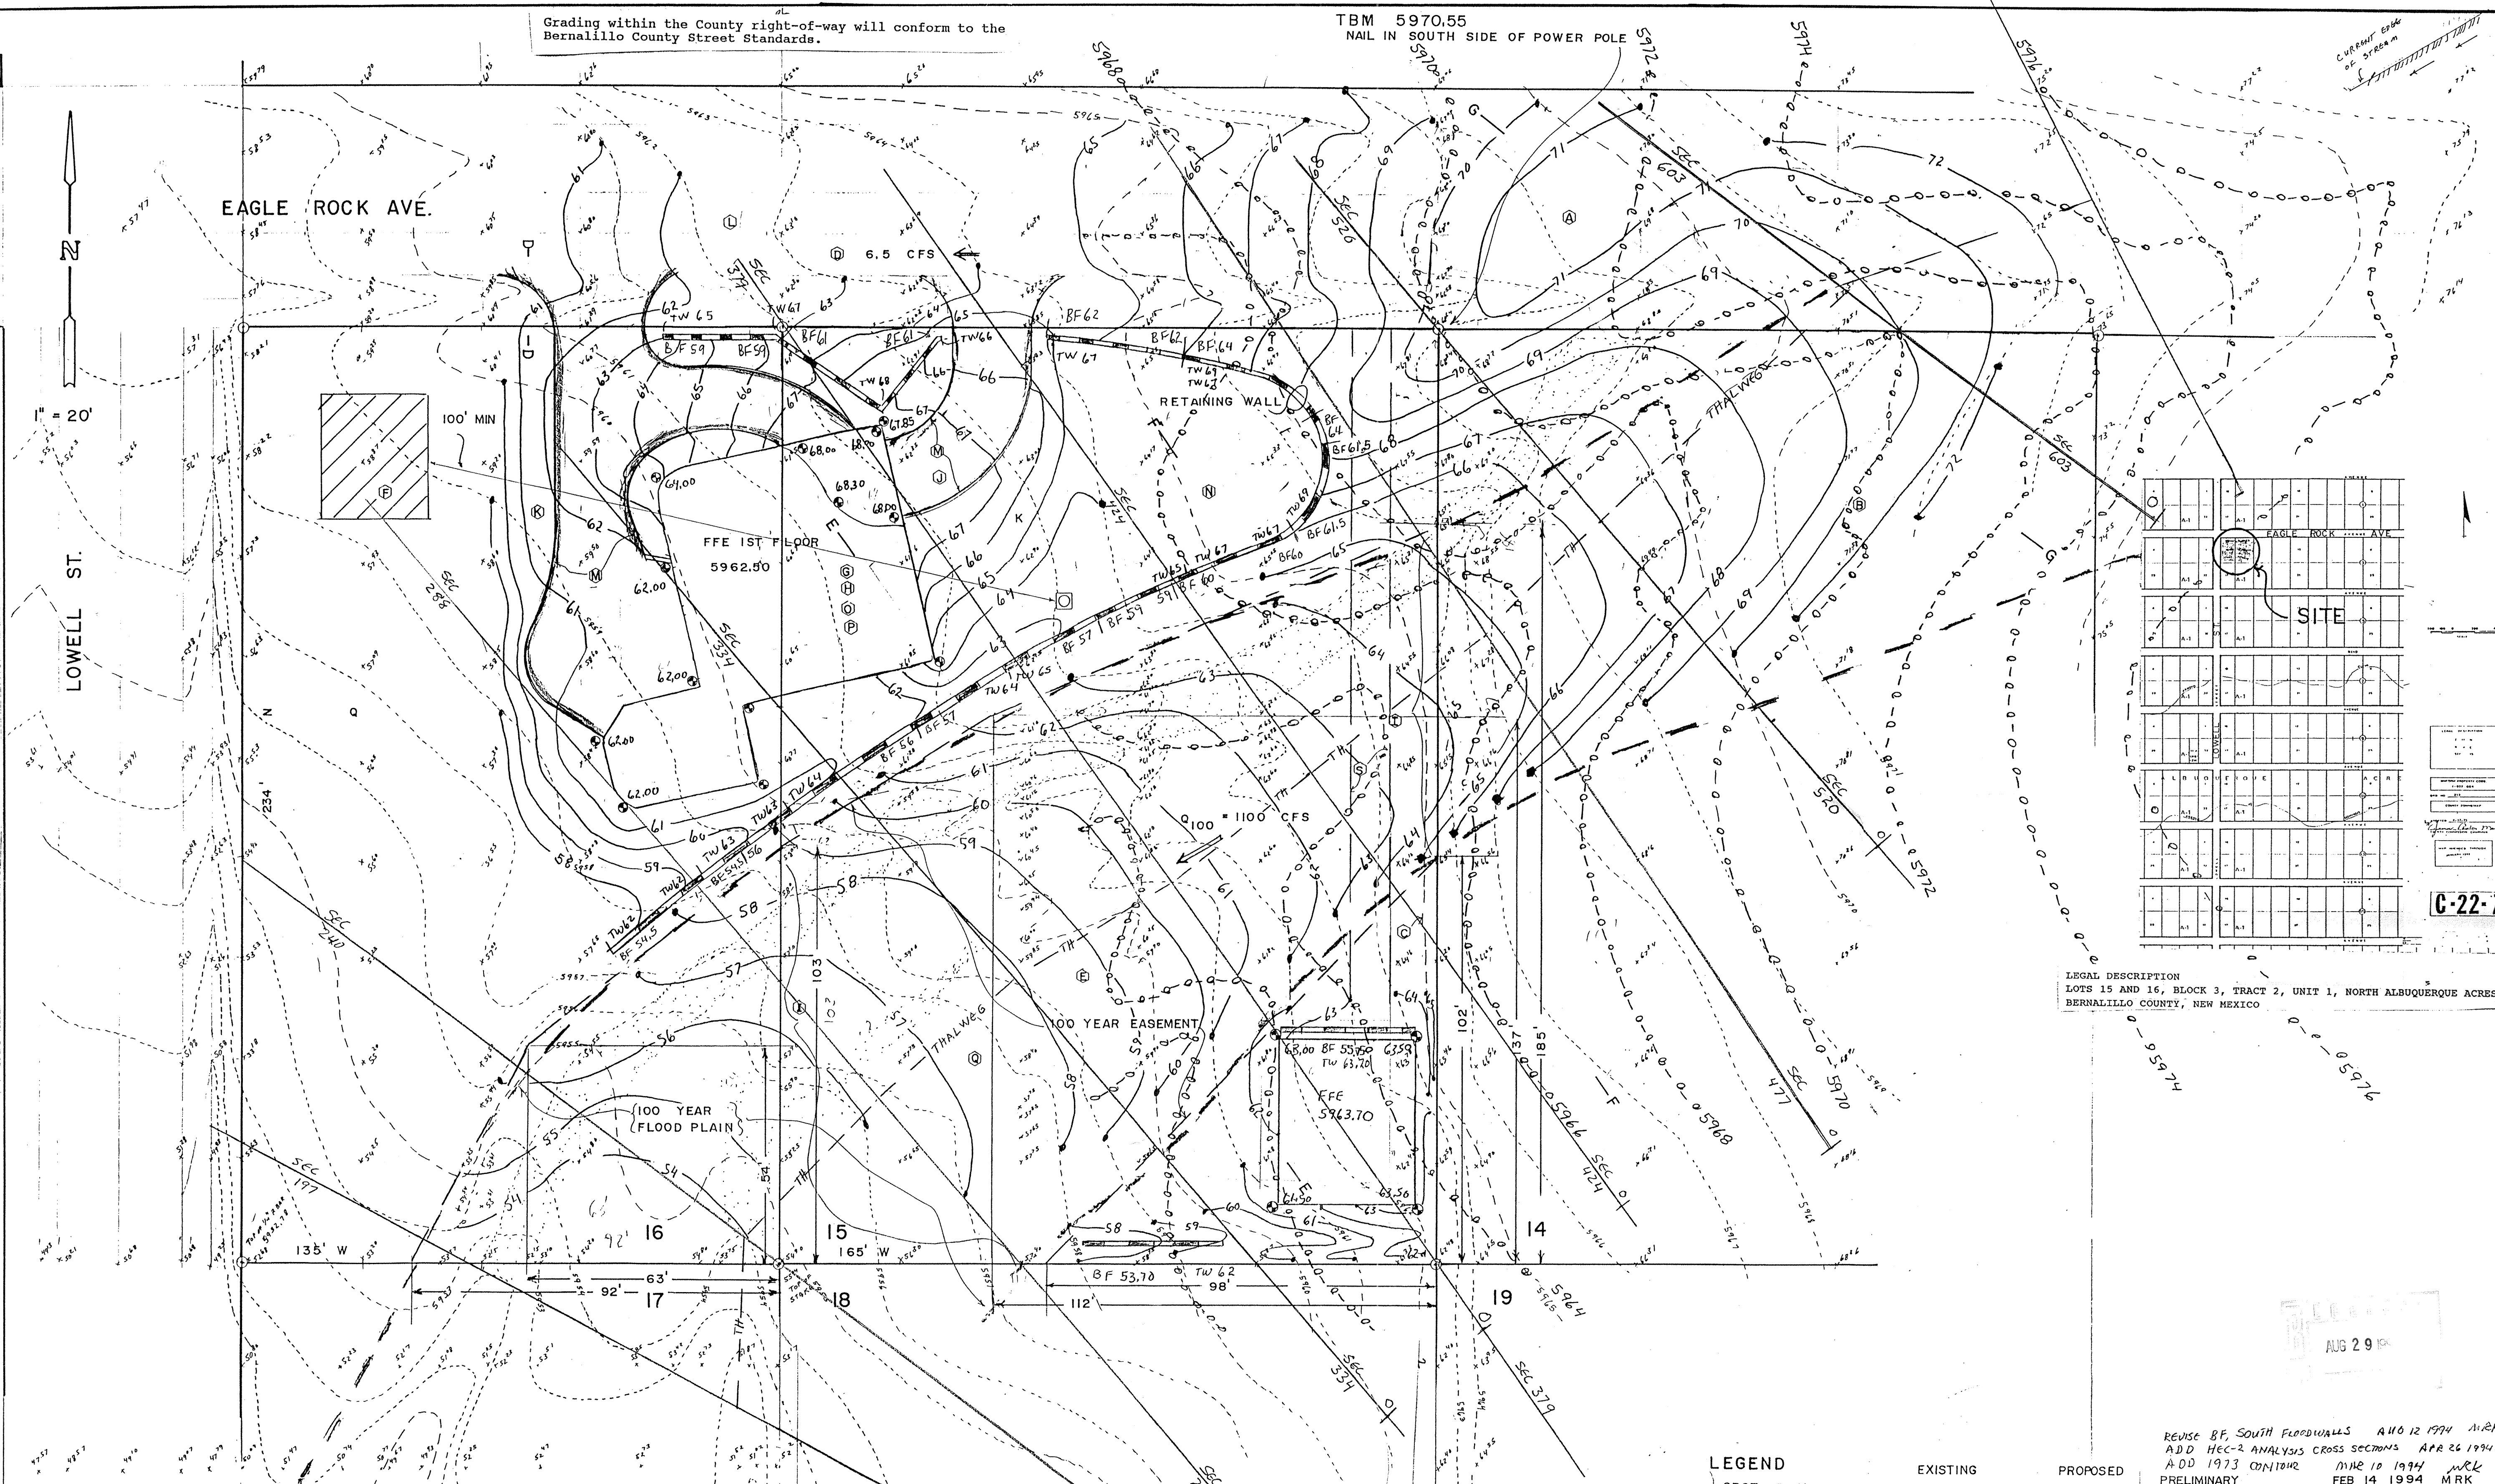
- (C) Fill material placed on lot 14 away from the designated flood plain will not create additional hazard for lot 15. The minor flows from this portion of lot 14 can be accepted on lot 15.

- (D) Runoff from basin A from north of lot 15/16 and north of Eagle Rock Avenue will flow along the ditch along the south side of Eagle Rock Avenue. The entry driveway into lot 15/16 will cross this drainage path. Table A shows the estimated flow from this basin A, and table D shows the flow pattern in the ditch section at the driveway. Flow depth is less than 4" for the 100 year storm. This runoff will cause no hazard to lot 15/16 and is accepted.

Grading within the County right-of-way will conform to the Bernalillo County Street Standards.

TBM 5970.55
NAIL IN SOUTH SIDE OF POWER POLE

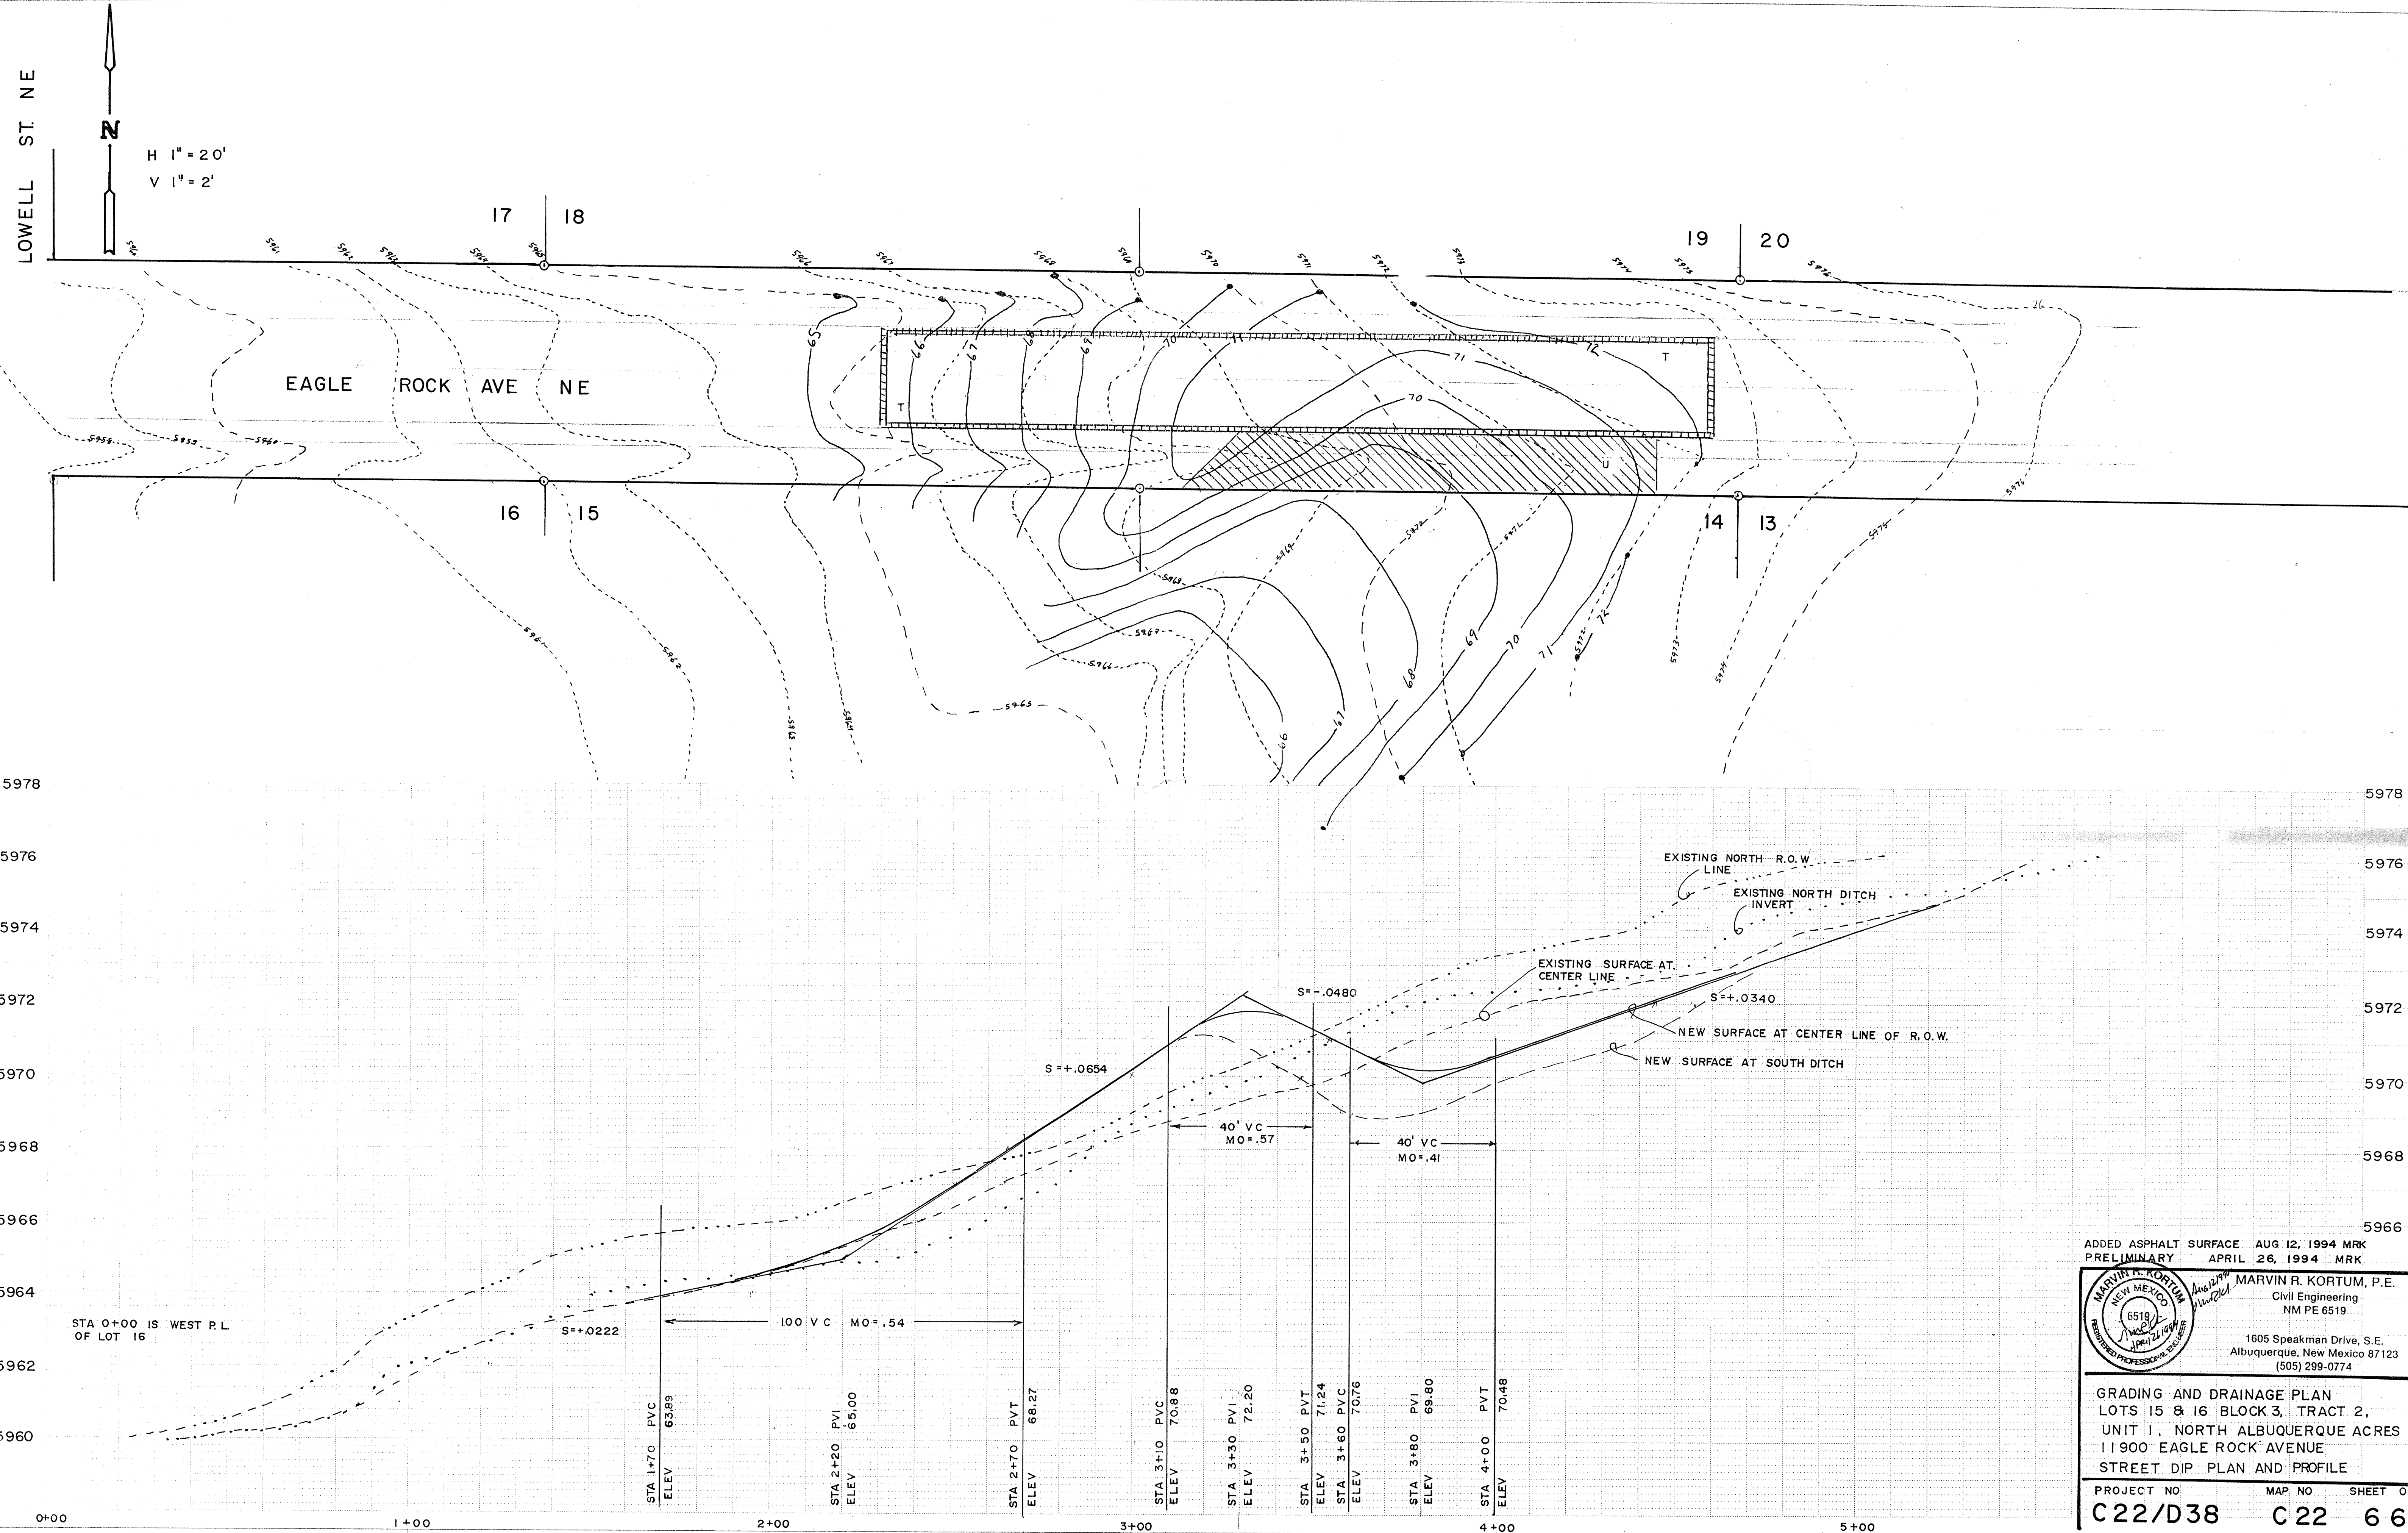
ADDED ASPHALT SURFACE AUG 12, 1994 MRK
PRELIMINARY APRIL 26, 1994 MRK
