RE: DRAINAGE PLAN FOR LOT 1477, SANDIA HEIGHTS SOUTH  
(D-23/D26) ENGINEER'S STAMP DATED JULY 15, 1992

- The proposed improvements are comprised of a 2500 SF (footprint) private residence with associated driveway, walks, and patio area.
- The present site is undeveloped land sloping at 3% westerly. The property fronts on Morning Glory Road NE, and undeveloped land to the south. Existing private residences occupy the lots east and west of the site.

**FLOOD HAZARD:** FEMA Boundary Map indicates the northern half of the site lies within the Arroyo de Domingo Baca Flood hazard zone. See Drainage/Grading plan for flood hazard zone boundary.

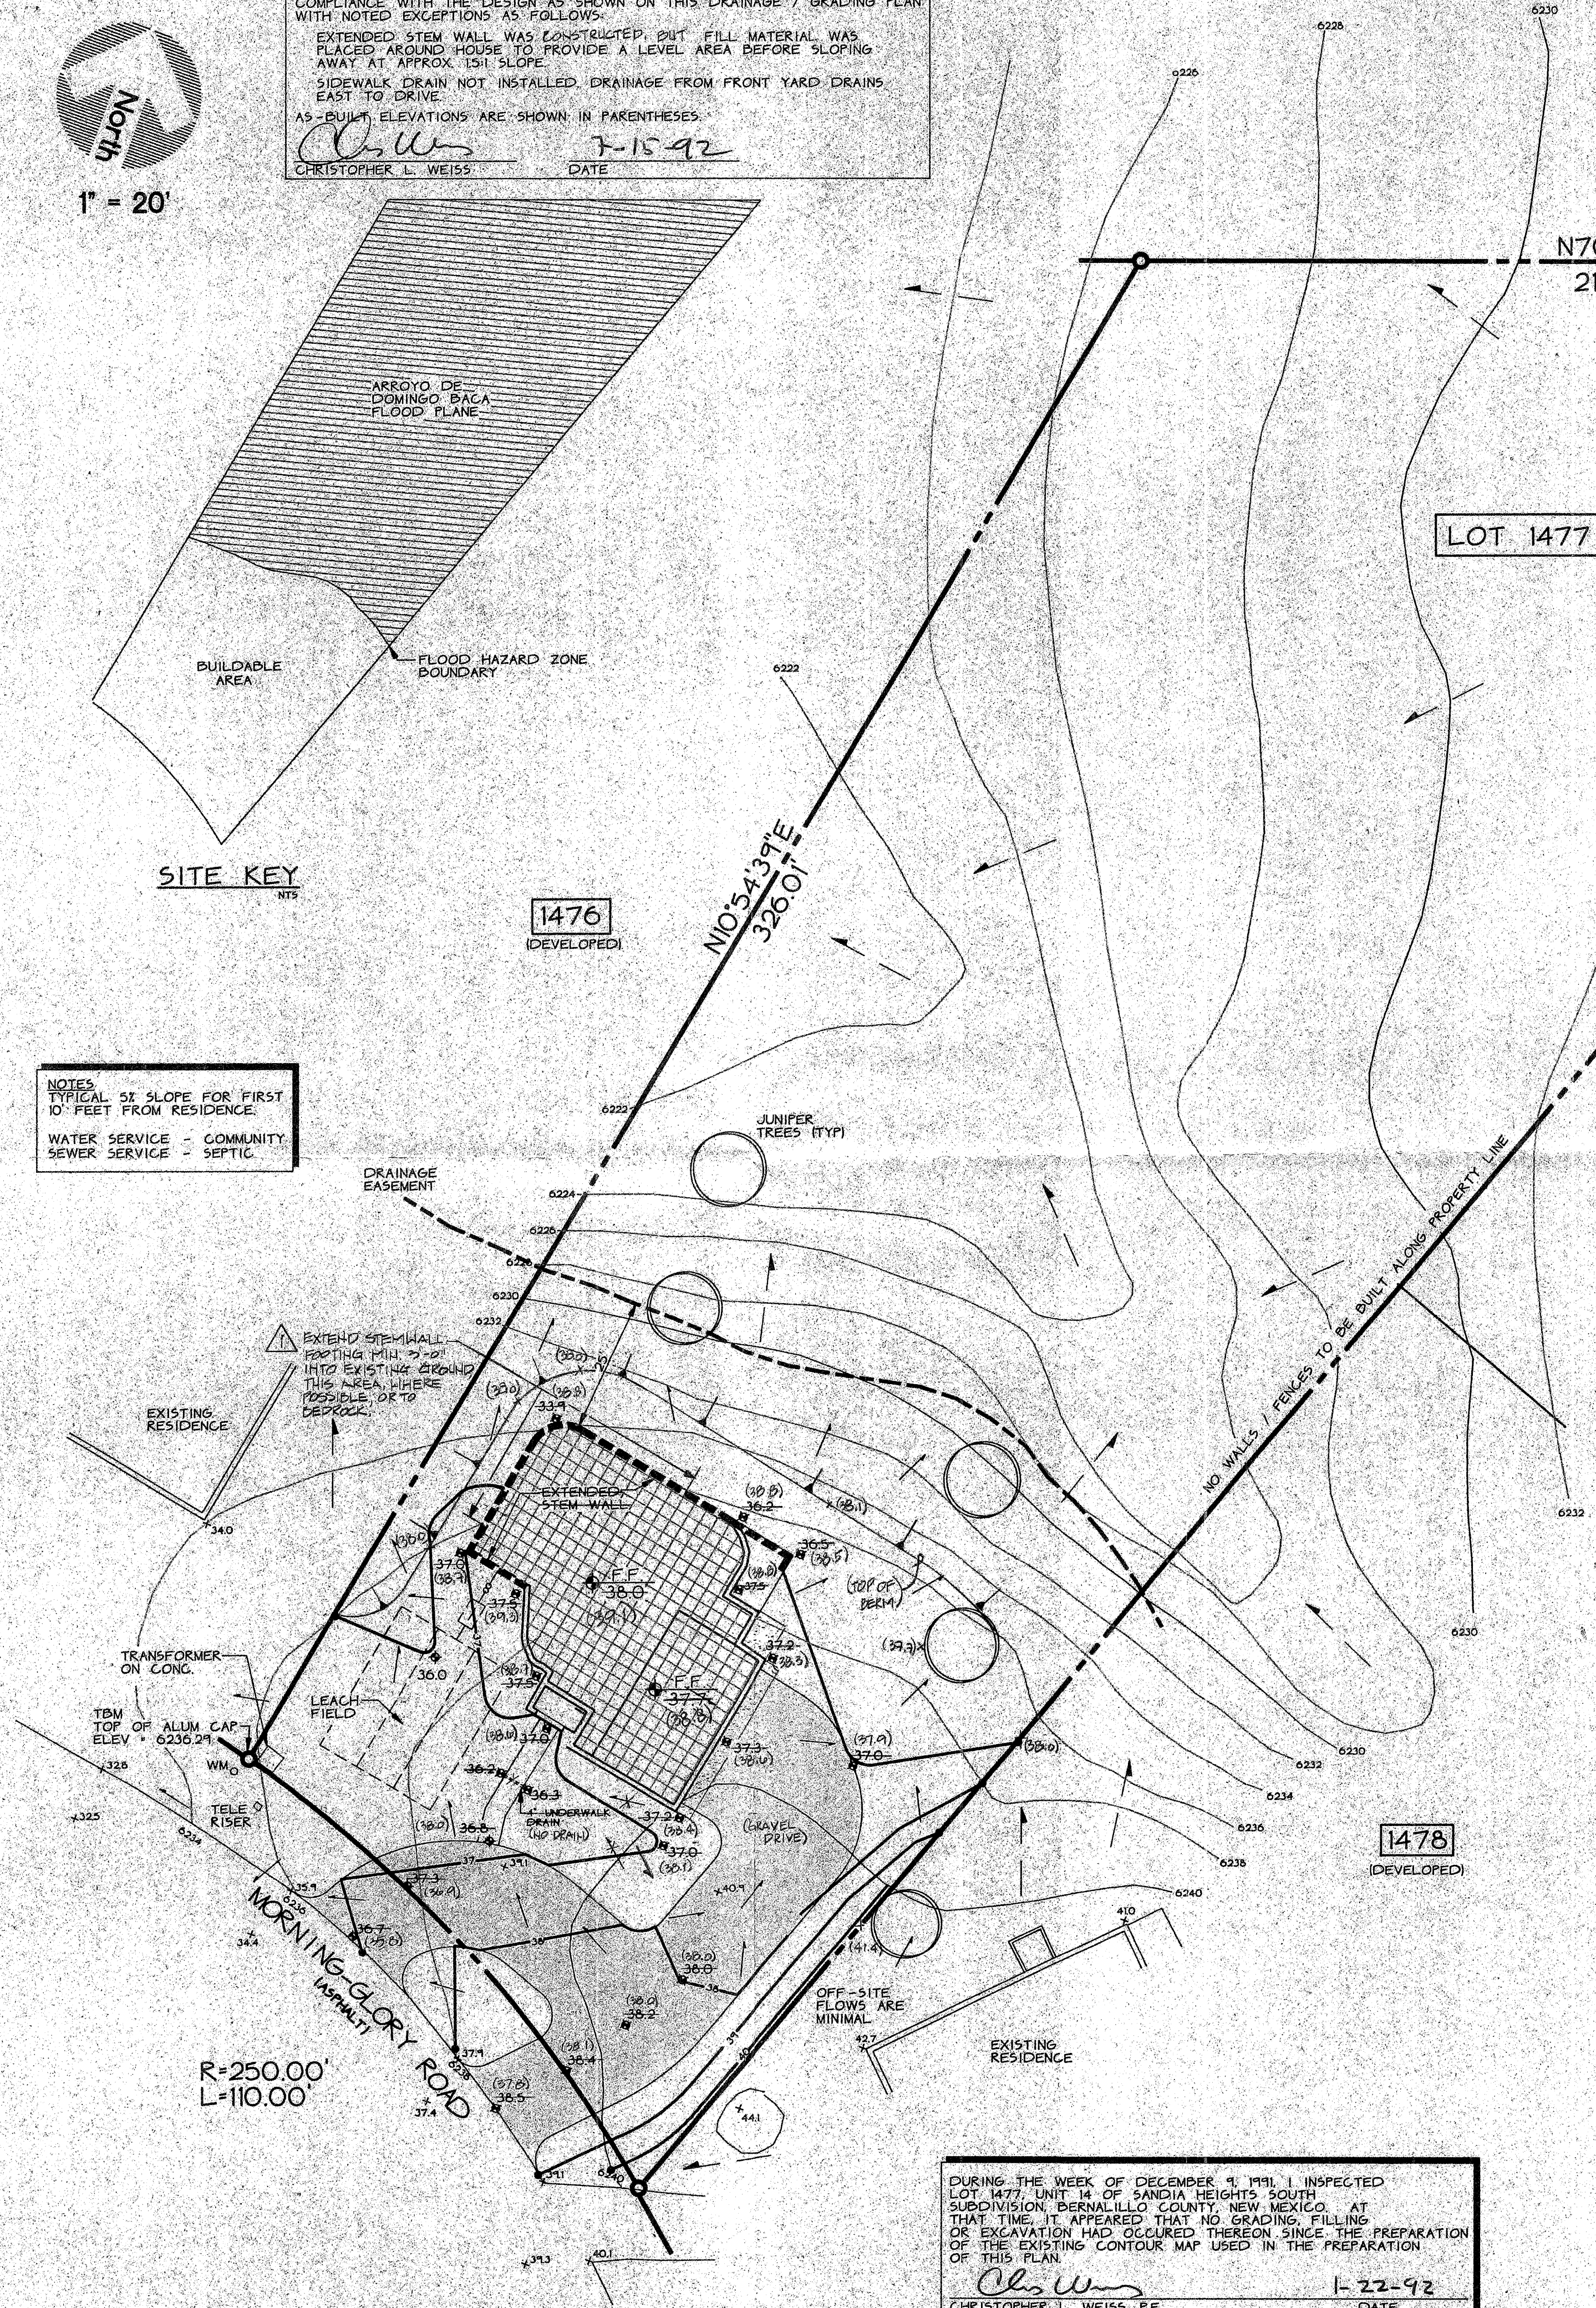
LOT 1477

ENGINEER'S CERTIFICATION:  
I CERTIFY THAT CONSTRUCTION OF SITE IMPROVEMENTS ARE IN SUBSTANTIAL COMPLIANCE WITH THE DESIGN AS SHOWN ON THIS DRAINAGE / GRADING PLAN WITH NOTED EXCEPTIONS AS FOLLOWS:  
EXTENDED STEM WALL WAS CONSTRUCTED, BUT FILL MATERIAL WAS PLACED AROUND HOUSE TO PROVIDE A LEVEL AREA BEFORE SLOPING AWAY AT APPROX. 15% SLOPE.  
SIDEWALK DRAIN NOT INSTALLED. DRAINAGE FROM FRONT YARD DRAINS EAST TO DRIVE.  
AS-BUILT ELEVATIONS ARE SHOWN IN PARENTHESES.  
CHRISTOPHER L. WEISS  
DATE 7-15-92

NOTES:  
TYPICAL 5% SLOPE FOR FIRST 10' FEET FROM RESIDENCE.  
WATER SERVICE - COMMUNITY  
SEWER SERVICE - SEPTIC

RESUBMITTAL - 1-30-92  
DESIGNATION OF EXTENDED  
STEMWALL FOOTINGS  
CHRISTOPHER L. WEISS  
DATE 1-30-92

- The intent of this plan is to show:
- Grading relationships between the existing ground elevations and proposed finished elevations in order to facilitate positive drainage to designated discharge points.

- The extent of proposed site improvements, including buildings, walks and pavement.
  - The flow rate/volume of rainfall runoff across or around these improvements and methods of handling these flows to meet County requirements for drainage management.

- The relationship of onsite improvements with existing neighboring property to insure an orderly transition between proposed and surrounding grades.

**DRAINAGE PLAN CONCEPT:** A shallow earth swale south of the residence will carry flows north to the floodway drainage easement crossing the property. All other run off onsite and offsite will be allowed to follow existing flow patterns in a westerly direction.

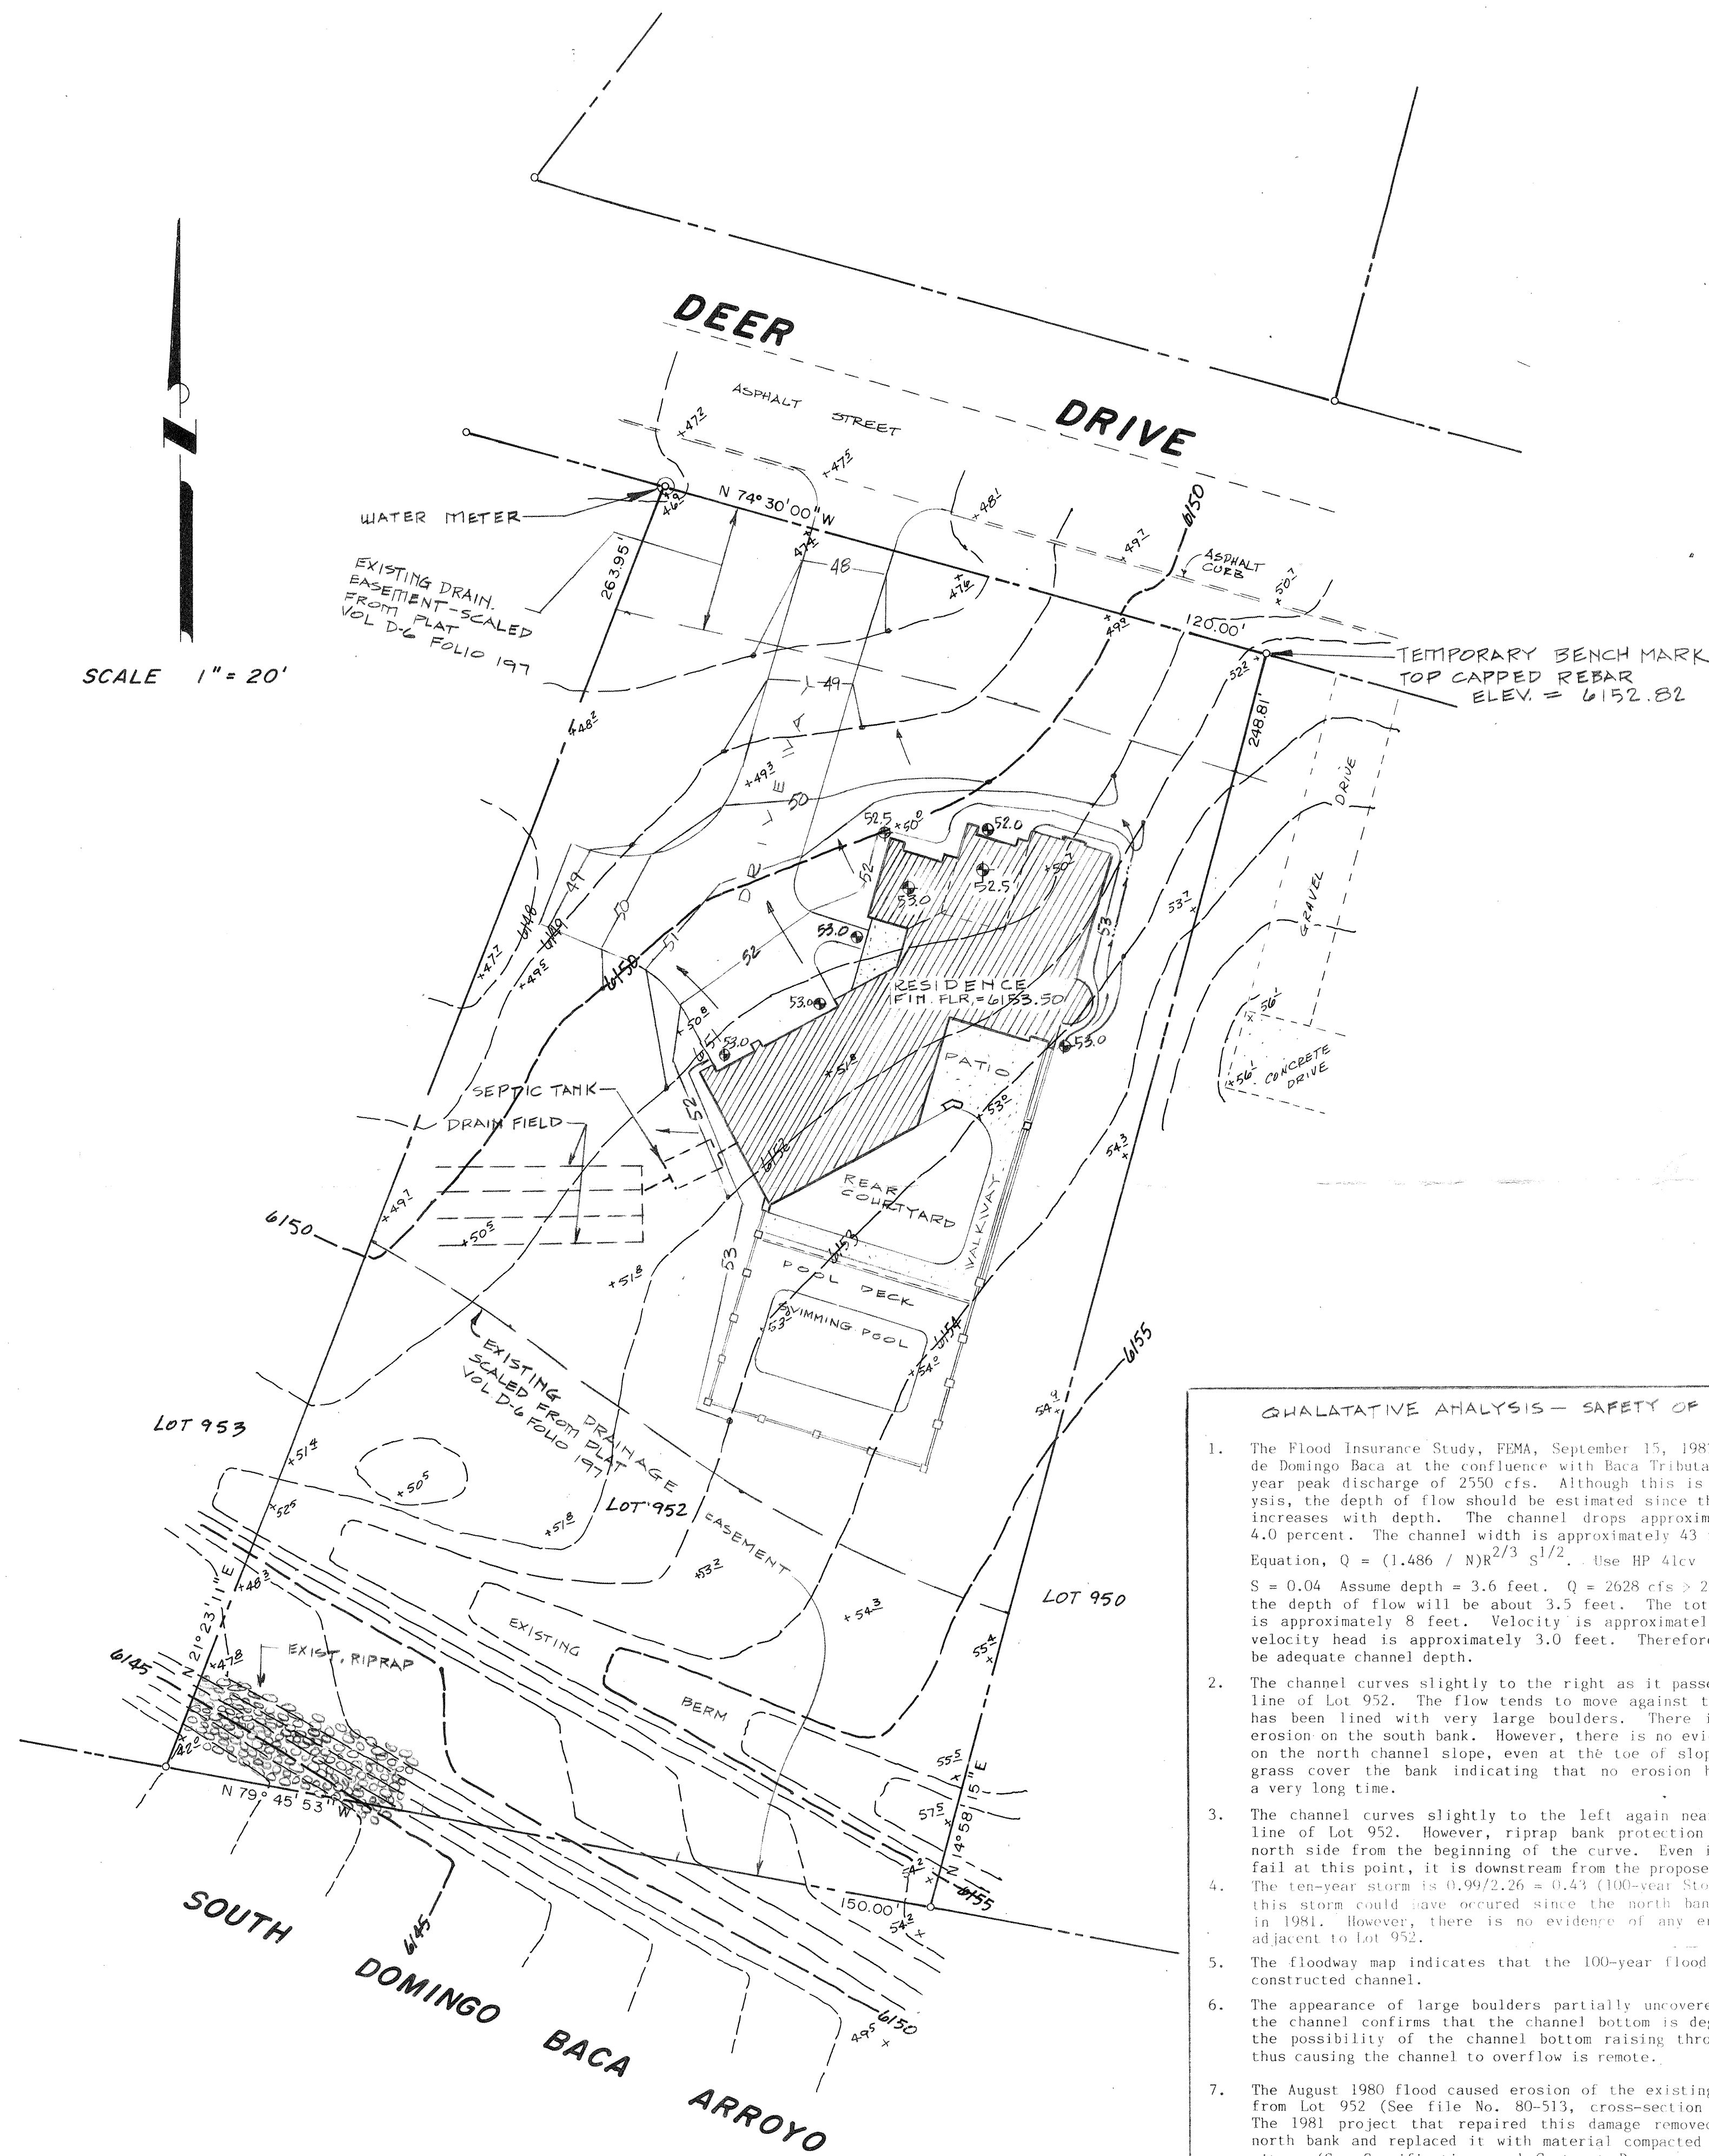
**QUALITATIVE ANALYSIS - SAFETY OF RESIDENCE**

- The Flood Insurance Study, FEMA, September 15, 1983, lists the Arroyo de Domingo Baca at the confluence with Baca Tributary as having a 100-year peak discharge of 2550 cfs. Although this is a qualitative analysis, the depth of flow should be estimated since the severity of scour increases with depth. The channel drops approximately 10' in 250', 4.0 percent. The channel width is approximately 43 feet. Use Manning's Equation,  $Q = (1.486 / N) R^{2/3} S^{1/2}$ . Use HP 41c program.  $N = 0.045$ .  $S = 0.04$ . Assume depth = 3.6 feet.  $Q = 2628$  cfs > 2550 cfs. Therefore, the depth of flow will be about 3.5 feet. The total depth of channel is approximately 8 feet. Velocity is approximately 13.6 fps, so the velocity head is approximately 3.0 feet. Therefore, there appears to be adequate channel depth.

- The channel curves slightly to the left again near the west property line of Lot 952. However, riprap bank protection is provided on the north side from the beginning of the curve. Even if the riprap should fail at this point, it is downstream from the proposed residence.

- The floodway map indicates that the 100-year flood is confined to the constructed channel.
- The appearance of large boulders partially uncovered in the bottom of the channel confirms that the channel bottom is degrading. Therefore, the possibility of the channel bottom raising through aggradation and thus causing the channel to overflow is remote.

- The August 1980 flood caused erosion of the existing channel downstream from Lot 952 (See file No. 80-513, cross-section at Station 137+00. The 1981 project that repaired this damage removed material from the north bank and replaced it with material compacted to 95% maximum density. (See Specifications and Contract Documents for Construction of Upstream Channel Improvements, South Arroyo De Domingo Baca, Section 203.035.) It is believed that the reason that no erosion took place adjacent to Lot 952 is the slight channel curvature described in Item 2 above. The curvature in the channel is documented in a letter of June 29, 1981 to A.M.A.F.C.A. from Ned A. Green who was concerned about Lot 1178 on the south side of the channel.

- In summary, the integrity of the north channel bank is very high at the section adjacent to Lot 952. Therefore, it is felt that this development will be safe from erosion from the Arroyo De Domingo Baca.
