RE: Carlisle Marketplace 2100 Carlisle NE

**Conceptual Grading Plan Stamp Date: none (7/19)**

**Drainage Report Stamp Date: none (7/19)**

# DRAINAGE REPORT FOR CARLISLE MARKETPLACE

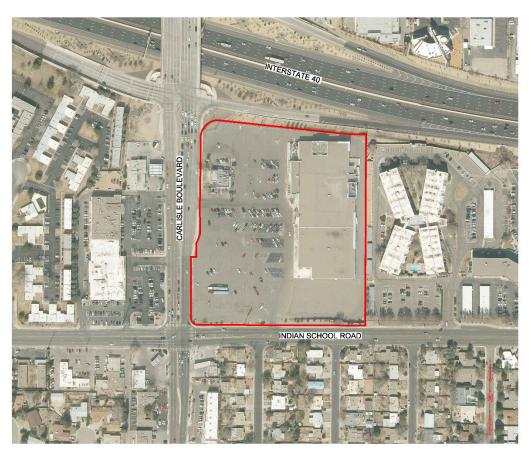
FIGURE 1.2.1 - PROJECT LOCATION

Tracts A and B are located at the northeast corner of the Carlisle Boulevard and Indian School Road intersection and contain approximately 10.7 acres. See Figure 1.2.1 below. The existing site includes a Burger King restaurant located on Tract B and an old K-Mart building and parking lot on Tract A that is currently vacant. The existing conditions are described in more detail in Section 3.1 and the proposed conditions are described in Section 3.2.
