PRELIMINARY PLAT

# SAWMILL TOWNHOUSES

DRAINAGE REPORT  
FOR  
SAWMILL TOWNHOUSES

SECTION 16, T. 10 N., R. 3 E., N.M.P.M.  
CITY OF ALBUQUERQUE  
BERNALILLO COUNTY, NEW MEXICO  
JULY, 1985

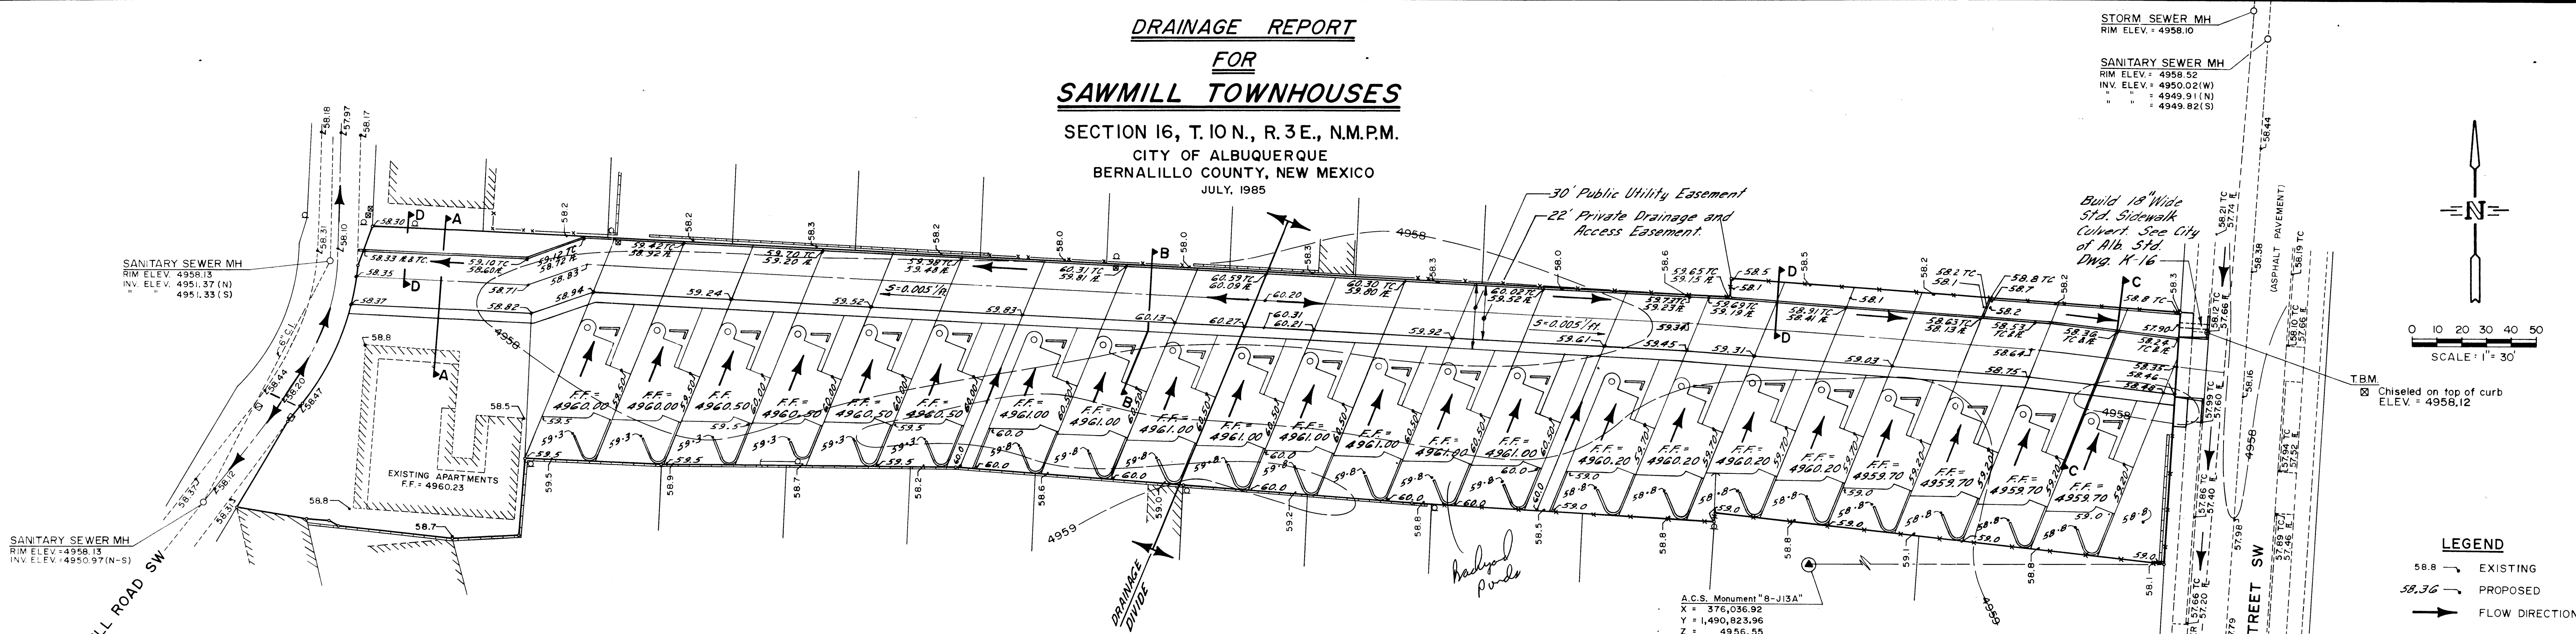
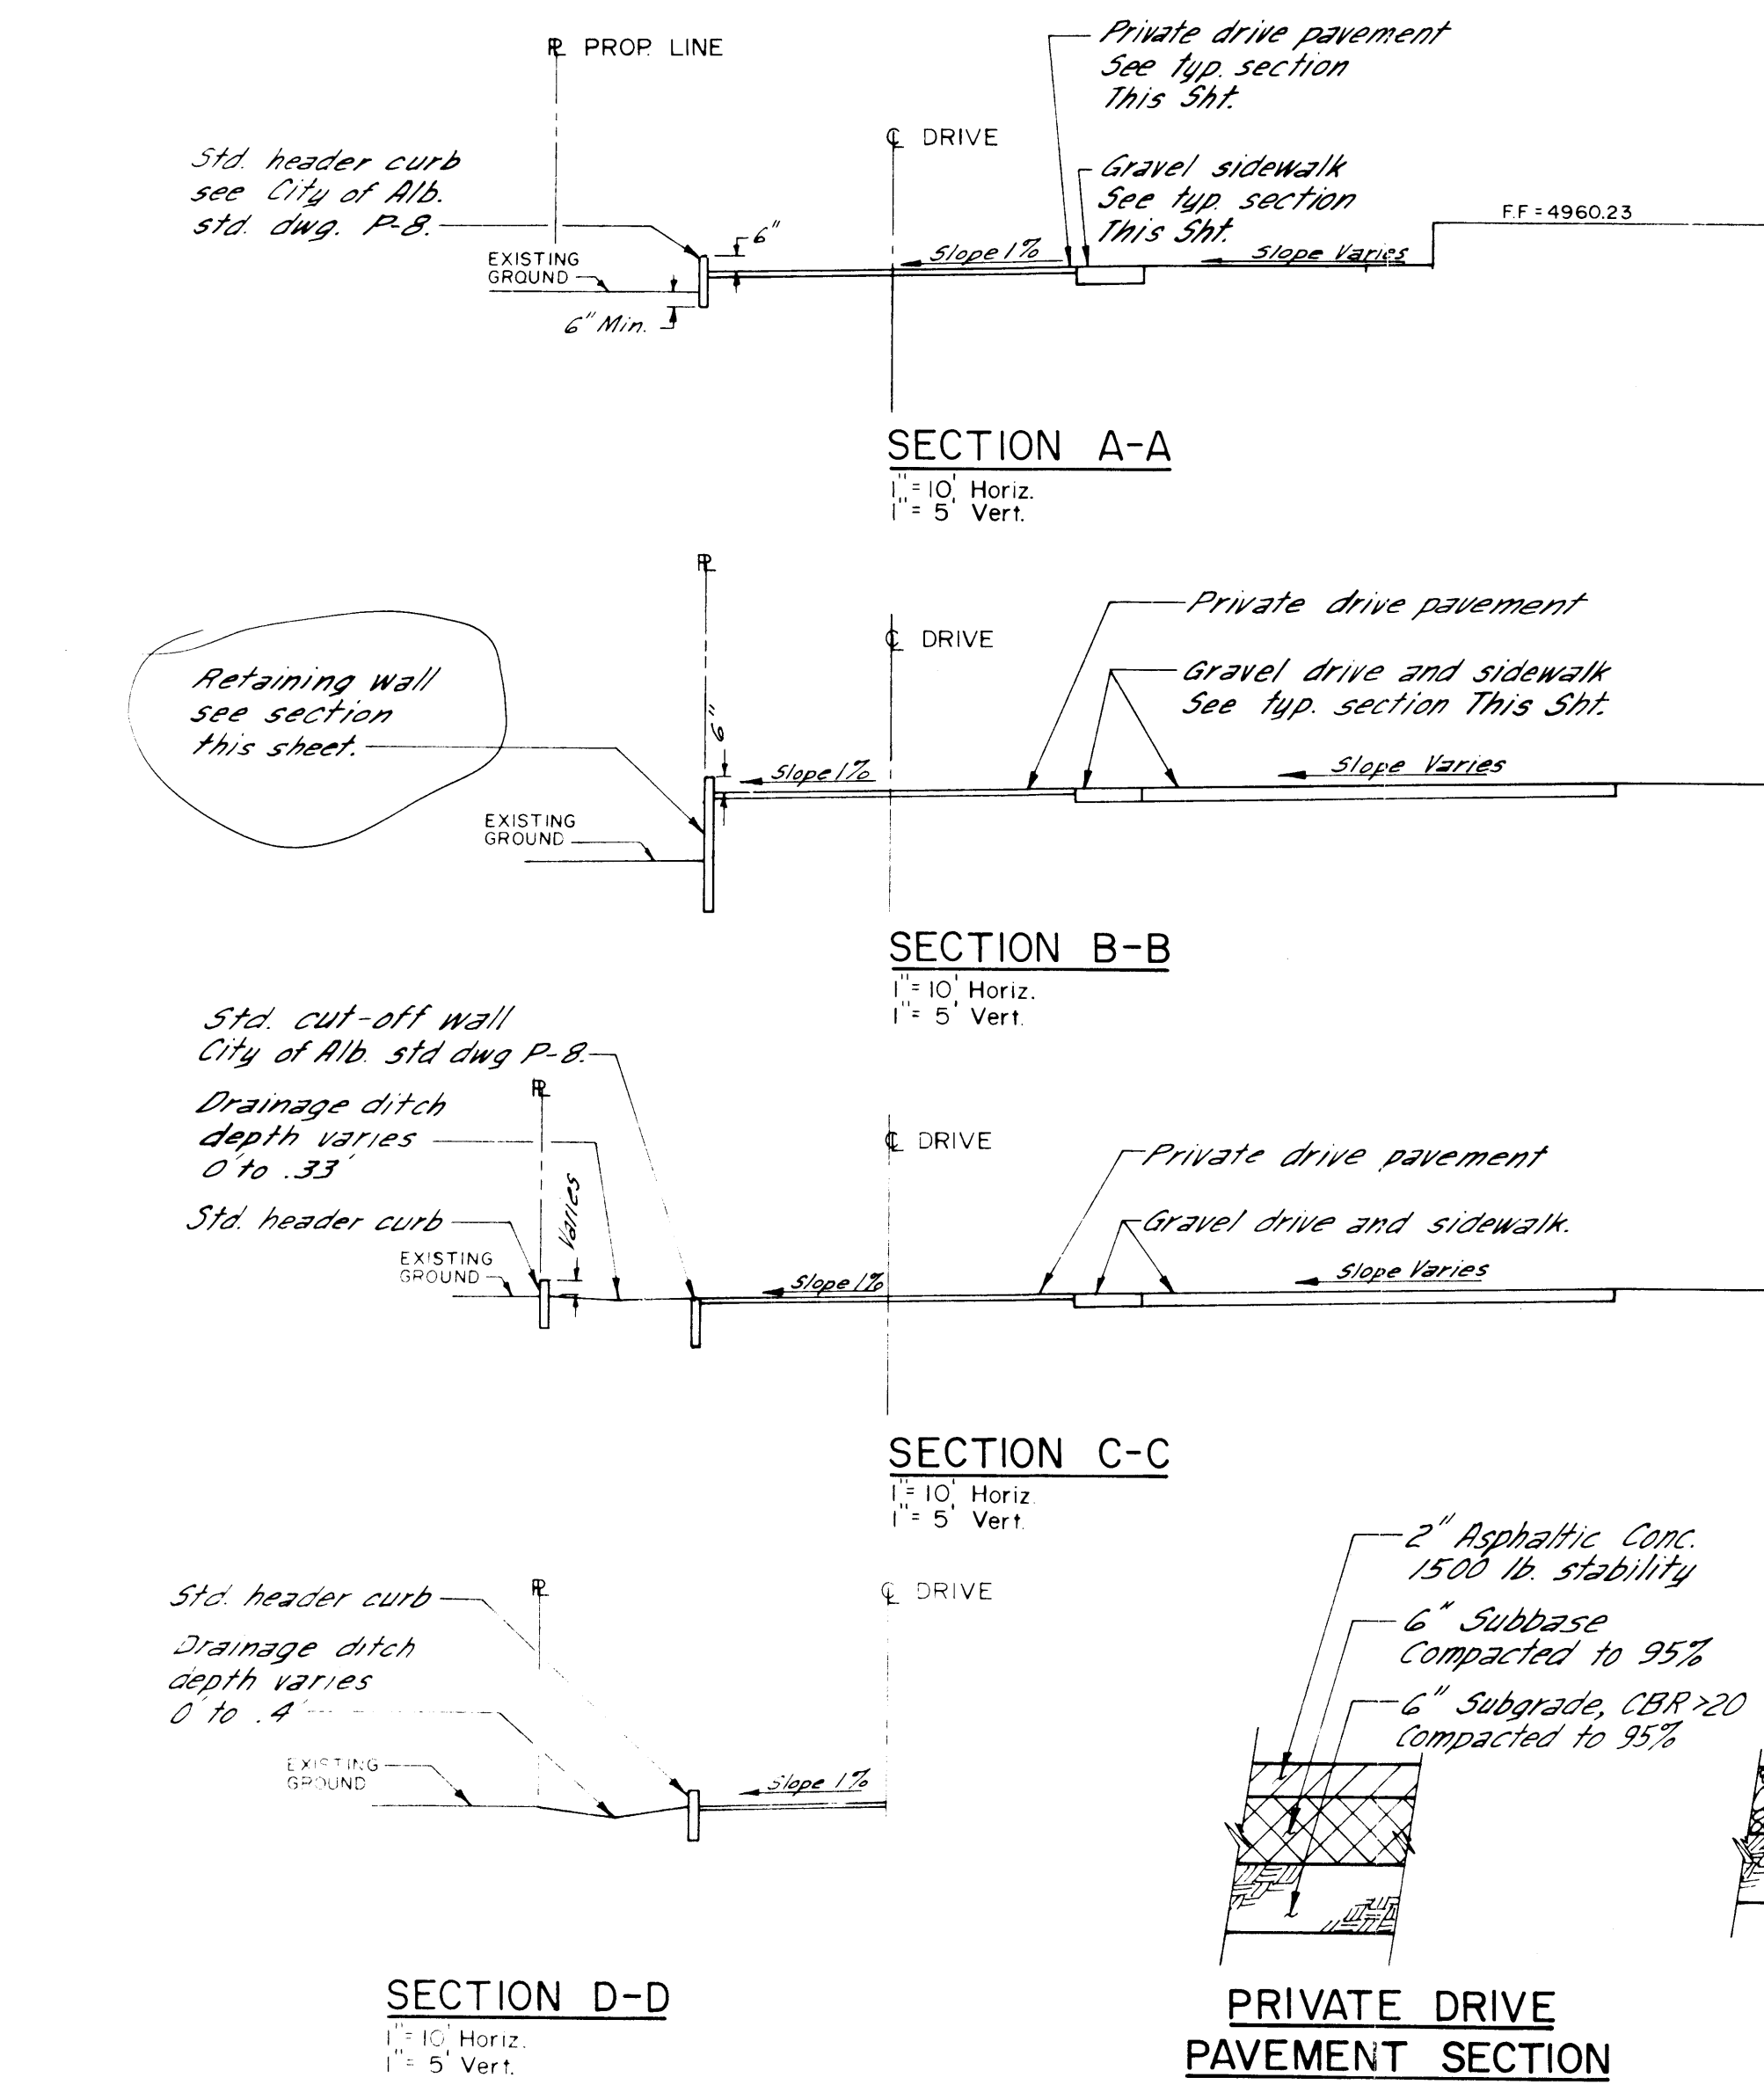
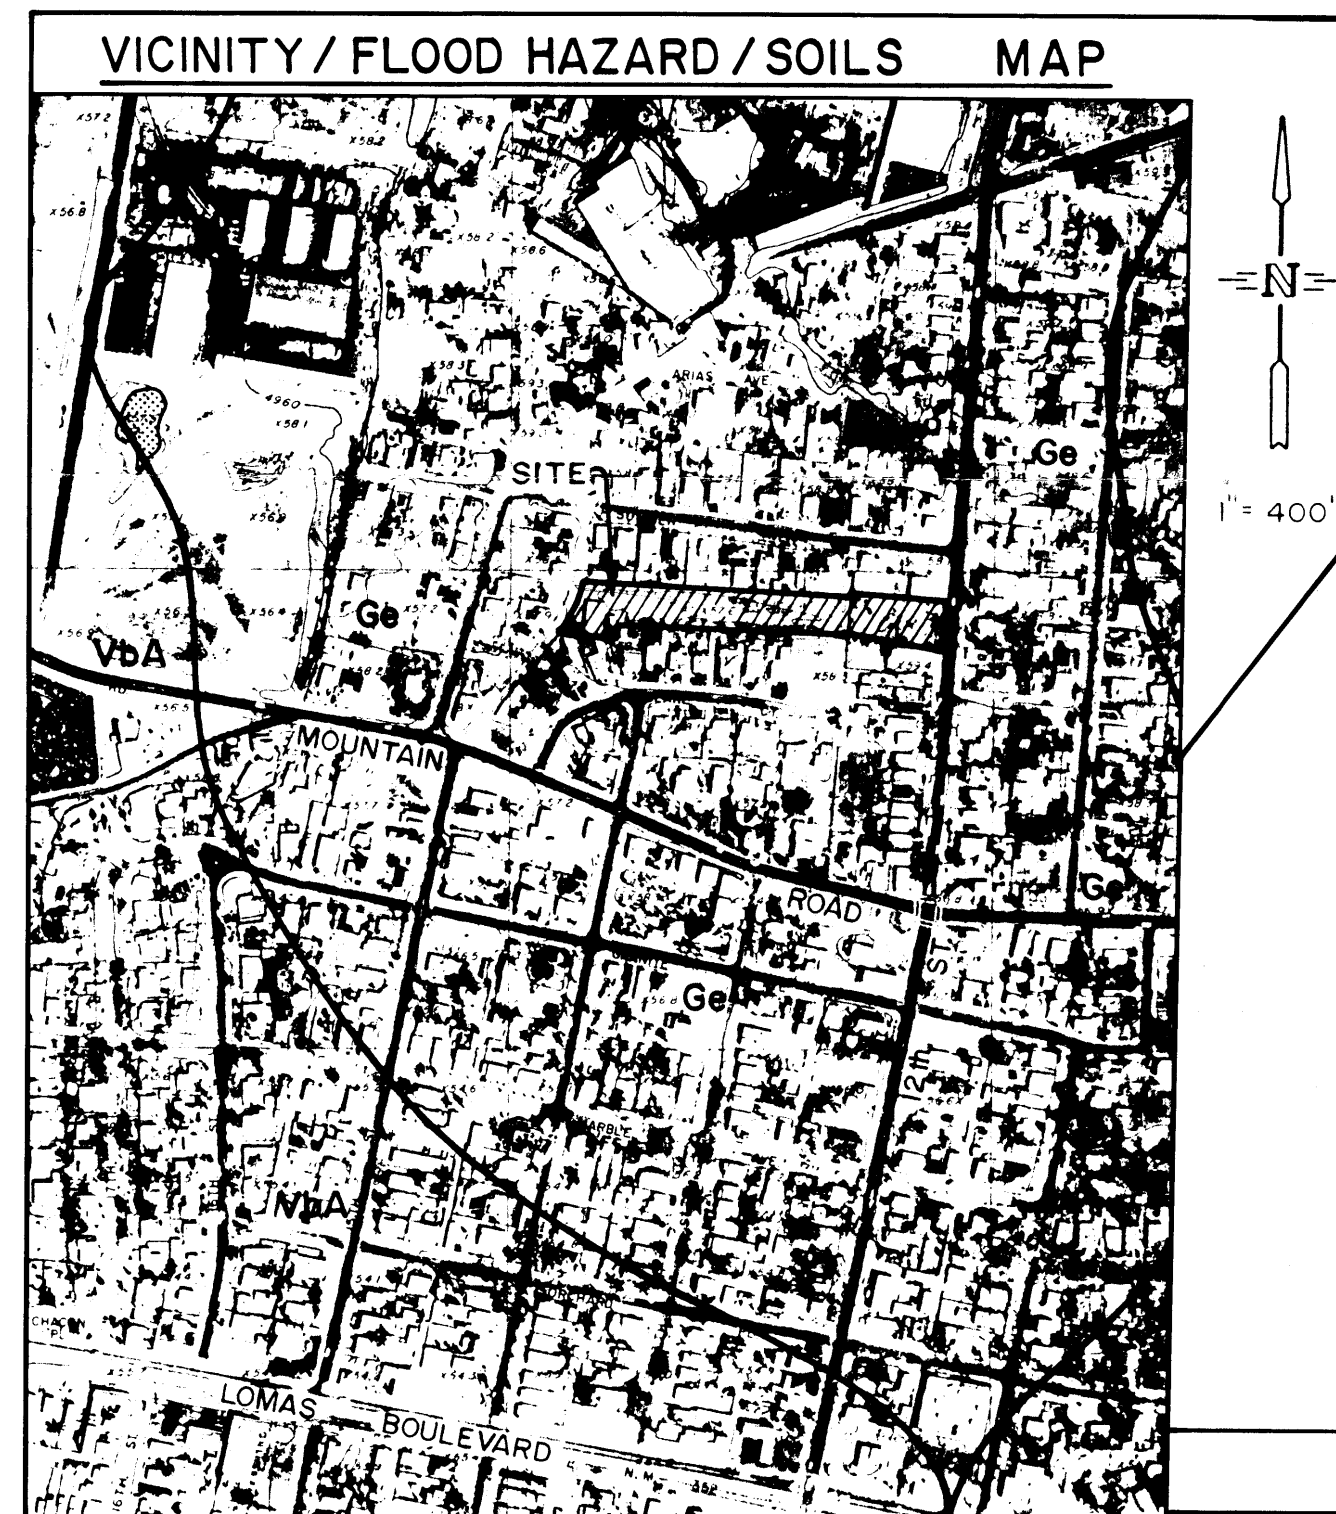
This infill project is planned as 22 townhouse lots. The roof drainage will be directed northward across a gravel driveway to the 22-foot private asphalt drive (see sections at left). Thirteen lots drain eastward to 12th Street and nine lots will drain westward to Sawmill Road where the runoff will split and flow both north and south eventually being intercepted by the Mountain Road storm drain. The backyard of each lot is graded to store the 100-year rainfall that falls directly into it. No credit for backyard ponding has been applied to the hydrology table below. The runoff directed eastward into 12th Street will be passed through a landscaped area in order to mitigate frequency. This was not possible on the west end due to the configuration of Sawmill Road. Maximum flow depth in the private drive will not exceed 0.25 feet or a velocity of 1.5 feet per second in a 100-year storm occurrence.

The 1.7 acre site is currently undeveloped with the exception of one multi-family unit located on the east end. There is little if any drainage either leaving or entering the site in the 100-year storm event. There is an existing storm drain in 12th Street and no downstream flooding problems indicated on the "Albuquerque Master Drainage Plan" maps. Sawmill Road is paved with an inverted crown concrete alley section which does not currently carry any significant amount of runoff as it is generally at grade with the adjacent property. There is a storm drain catch basin on Mountain Road immediately downstream of its intersection with Sawmill Road. Flows that enter Sawmill Road and flow north to Summer eventually flow to Mountain Road via 15th Street. Where they are intercepted by the Mountain Road storm drain. The site is shown on the current floodway maps not to be subject to inundation from the 100-year and smaller storms.
