**DRAINAGE REPORT**  
**FOR**  
**OFFICE BUILDING ADDITION**  
**7TH ST. AND MARQUETTE AVE.**

Zone Atlas Sheet J-14-Z

APRIL 1994

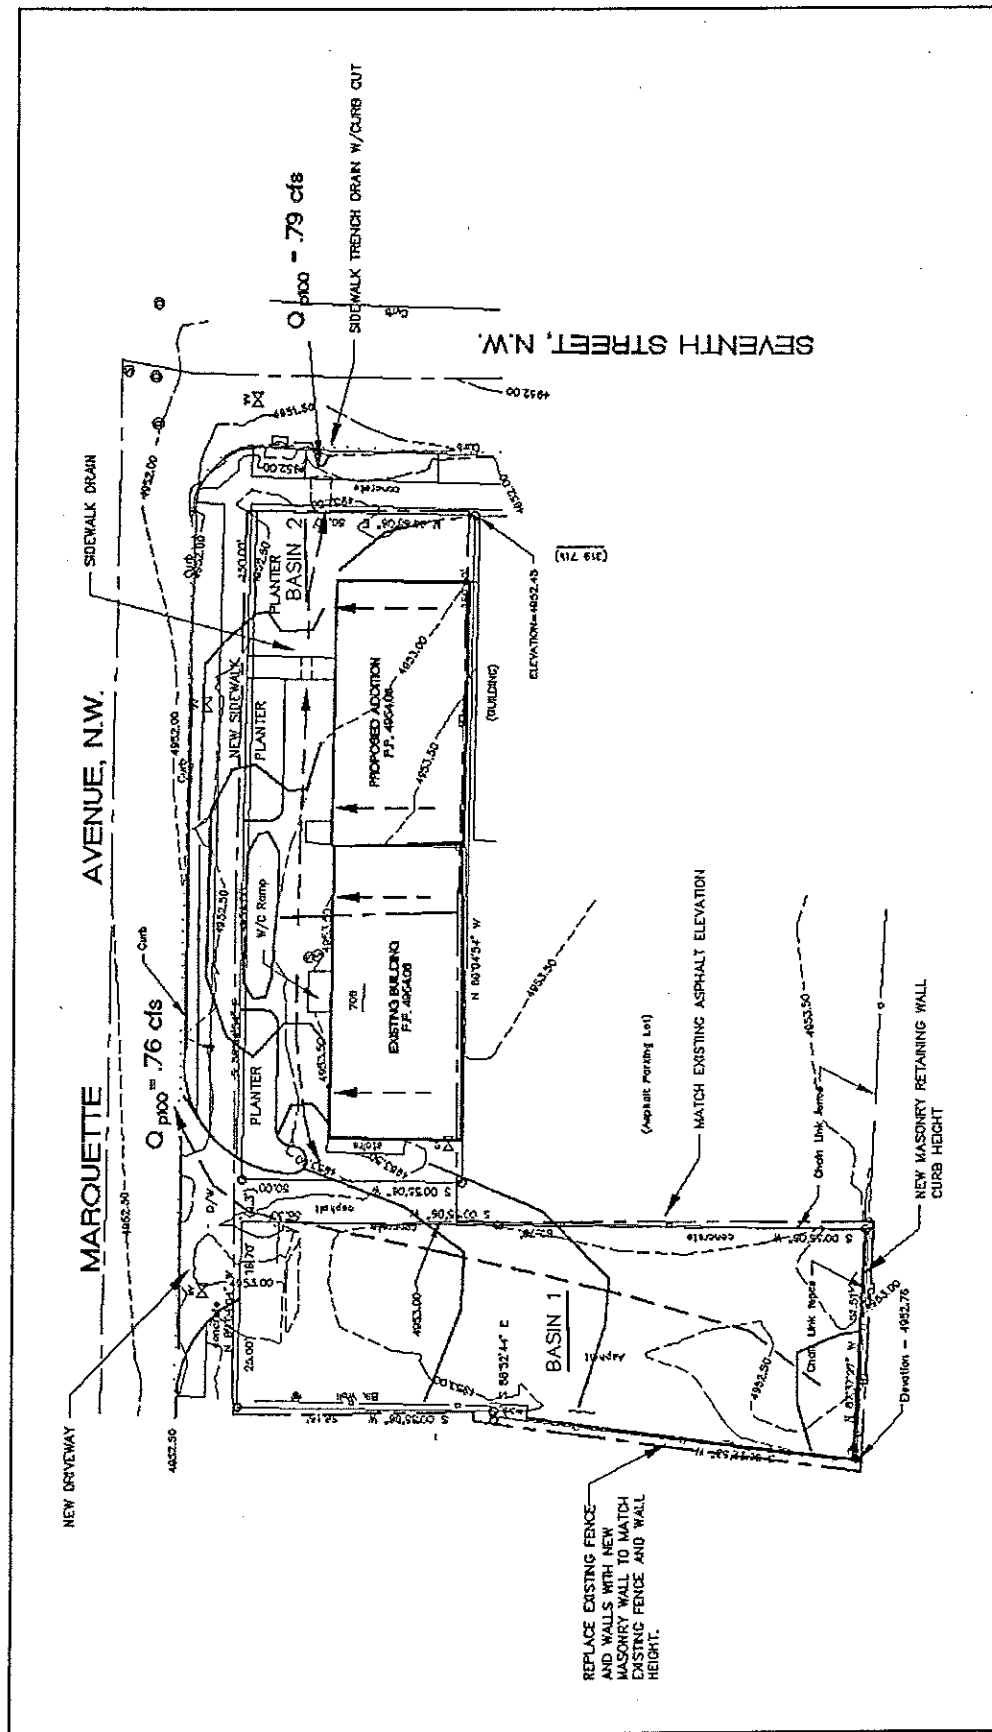
Figure 2 - Developed Site Plan (Plate 3)

The site plan (Plate 3) shows the configuration of the proposed development of the property. Approximately 1,800 square feet will be converted from asphalt paving to building retaining the impermeable surfaces. In addition, there will be planters created in basin 2, while the minor landscape area of basin 1 will be paved.

Subsequent to development the property will be consist of impervious surfaces, Treatment "D", and landscaped areas, Treatment "B".

<u>BASIN 1</u>	<u>AREA</u>	<u>PEAK DISCHARGE</u> <u>(table A-9)</u>	<u>FLOW</u>
Treatment B	400 sf	.78 cfs/acre	.007 cfs
Treatment D	6,988 sf	2.12 cfs/acre	.340 cfs
Total	7,388 sf		.347 cfs
<u>BASIN 2</u>			
Treatment B	1,421 sf	.78 cfs/acre	.025 cfs
Treatment D	5,479 sf	2.12 cfs/acre	.267 cfs
Total	6,900 sf		.292 cfs

The difference between the existing conditions and the developed conditions is insignificant. The total out flow from both basins for the proposed development is .639 cfs, compared to the existing conditions of .686 cfs. There is a minor variance in the distribution between basin 1 and 2. However, the gutter flow on Marquette and the out flow on to Seventh St. converge on the same drop inlet at the corner of Seventh and Marquette.
