EXISTING HYDROLOGY

PROPOSED HYDROLOGY

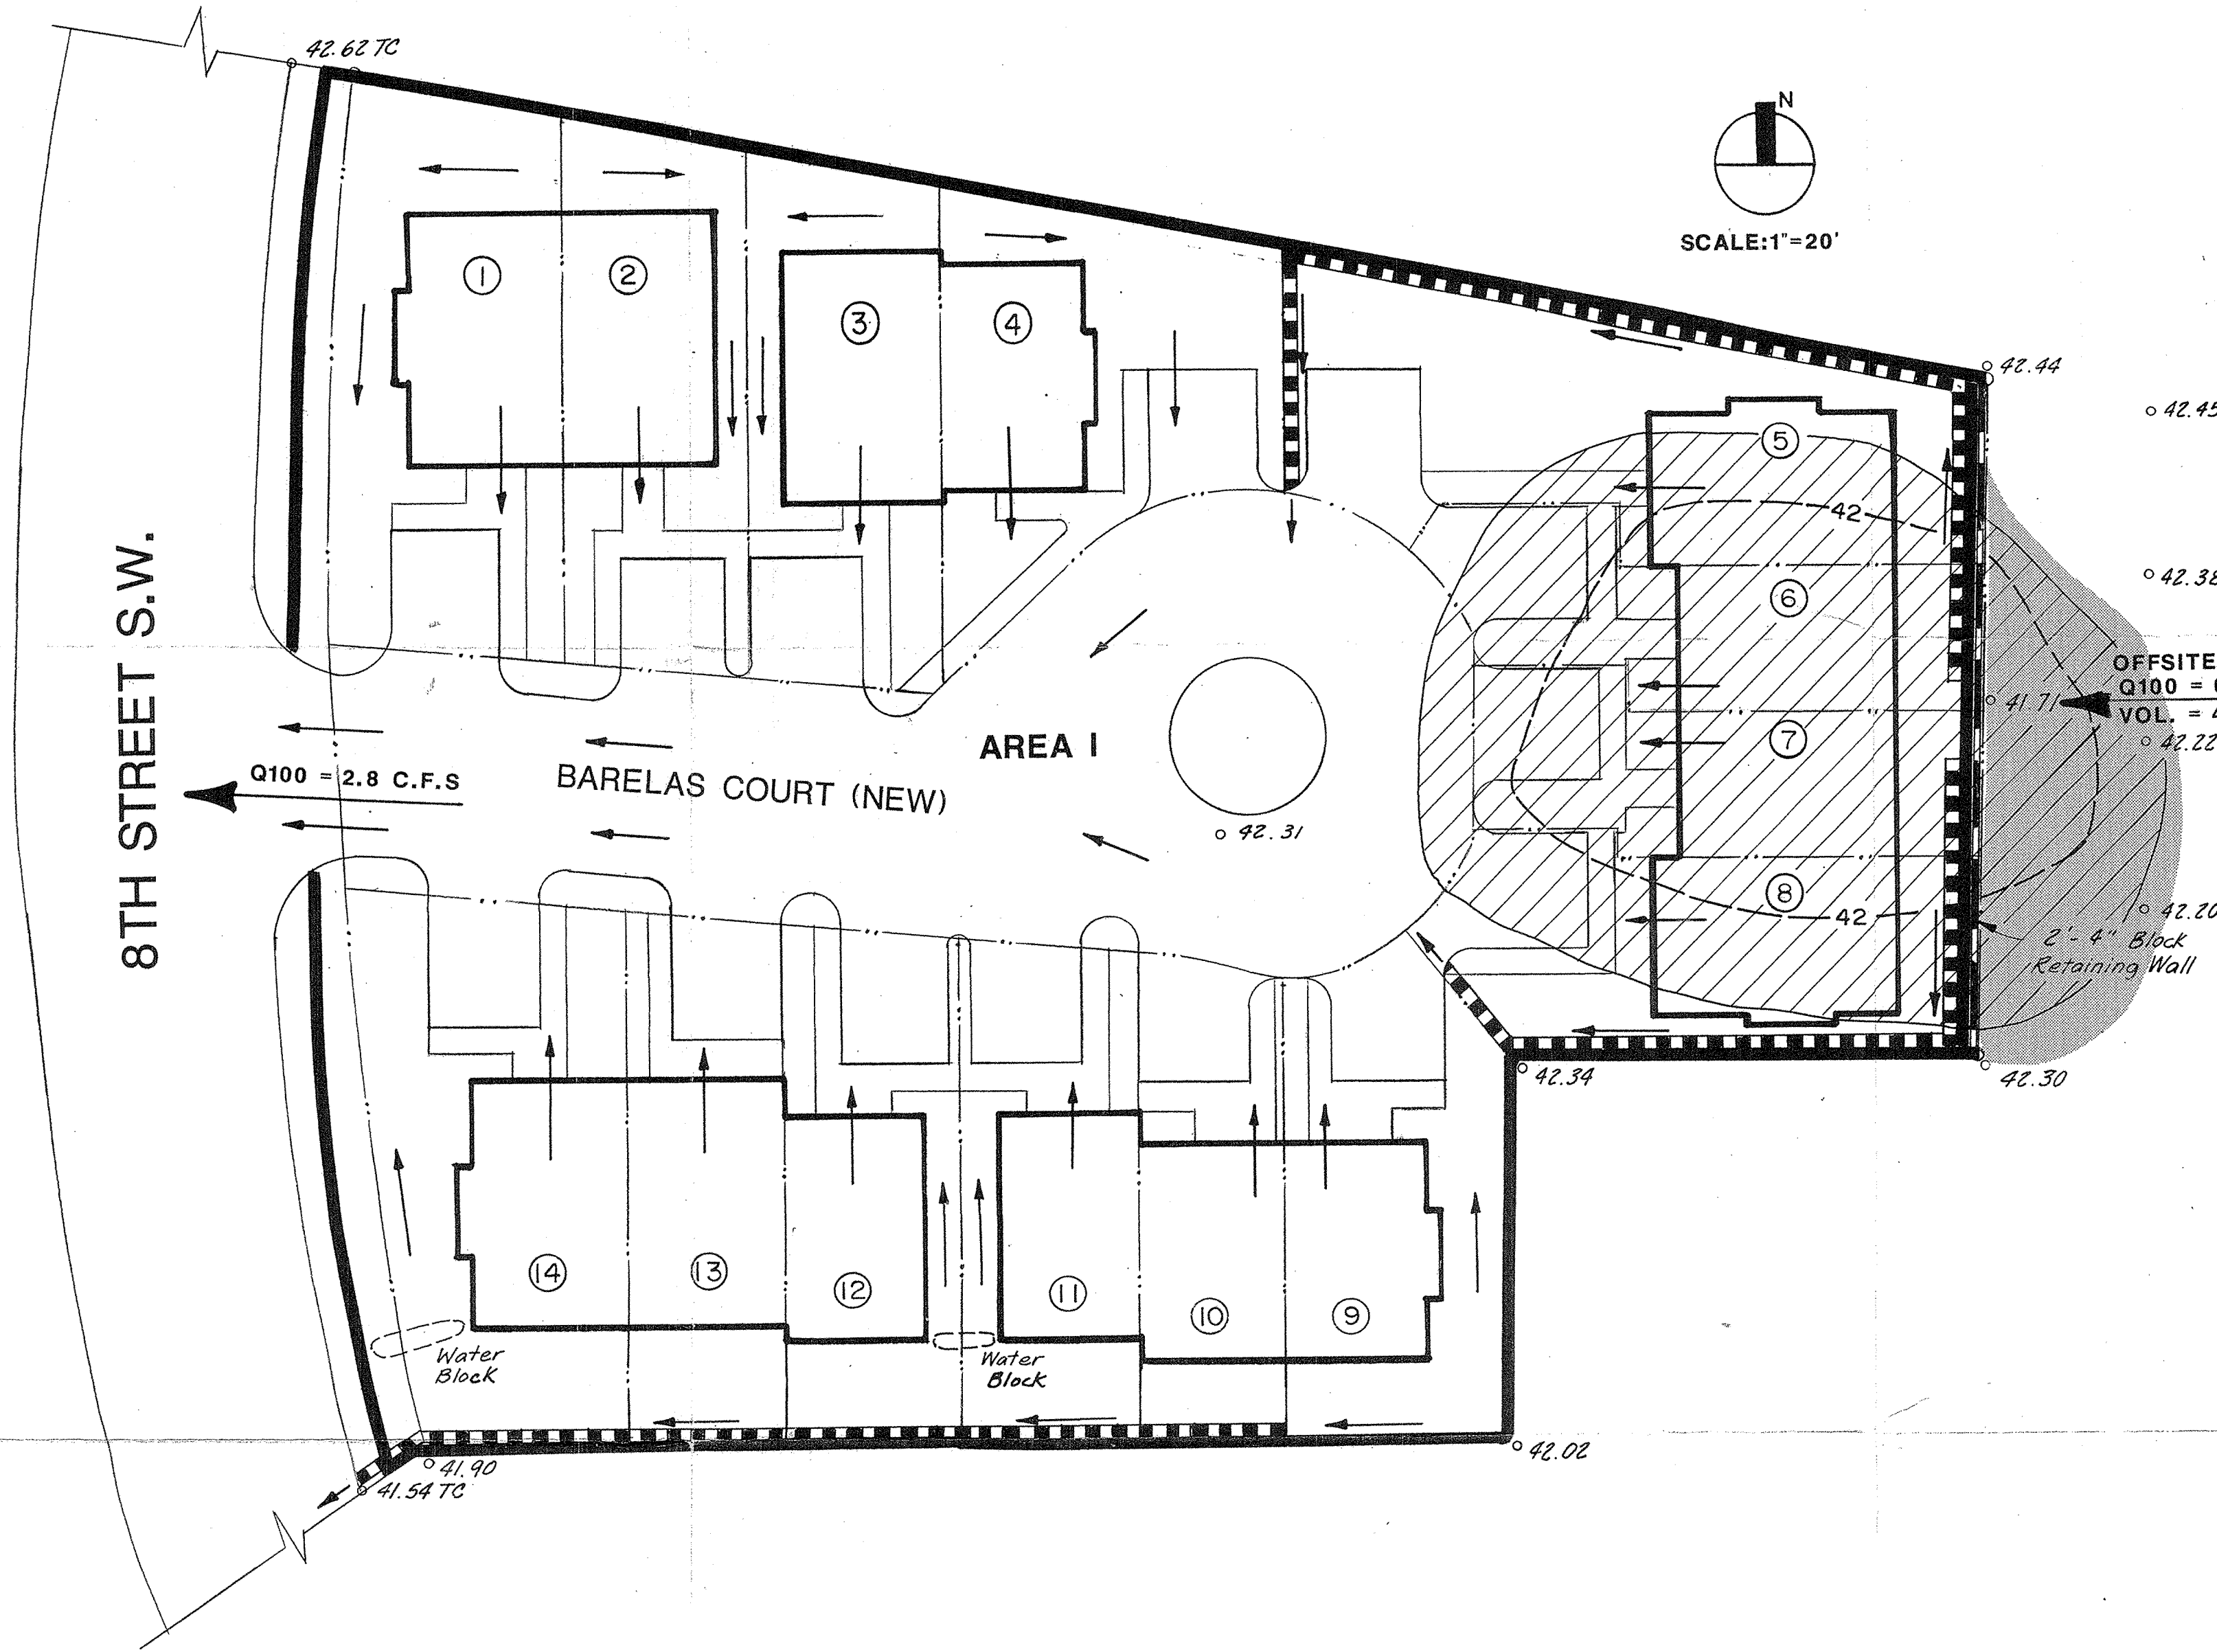
- DRAINAGE AREA BOUNDARY
- DIRECTION OF FLOW
- PROPOSED CONCRETE RUNDOWN
- EXISTING SPOT ELEVATION
- RETAINING WALL
- APPROXIMATE OFFSITE PONDING (PROPOSED)
- APPROXIMATE PONDING (EXISTING CONDITIONS)
