PROJECT NAME	OFFICE BUILDING 3212 MONTE VISTA BLVD NE
PROJECT NUMBER	
DRAWING TITLE	FOUNDATION & FRAMING PLAN
REVISIONS NO. DATE	
DATE

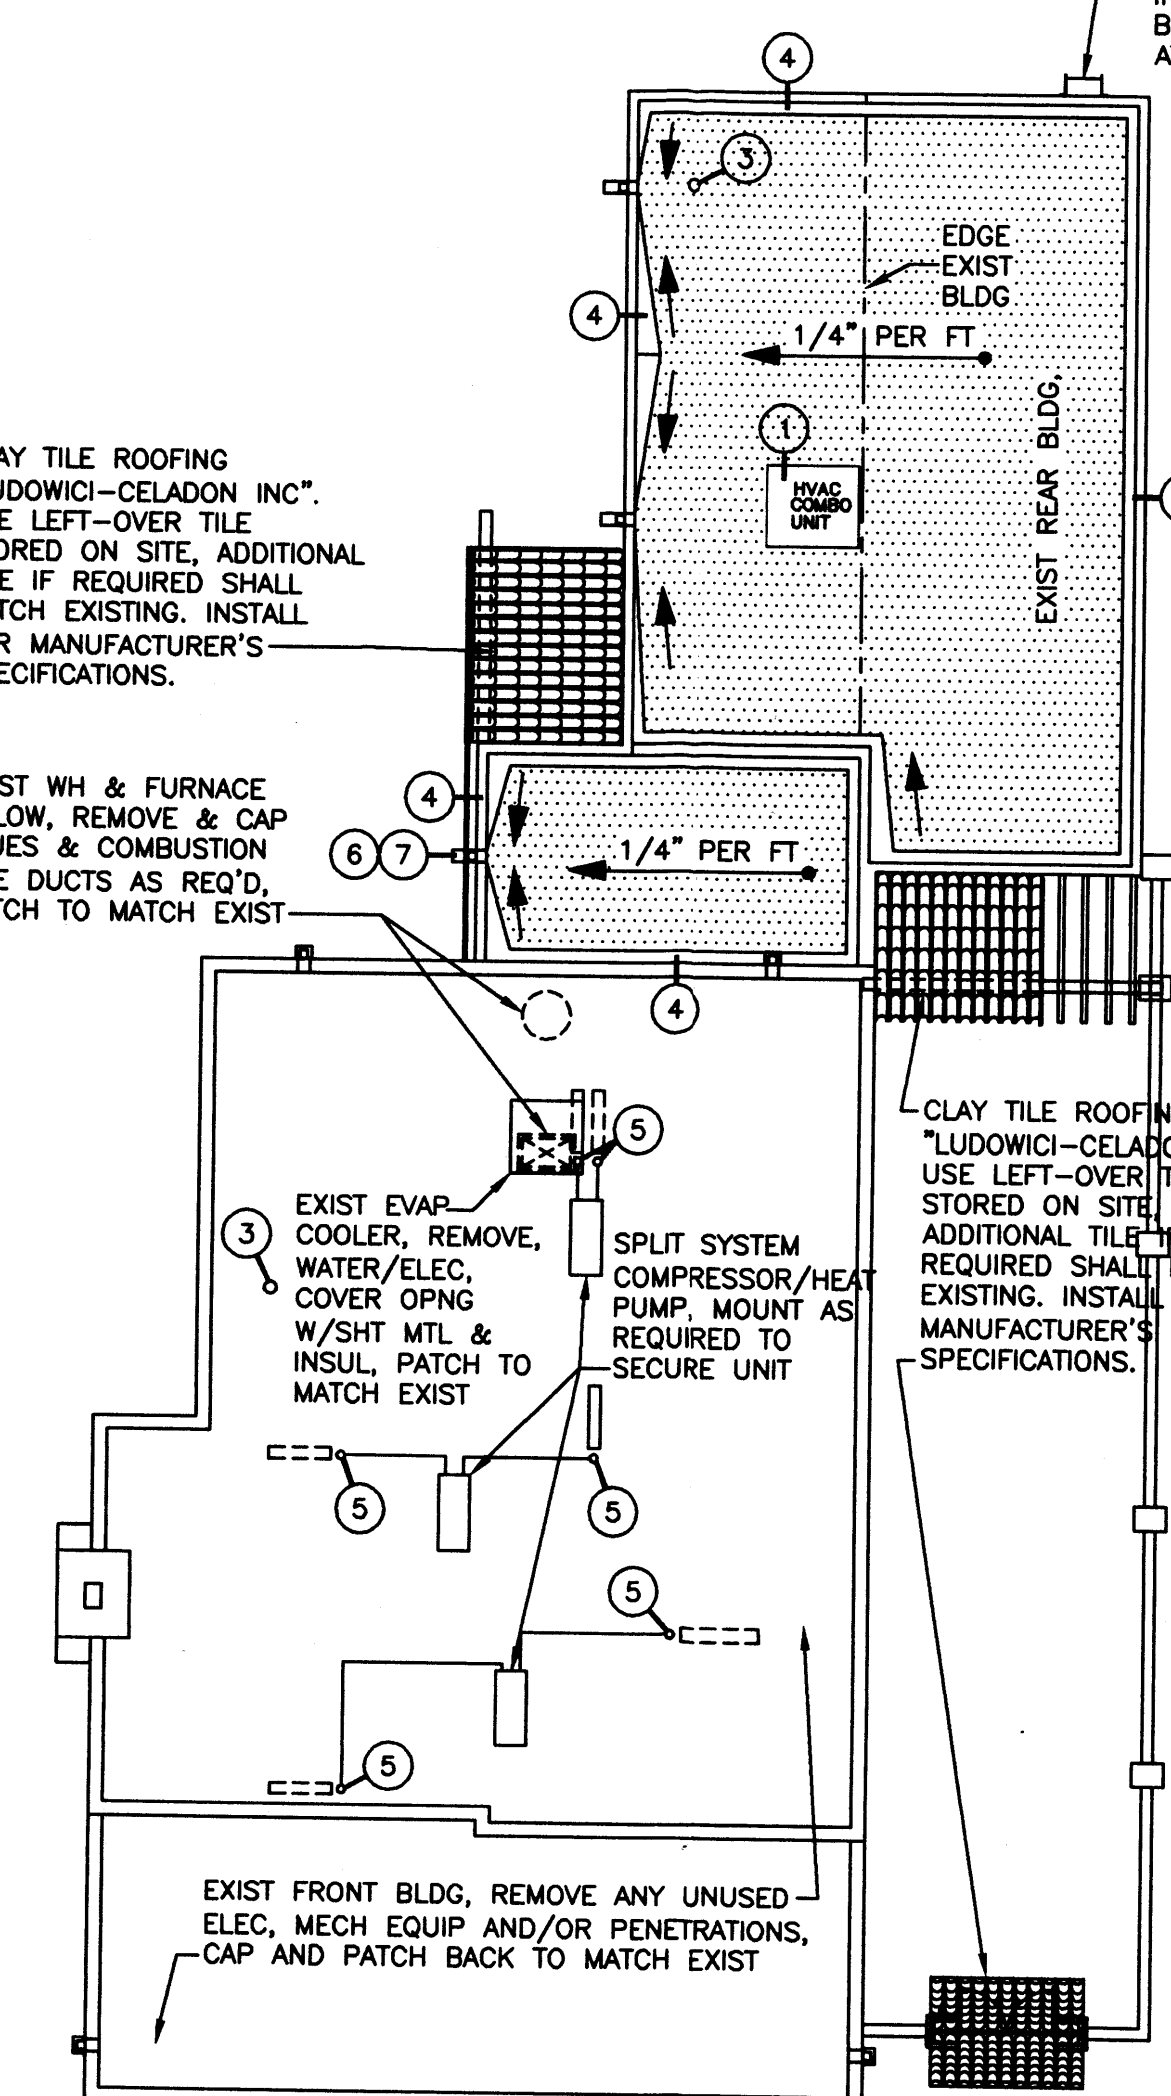
ROOF PLAN
1/8" = 1'-0"

CLAY TILE ROOFING "LUDOWICI-CELADON INC." USE LEFT-OVER TILE STORED ON SITE, ADDITIONAL TILE IF REQUIRED SHALL MATCH EXISTING. INSTALL PER MANUFACTURER'S SPECIFICATIONS.

EXIST WH & FURNACE BELOW, REMOVE & CAP FLUES & COMBUSTION ARE DUCTS AS REQ'D, PATCH TO MATCH EXIST
