**DOMINGO B RECONSTRUCTION GRADING AND DRAINAGE**

<b>BENCHMARK</b> ACS STATION 5_K18A ELEV.= 5280.174 NAVD 1988		<b>SCALES:</b> 1" = 20' CONT. INT. = 1'		<b>Easterling Consultants LLC</b> Engineering and Environmental Consulting 3613 NMSR 528 NW, Suite E-2 Albuquerque, New Mexico 87114 (505) 821-6646 FAX (505) 897-2965		<b>DOMINGO B RECONSTRUCTION</b> ALBUQUERQUE, NEW MEXICO <b>DOMINGO B RECONSTRUCTION</b> 6320 B Domingo Road NE GRADING AND DRAINAGE PLAN		 © COPYRIGHT Sheet C1 of C1	
<b>NO.</b>		<b>REVISIONS</b>		<b>BY</b>		<b>DATE</b>		<b>File No.</b> 140-11-01	
								<b>Date:</b> JUNE 2011

**PROJECT:**  
Domingo B Reconstruction  
6320 B Domingo Av NE  
Albuquerque, NE 87108

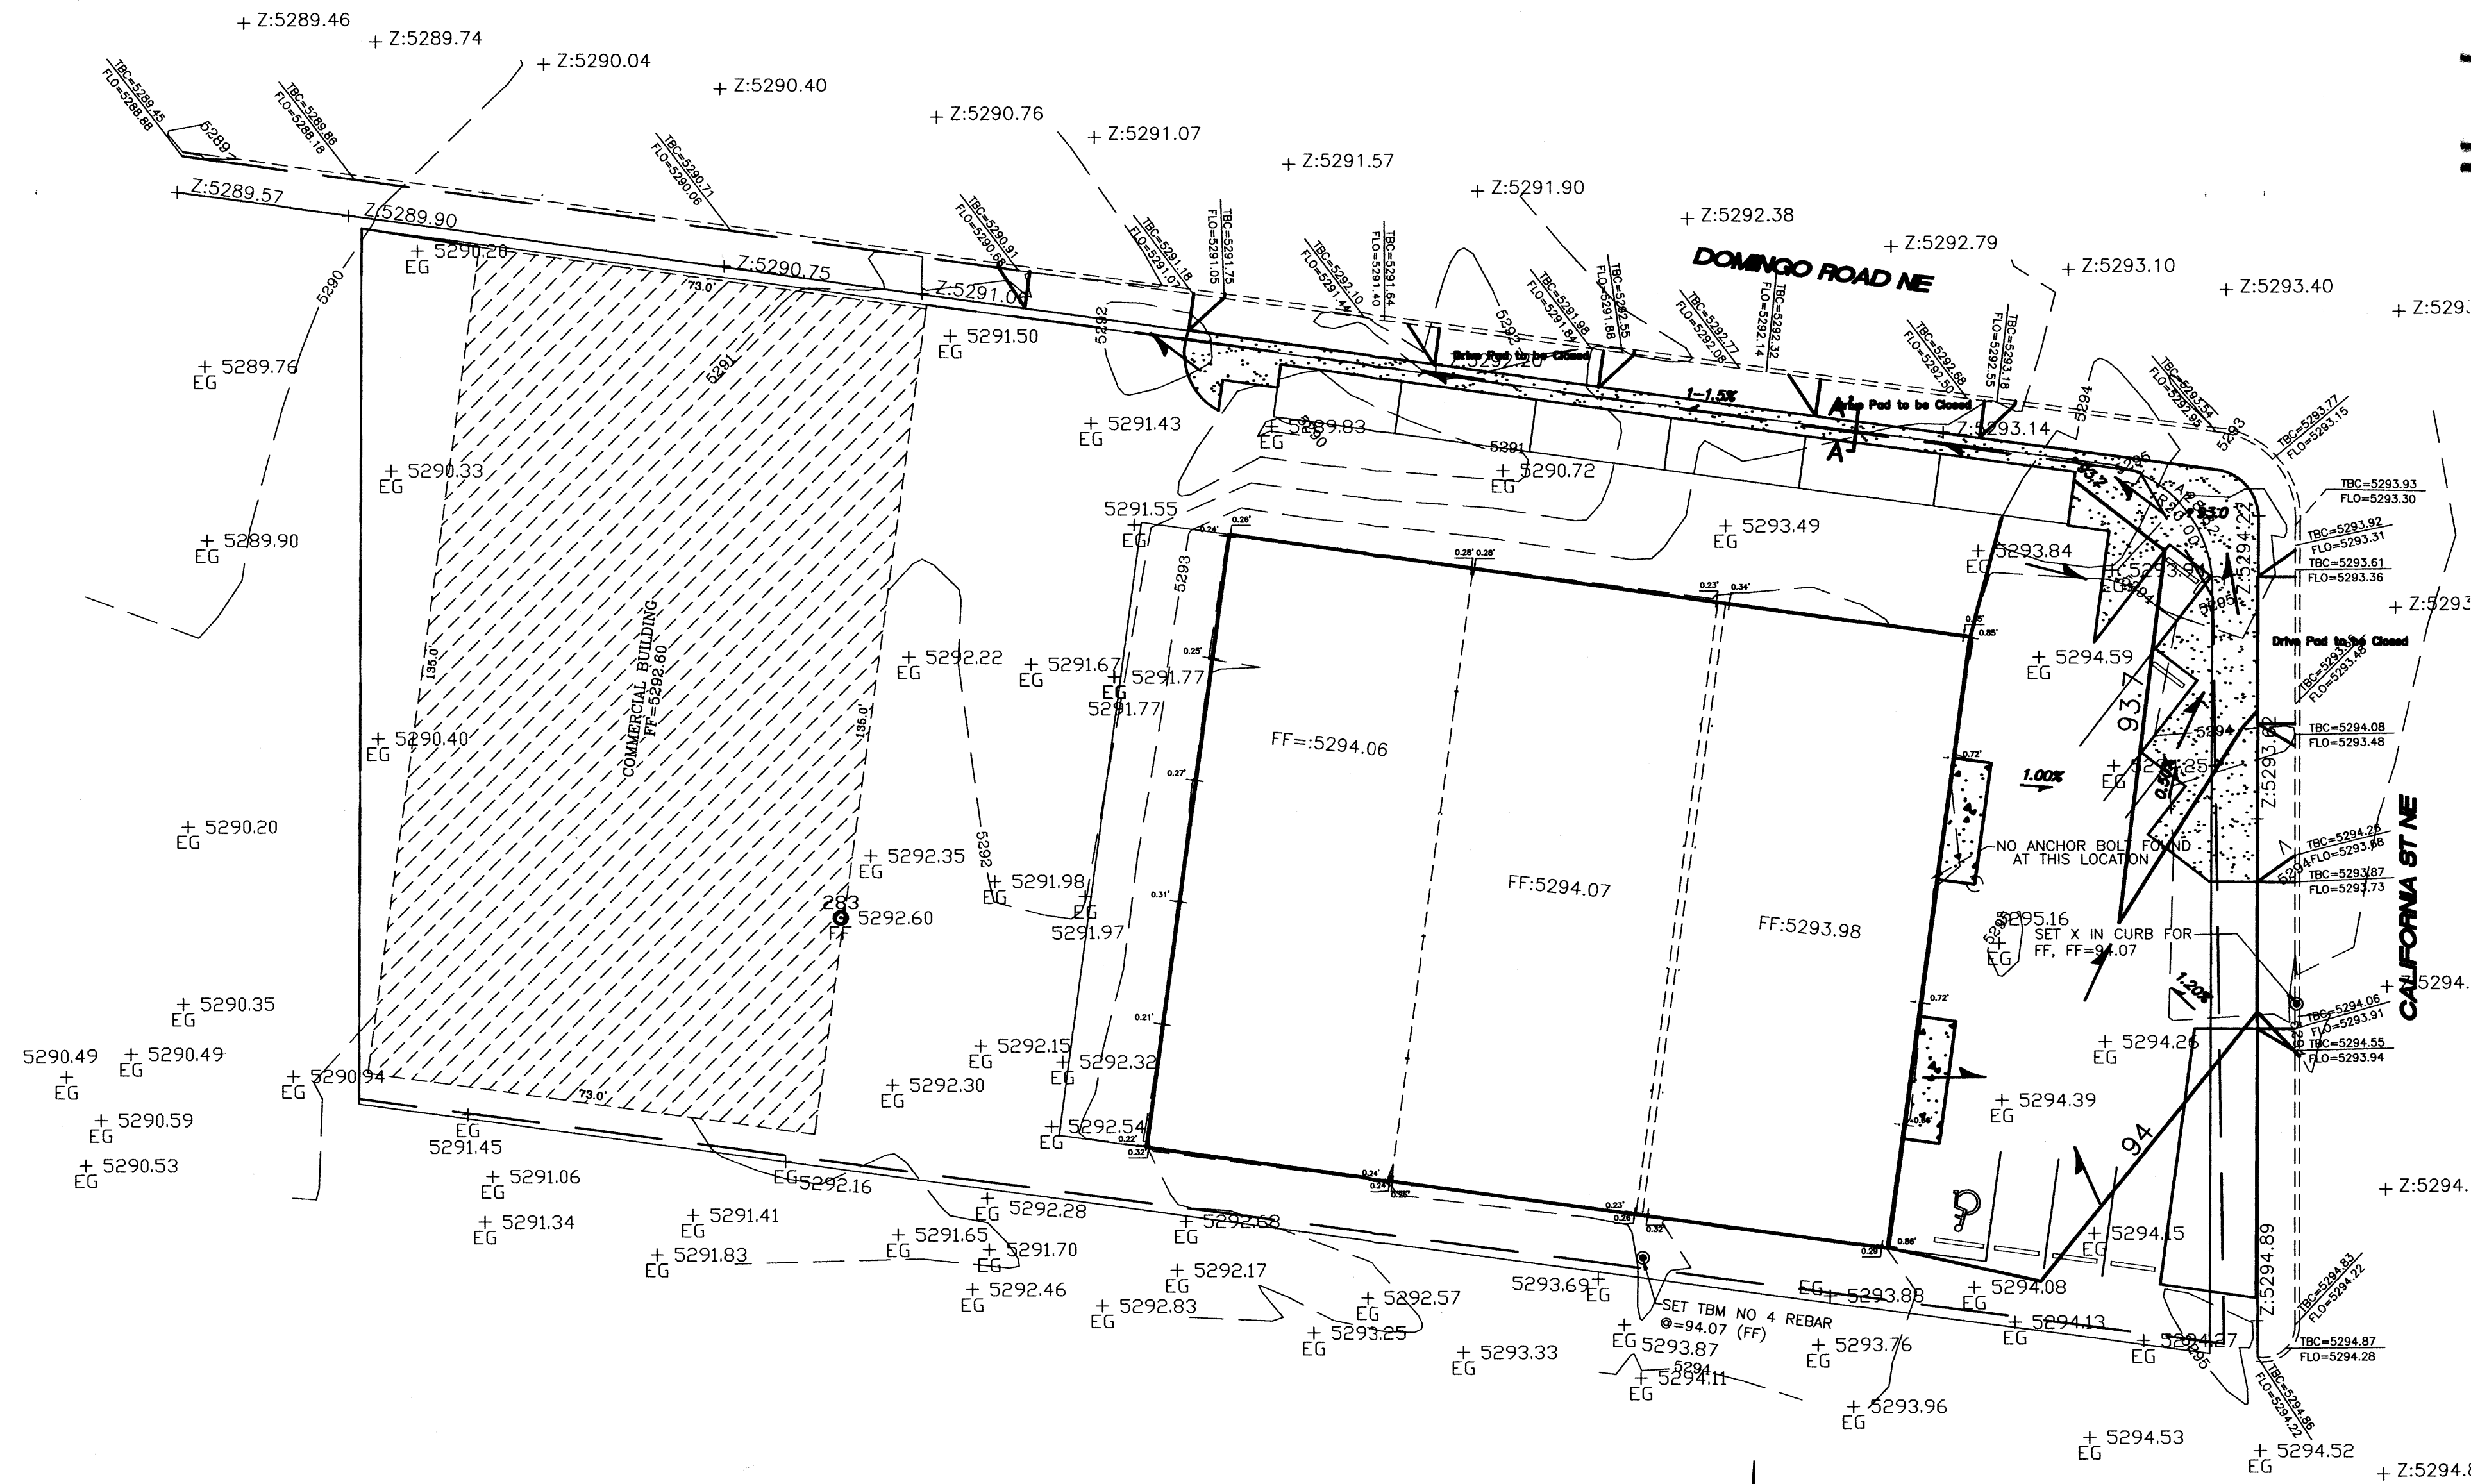
The eastern building on Lot 7-A was destroyed by fire. The building is being reconstructed with the same size and type of building. The majority of the parking lot is undamaged and will remain in place. The portion of the parking lot east of the proposed reconstruction is in disrepair and is uneven. This portion of the parking lot will be re-paved with improvements in the grades to prevent water pooling along the eastern side of the building.

Currently the majority of runoff flows in this eastern area discharge sporadically over the sidewalk to California St. NE which in turn discharges flows to Domingo Road NE which runs along the northern edge of the property. Domingo Road slopes from east to west. The remaining flows on the eastern side parking lot are pooled along the eastern edge of the building until spilling to the east around the NE edge of the building. This is caused by an irregular highpoint approximately 15-20 feet from the building. This flow ultimately drains via the northern drive pad to Domingo NE.

The proposed grading concentrates flows from the eastern area to a proposed landscaped area, along the north-east and northern boundary between the parking lot and the sidewalk, with a consistent slope away from the building. The landscaping is graded to be slightly depressed (0.5' deep) at the north-east corner with a landscaping swale that will drain overflow to the west and ultimately to the northern drive pad where flows are currently being discharged to Domingo Road NE. This improves conditions for the building and does not change the existing condition where all flows ultimately discharge to Domingo Road NE. In addition this configuration provides water quality benefit by the use of the landscaping swale to slow flows and allow filtration by planted vegetation.

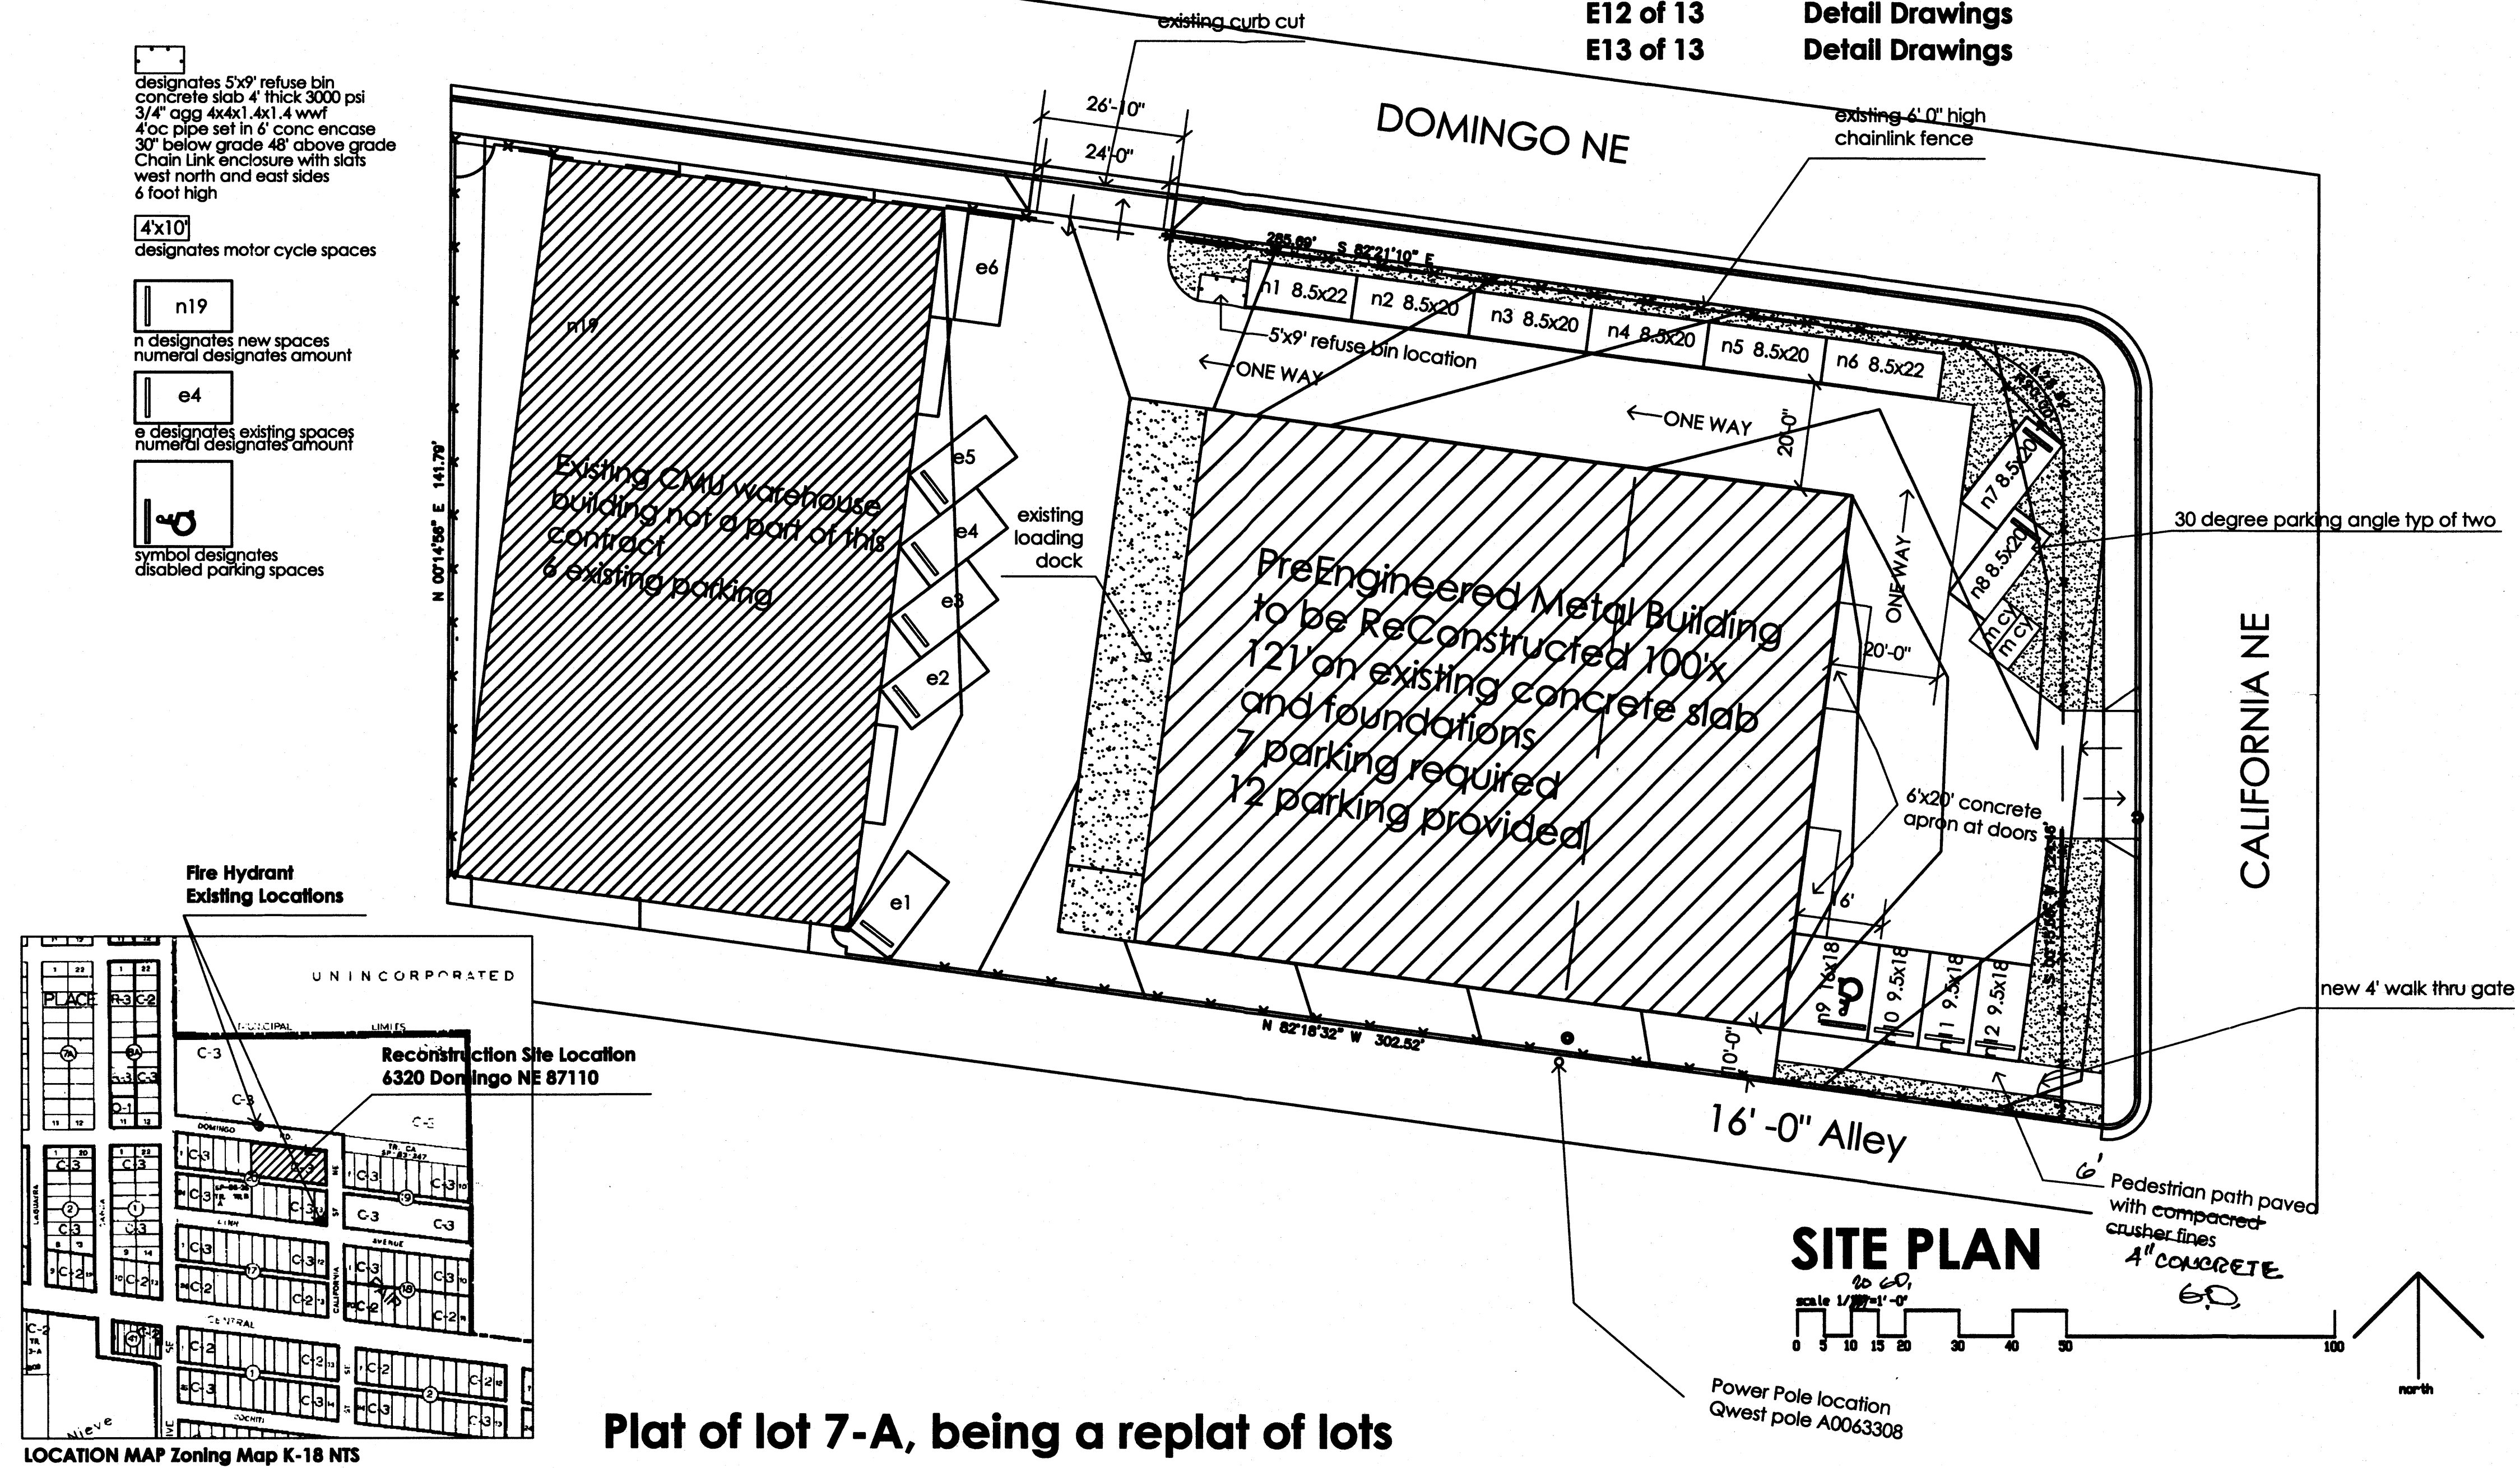
COVER SHEET-SITE PLAN  
scale 1" = 20'-0"

**Plat of lot 7-A, being a replat of lots  
7 through 12, inclusive, Block 20  
Fairgrounds Addition  
within section 24 T10N N. M. PM  
Albuquerque, New Mexico**

## **Zoning C3, Zoning atlas K-18 Near Heights Metropolitan Redevelopment Area**

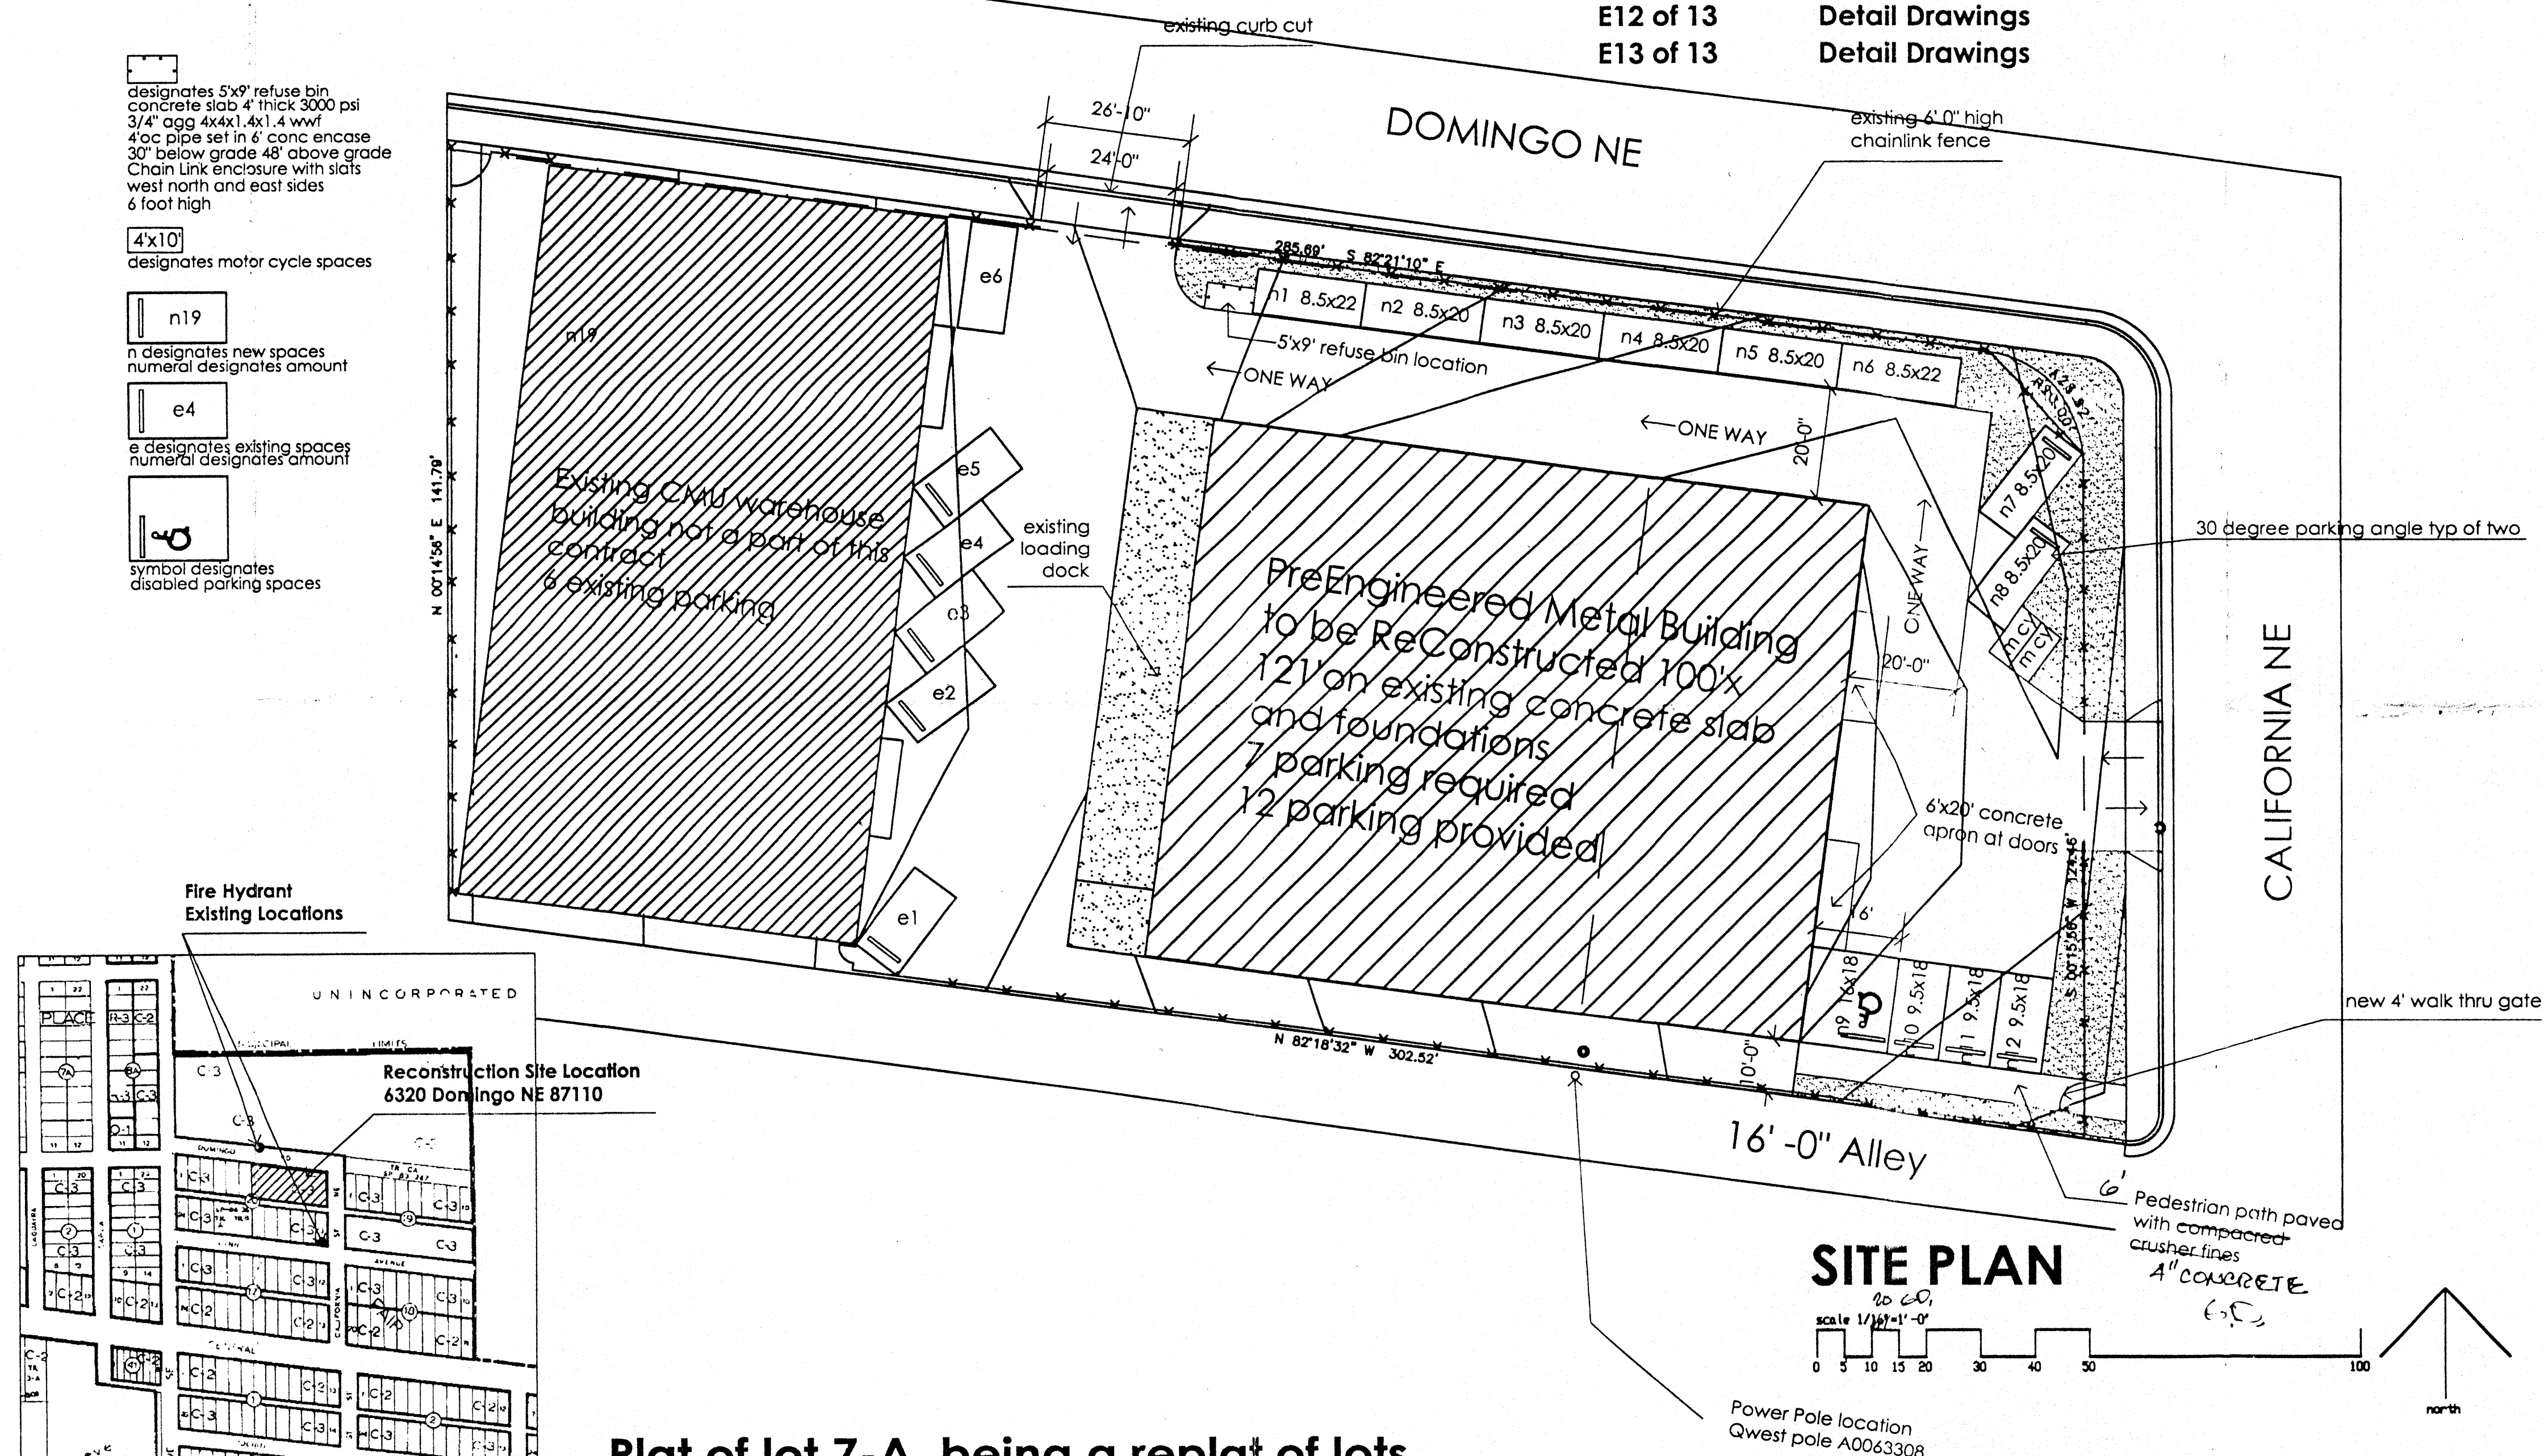
## SITE PLAN

**Plat of lot 7-A, being a replat of lots  
7 through 12, inclusive, Block 20  
Fairgrounds Addition  
within section 24 T10N N. M. PM  
Albuquerque, New Mexico**

**Zoning C3, Zoning atlas K-18**  
**Near Heights Metropolitan Redevelopment Area**

Power Pole location  
Qwest pole A0063308

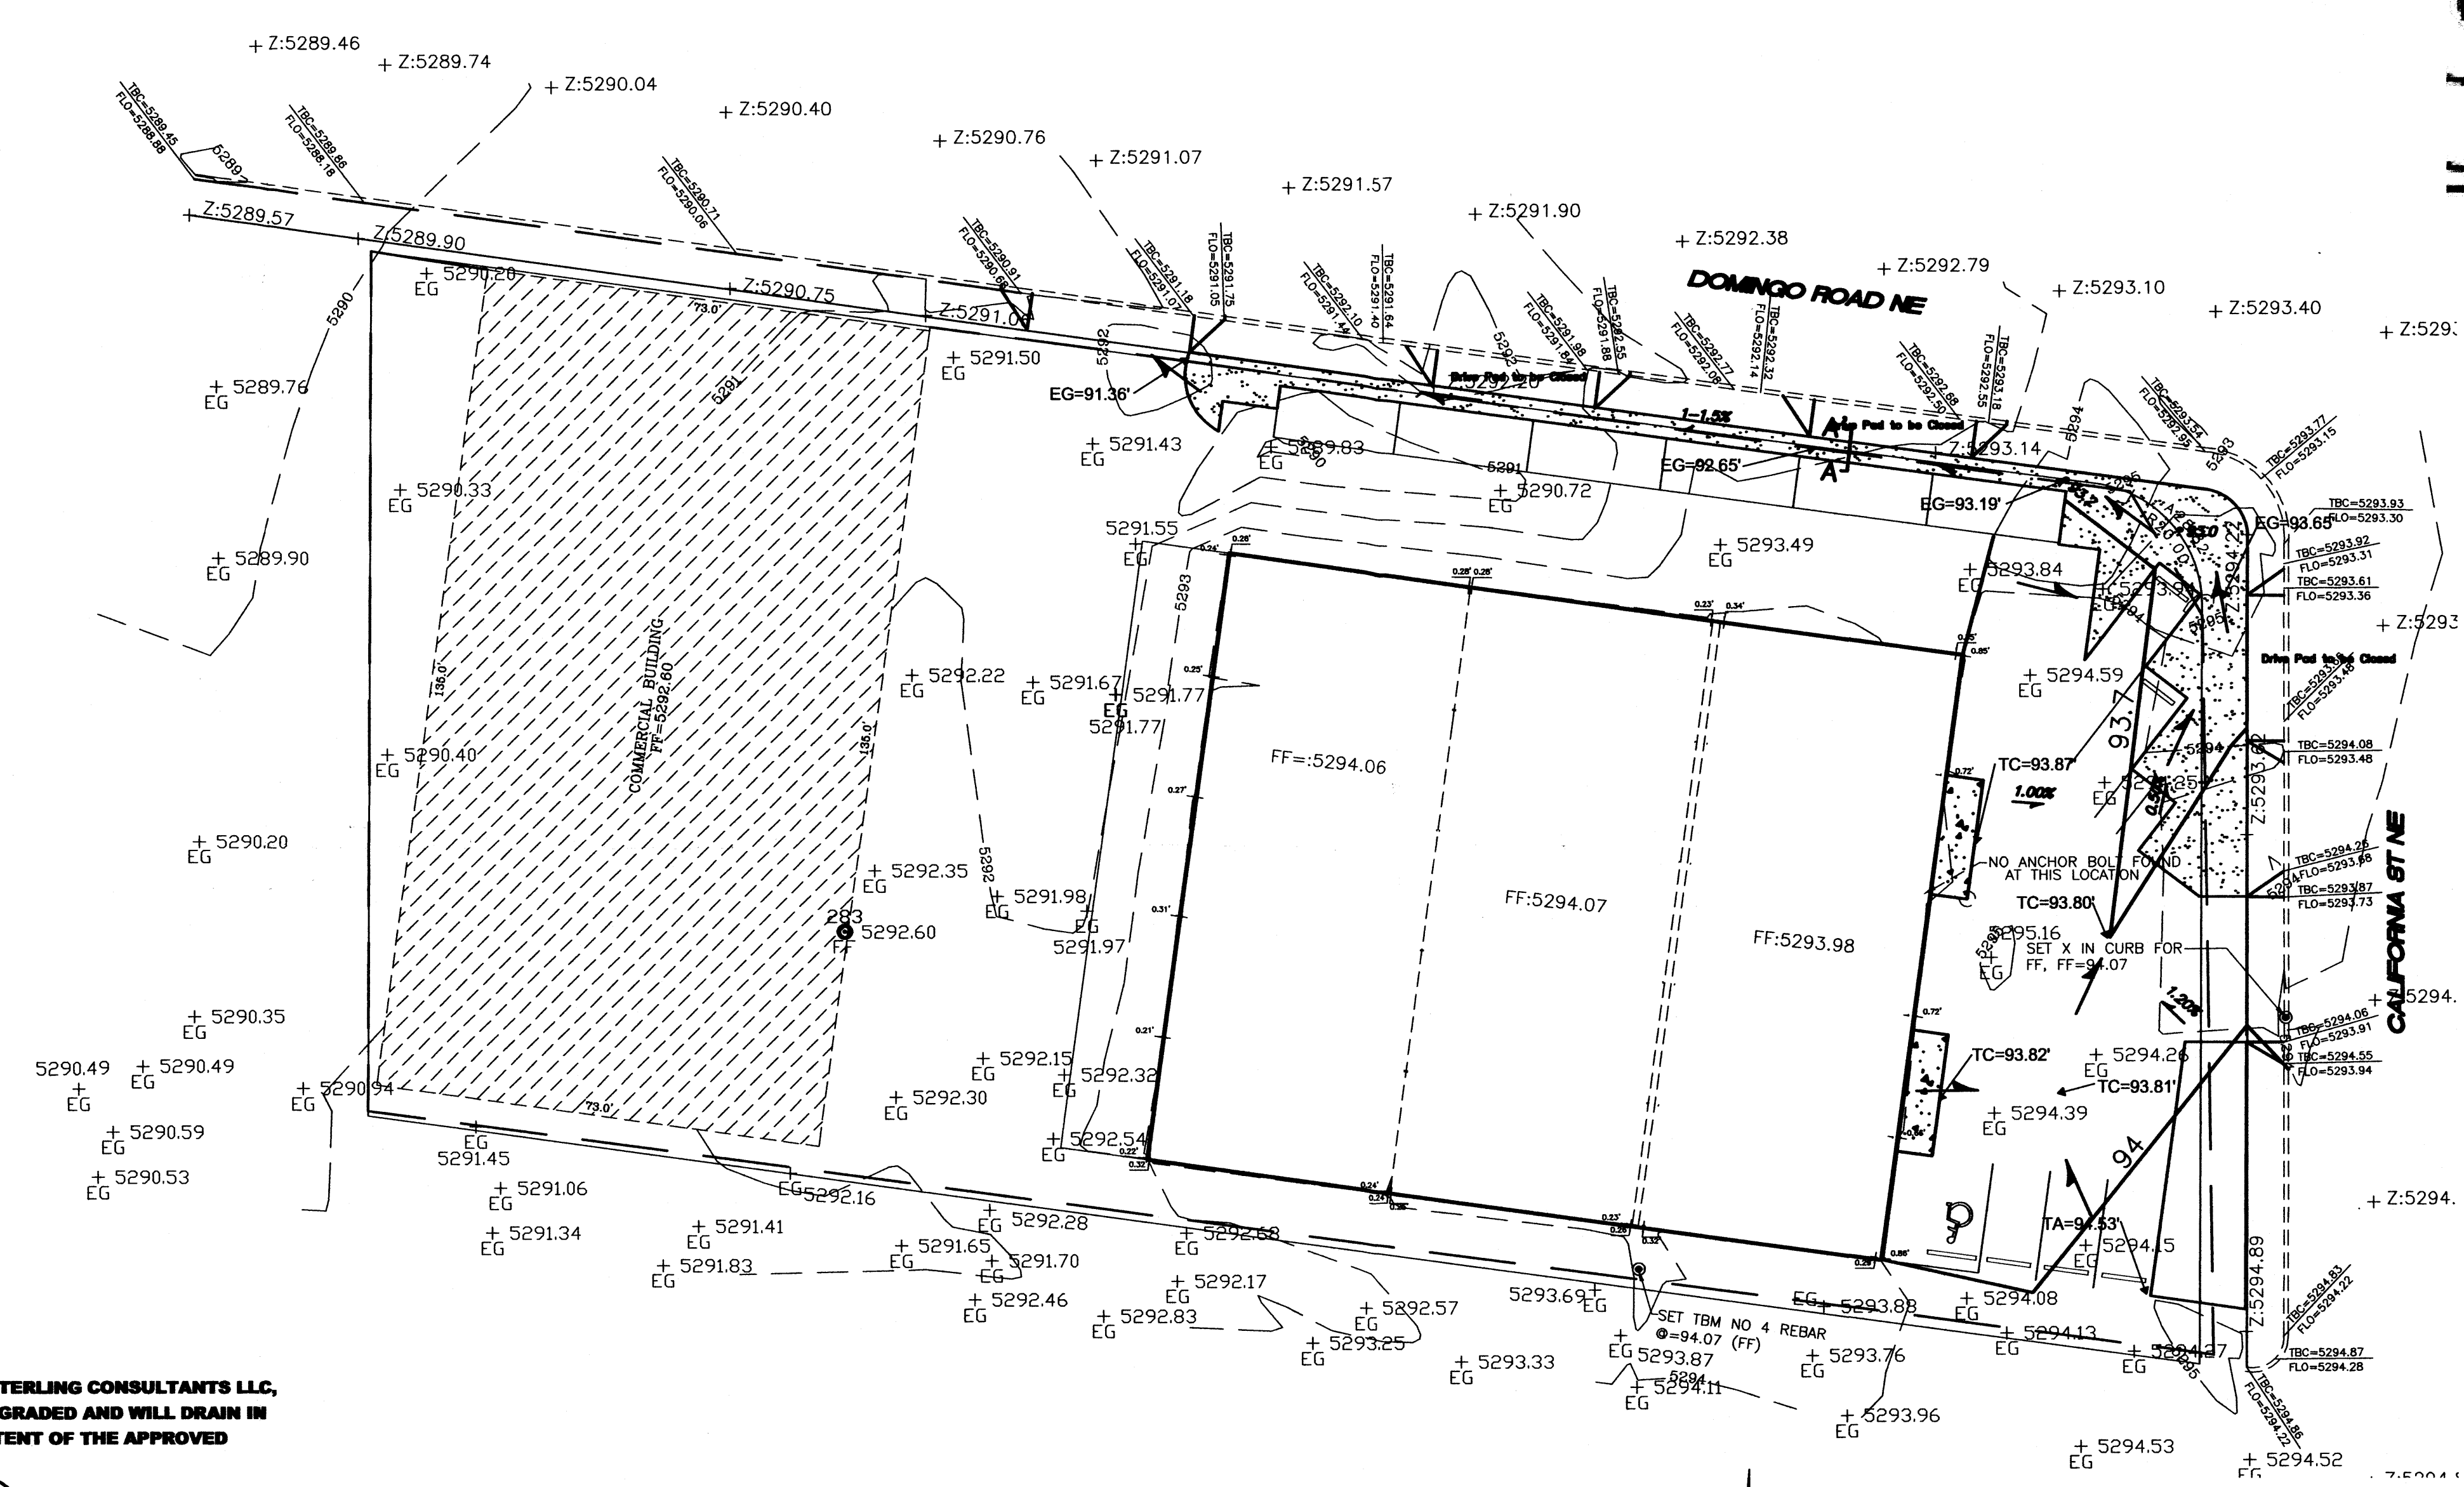
**DOMINGO B RECONSTRUCTION GRADING AND DRAINAGE**

The eastern building on Lot 7-A was destroyed by fire. The building is being reconstructed with the same size and type of building. The majority of the parking lot is undamaged and will remain in place. The portion of the parking lot east of the proposed reconstruction is in disrepair and is uneven. This portion of the parking lot will be re-paved with improvements in the grades to prevent water pooling along the eastern side of the building.

Currently the majority of runoff flows in this eastern area discharge sporadically over the sidewalk to California St. NE which in turn discharges flows to Domingo Road NE which runs along the northern edge of the property. Domingo Road slopes from east to west. The remaining flows on the eastern side parking lot are pooled along the eastern edge of the building until spilling to the east around the NE edge of the building. This is caused by an irregular highpoint approximately 15-20 feet from the building. This flow ultimately drains via the northern drive pad to Domingo NE.

The proposed grading concentrates flows from the eastern area to a proposed landscaped area, along the north-east and northern boundary between the parking lot and the sidewalk, with a consistent slope away from the building. The landscaping is graded to be slightly depressed (0.5' deep) at the north-east corner with a landscaping swale that will drain overflow to the west and ultimately to the northern drive pad where flows are currently being discharged to Domingo Road NE. This improves conditions for the building and does not change the existing condition where all flows ultimately discharge to Domingo Road NE. In addition this configuration provides water quality benefit by the use of the landscaping swale to slow flows and allow filtration by planted vegetation.

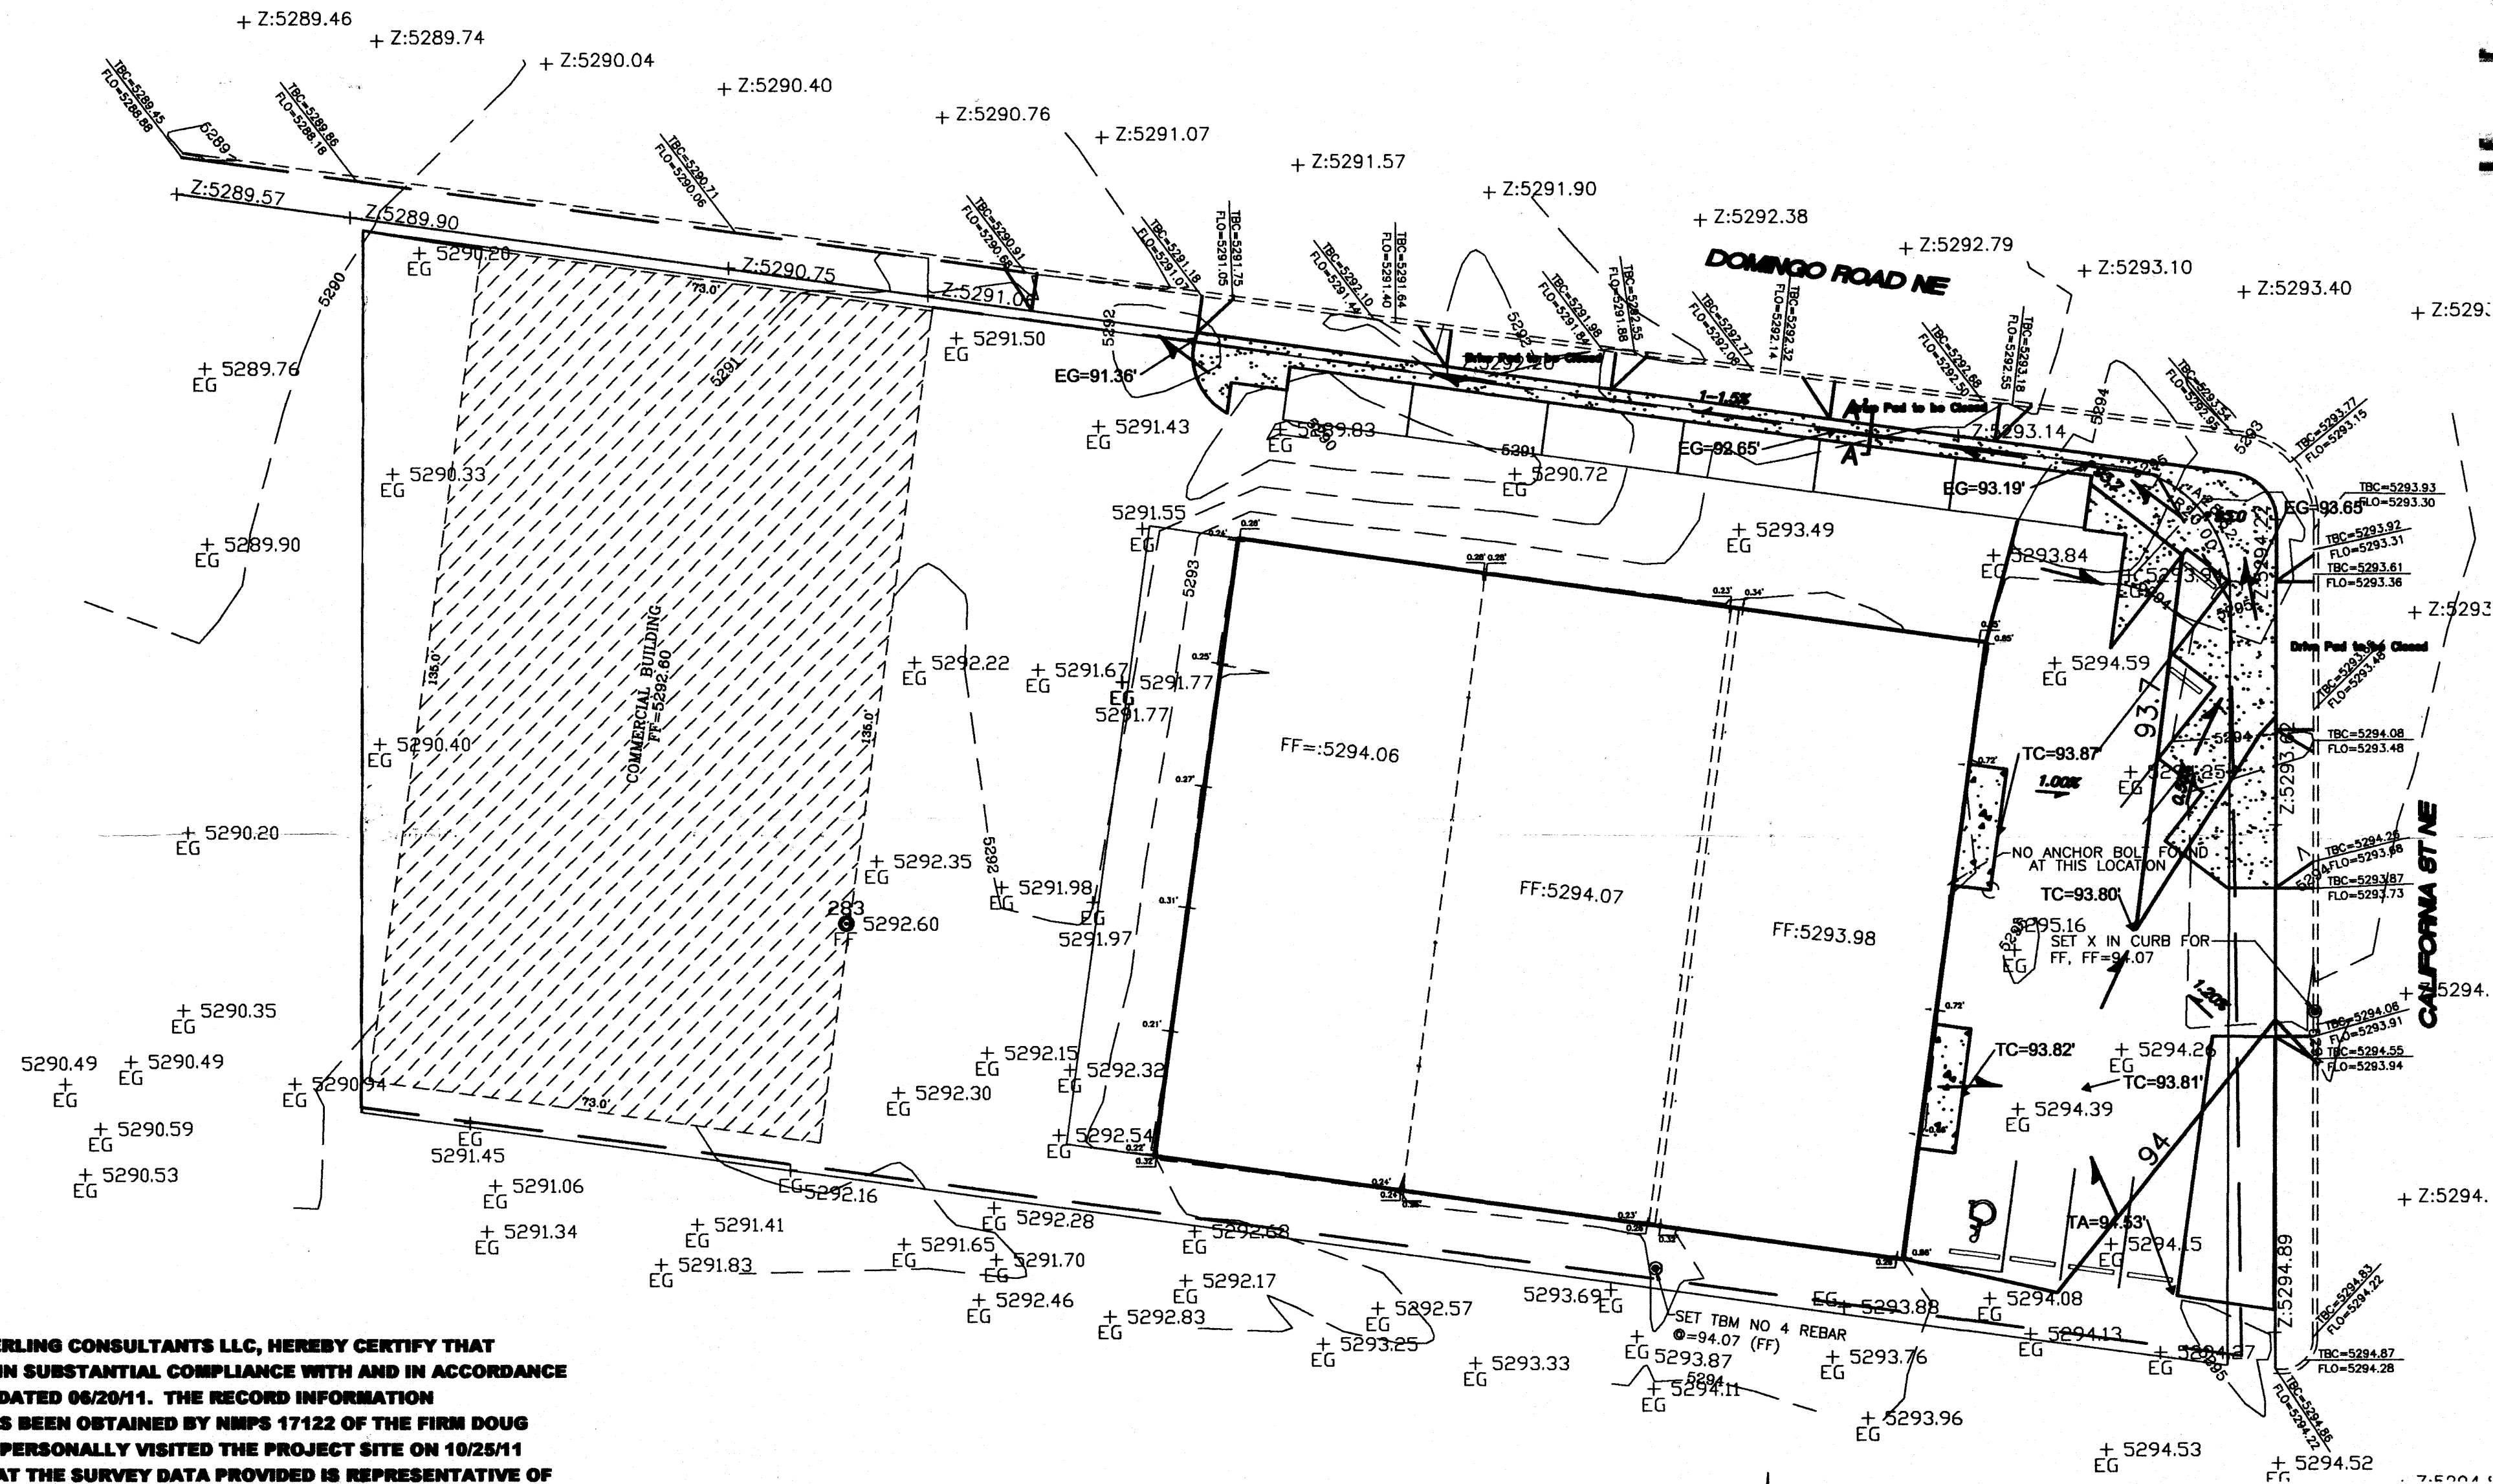
#### DOMINGO B RECONSTRUCTION GRADING AND DRAINAGE

The eastern building on Lot 7-A was destroyed by fire. The building is being reconstructed with the same size and type of building. The majority of the parking lot is undamaged and will remain in place. The portion of the parking lot east of the proposed reconstruction is in disrepair and is uneven. This portion of the parking lot will be re-paved with improvements in the grades to prevent water pooling along the eastern side of the building.

Currently the majority of runoff flows in this eastern area discharge sporadically over the sidewalk to California St. NE which in turn discharges flows to Domingo Road NE which runs along the northern edge of the property. Domingo Road slopes from east to west. The remaining flows on the eastern side parking lot are pooled along the eastern edge of the building until spilling to the east around the NE edge of the building. This is caused by an irregular highpoint approximately 15-20 feet from the building. This flow ultimately drains via the northern drive pad to Domingo NE.

The proposed grading concentrates flows from the eastern area to a proposed landscaped area, along the north-east and northern boundary between the parking lot and the sidewalk, with a consistent slope away from the building. The landscaping is graded to be slightly depressed (0.5' deep) at the north-east corner with a landscaping swale that will drain overflow to the west and ultimately to the northern drive pad where flows are currently being discharged to Domingo Road NE. This improves conditions for the building and does not change the existing condition where all flows ultimately discharge to Domingo Road NE. In addition this configuration provides water quality benefit by the use of the landscaping swale to slow flows and allow filtration by planted vegetation.
