The site is a 1.03 acre mobile home sales lot, known as "Quality Homes" located on Block 6 of the East Central Business Addition in Albuquerque. The site is situated on Tract A-1-B, and portions of Tract A-2-B and Lot 23. Tracts A-1-B and A-2-B are owned by U.S. West Communications, while Lot 23 is owned by Bell Industries. Both landowners lease portions of their lots to Quality Homes, as shown on the plan.

QUALITY MOBILE HOMES 2 0 1994 105 JUAN TABO N.E. GRADING and PAVING PLAN

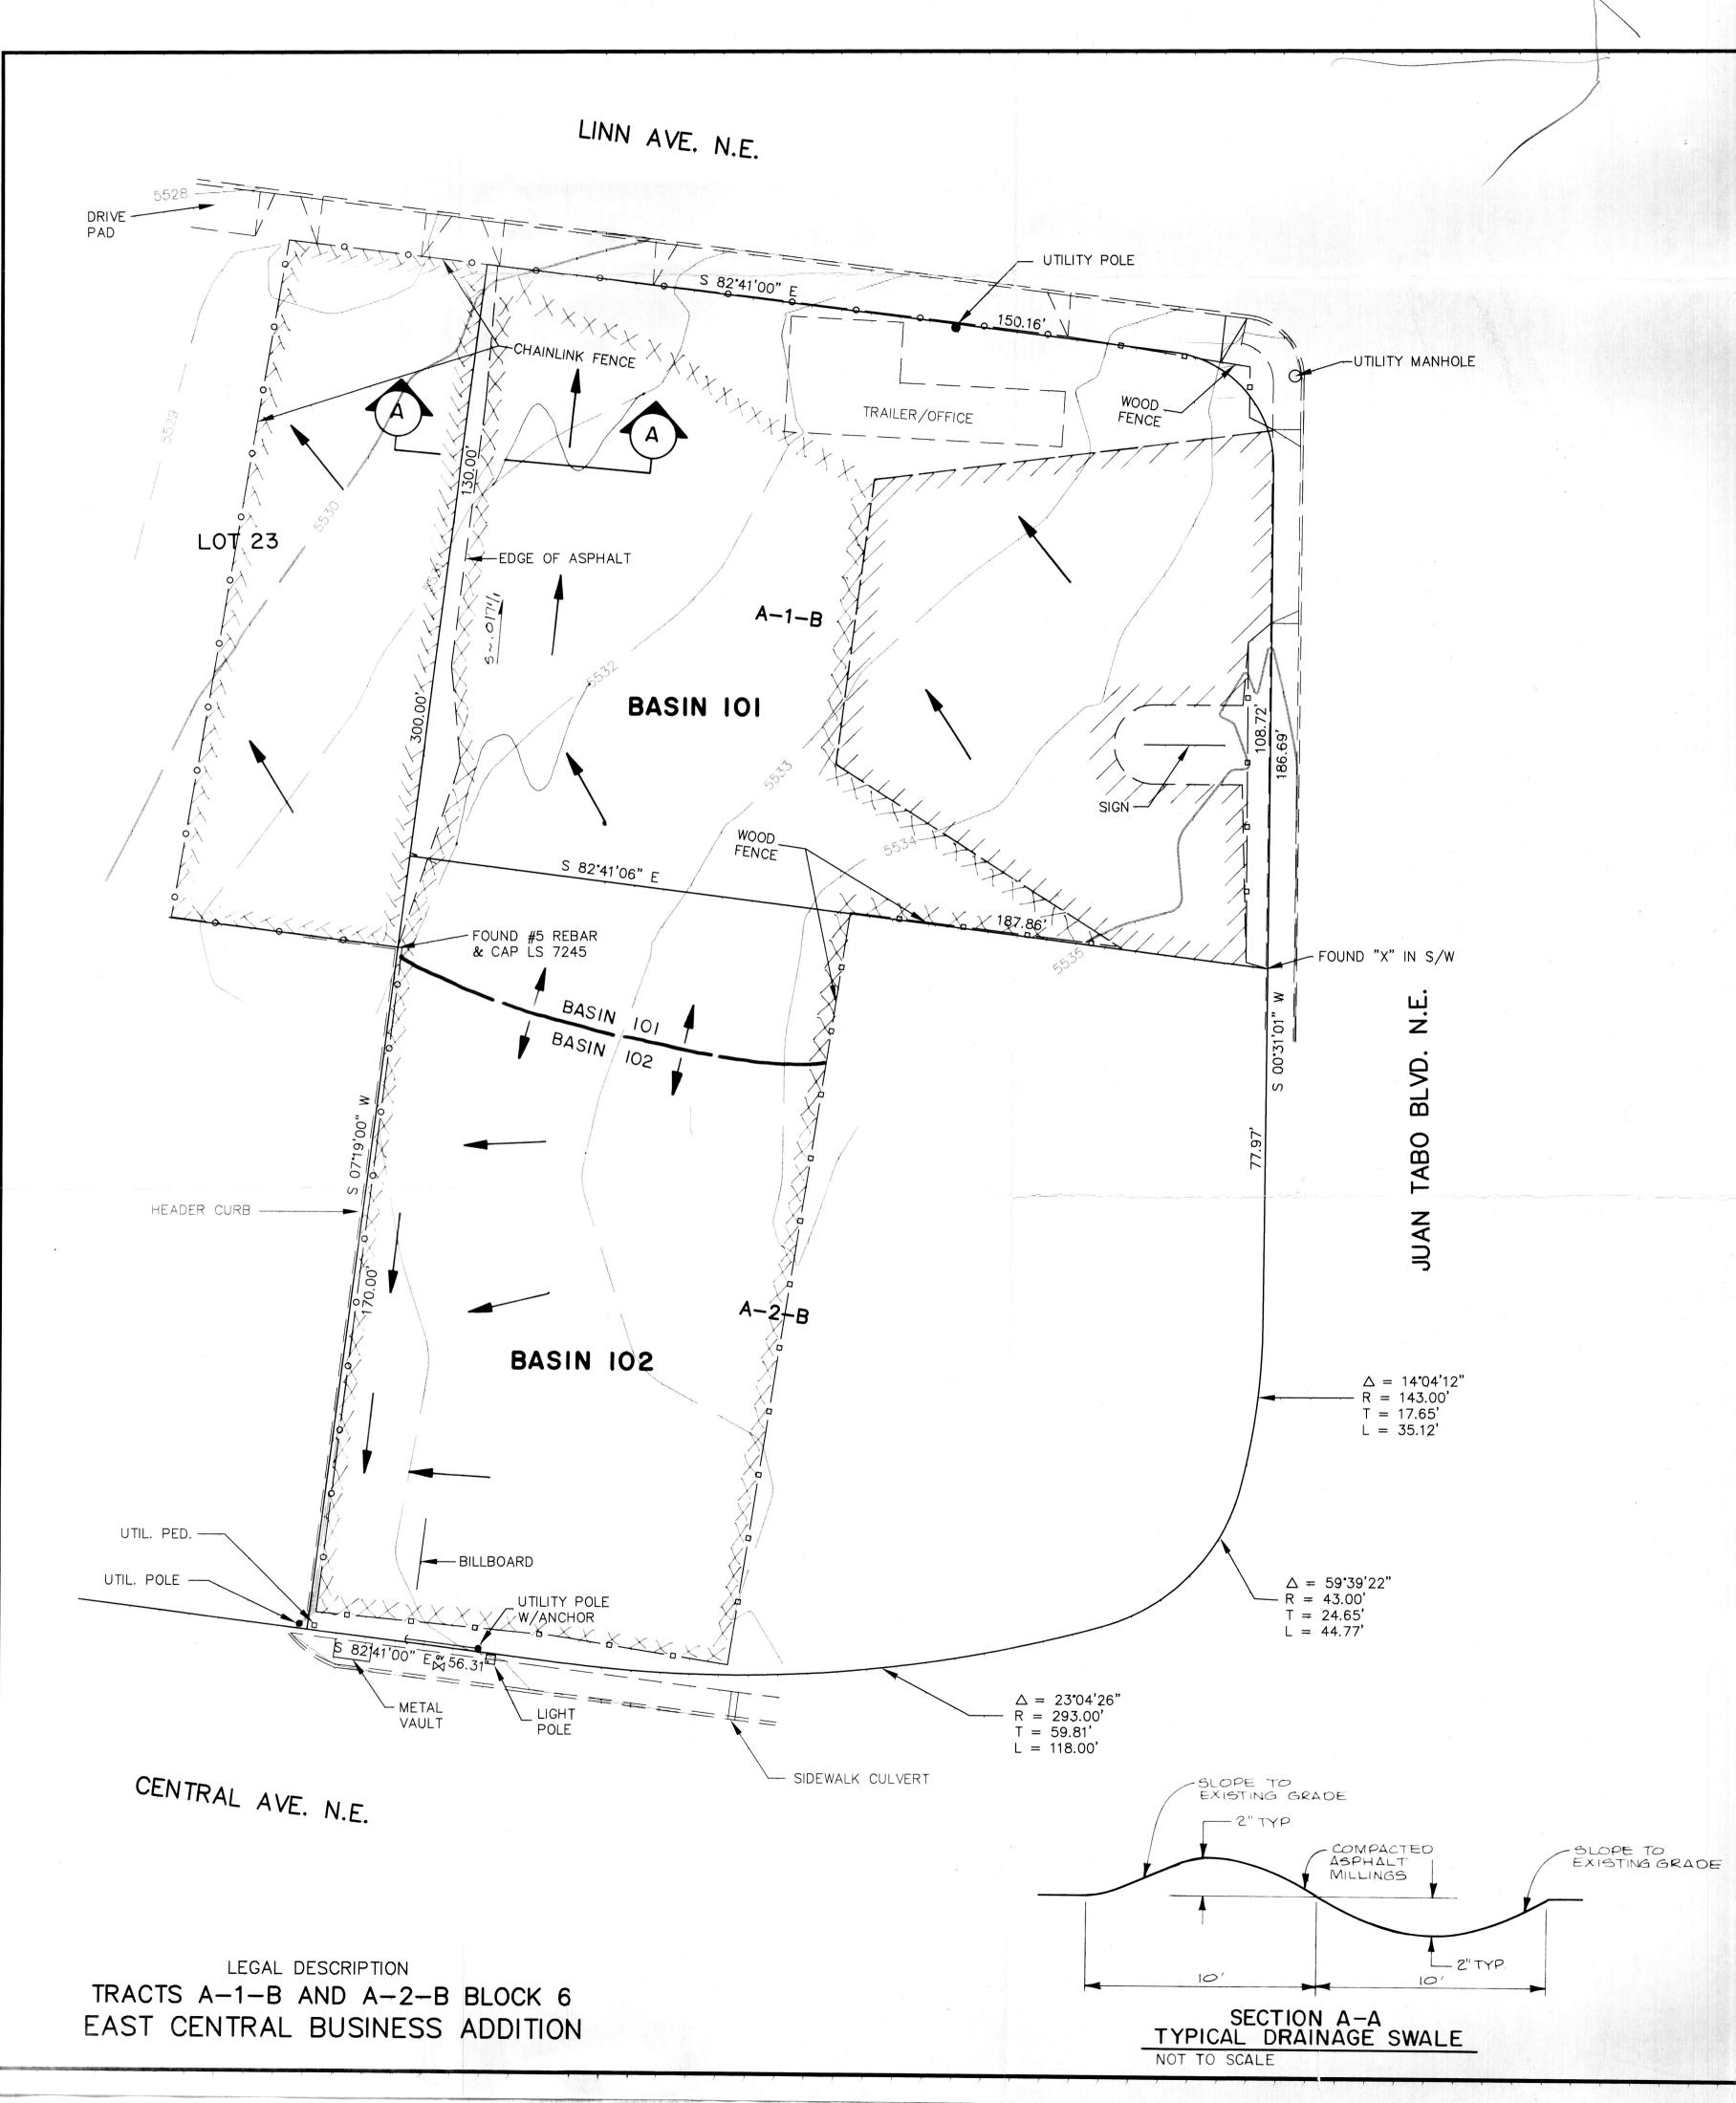
The site consists of a parking area, and a larger area on which a sales office and several mobile homes are located. The portion of the site located on Tracts A-1-B and A-2-B was recently resurfaced by Quality Homes (with permission of the landowner), thus affecting hydrology on the site. The portion of the site located on Lot 23 was not resurfaced and remains as compacted earth. The surface area that was affected exceeds 2000 square feet and therefore a grading and drainage plan is required.

Drainage paths on the site were not changed and remain as they were prior to the work. Runoff from the southern portion of the site (Basin 102) accumulates in a swale on the western side of the tract and eventually flows to Central Avenue. Runoff from the remainder of the site (Basin 101) flows in a northwest direction and onto Linn Avenue. (A portion of the runoff from Tract A-1-B flows onto Lot 23 before draining to Linn Avenue.) The runoff on Linn Avenue flows to a storm drain located under Buena Ventura Road.

A shallow swale will be dug along the west property boundary of Tract A-1-B, as shown on the plan. The purpose of this swale is to prevent runoff from flowing across the lot line separating Tract A-1-B and Lot 23. The swale will be graded so that it does not present an obstacle to mobile home movement on

The results indicate an increase in the 100-yr peak discharge of 0.9 cfs and 0.4 cfs for Basins 101 and 102 respectively, due to the resurfacing. Staff of the City of Albuquerque Hydrology Division have indicated that this runoff increase does not present a problem to downstream drainage and is permissible.
