RE: L.O.M.R. Request for Sunport Park, Phase I  
(FEMA Case 6-91-127).

## COMPACTION TEST RESULTS

# PROCTOR TEST REPORT

SUNPORT PARK  
EXISTING CONDITIONS  
12-23-91

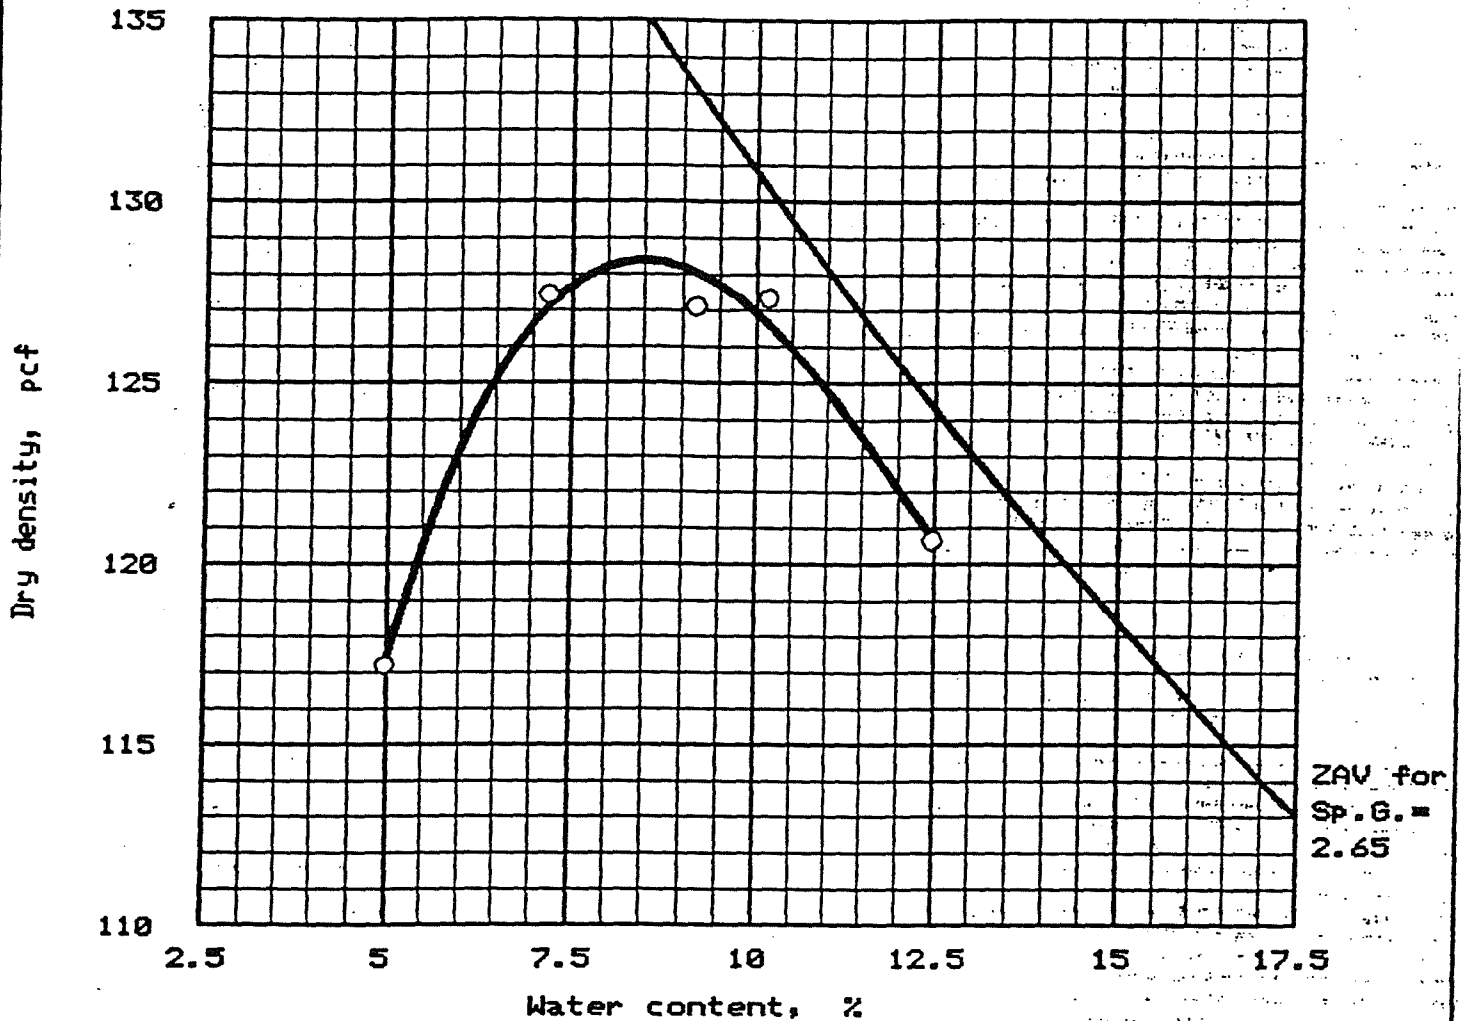
Figure No. 1

"Modified" Proctor, ASTM D 1557, Method C

Elev/ Depth	Classification		Nat. Moist.	Sp.G.	LL	PI	% > No. 4	% < No. 200
	USCS	AASHTO						
-7.0'	SM	-		2.65	20.7	NP	9.2 %	26.2 %

Optimum moisture = 8.5 %  
Maximum dry density = 128.4 pcf

SAND, very silty, sli.  
gravelly, brown

Project No.: 6074  
Project: Sunport Parking  
Location: Transport and Woodward

2. Results of compaction tests performed on the new fill mentioned in Item 1. The compaction test uses the modified proctor density methods based upon maximum density testing performed in May of 1988 when the project was originally constructed (also enclosed). Using the modified densities, the new fill shows a compaction of 90% with ASTM D 1557 method C. This is for all practical purposes equivalent to a compaction of 95% based upon Standard Proctor methods (ASTM D-698).

Proctor No.	Soil Description	Optimum Moisture Content (%)	Maximum Dry Density (pcf)	Remarks
1	SAND, very silty, sli. gravelly, brown	8.5	128.4	Provided by client
