Erosion Sediment Control Plan

Eagle Ranch NM MVD

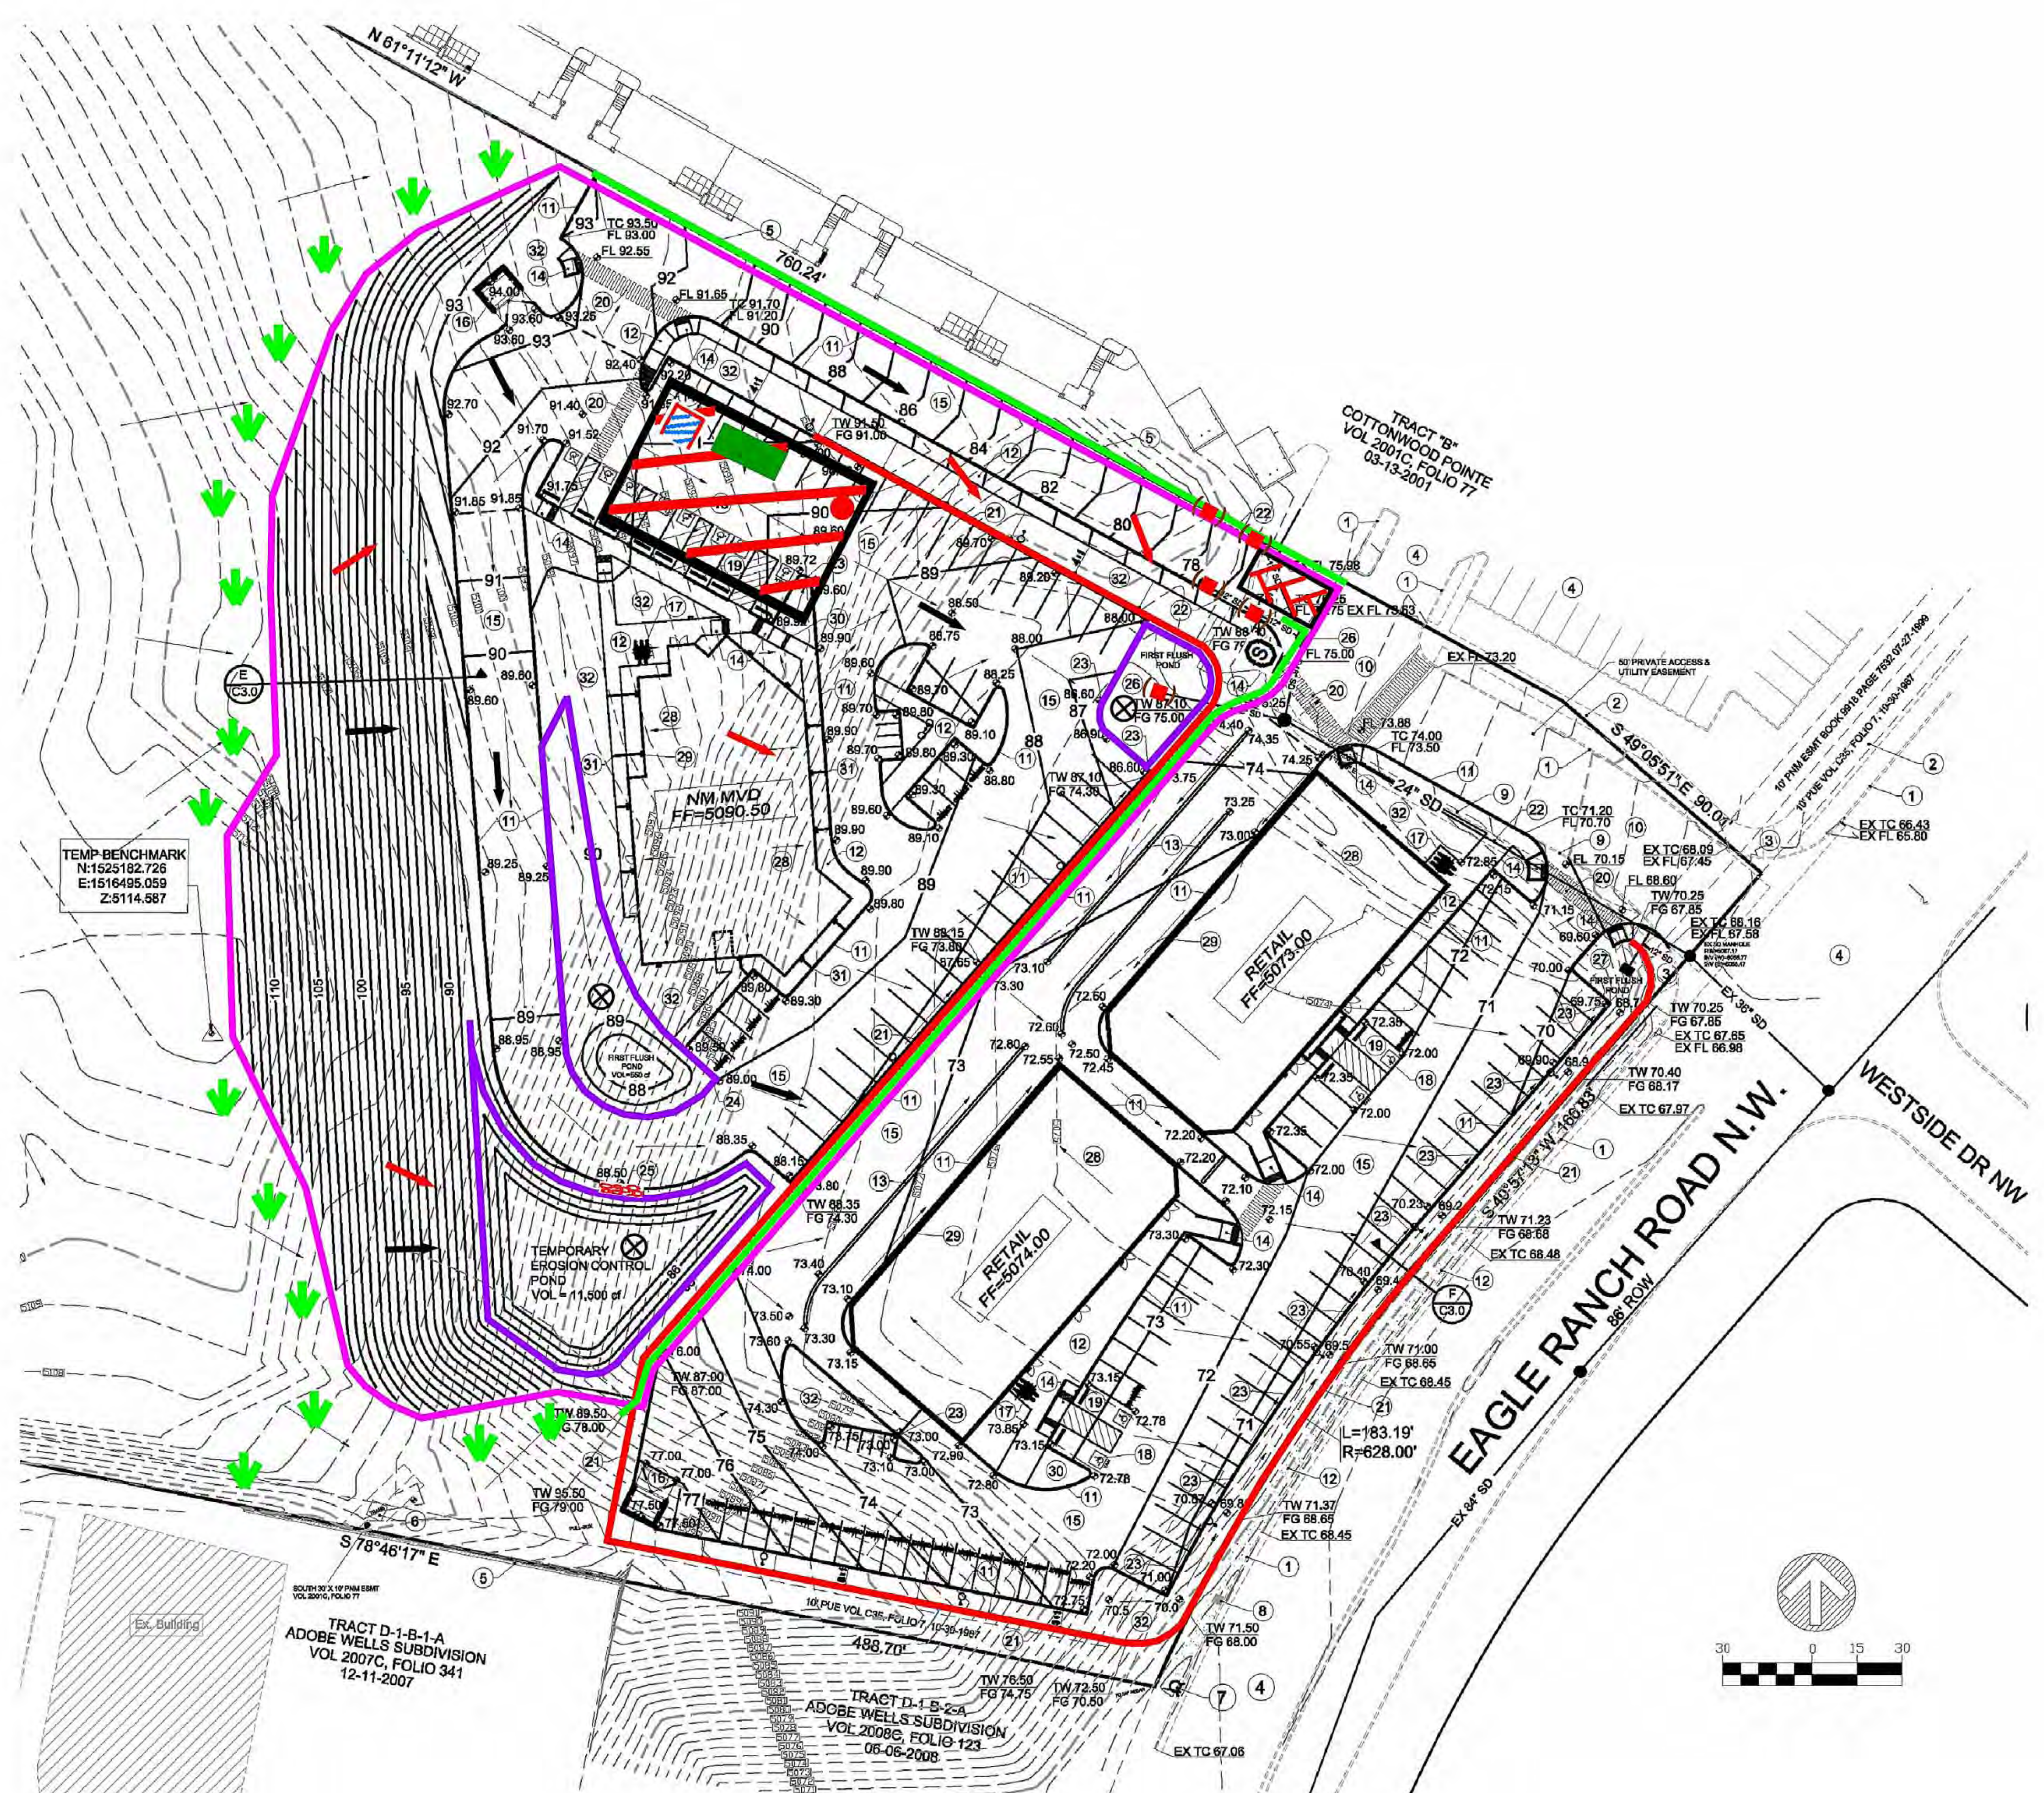
Receiving Waters: Calabacillas Arroyo is located 428 yards to the NorthEast.

Critical Habitat: Rio Grande is located 0.86 miles to the SouthEast.

Impairments: None

Grade: Before 0.5% to 2% Variable After 0.5% to 4 % variable
