CITY OF ALBUQUERQUE

Site: Tierra Serena

Re: Drainage Ordinance (14-5-2-1) Violations for Erosion and Sediment Control and Construction Site Waste(s)

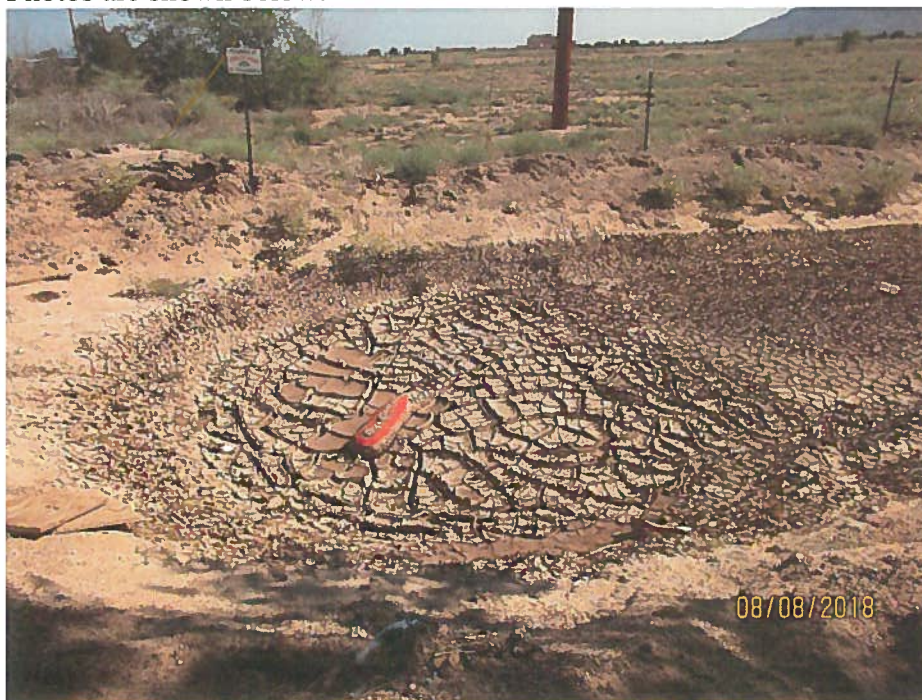
Inlet grate buried under sediment.

1. Remove sediment from the grate and inlet for the inlet at the west end of Glendale Ave. If sediment is observed (from the inlet) in the storm drain downstream of the inlet, this sediment is also to be removed.

2. Install a sediment BMP that prevents sediment from entering the grate and minimizes the amount of sediment getting to the grate (e.g. mat on grate with filter socks two-high around the grate or similar). The sediment BMP(s) are to be maintained and sediment prevented from entering the inlet until the inlet is removed or until the project is determined stabilized by the City.

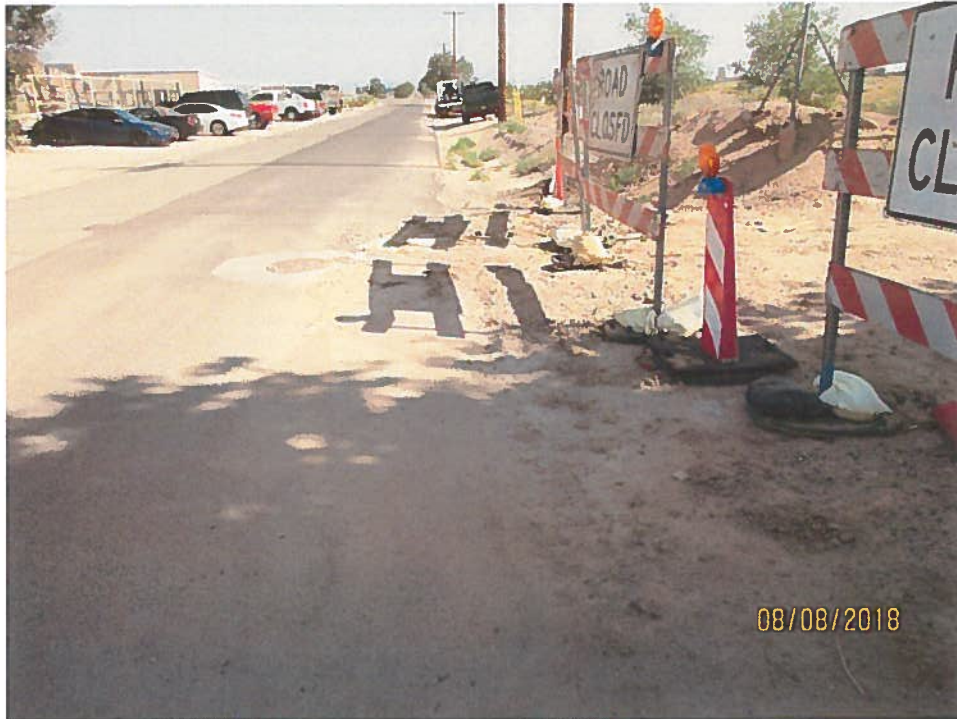
Sediment in San Pedro Blvd. Partial sediment BMP for a portion at San Pedro.

3. Remove sediment from San Pedro Blvd at Glendale.
4. Install and maintain a sediment BMP, for the missing portion, on the east side of San Pedro at Glendale Ave.

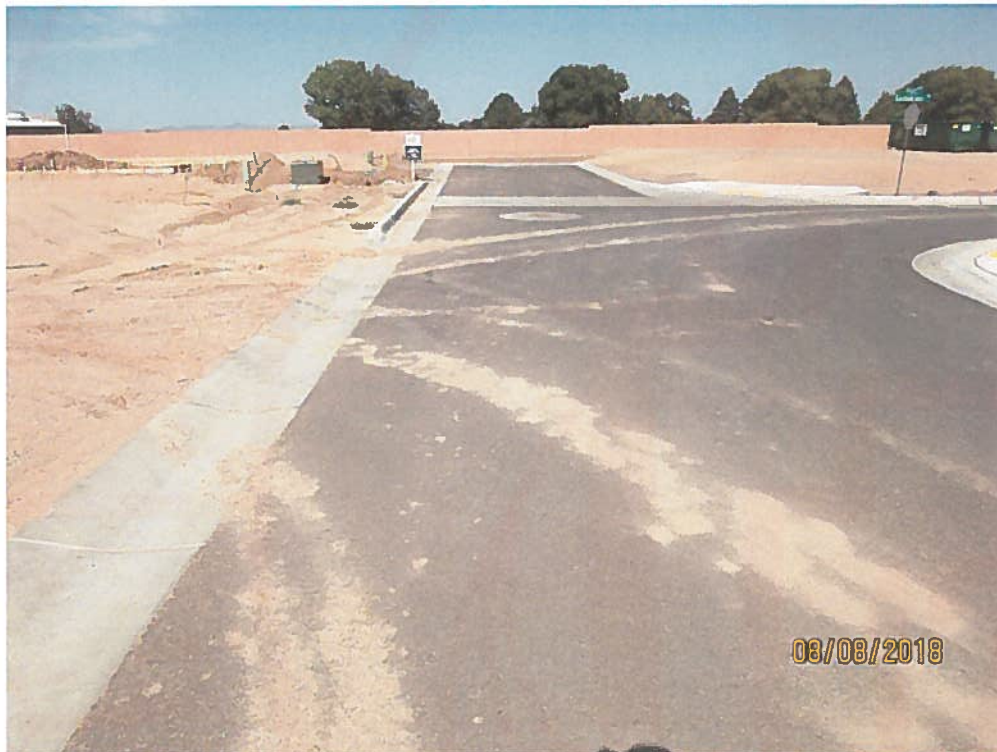
Sediment in street.

5. Remove sediment from onsite streets.
6. Remove stucco wash-out that would enter the street due to flows from the temporary parking lot. Have workers use the wash-out facility.

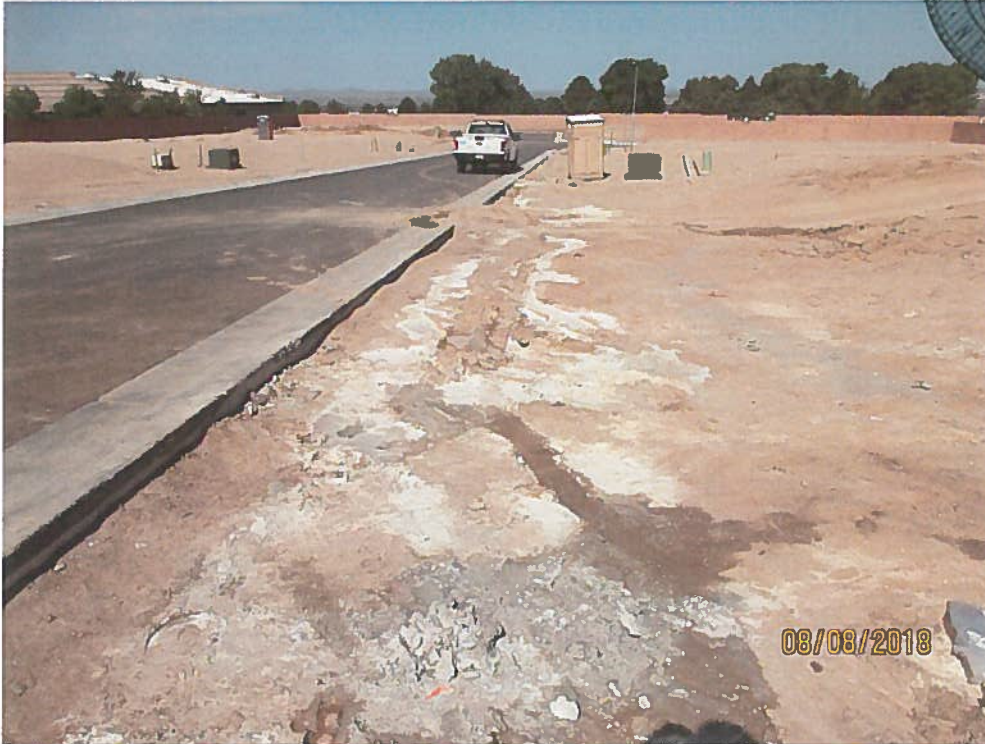
Stucco wash-out.

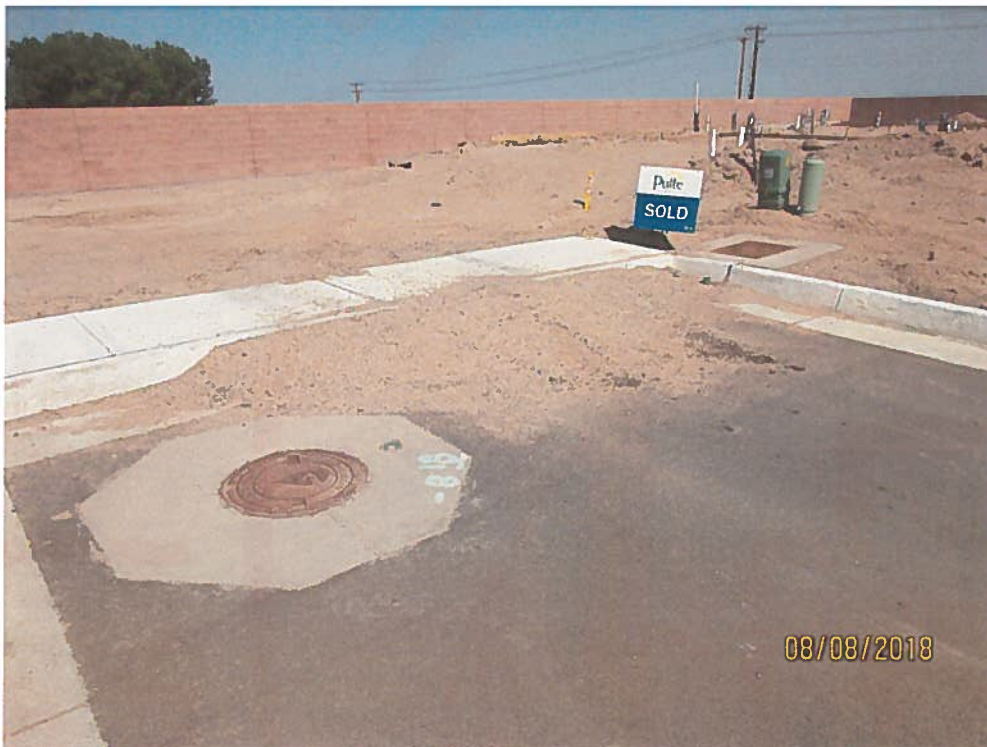
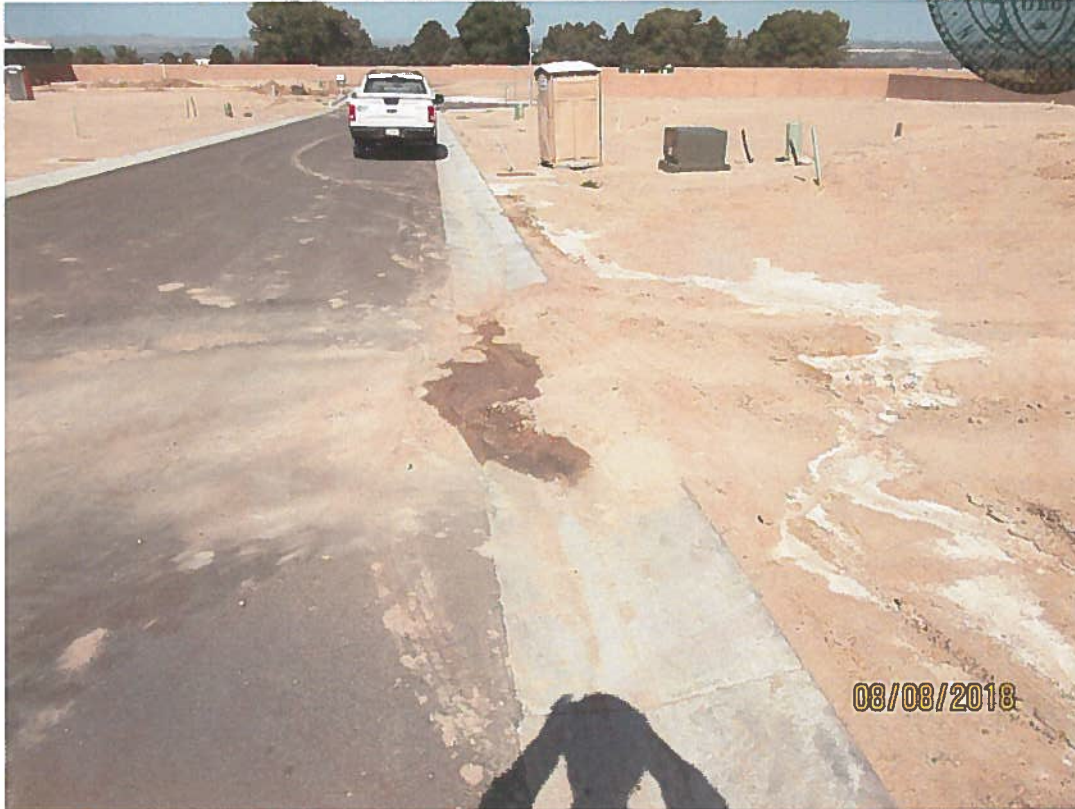
Dirt ramp.

7. Remove the dirt ramps from the street(s) and do not construct new ones.
8. Improve the sediment BMP (cut-back) on the lot shown in the picture above.

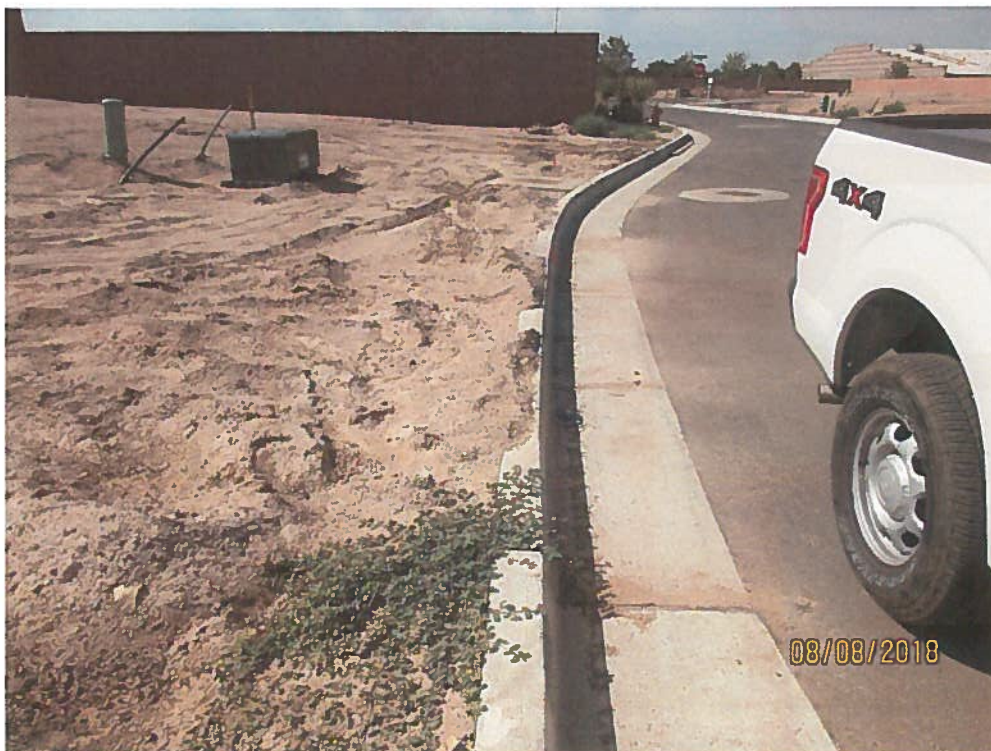
Sediment BMP (cut-back) needs improvement on this lot.
