**Sites: Lot 24-A Blk 3 Plan for Lots 24-A and 24-B Block 3 Tract A Unit B North Albuquerque Acres – Rocky Ledge Properties LLC - B18E026**  
**Part of Lot 21 & all of Lots 22 & 23 Block 3 Tract A Unit B North Albuquerque Acres – Tinmill LLC**

**Re: Drainage Ordinance (14-5-2-11) Violations for Erosion and Sediment Control**

The Storm Water Quality (SWQ) Section of the City of Albuquerque conducted an Erosion and Sediment Control (ESC) inspection of the site on 12/13/24 to determine compliance with City Ordinance § 14-5-2-11 (attached) and the Environmental Protection Agency's (EPA's) Construction General Permit (CGP) [2022 Construction General Permit \(CGP\) | US EPA](#).

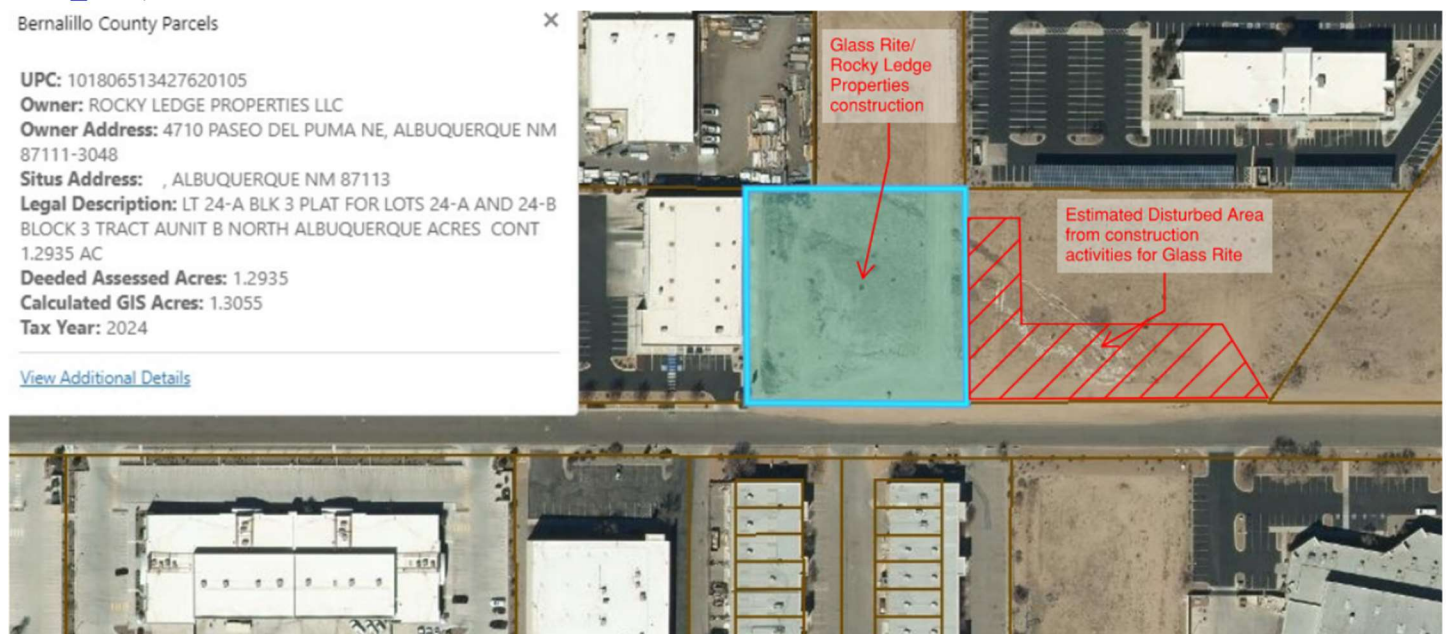
During the City's inspection, construction vehicles were observed parking and staging on the neighboring property of the Glass Rite construction site destroying vegetation, disturbing the soil, and causing sediment track-out. This land disturbance does not appear on the ESC Plan and Landscape Plan submitted to the City by Rocky Ledge Properties LLC, nor was an NOI for the neighboring property owner (Tinmill LLC) submitted, meaning the construction activity (equipment staging and vehicle parking) on this property was not approved by the City. Both the acts of starting construction activities without approval from the City and starting construction without implementing stormwater controls (BMPs) result in the immediate escalation and the issuance of this Formal Notice of Violation as addressed in the Escalation Policy (attached).

The following photo is a screenshot of the Zoning Advanced Map Viewer and Bernalillo County Tax records showing the estimated area of disturbance of the neighboring property to the construction site.

1. **NOI** - You must either provide an ESC Plan and NOI per CGP 1.4 to the City's Storm Water Quality (SWQ) Section for approval for Tinmill LLC, the owner of Lot 21 & all of Lots 22 & 23 Block 3 Tract A unit B North Albuquerque Acres per ordinance § 14-5-2-11, or you must stabilize the disturbed portion of that property with "Native Seed and Aggregate Mulch" per City Std Spec 2012 or equivalent, to comply with the Final Stabilization Criteria in the CGP Part 2.2.14.c.
2. **BMPs** – Complete installation of stormwater controls by the time each phase of construction activities has begun per CGP Part 2.1.3. Install sediment controls along any perimeter areas of the site that are downslope from any exposed soil or other disturbed areas per CGP Part 2.2.3.

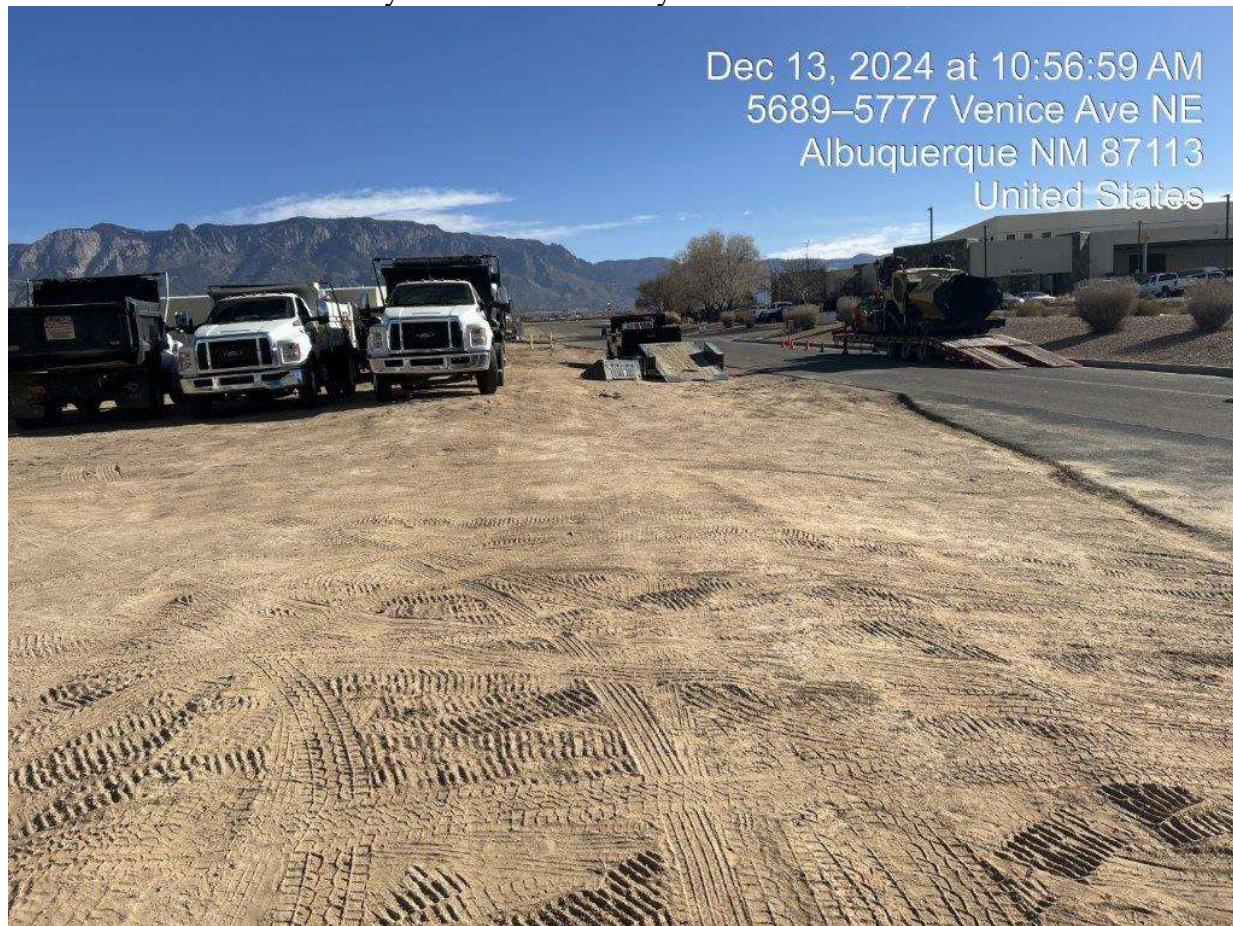
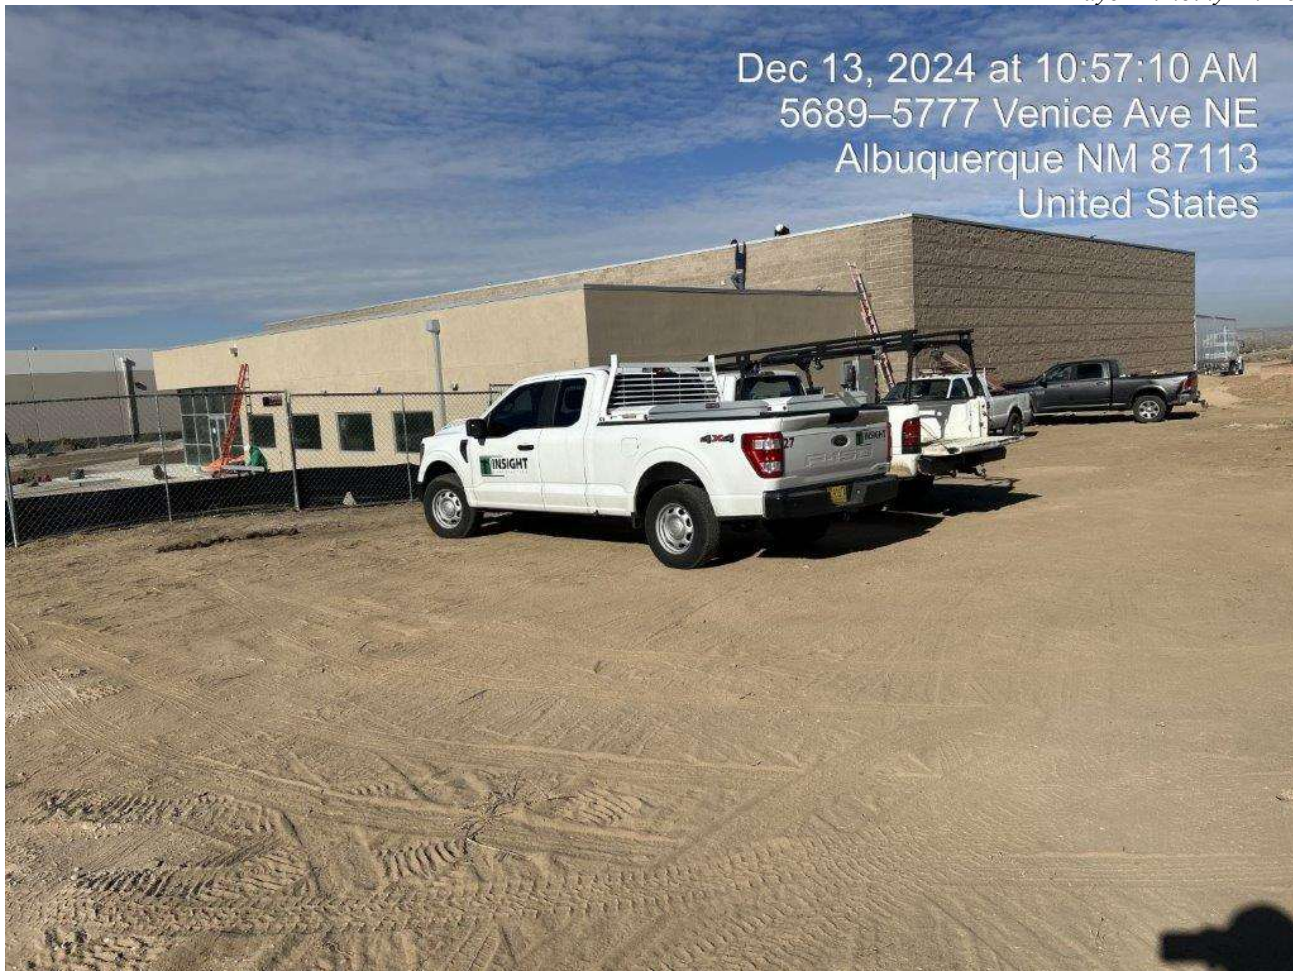
Photos of construction activity on the site owned by Tinmill LLC.

1. **NOI**- Land disturbance on Tinmill, LLC's property was not approved by the City because the property owner's NOI and ESC Plan for the additional construction activity weren't submitted to the City in Violation of City Ordinance § 14-5-2-11(A).
2. **BMPs** - Erosion and sediment controls were not implemented for the land disturbance on Tinhill, LLC's property to minimize the discharge of pollutants in stormwater from this site in violation of CGP Parts 2.1.3 and 2.2.3.
