Erosion Sediment Control Plan

Valle Vista At The Trails

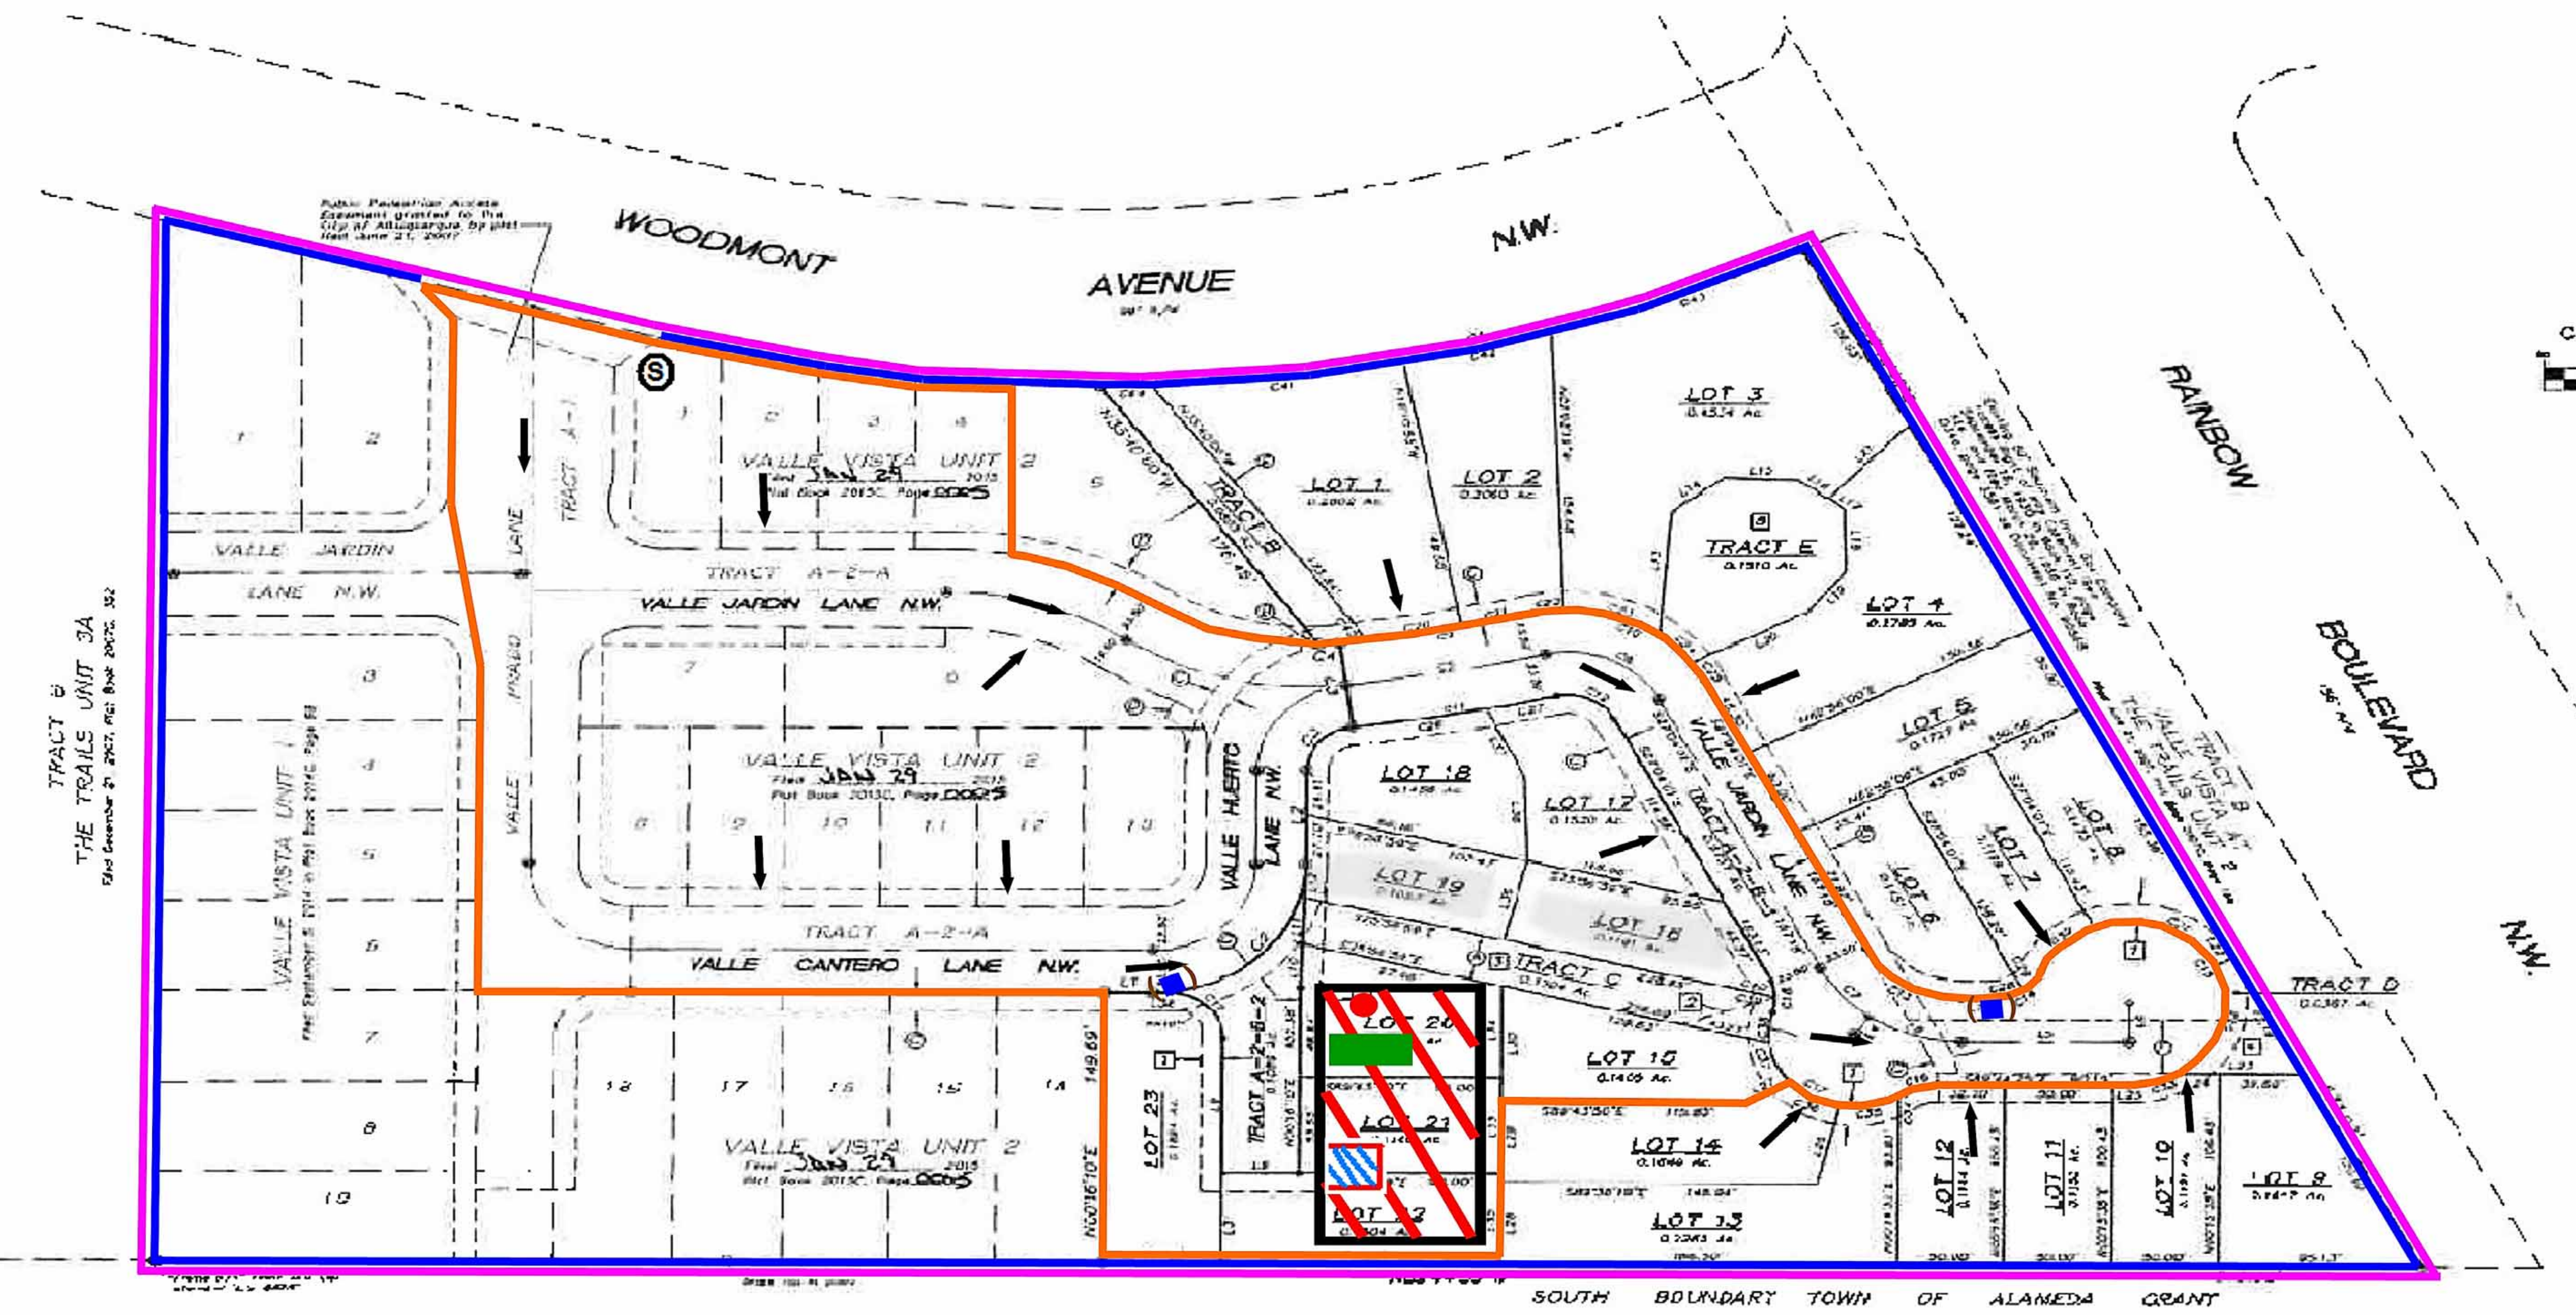
Receiving Waters and Critical Habitat: Ri Grande is located 4.86 miles to the East.

Impairments: E. coli, Dissolved Oxygen, PCBs in Fish Tissue, Water Temperature

Grade: Before and After 0.5%

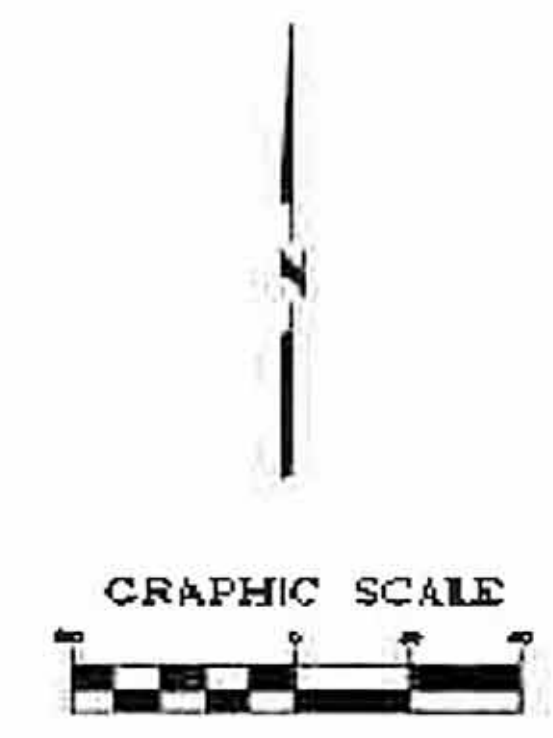
- Project Perimeter
- Disturbed Area
- Block Wall
- Pre Flow & Post Flow
- Outfall
- Posting Sign
- Natural Buffer Zone / Maintain Existing Vegetation
- Staging Area
- Stabilized Construction Entrance
- Trash Receptacle
- Chemical Toilet
- Concrete Washout
- Existing inlet with protection
