General Information			
Project Name and Location	American Toyota San pelon & Marian			
Site Contact Name & Agency	Pat Ooseph ESC File No. CIEE012			
Date of Inspection	11-17-17 Start/End Time /0:10/10:15			
Inspector Name, COA Dept.	Curtis Cherne, Stormwater Quality			
Describe Present Phase of Construction	Stehih Zez			
Type of Inspection: Regular • During stor	m event • Post-storm event (> 0.5 inch) • 311 / Complaint Response • Follow-Up			
	Weather Information			
Weather at time of this inspection? • Clear • Cloudy • Rain • Sleet • Fog • Snowing Windy Has there been a storm event since the site was Permitted? • Yes • No Amount: • < 1/4" • 1/4" to 1/4" • > 3/4" • Snow"				
	, Erosion & Sediment Control Inspection			
Entrance / Track-Out Erosion & Sediment Control Inspection				
Sediment Controls / Silt Fence, Inlet Protection, Wattles, etc. 5 Jahrl 1726				
Erosion Controls Housekeeping/Pollutant Controls

Re: American Toyota Construction site Inspection

American Toyota Construction Site inspection

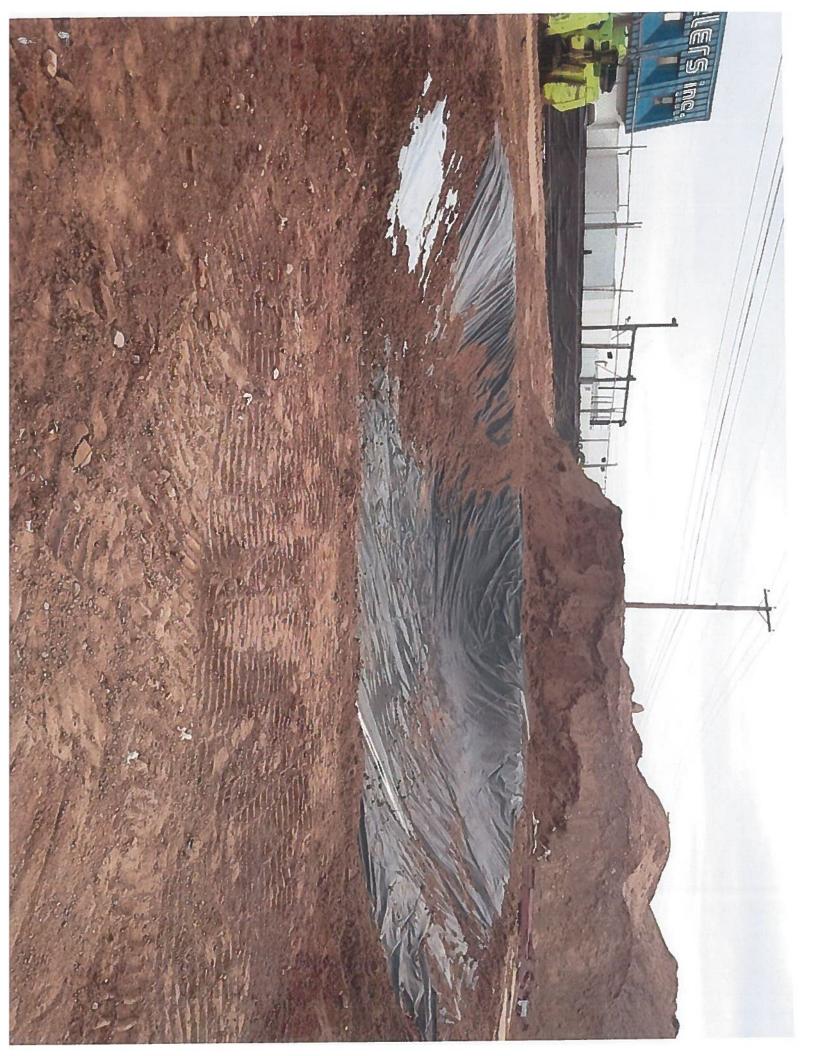
imagejpeg_0.jpg; ATT00001.txt

Thanks for the information We actually did line the cleanout pit it just needs to be emptied I will get it cleared next week and send you a picture once it is more visable hope that is good with you let me know

Curtis just wanted to give you an updated photo of the liner for the concrete clean out pit we re do it each time we clean it out

If you want to use a pit rather than a wash-out bin (recommend one with ramps), you need to line it.
