## CITY OF ALBUQUERQUE

Re: Drainage Control Ordinance (14-5-2-1) and NPDES CGP Violations for Erosion and Sediment Control- Sol Vita Subdivision

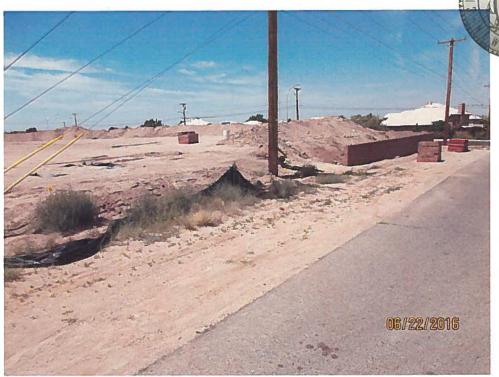
Partial silt fence installation and silt fence requires maintenance on Signal Rd West of the construction entrance.

1. Install/maintain the silt fence at the site per approved methods.

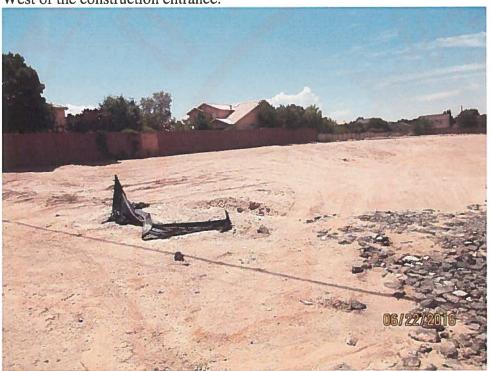
Partial silt fence installation and silt fence requires maintenance on Signal Rd East of the construction entrance.

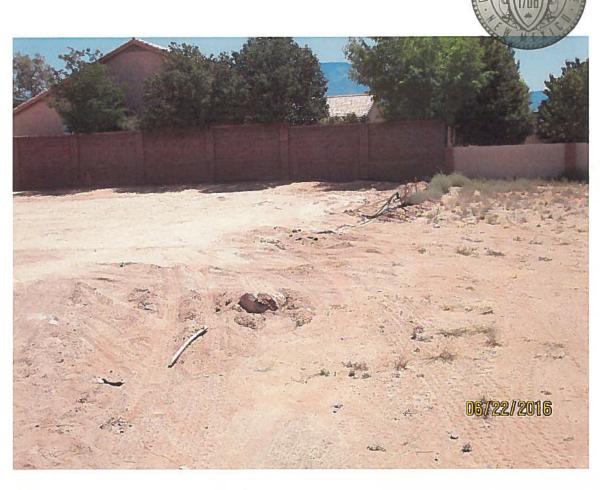
South project boundary there is no silt fence and site is being accessed from the site to the south. There is no sediment BMP for this area.

2. Provide a sediment BMP for the land south of the development that is being

New Mexico 87103 used for access/staging.
