## CITY OF ALBUQUERQUE

Site: Rohan Subdivision

Drainage Ordinance (14-5-2-1) Violations for Erosion and Sediment Control Re:

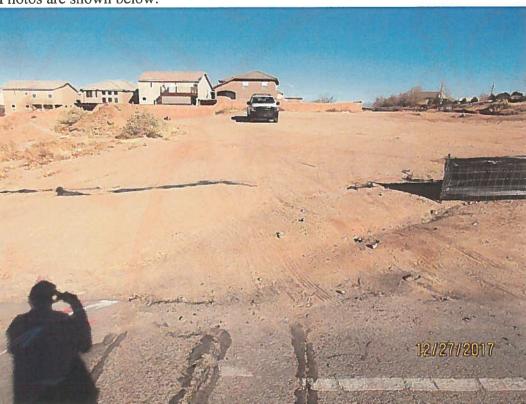
- 1. There was no stabilized construction entrance/track-out pad.
- 2. The silt fence did not extend fully across the western edge of the project.
- 3. The silt fence was not buried. Silt fence does not work if it is not buried.

No stabilized Construction Entrance/track-out pad.

1. Install a stabilized construction entrance/track-out pad per the approved Erosion and Sediment Control plan.

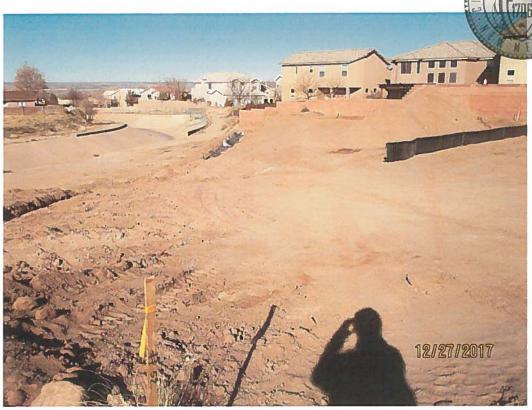
Silt fence does not extend across western edge of disturbed area.

2. Install silt fence/sediment BMP (e.g filter sock) across the western edge of the disturbed area; including Lot 9C which has become part of the grading of the site. Silt fence/sediment BMP is to have a terminus at the Eagle Rock Rd ROW.

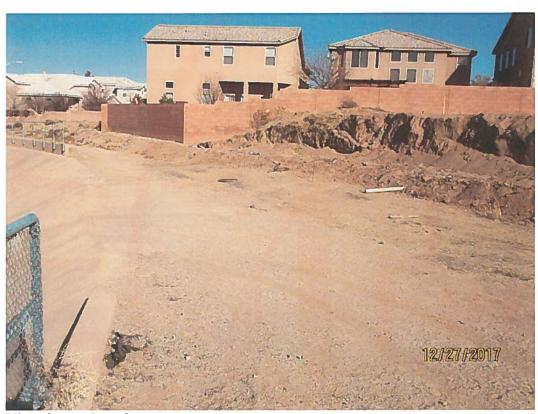
View from edge of arroyo.

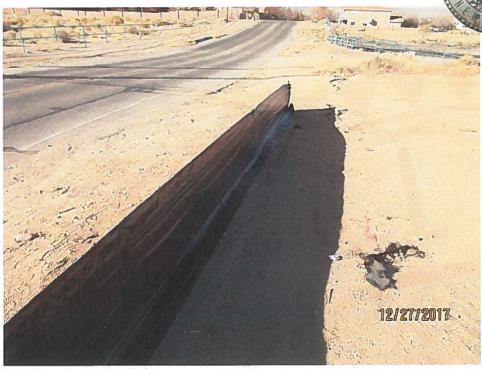
Silt fence is not buried.

3. Bury the silt fence per the approved Erosion and Sediment Control plan.
