CITY OF ALBUQUERQUE

Site: La Cuentista Unit 2

Re: Drainage Ordinance (14-5-2-1) Violations for Erosion and Sediment Control

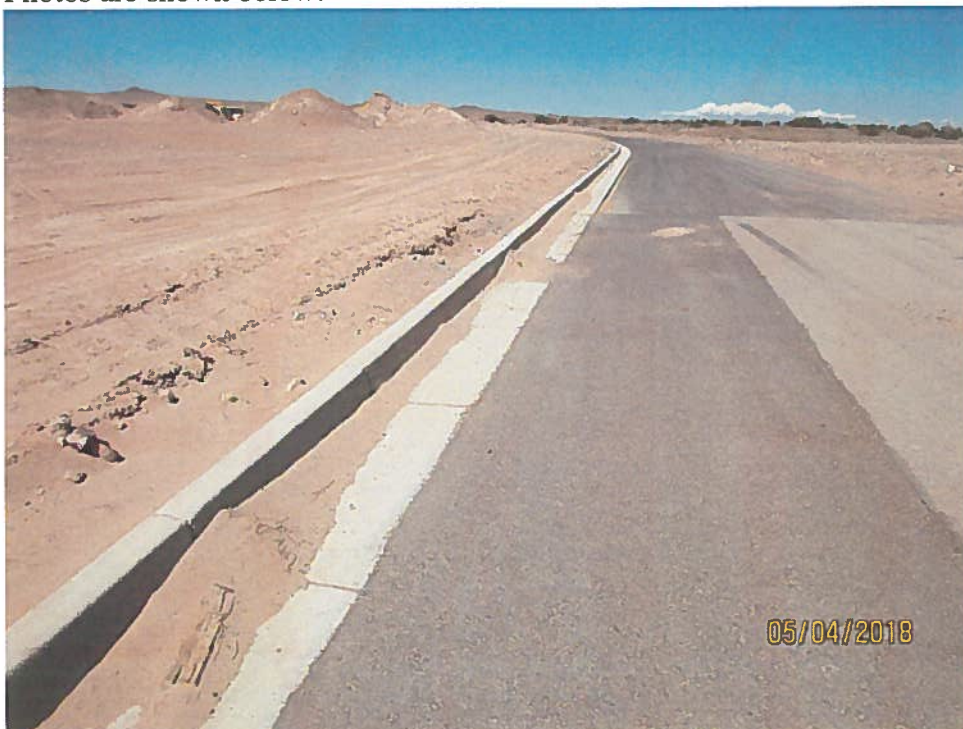
Sediment in gutter Rosa Parks Rd; south gutter.

1. Remove sediment from the gutters on Rosa Parks Rd and Kimmick Dr. and prevent from occurring in the future.
2. Remove dirt ramps from Rosa Parks Rd that were placed to facilitate transporting material across the roadway and do not construct dirt ramps in the streets in the future.

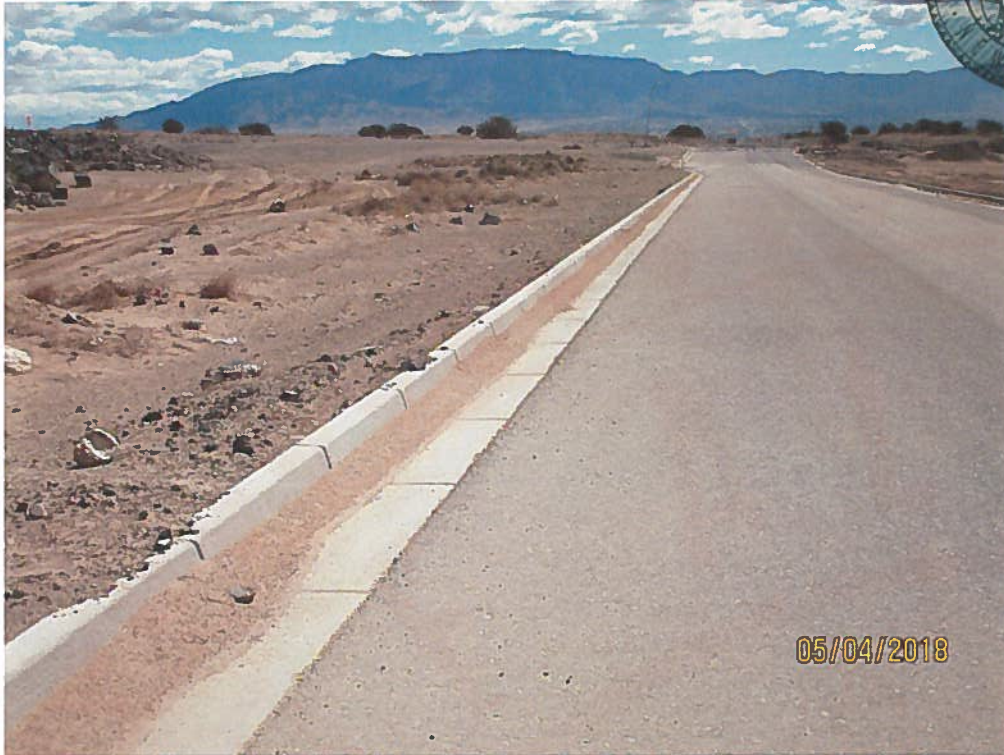
Sediment in gutter Rosa Parks Rd; north gutter.

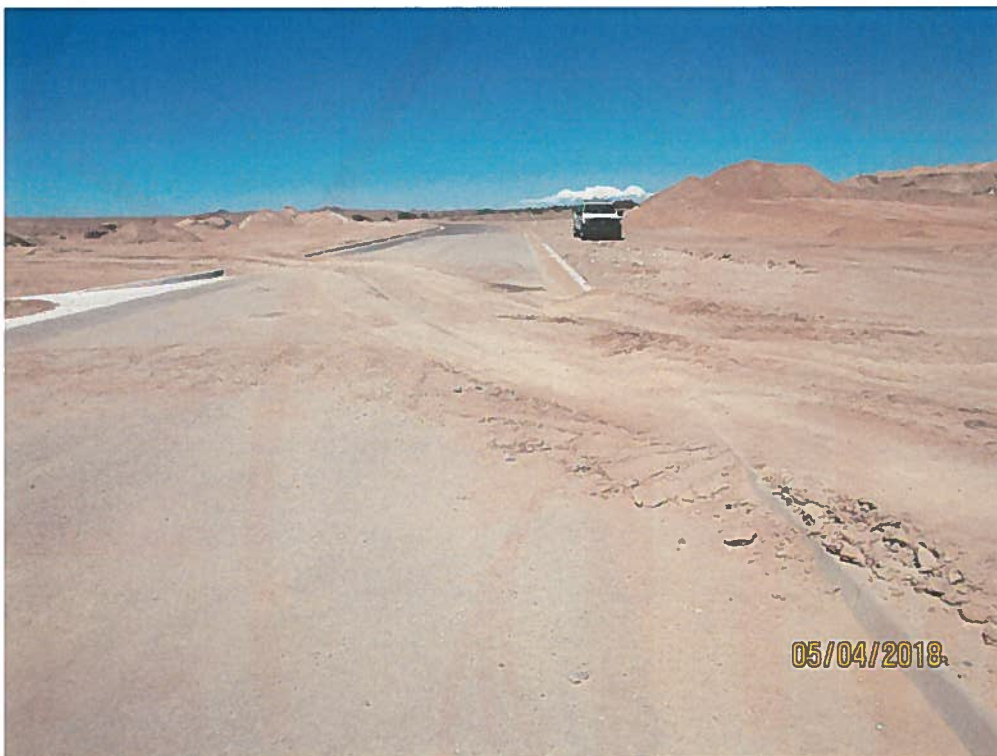
Dirt ramps in Rosa Parks Rd.

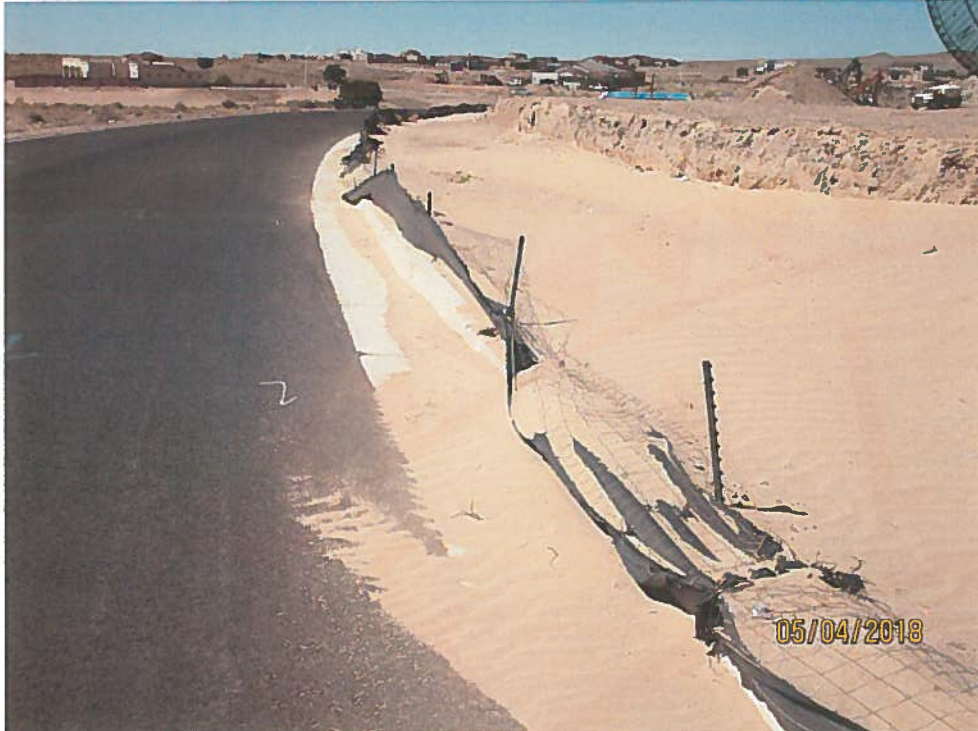
Silt fence in poor condition and sediment in Kimmick Dr.

3. Provide vehicle tracking control for vehicles transporting material across Rosa Parks Rd.
4. Maintain/replace the silt fence along Kimmick Dr. per the approved Erosion and Sediment Control (ESC) Plan. Silt fence are to be kept in operable condition.

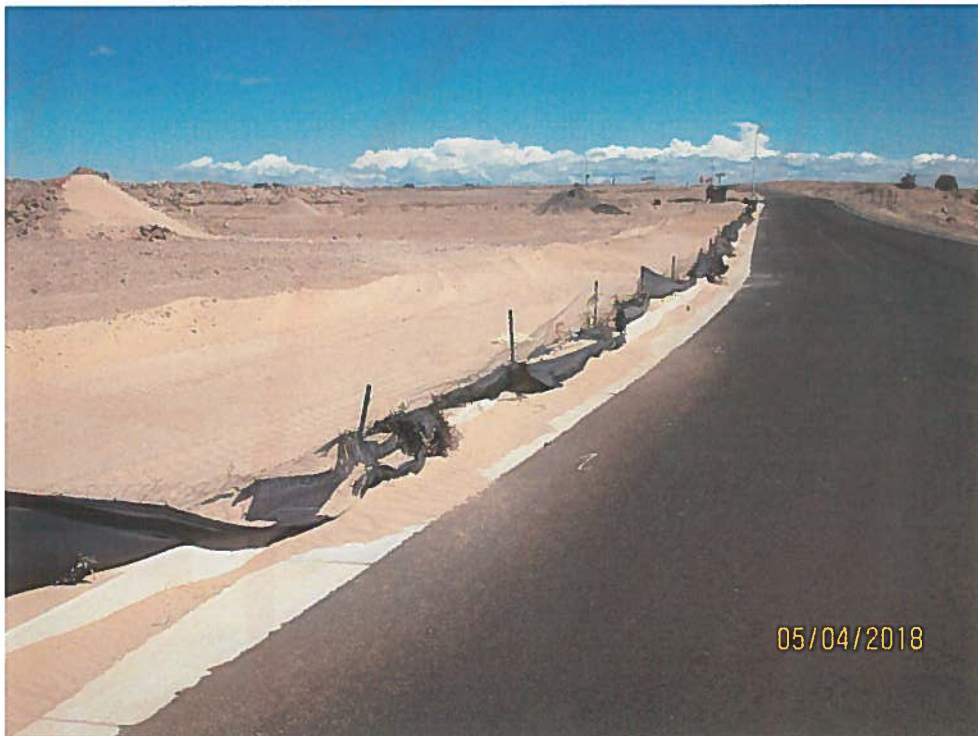
Silt fence in poor condition and sediment in Kimmick Dr.

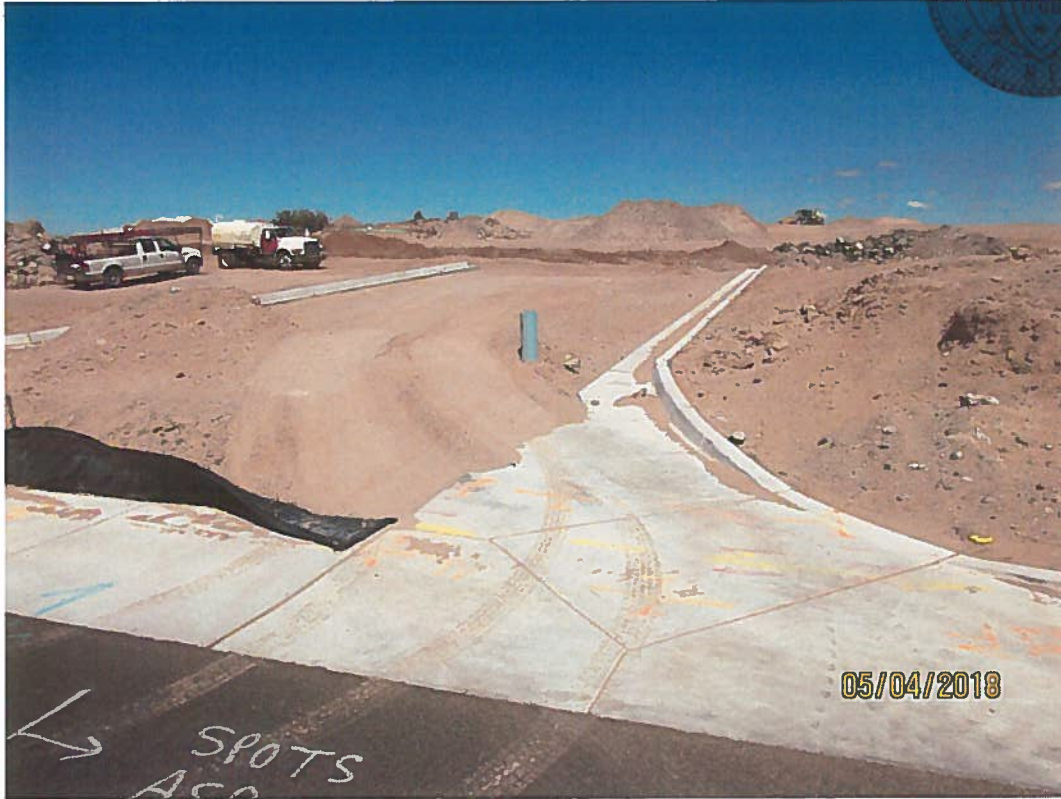
Workers exiting the site without vehicle tracking control. Sediment BMP required.

5. If workers are going to exit the site on Red Root St., then vehicle tracking control is required per the approved ESC plan.
6. A sediment BMP (e.g. rock bags or mulch sock) is required on the concrete apron at Red Root St.

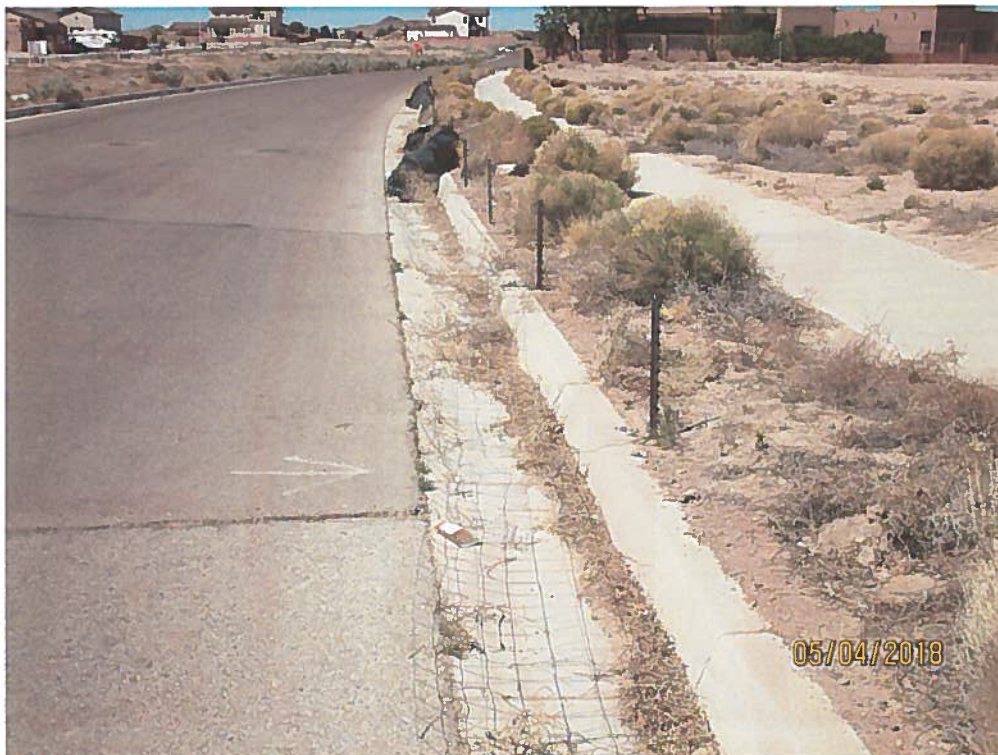
The remains of the silt fence have fallen/blown into the roadway.

7. Remove the fallen/blown over silt fence from the roadway in Kimmick ave. Reinstall per the approved ESC plan.
8. Provide self-inspection reports. Self-inspection reports can be kept on-site, hand-delivered or e-mailed.
