Site: La Cuentista Unit 2 (D10E002B)

Re: Violations for Erosion and Sediment Control Drainage Ordinance (14-5-2-1)

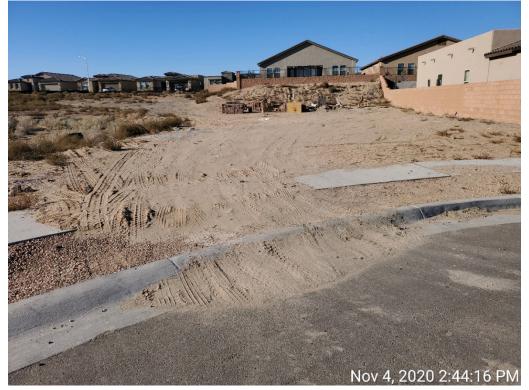
1. Concrete washout was still on the ground on Tract 1 and sediment was still on the street and sidewalk in front of Tract 1. Tract 1, still owned by Double M Properties, is being used as a staging area by Aspen Masonry, a subcontractor for DR Horton Inc.

- 1. Direct wash water from concrete, paint, and stucco into a leak-proof container per CGP 2.3.4. Remove and dispose of hardened concrete with other waste in per CGP 2.2.3.
