BENCHMARK INFORMATION			
CP-13, #5 REBAR WITH PLASTIC CAP STAMPED			
"LARKIN GROUP CONTROL POINT",			
N=1755477.38, E=1723118.79			
ELEV.=6337.27, NAVD 1988			
SEPTEMBER 26, 2011			
IISA - INDOOR SOCCER ARENA ALBUQUERQUE, NEW MEXICO			
DETAILS

<b>LARKIN GROUP</b> NM, INC. CONSULTING ENGINEERS AND SURVEYORS 8500 MENAUL BLVD. NE, SUITE A-440 ALBUQUERQUE, NEW MEXICO 87112 505-275-7500, FAX 505-275-0748 www.larkinmm.com			
PROJECT NO.: 2011-0007	DRAWN: KW	CHECKED: JC	DATE: SEPT. 2011
SHEET: C-103

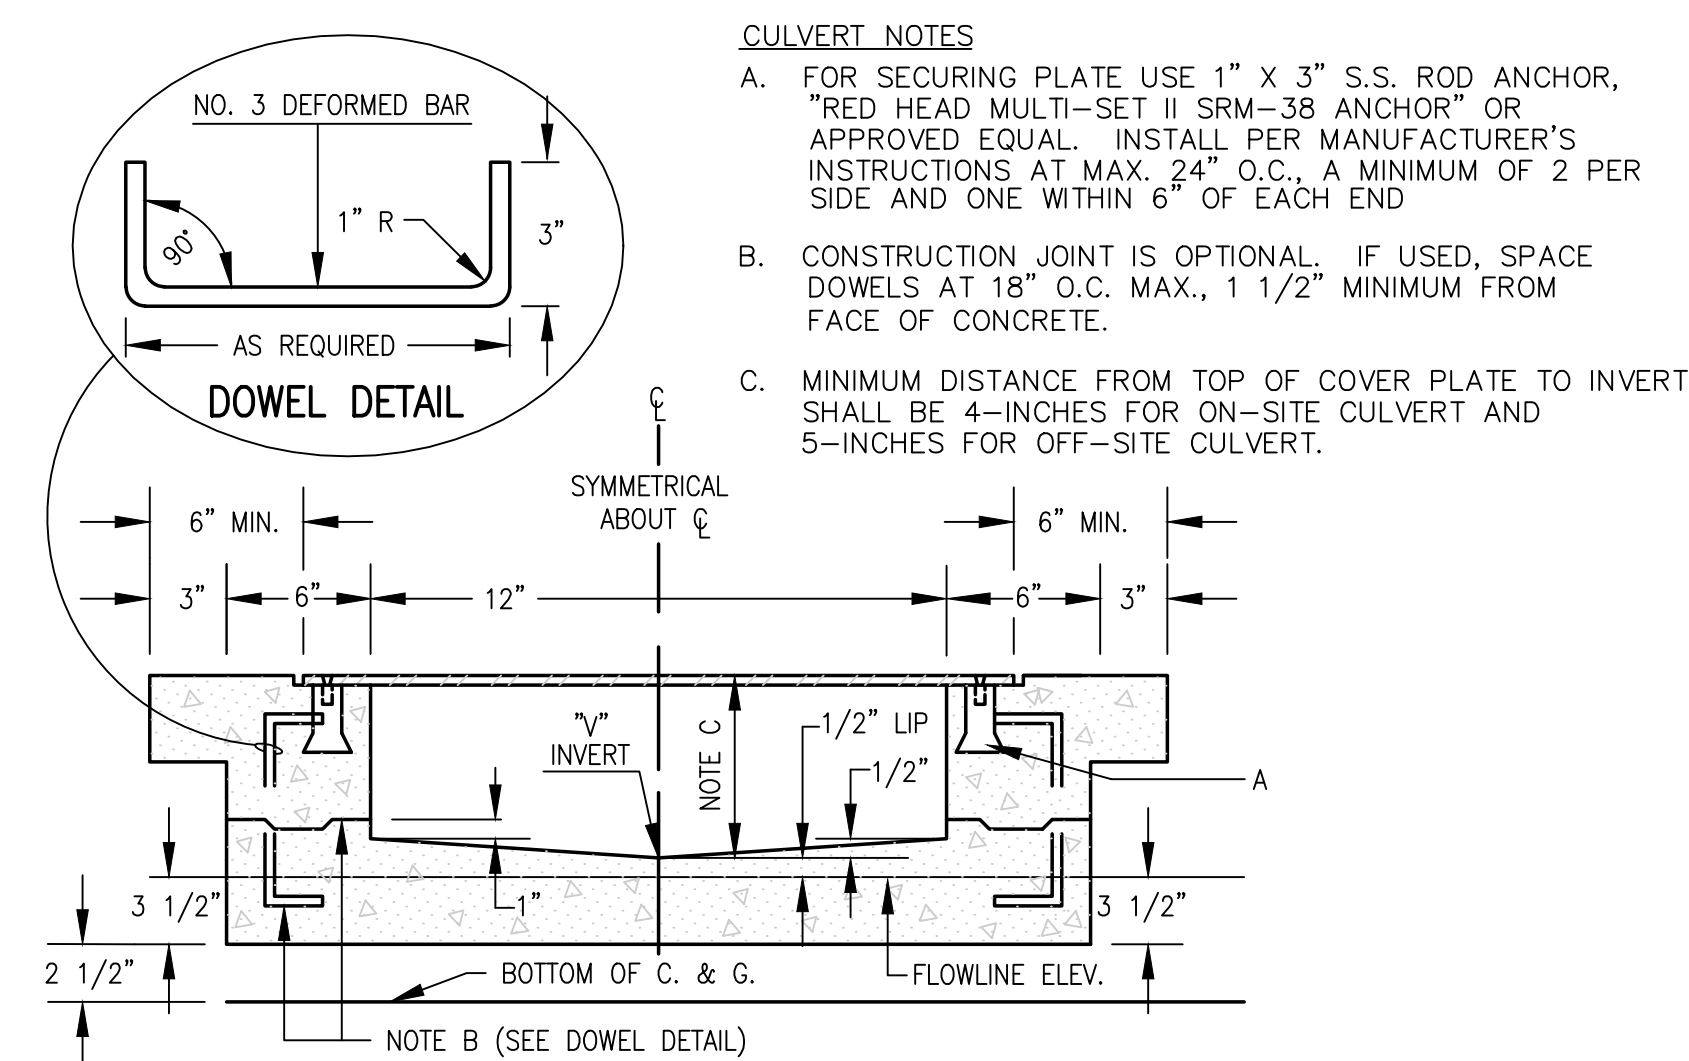
⑬ ON-SITE SIDEWALK CULVERT  
SCALE: NONE

NOTE:  
OFF-SITE SIDEWALK CULVERT MUST BE CONSTRUCTED IN ACCORDANCE WITH THE LATEST EDITION OF COA STANDARD DRAWING 2236. PLATES FOR OFF-SITE CULVERTS SHALL NOT BE SECURED AS SHOWN IN THIS DETAIL. REFERENCE DRAWING 2236 REVISED MAY 2011 FOR NEW SECURING PLATE PROCEDURES AND OTHER DETAILS.
