Erosion Sediment Control Plan

Santa Monica Estates Subdivision

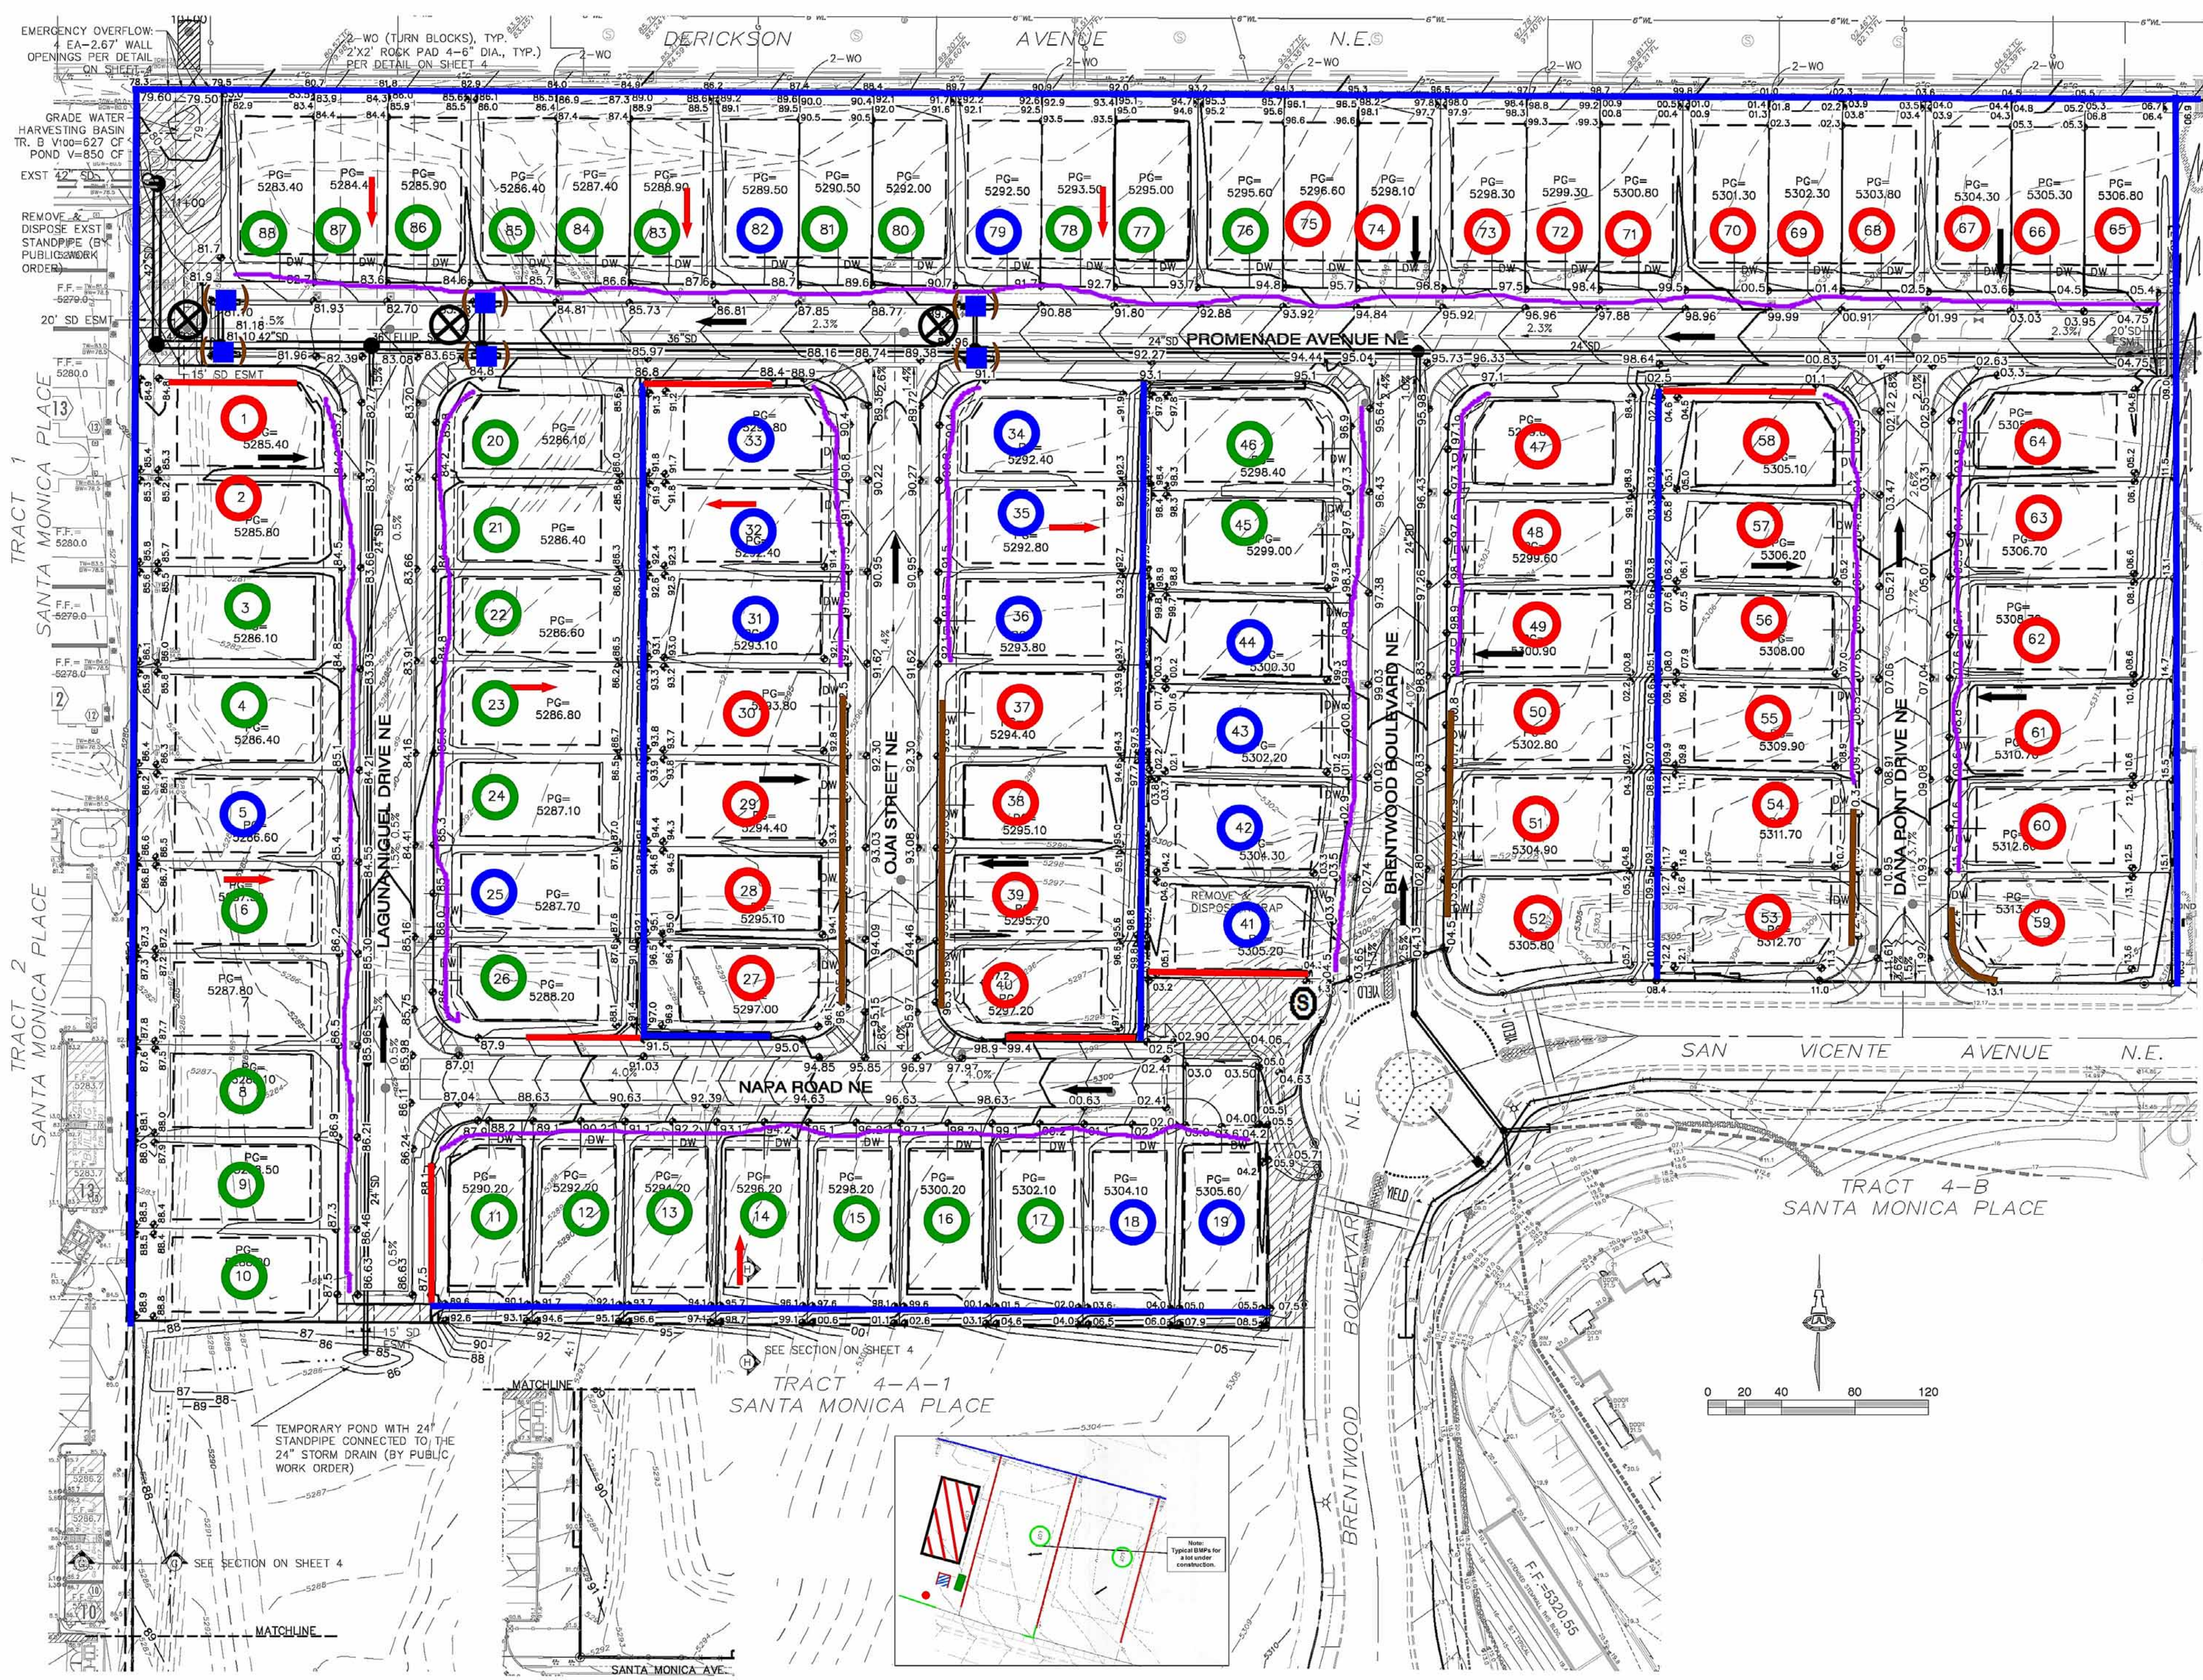
Receiving Waters and Critical Habitat: Rio Grande is located 5.4 miles to the NorthWest.

Impairments: E. coli, Dissolved Oxygen, PCBs in Fish Tissue, Water Temperature

Grade: Before and After 1.5% to 4%
