## Erosion Sediment Control Plan

**Andalucia - Building Shells E, F, G  
and Site Work - Phase II**

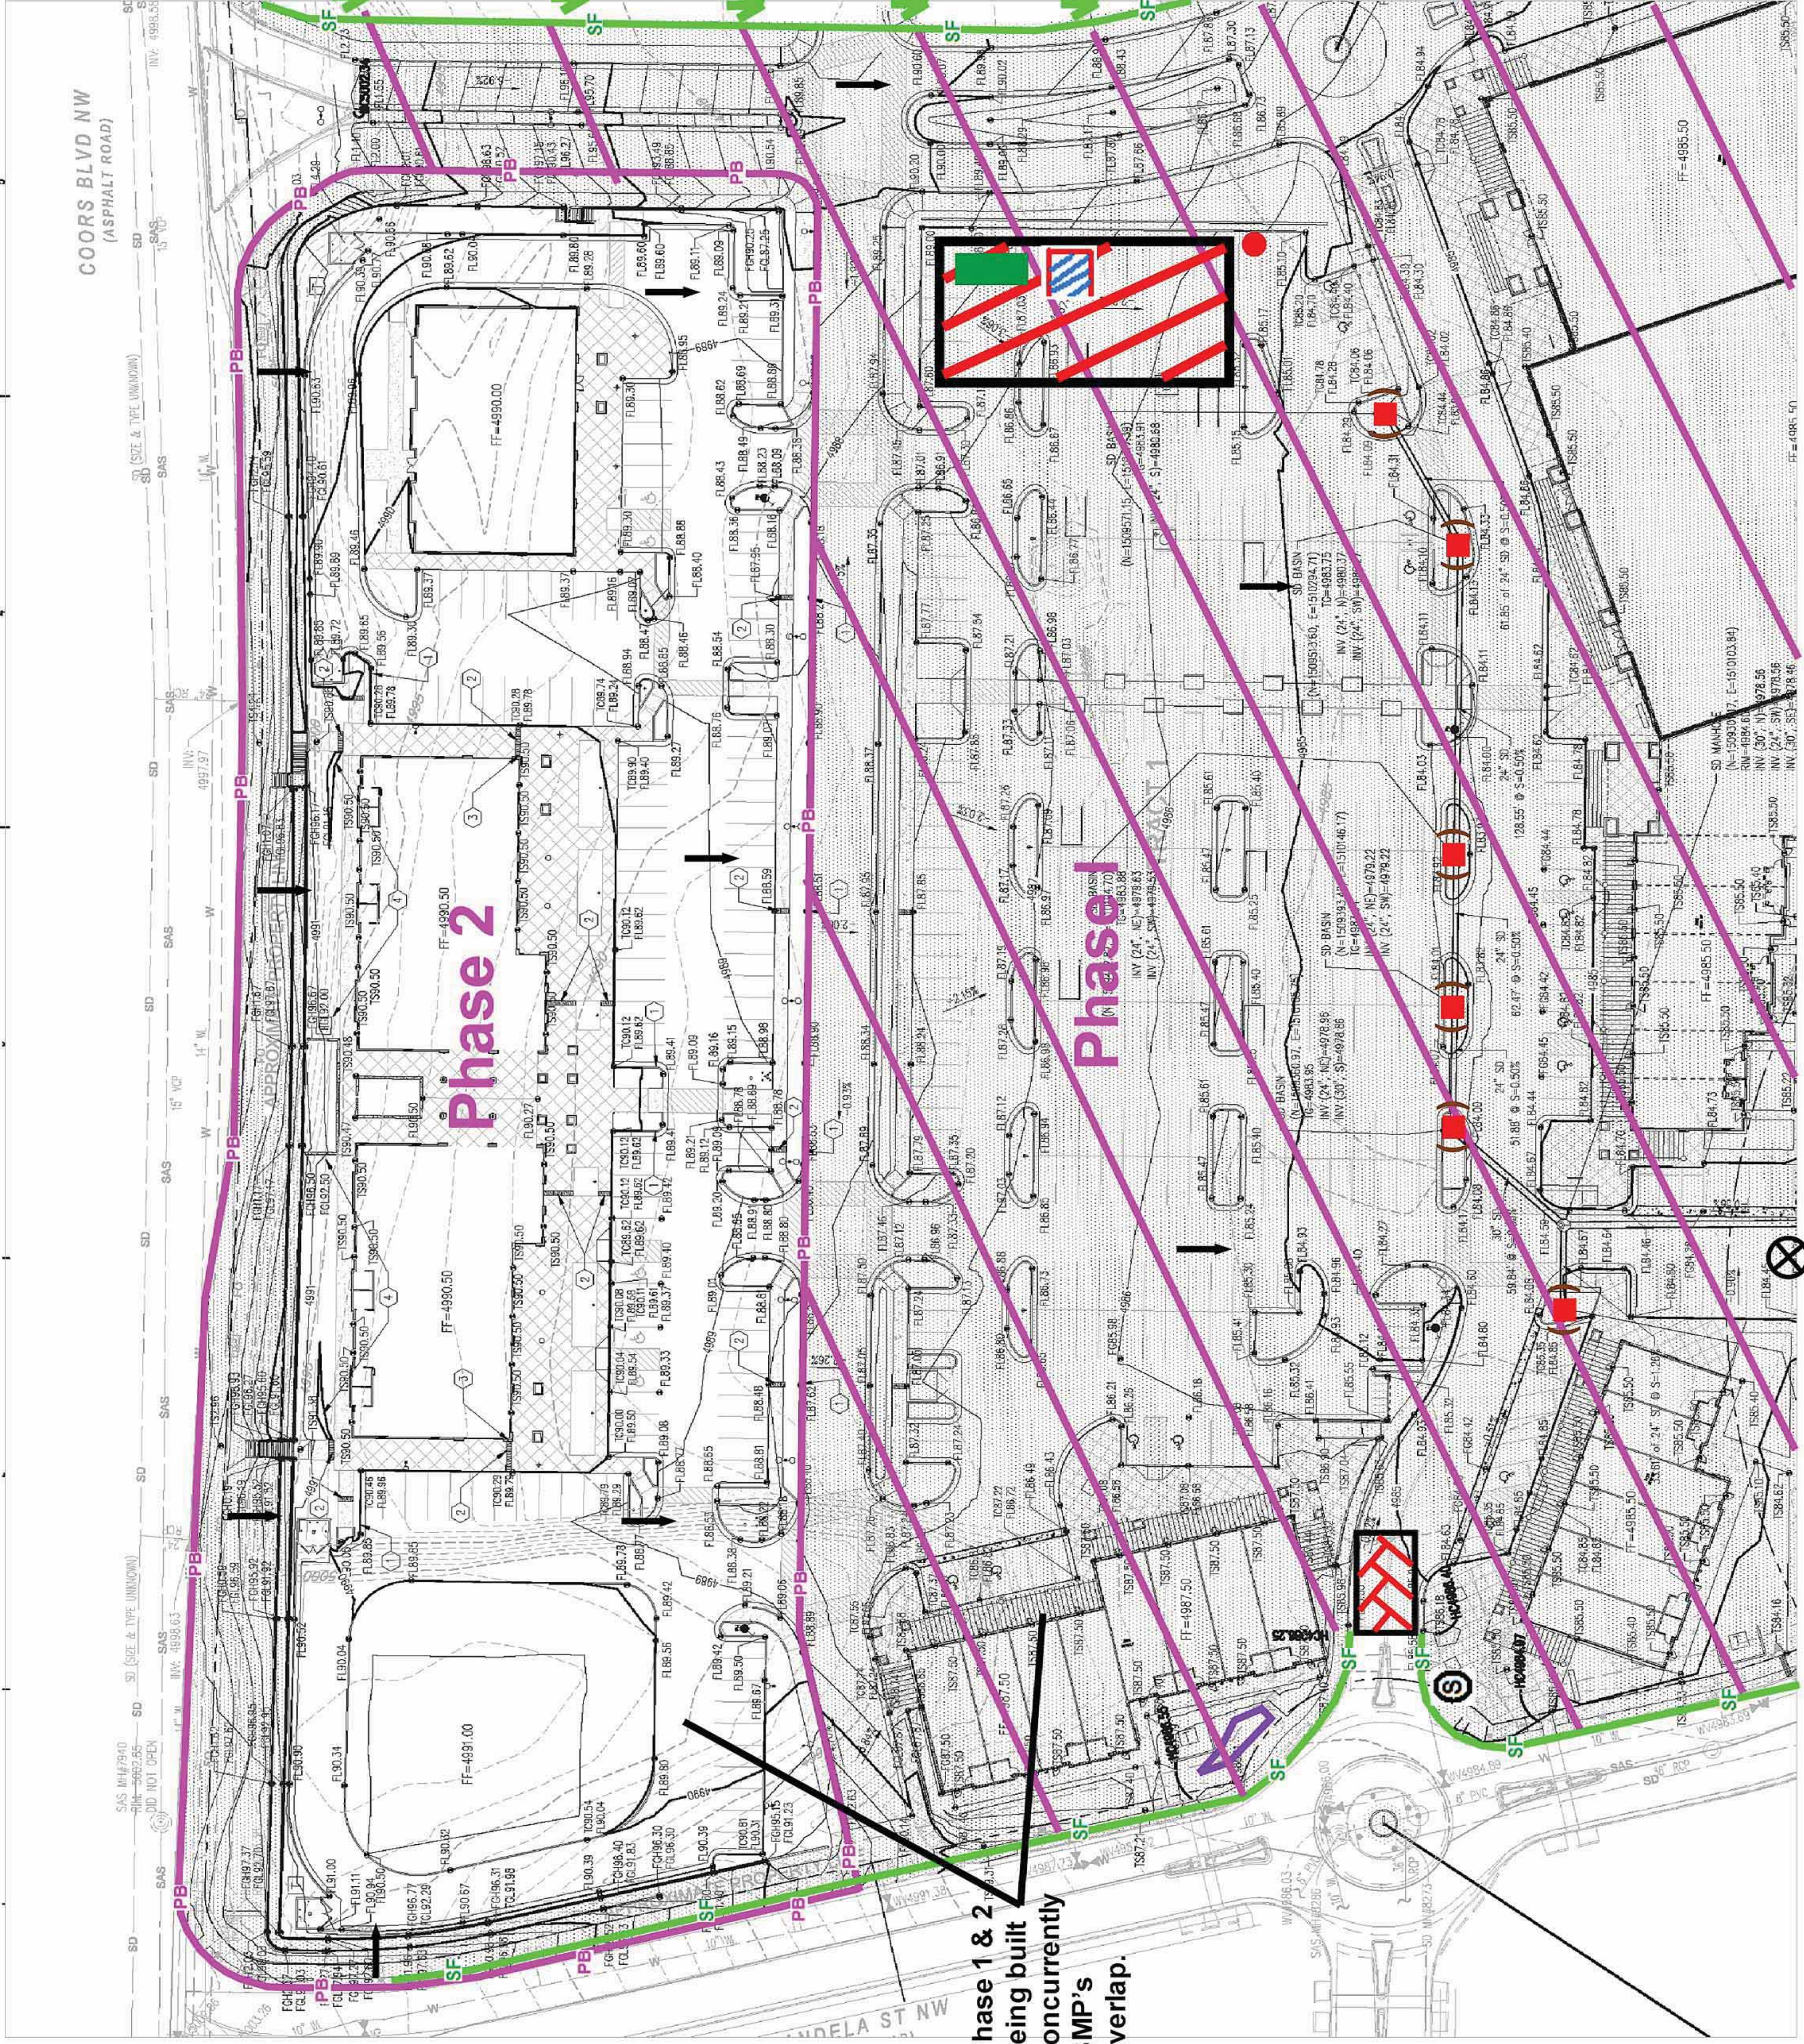
**PB** Project Perimeter & Disturbed Area

**SF** Silt Fence

Pre Flow & Post Flow

Outfall

Natural Buffer Zone / Maintain Existing Vegetation

Staging Area

Stabilized Construction Entrance

Concrete Washout

Retention Pond

Proposed Storm Inlet - Install protection when the inlet becomes

**Receiving Waters and Critical Habitat:** Rio Grande is located 200 yards to the East.

**Impairments:** E. coli, Dissolved Oxygen, PCBs in Fish Tissue, Water Temperature

**Grade:** Before 2% to 3%    After 1% to 2.5%
