BASIN MAP EXCERPT FROM REPORT  
"DRAINAGE REPORT FOR NORTHTOWN SHOPPING CENTER (MAP #E-19)"  
DATED 4-21-95

Figure 2 Existing Drainage Basin Map

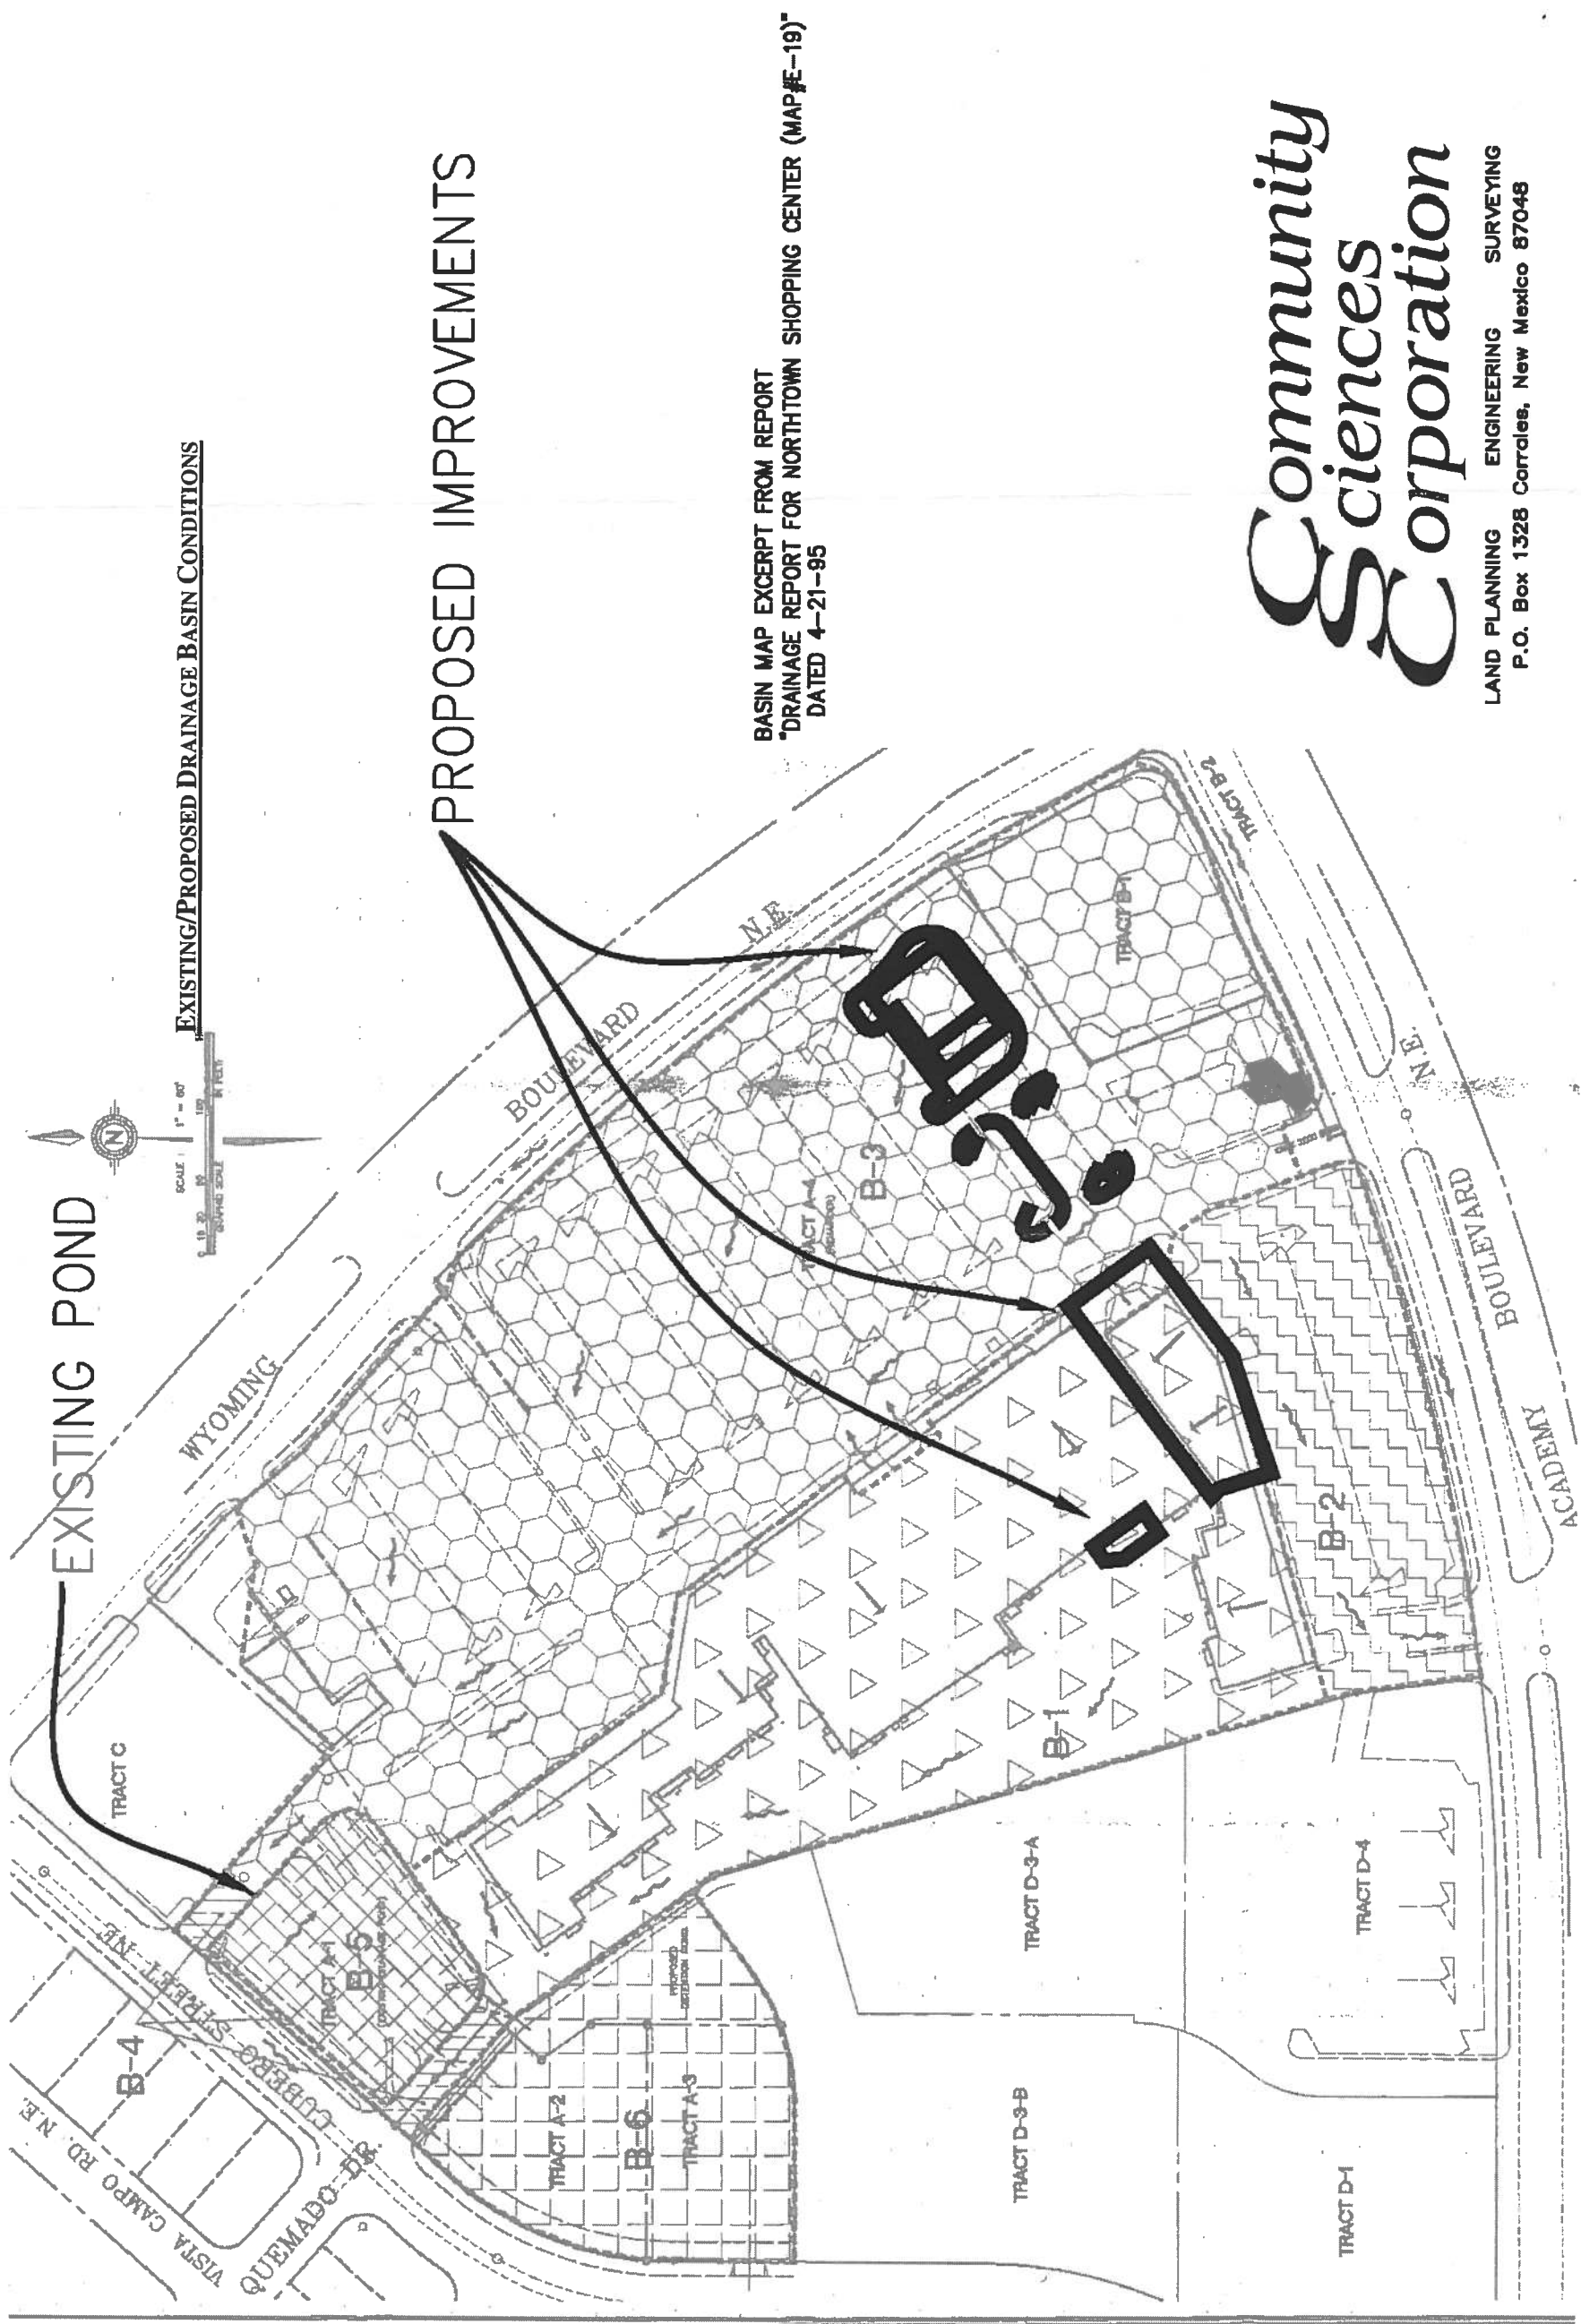
EXISTING/PROPOSED DRAINAGE BASIN CONDITIONS

PROPOSED IMPROVEMENTS

EXISTING POND
