NEW MEXICO STATE PLANE-CENTRAL ZONE

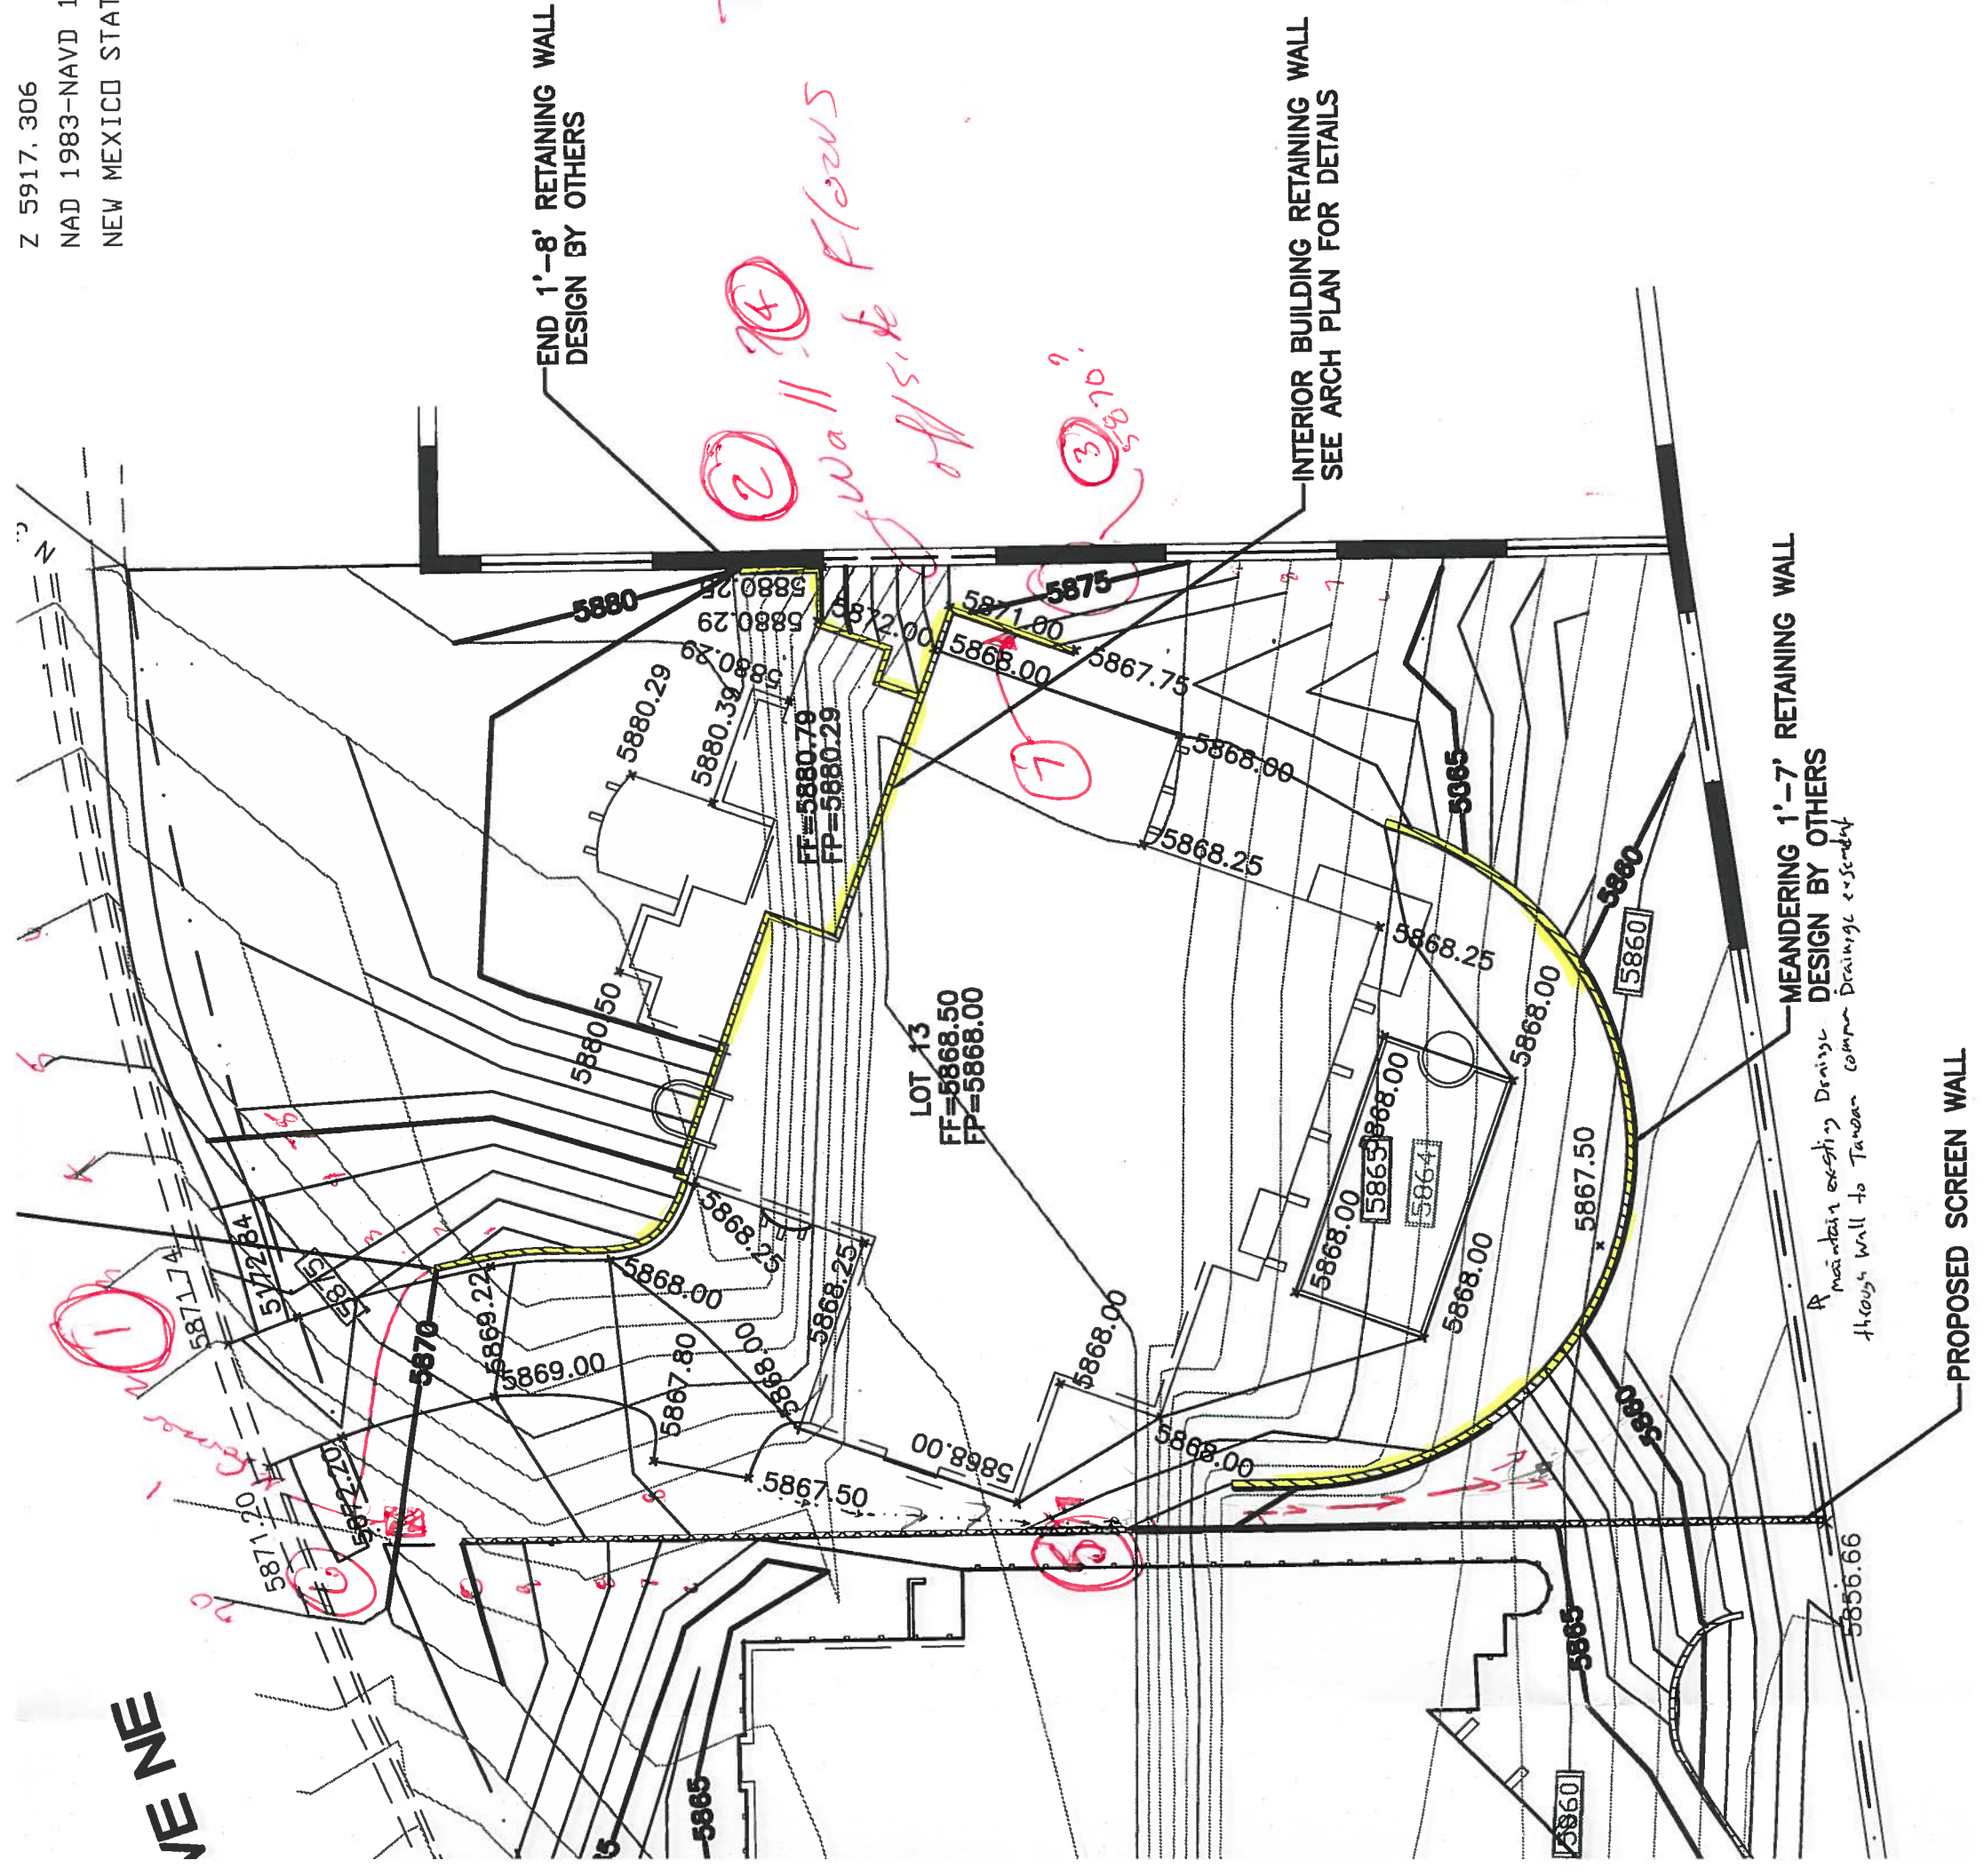
- ① Grades within 2 in fall must slope to road & missing 5875 contour
- ② Clarify Grades and easement at east R. show that will not be too low structures
- ③ 5875 Contour at east appears to be significant
- ④ what is the hearing date east & south R?
- ⑤ Cobble swale sketched R appears to channel (Front yard & driveway) narrow path again which also appears at narrowest point a) check grades for b) provide detail & swale away from driveway
- ⑥ Grading @ NW corner different from that approved recently. 1'-2' cut at a local by a Power Transformer
- ⑦ Drainage toward Back of lot - not side of lot
