CITY OF ALBUQUERQUE

Site: MJ Hospitality, LLC., Self Storage, 1400 Yale Blvd NE

Re: Drainage Ordinance (14-5-2-1) Violations for Erosion and Sediment Control

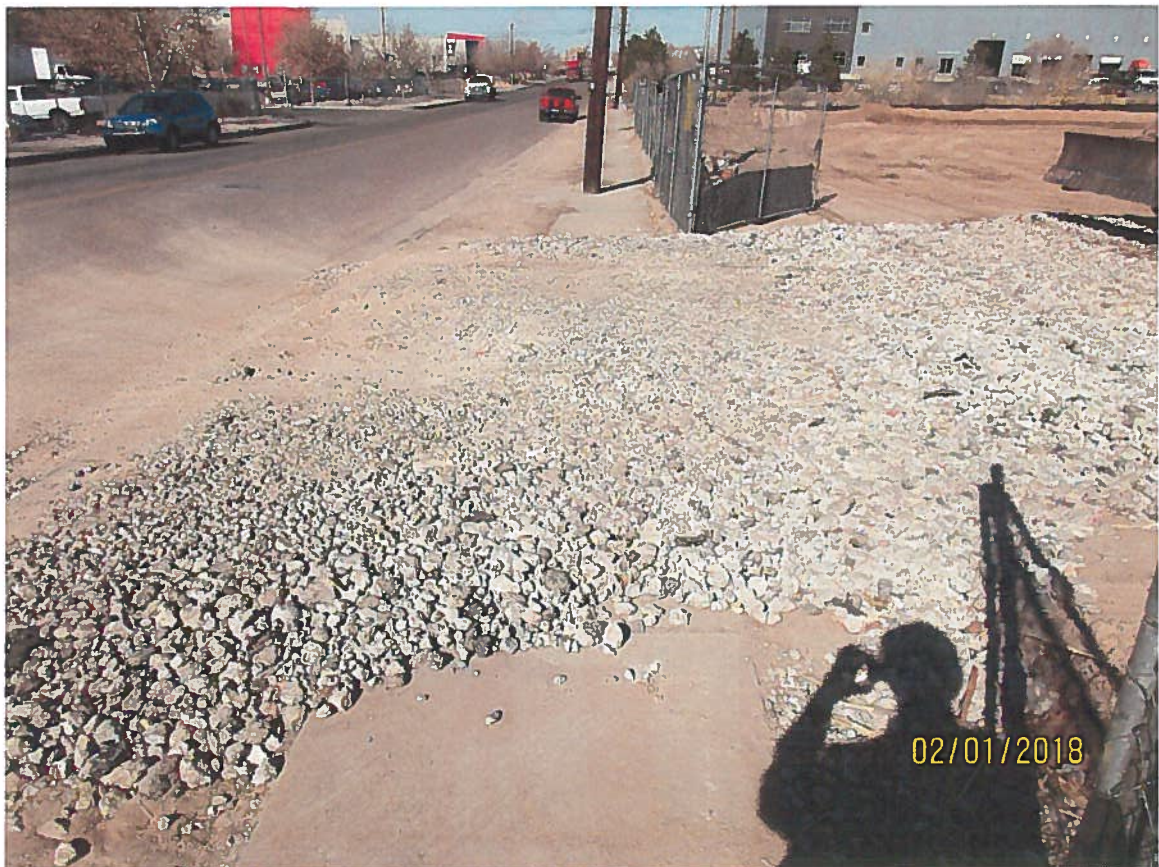
1. The track-out pad/stabilized construction entrance was built over the sidewalk.
2. Dirt and rocks were placed in the gutter pan as a ramp.
3. In one location, the dirt was graded too high against the silt fence which caused a breach and put sediment on the sidewalk.
4. In other locations along the west and north side of the site the grade is too high against the silt fence.

Track-out pad built over the sidewalk.

1. The track-out pad/stabilized construction entrance needs to be re-built so that: there are no rocks on the sidewalk, the rocks should be removed and the grade be cut down behind the sidewalk and between the sidewalk and gutter so that when the aggregate is placed for track-out control the top of the rocks is not higher (approximate) than the sidewalk or curb. This will help prevent rocks from getting onto the sidewalk and falling into the gutter. Filer fabric is to be placed under the aggregate. Filter fabric extends the life of the track-out pad as the aggregate will not get "pushed" into the soil.

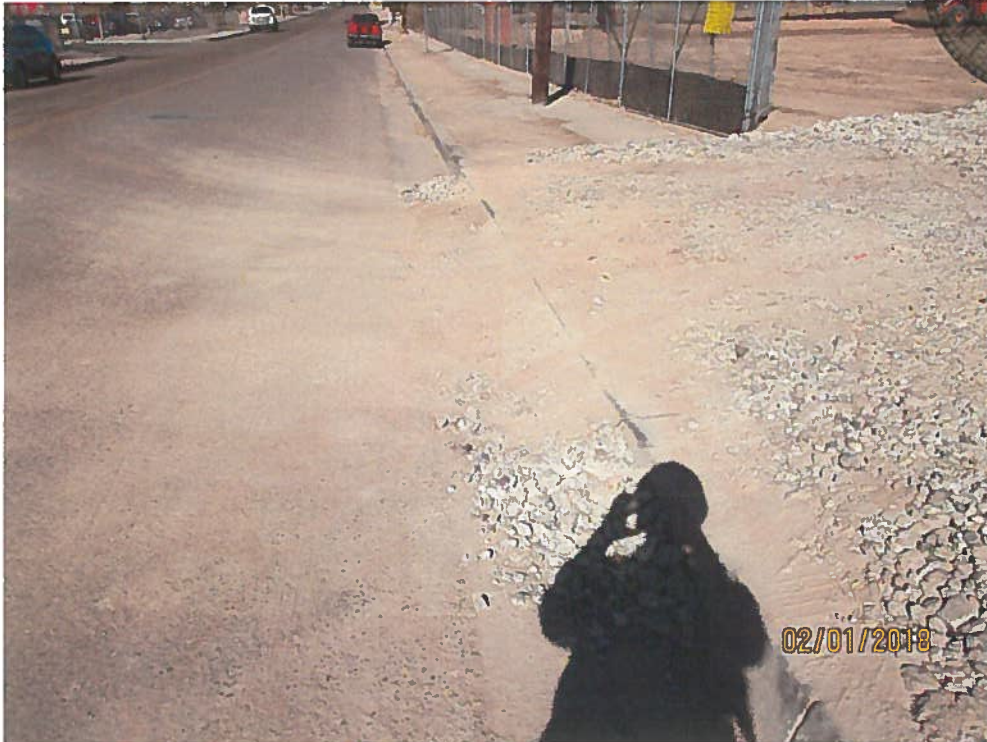
Dirt and rocks in gutter pan. Dirt in the street.

2. Remove the dirt and rocks from the gutter pan where they were used as a ramp. Cold-mix asphalt can be used as a ramp or the curb could be cut (requires permit) since this is the permanent location of your entrance.

3. Remove the dirt from the street.
4. In the location of the silt fence breach, the silt fence is to be repaired and the dirt removed from the sidewalk. The grade is to be lowered adjacent to the silt fence so it is near (1/4 height or less) the bottom of the silt fence.

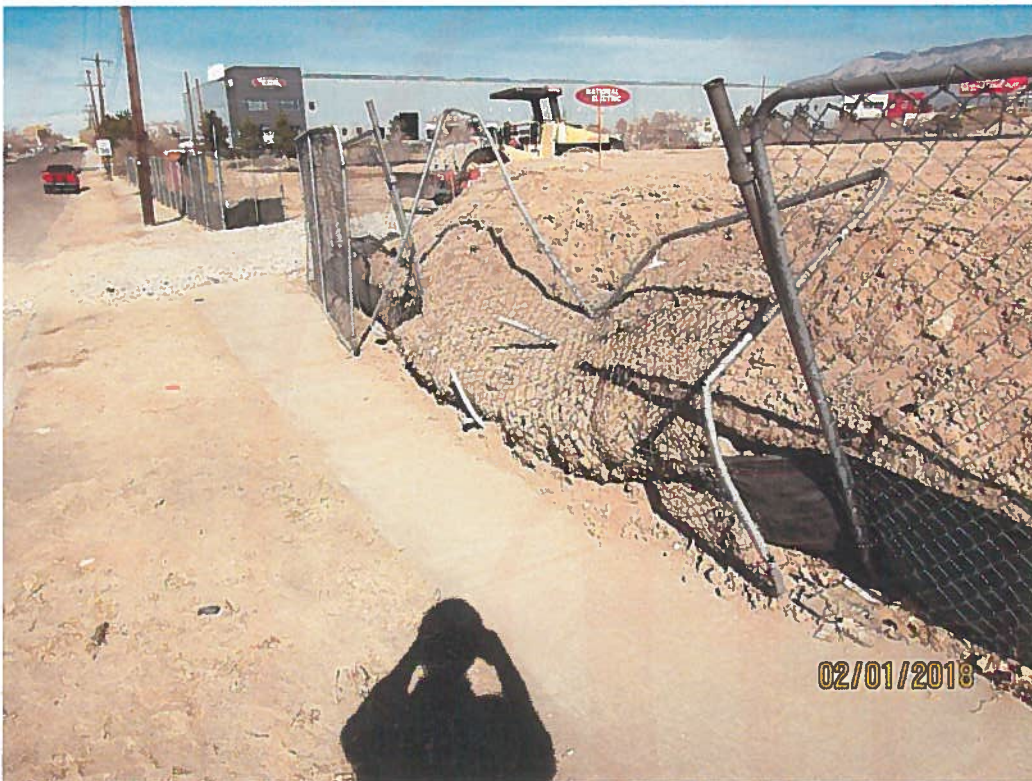
Too much dirt graded against silt fence caused a breach. Sediment on the sidewalk.

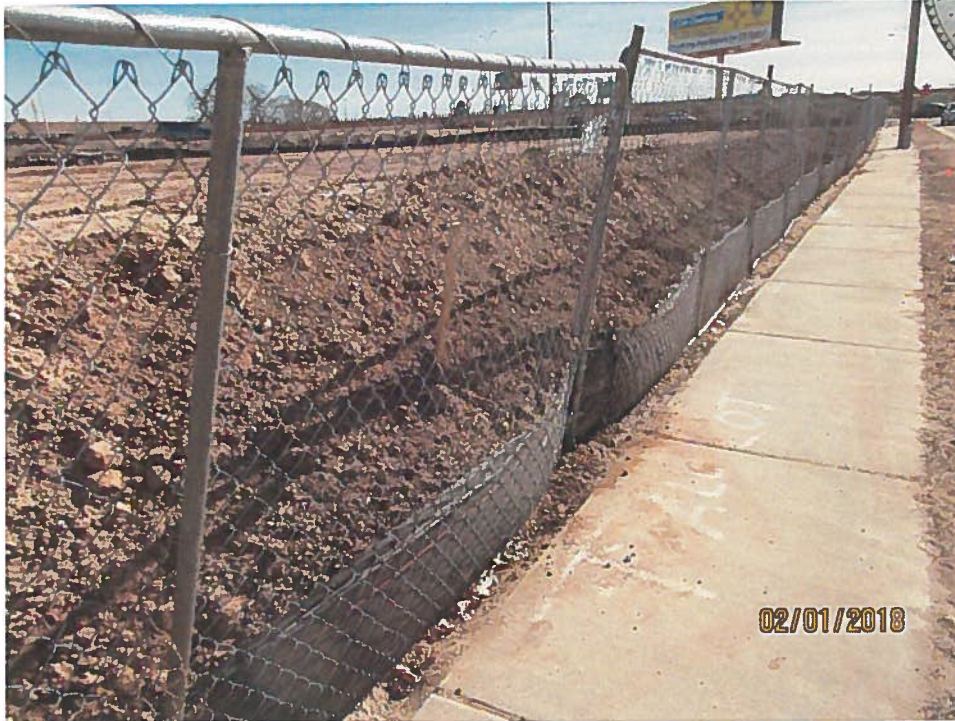
Grade too high against silt fence on west side of the site.

5. In other locations along the west and north side of the site the grade is too high against the silt fence and it is to be lowered adjacent to the silt fence so it is near (1/4 height or less) the bottom of the silt fence

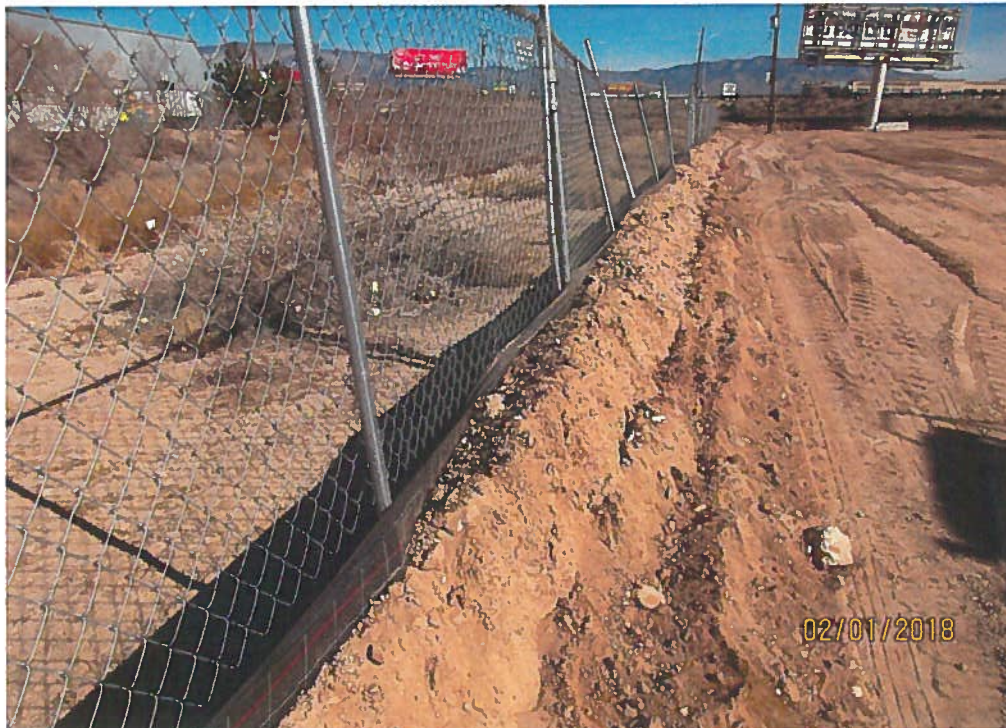
Grade too high against silt fence on north side of the site.
