NATIONAL STORM WATER QUALITY PROGRAM SITE INSPECTION REPORT (SIR)

Community Name:		PulteGroup-MS-1026	PulteGroup-MS-1026:Mirehaven, 9043 Fenton Lake Road NW, Albuquerque, NM 87120 NPDES: NMR1000C1									
		(Include Site Name, Ci	ty, State, Zip Code and NPDES/	Construction Storm Water Perm	it Number)							
Master Site List ID:		369	Inspection performed by: Mario Alderete, Inspector, Green Globe Environmental									
				(Print N	ame, Company, and Title / Qua	lifications)						
Stages	of Construction:	(check all that apply)	Land Development	Inactive	Vertical Construction	Post-Construction						
			Land and Vertical									
Type of	Inspection:	(check all that apply)	Routine Inspection Other:	Storm-Event Related	Final Site Inspection

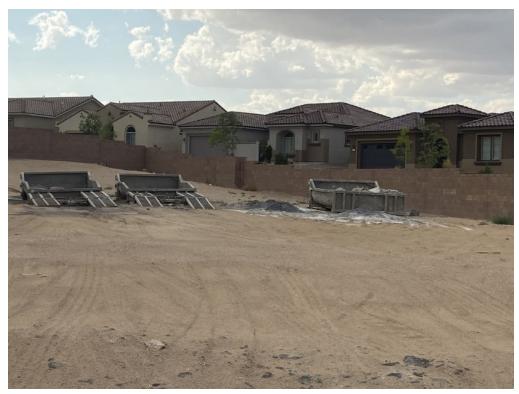
Deficiency Name: Concrete washout lot

$\textbf{Corrective Actions:} \ \ \text{Concrete washout on the ground needs to be cleaned up}$
