Vista Oriente Bldg. 4 4700 2220

TEMPORARY EROSION AND SEDIMENT CONTROL PLAN

PAGE INDEX	
1	TITLE PAGE
2	SWPPP INFO & NOTES
3	DETAILS
4&5	TEMPORARY EROSION CONTROL PLAN
6	SCHEDULE & SWPPP TEAM

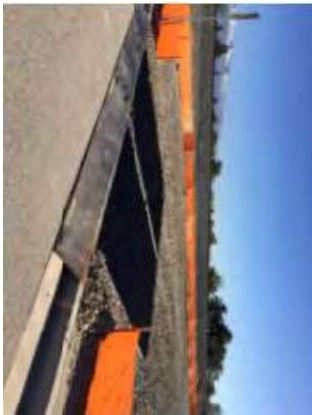
SEDIMENT TRACK OUT CONTROL

BMP Objectives

- Sediment Control

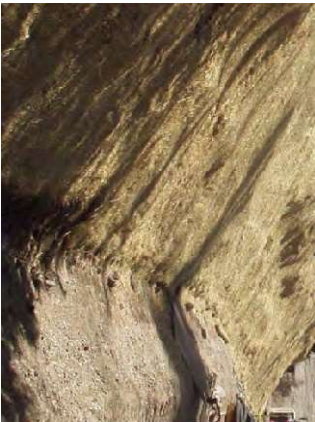
BERRIS AND SWALES

BMP Objectives

- Runoff Control
- Run-on Diversion

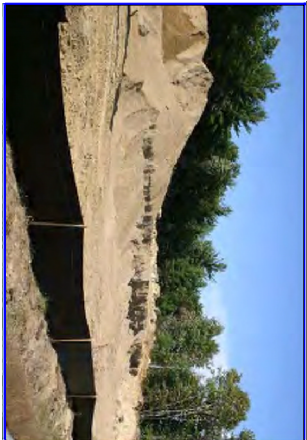
SILT FENCE

BMP Objectives

- Sediment Control
- Sheet Flow Runoff Control
- Wind Erosion Control

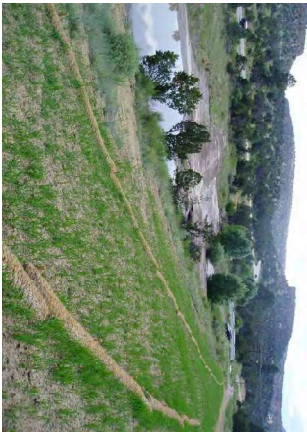
MULCH SOCK/STRAW WATTLE

BMP Objectives

- Sediment Control
- Reduce Runoff Velocity
- Inlet Protection
