# Marble Arno LOMR

## Marble Arno LOMR Field Work - Roma Ave, Commercial St and Marquette Ave

| Project Number | 04270.0005 |
| Date | April 13, 2023 |

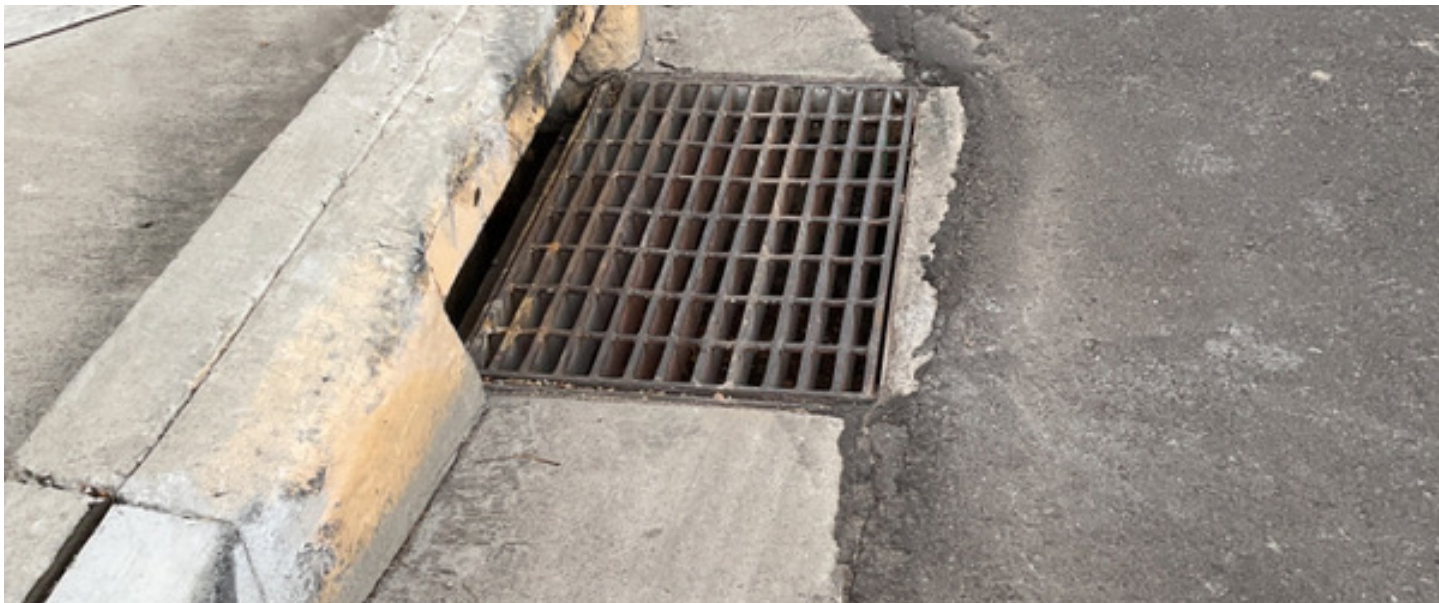
| Inlet ID | Roma and Spur and Commercial inlets. |
| Type of Inlet | COA Type Single A w/o curb throat (5). (4) Type double grate C inlet w/o curb throat. (1) median grate w/o curb opening. |
| Dimensions of grate | Single: 40" grate x 26". Double 82" x 26". Median 81" x 25". |
| Clogged? | Yes |
| Percent Clogged | 20% on 1. 75% on 1 inlet. |
| Inlet condition | Good. |

| Recommendation | N/A |

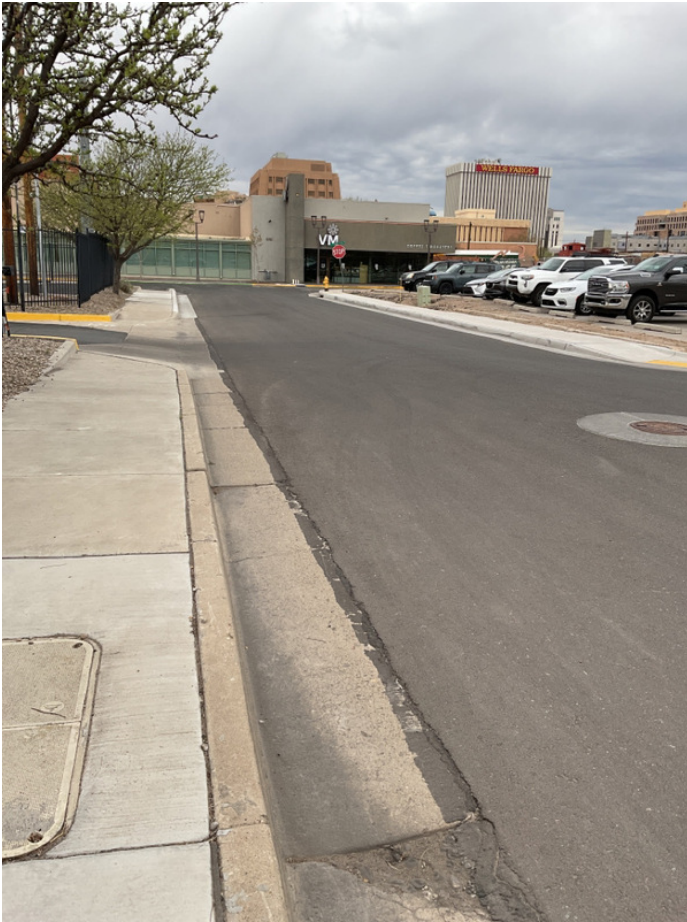
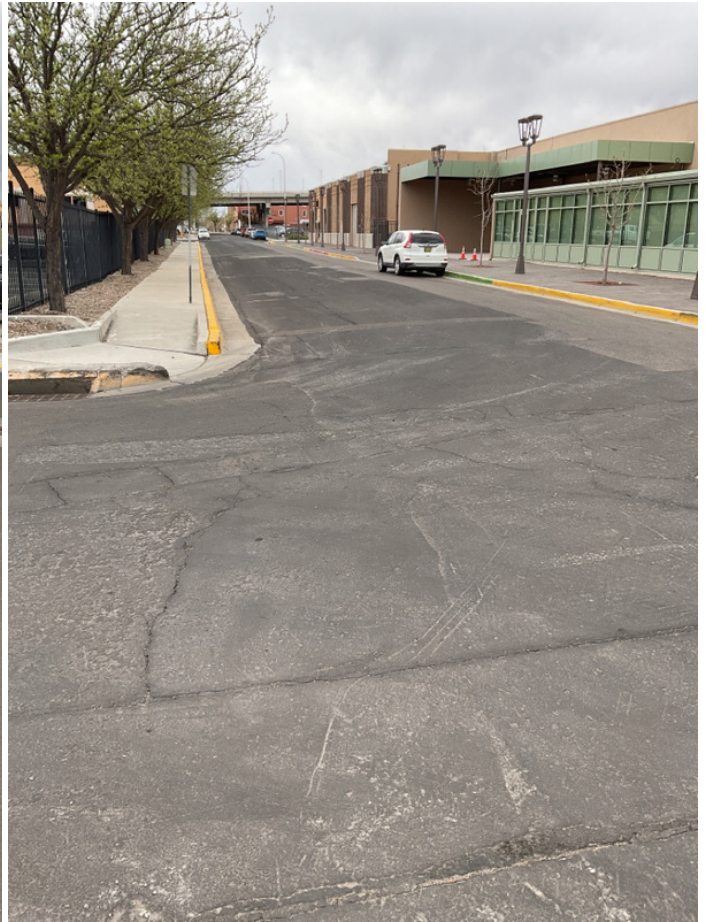
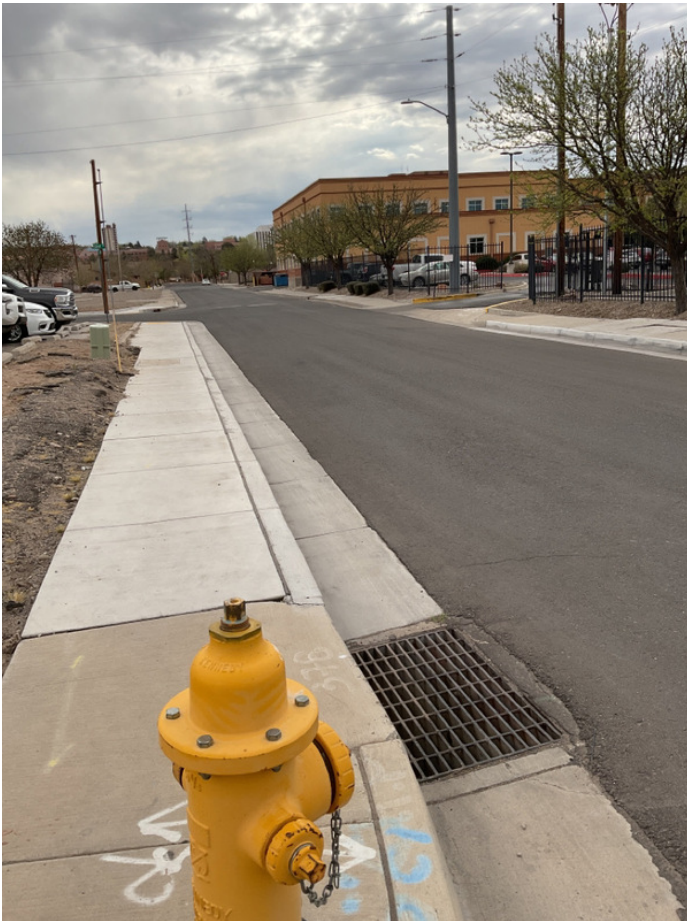
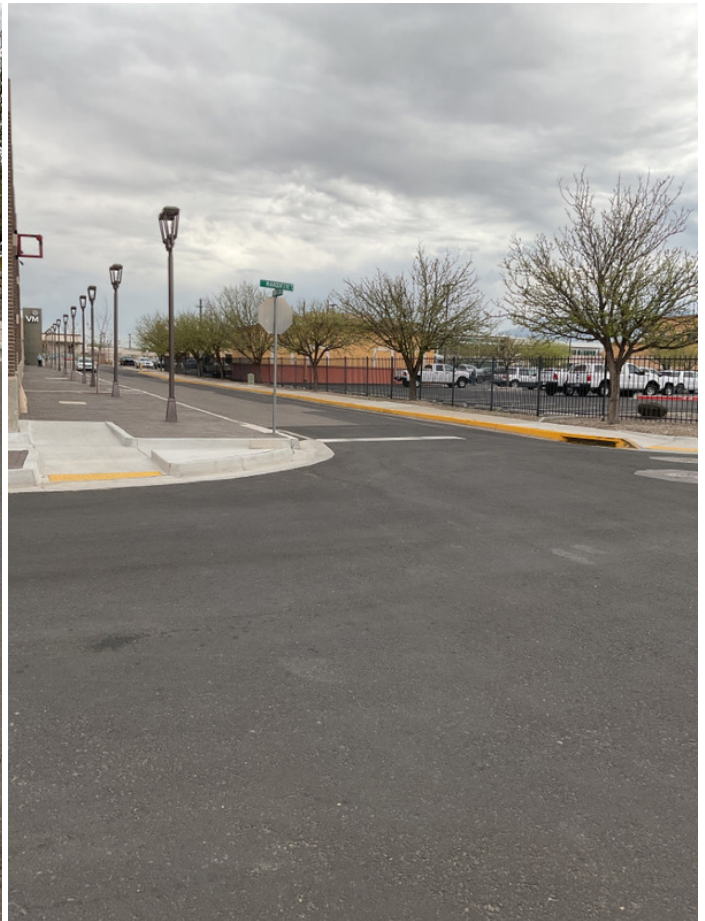
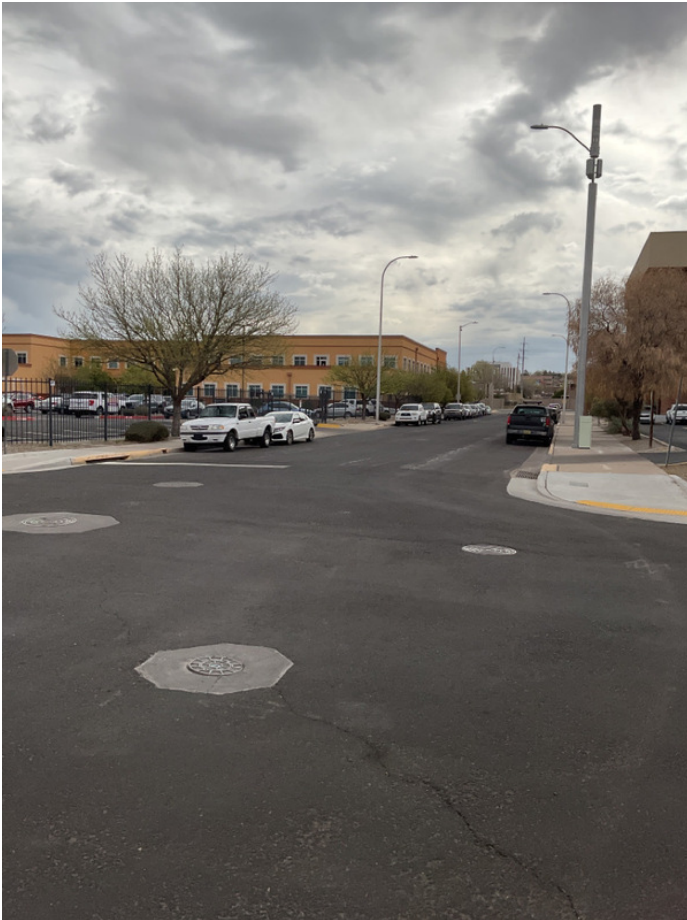
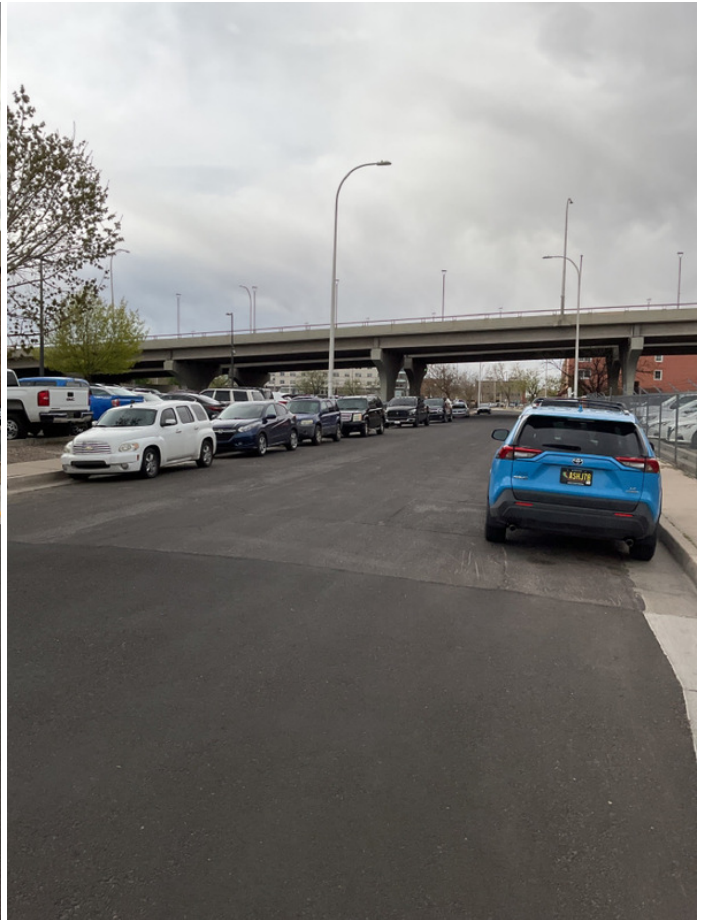
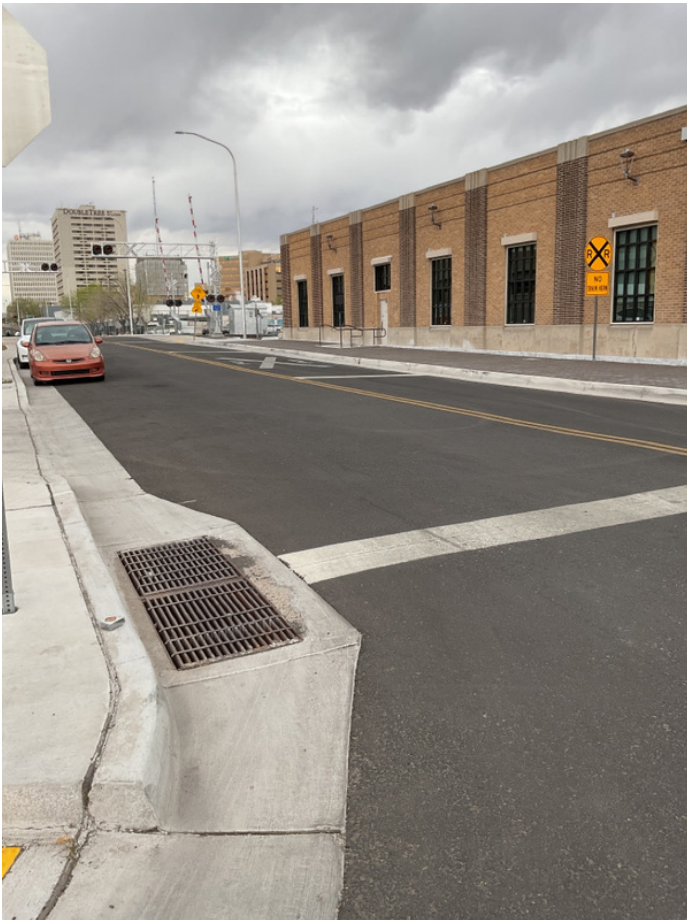
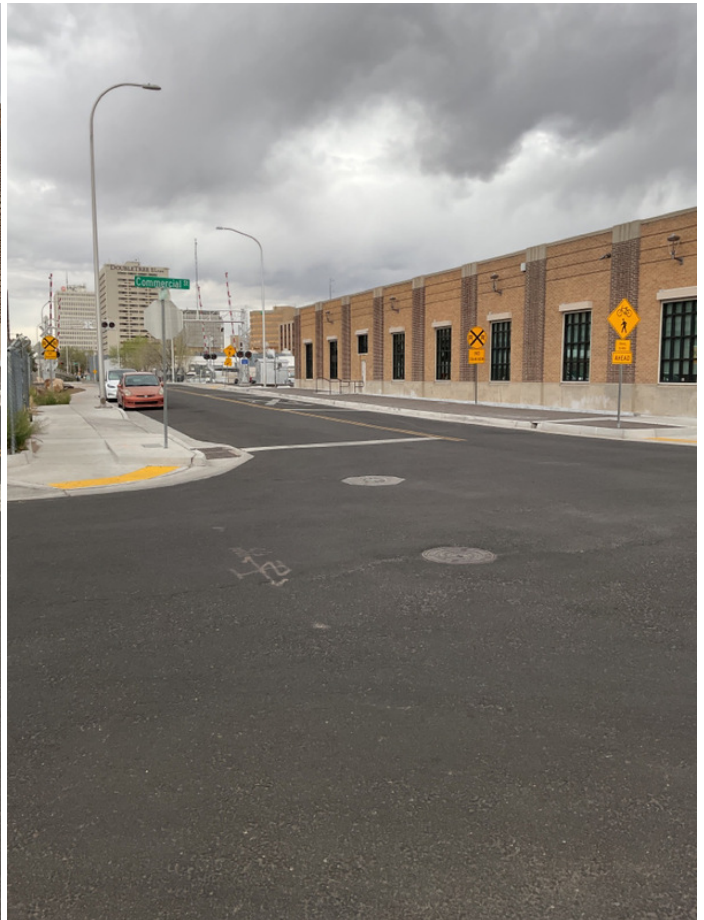
General Field Photos

Walked on Spur for inlets and roadway profiles.
