CITY OF ALBUQUERQUE

Sites: Nu Vue at 1171 Jaffa Rd NE (J20E028)

Re: Drainage Ordinance (14-5-2-11) Violations for Erosion and Sediment Control

The city conducted a fourth ESC Inspection today, 3/27/24, as a follow-up to the first three inspections, which were conducted on 2/27/24, 3/7/24, and 3/20/24. The following violations were identified at the time of this fourth inspection.

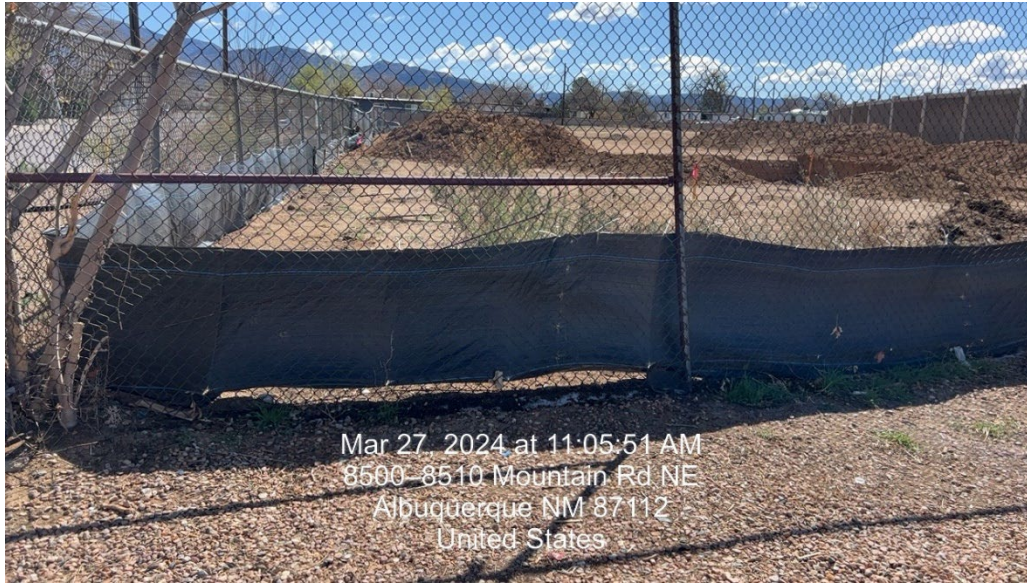
2. The BMPs were not installed properly. The Silt fence had a big gap at the bottom and wasn't embedded in Violation of CGP 2.1 and CGP 2.2.3.

2. Ensure that all stormwater controls (BMPs) are maintained and remain in effective operating condition during permit coverage per CGP 2.1.4. If at any time you find that a stormwater control needs routine Maintenance, you must immediately initiate the needed maintenance work and complete such work by the close of the next business day. When the problem requires a new or replacement control or significant repair, install the new or modified control and make it operational or complete the repair by no later than seven (7) calendar days from the time of discovery per CGP 5.2.1.
