Stormwater Construction Site Inspection Report

General Infor	mation				
Project Name	Mr. Carwash					
NPDES Tracking No.	NMR1002N8/NMR1002LG	Los Ranchos and RR Tracks				
Date of Inspection	8-11-20	Start/End Time	4:30-5:00			
Inspector's Name(s)	Brad Frosch					
Inspector's Title(s)	SWPPP Compliance Inspect	or				
Inspector's Contact Information	bfrosch@tierrawestllc.com	505 263-5808				
Inspector's Qualifications	Qualified SWPPP Preparer and Inspector of Stormwater Controls					
Describe present phase of construction	SWPPP Compliance Inspection- Foundation Start					
Type of Inspection: X Regular ☐ Pre-storm event ☐	During storm event Post		Day Follow Up- Initial BMP Inspection			
Has there been a storm event since						
Reporting Weather Station- Onsite Storm Start Date & Time: Storm Du Approximate Amount of Precipitati	gauge ration (hrs):	XXX				
Weather at time of this inspection	?					
X Clear						
Have any discharges occurred since	e the last inspection?	X No

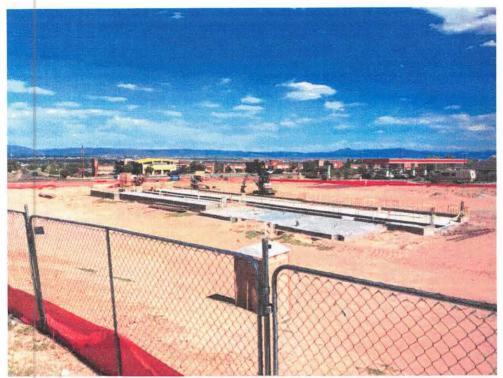
Site Active

BMP/activity	Implemented?	Maintenance Required?	Corrective Action Needed and Notes
1	Are all slopes and disturbed areas not actively being worked properly stabilized?	☐ Yes X No	X Yes □No	Minor site work has restarted. Pond area and slopes should have temporary erosion controls installed
2	Are natural resource areas (e.g., streams, wetlands, mature trees, etc.) protected with barriers or similar BMPs?	Yes No	☐ Yes ☐No	Currently not required
3	Are perimeter controls and sediment barriers adequately installed (keyed into substrate) and maintained?	X Yes □ No	X Yes • No	Bury silt fencing 6" below grade along the 98th St frontage
4	Are discharge points and receiving waters free of any sediment deposits?	X Yes 🗖 No	☐ Yes X No	No evidence of any discharges were observed
5	Are storm drain inlets properly protected?	☐ Yes ☐ No	X Yes No	Inlet protection at the east end of Volcano needs to be cleared of sediment build up and replace control

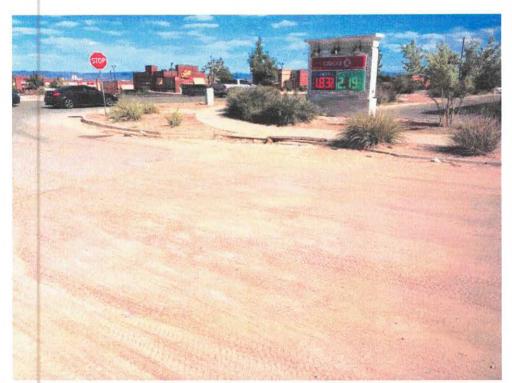
Inlet Protection

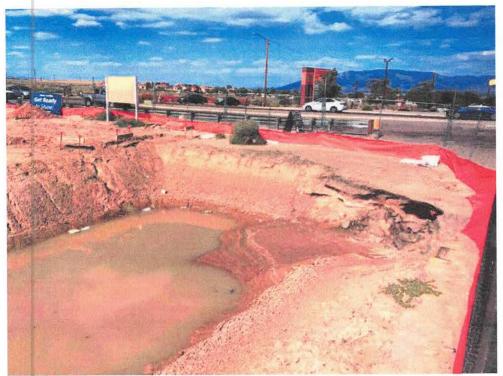
Sediment Trap

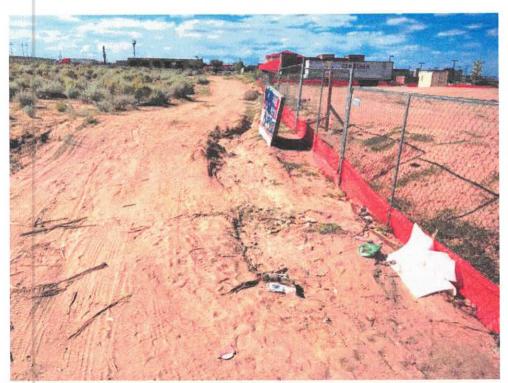
Offsite By-pass

BMP	BMP Installed?	BMP Maintenance Required?	Corrective Action Needed and Notes
4	Sediment Basins/Off- Site run on/by-pass	X Yes □No	X Yes □No	Add erosion control waddle or check dam to the offsite run on from the west. The offsite run appears to transfer sediment and prevents run off from entering the inlet, causing the onsite sediment trap to fill with runoff and sediment from the upstream basin and roadway.
5	Contractor Support Area	X Yes 🗖 No	☐ Yes X No	New location is noted on ESC plan. Insure any potential chemicals or materials are protected from precipitation while in storage.
6	Inlet Protection	X Yes 🗆 No	X Yes □No	Inlet protection at the east end of Volcano needs to be cleared of sediment build up and replace control
7	Other SWPPP Book ESC Plan	X Yes 🗖 No	☐ Yes X No	SWPPP Book was unavailable for review

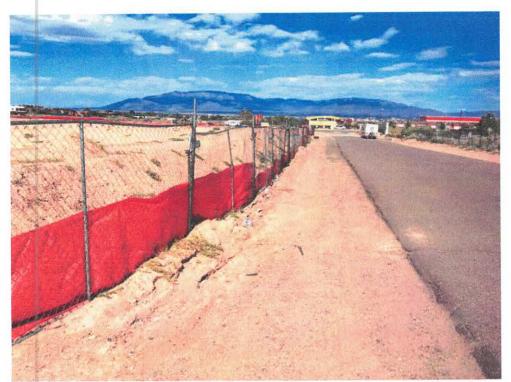
Trash Accumulation from Other Sources

BMP/activity	Implemented?	Maintenance Required?	Corrective Action Needed and Notes
7	Is trash/litter from work areas collected and placed in covered dumpsters?	☐ Yes X No	X Yes □ No	Offsite trash accumulating from other sources could be attributed to the construction site. A perimeter clean-up is recommended.
8	Are washout facilities (e.g., paint, stucco, concrete) available, clearly marked, and maintained?	X Yes 🗖 No	X Yes □ No	Remove, dispose and re-establish or have vendor supplied container
9	Are vehicle and equipment fueling, cleaning, and maintenance areas free of spills, leaks, or any other deleterious material?	X Yes □ No	☐ Yes X No	All fueling and equipment maintenance should be performed in a designated area.
10	Are materials that are potential stormwater contaminants stored inside or under cover?	X Yes No	☐ Yes ☐ No	None Observed
11	Are non-stormwater discharges (e.g., wash water, dewatering) properly controlled?	☐ Yes ☐ No N/A	☐ Yes ☐ No	Currently not required

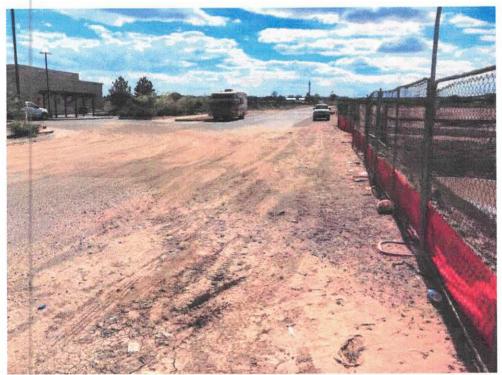
Trash and Sediment on Volcano Rd

6	Is the construction exit preventing sediment from being tracked into the street?	X Yes □ No	☐ Yes X No	Monitor track out sweep clean as necessary.

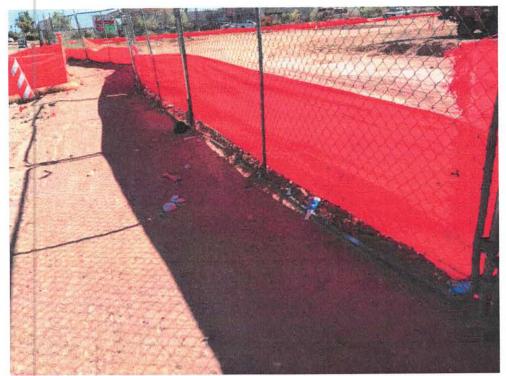
Bury Silt fencing 6" below grade

ВМР	BMP Installed?	BMP Maintenance Required?	Corrective Action Needed and Notes
1	Stabilized Entrance	X Yes 🗖 No	☐ Yes X No	Sweep any track out leaving the site back into the property at the end of each day.
2	SWPPP Board	X Yes 🗖 No	☐ Yes X No	SWPPP Board is in good condition and has contact information posted.
3	Perimeter Controls	X Yes 🗆 No	X Yes □No	Bury silt fencing 6" below grade along the 98th St frontage

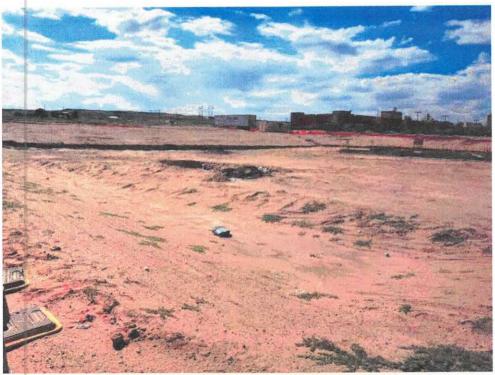
Dispose and Re-establish Concrete Wash Out
