Mercado El Milagro
10,000 Central Avenue SW

TEMPORARY EROSION AND SEDIMENT CONTROL PLAN

PAGE INDEX	
1	TITLE PAGE
2	SWPPP INFO & NOTES
3	DETAILS
4	BMP MAP (1)
5	MAP (1) LEGEND
6	BMP MAP (2)
7	MAP (1) LEGEND
8	CONSTRUCTION SCHEDULE & STORMWATER TEAM

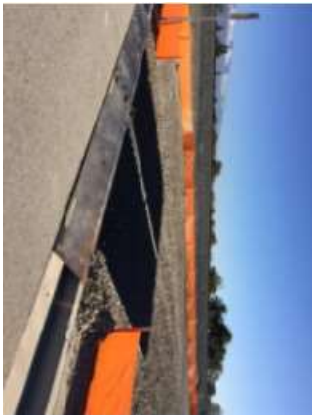
SEDIMENT TRACK OUT CONTROL

- BMP Objectives**
- Sediment Control

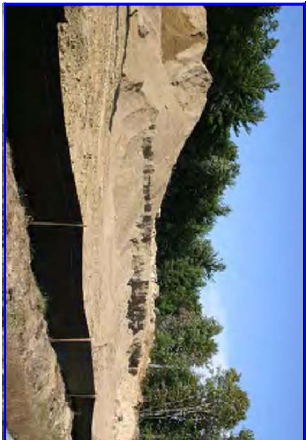
SILT FENCE

- BMP Objectives**
- Sediment Control
 - Sheet Flow Runoff Control
 - Wind Erosion Control

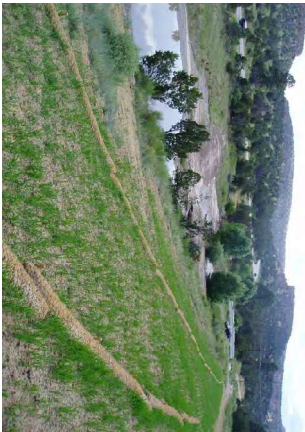
MULCH SOCK/STRAW WATTLE

- BMP Objectives**
- Sediment Control
 - Reduce Runoff Velocity
 - Inlet Protection
