EXECUTIVE SUMMARY

GRADING & DRAINAGE PLAN
1910 BUENA VISTA DRIVE S.E.
ALBUQUERQUE, NEW MEXICO
APRIL 2008

DRAINAGE PLAN

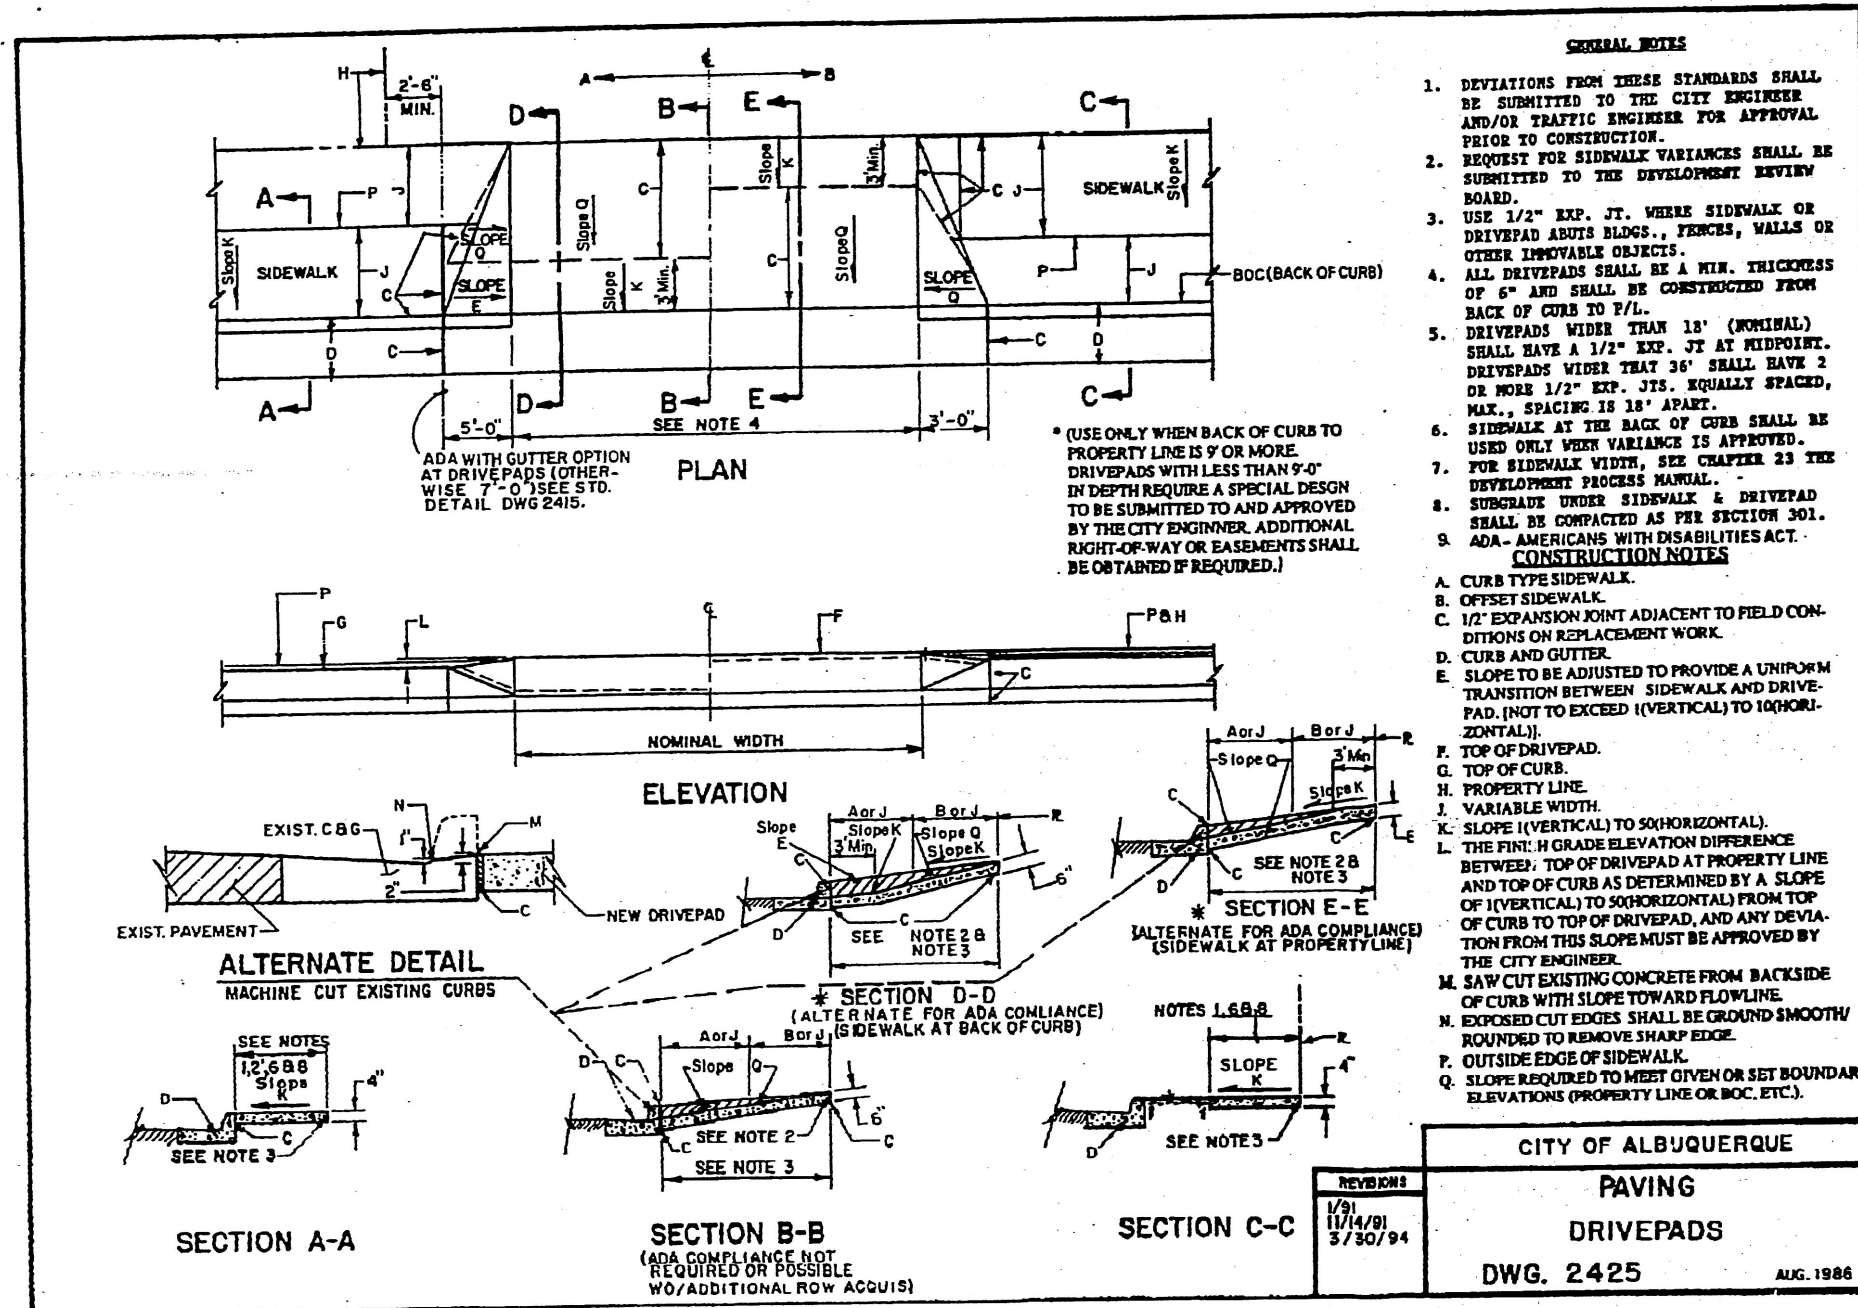
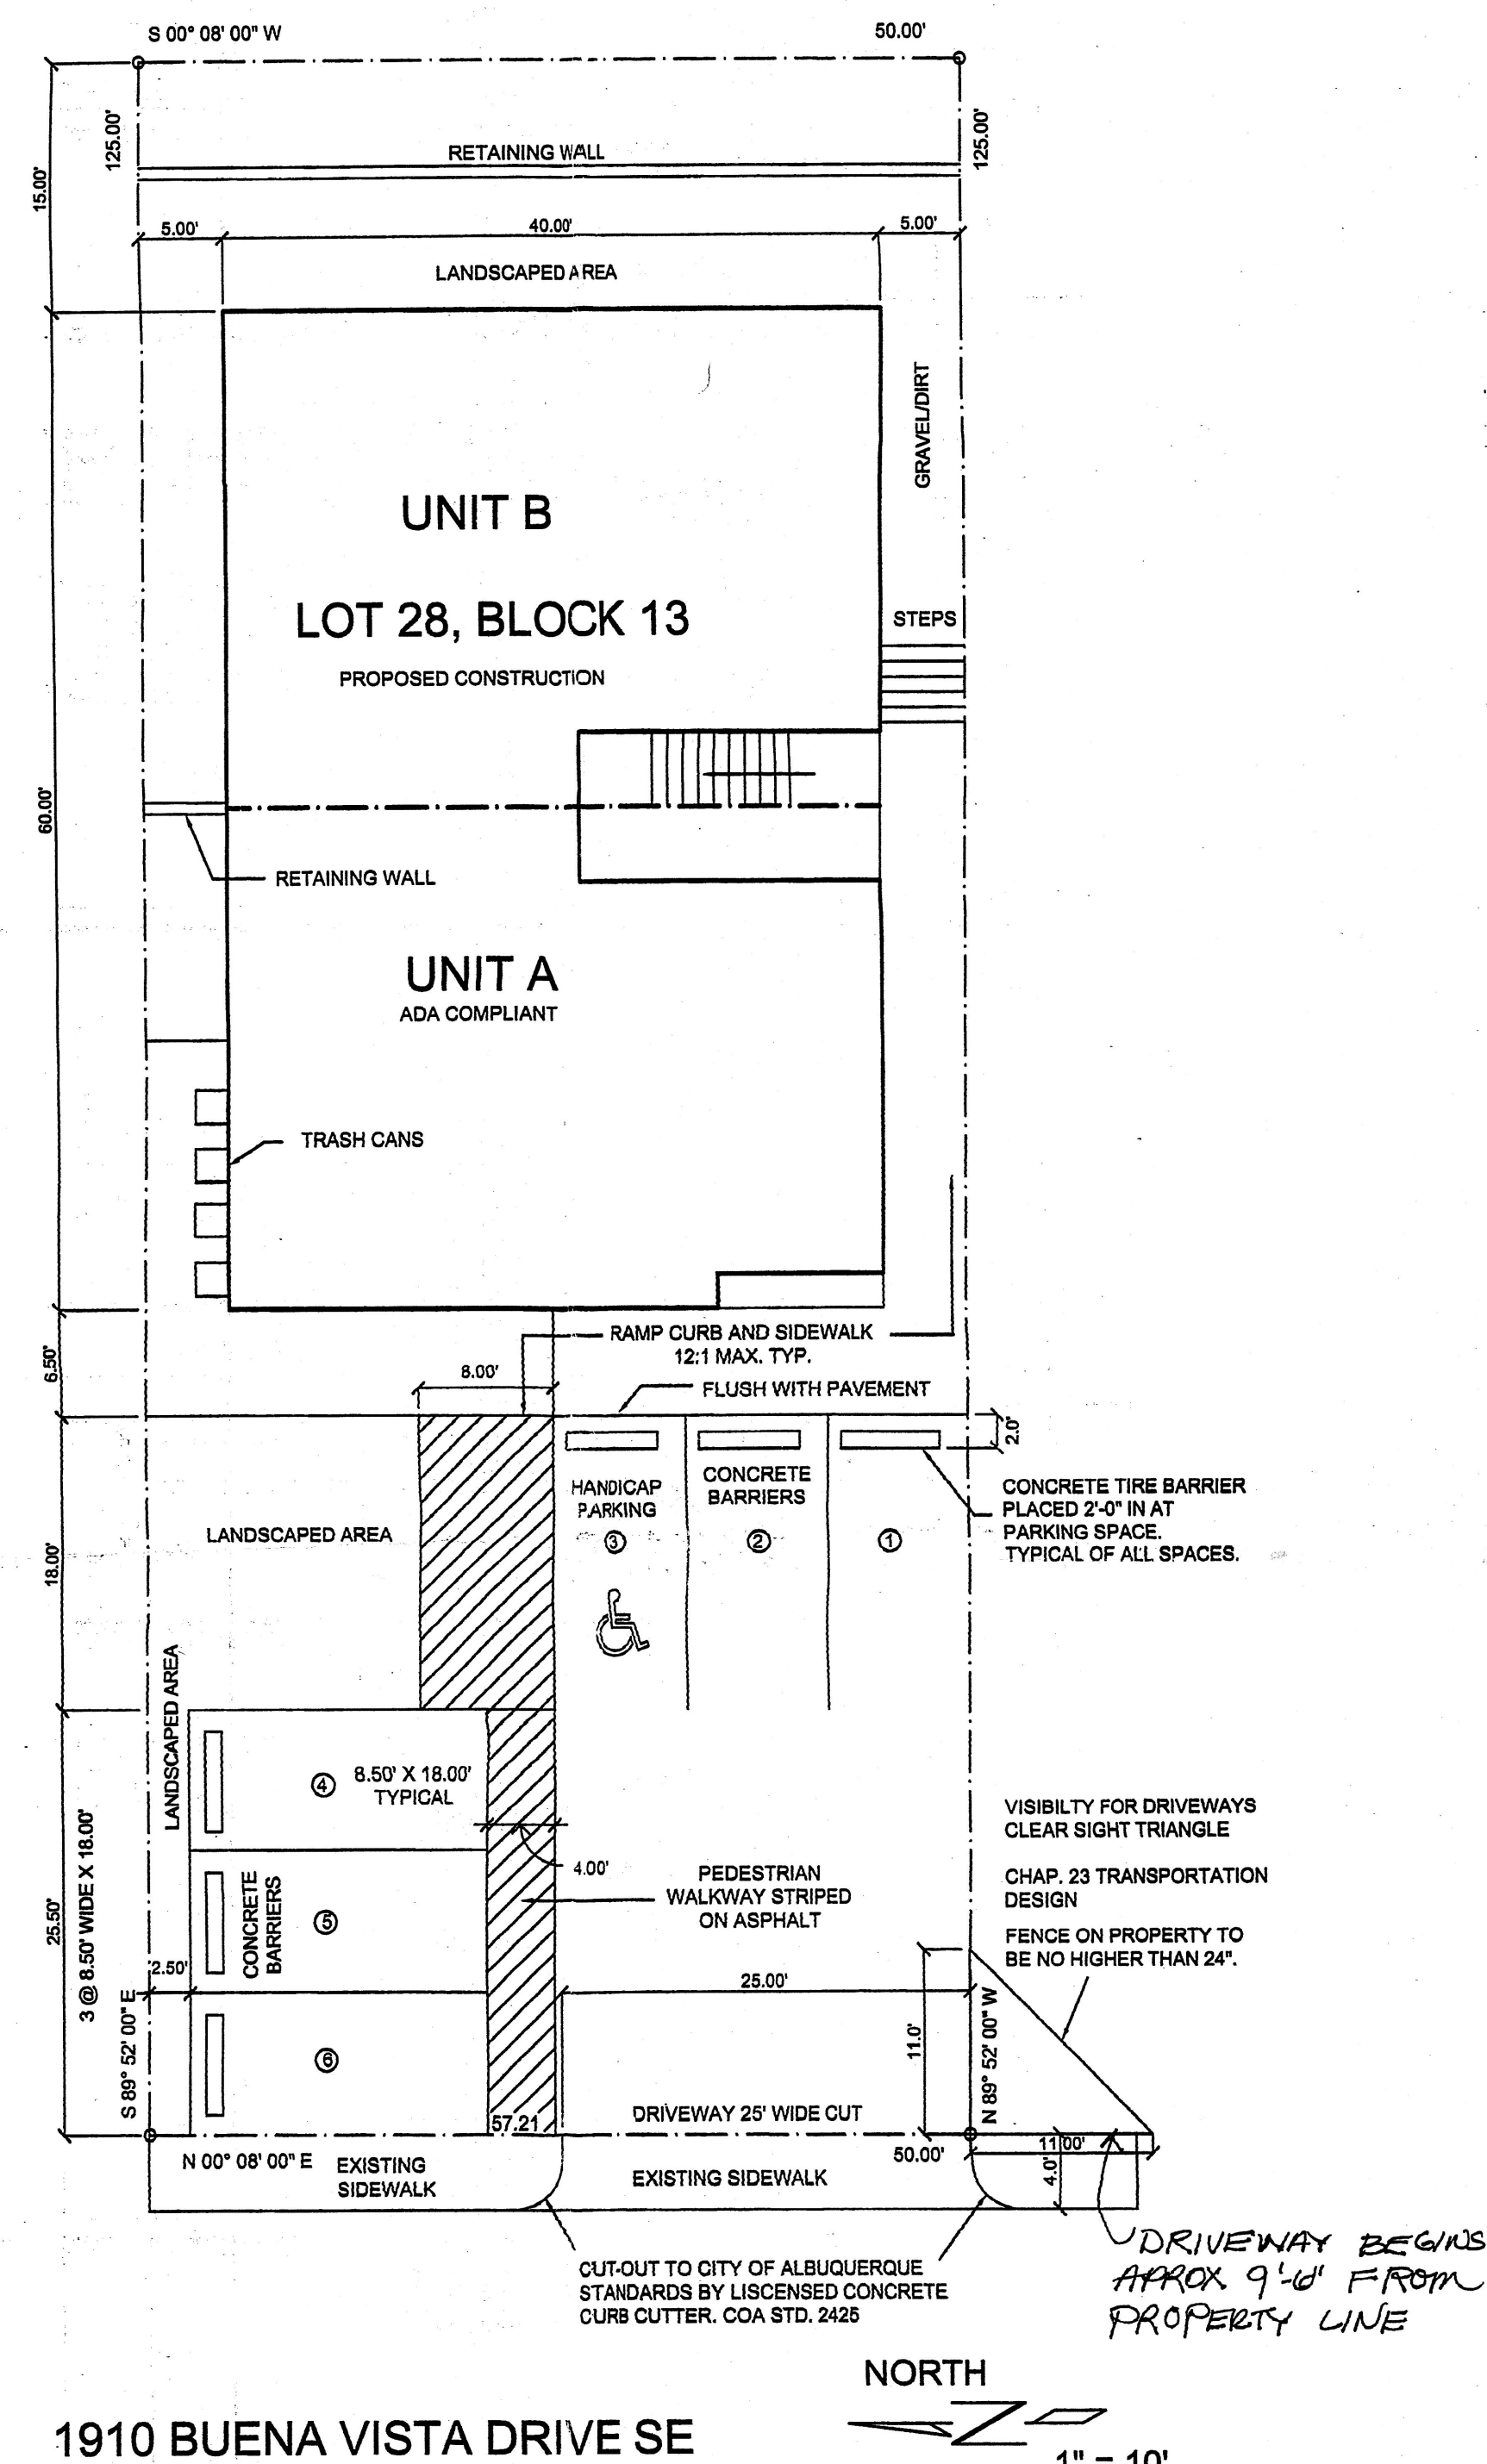
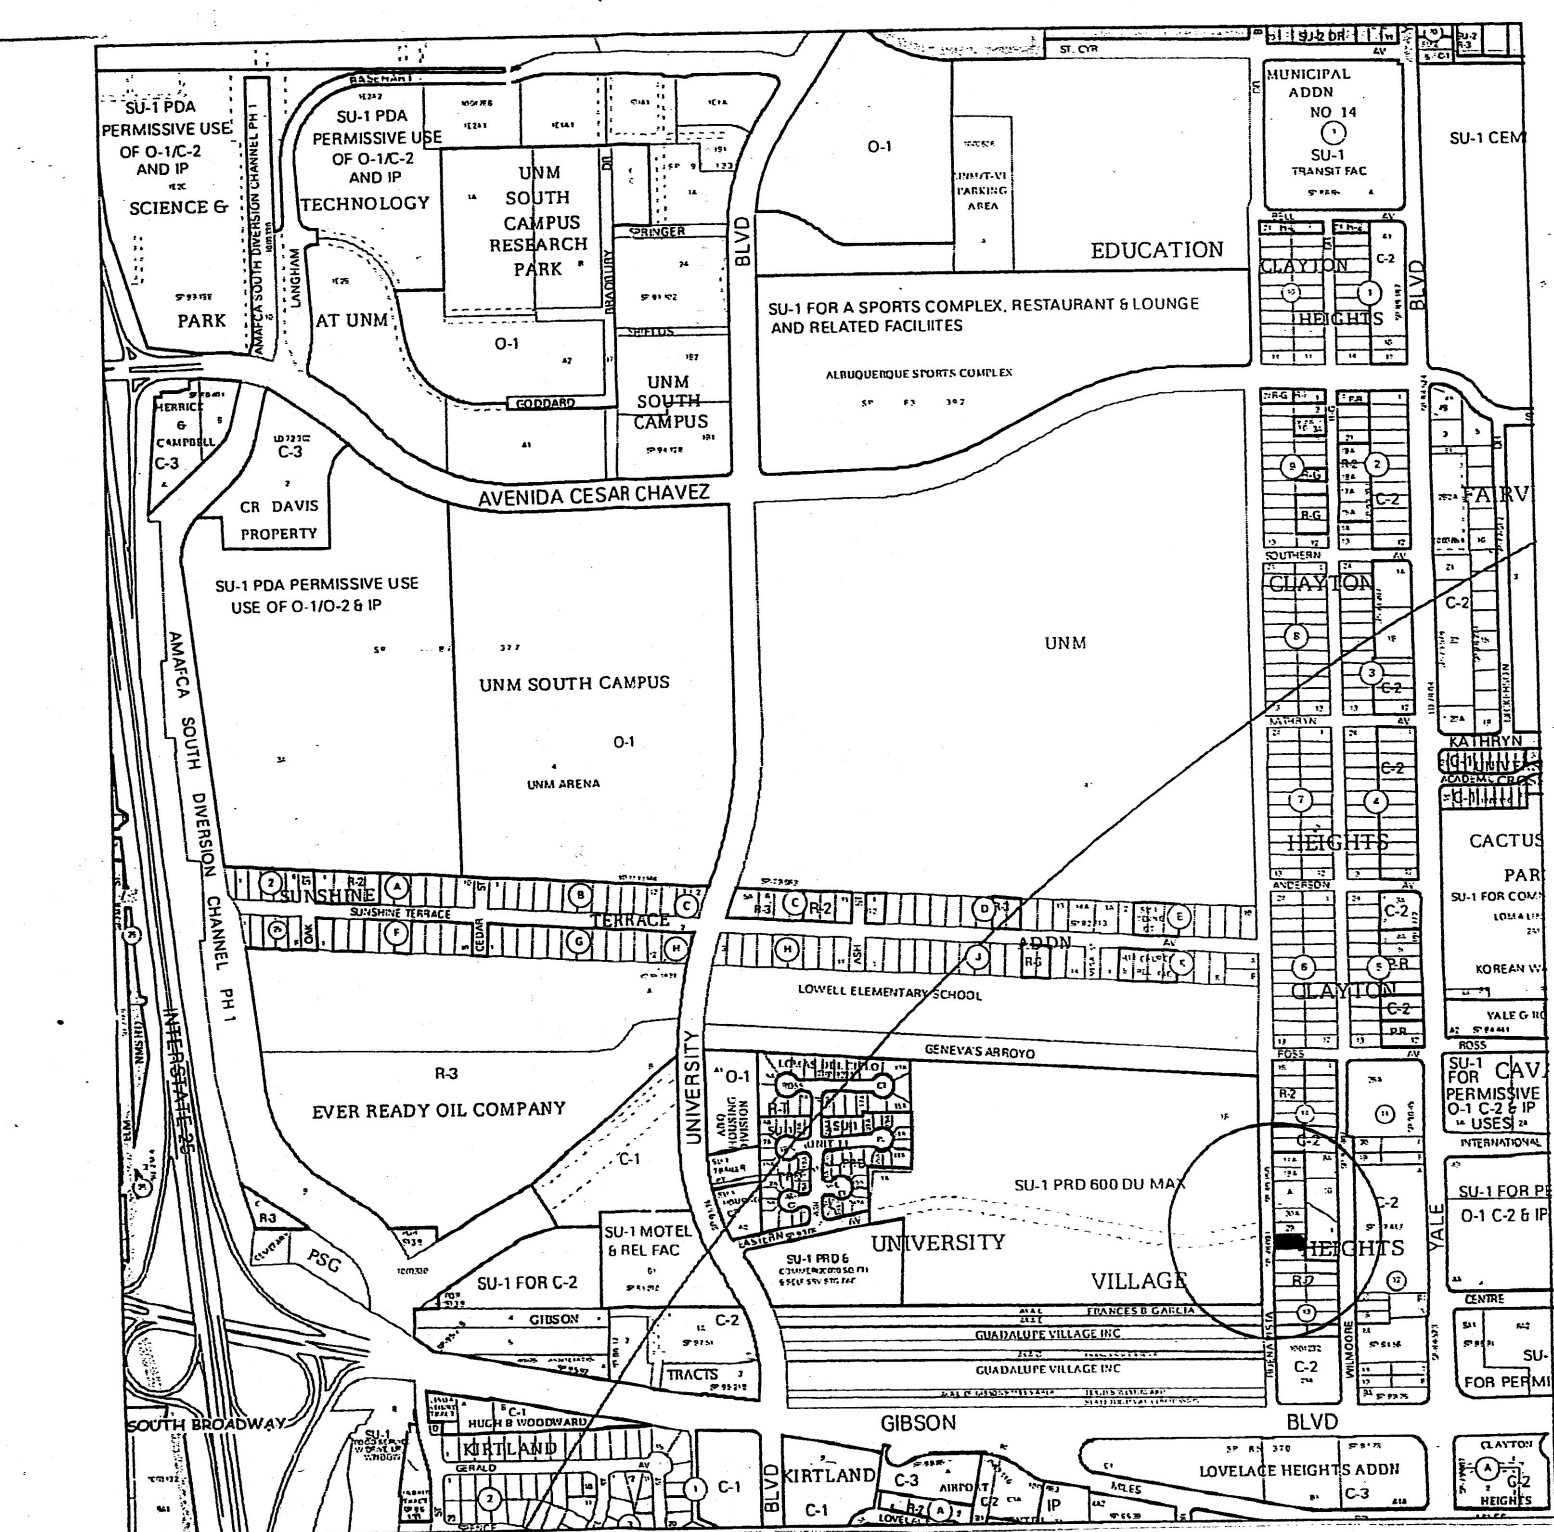
THE PROJECT IS LOCATED AT 1910 BUENA VISTA DRIVE SE, NORTH OF GIBSON AND SOUTH OF GIRARD. THE SITE CURRENTLY CONSISTS ONE VACANT LOT. ONE APARTMENT 4-PLEX UNIT IS PROPOSED FOR THE SITE. THE 4-PLEX UNIT HAS 6 PARKING SPACES. THE DRIVEWAY SHOWN IN THE PLAN ABOVE. A CROSSLOT DRAINAGE EASEMENT WILL BE PROVIDED FOR THE PARKING AREA. NO FORMAL CIRCULATION OF TRAFFIC IS WARRANTED FOR THIS DEVELOPMENT. THE PROJECT WILL HAVE A MINIMAL IMPACT ON ADJACENT SITES. NO VARIANCE IS BEING REQUESTED FOR THIS SITE.

THE 6250 SQ FT LOT, IS CURRENTLY VACANT, AND UNIMPROVED.
THE LOT DOES NOT ACCEPT OFFSITE FLOWS AND DISCHARGES TO THE STREET.
FIRM MAP 350002 0361E SHOWS ZONE X FOR THE LOT.

A NEW RESIDENTIAL STRUCTURE IS PROPOSED. THE PROPOSED IMPROVEMENTS WILL DISCHARGE TO THE ADJOINING STREET. THE STORM WATER WILL TRAVEL NORTH TO A DROP INLET APPROXIMATELY 170' NORTH OF THE PROPERTY, THEN IN UNDERGROUND STRUCTURE THROUGH GENEVA'S ARROYO TO THE SOUTH DIVERSION CHANNEL.

THE PROPOSED PARKING WAS REVERSED (MIRROR IMAGE) AND THE DRIVEWAY RELOCATED TO MATCH THE NEW PARKING LAYOUT.

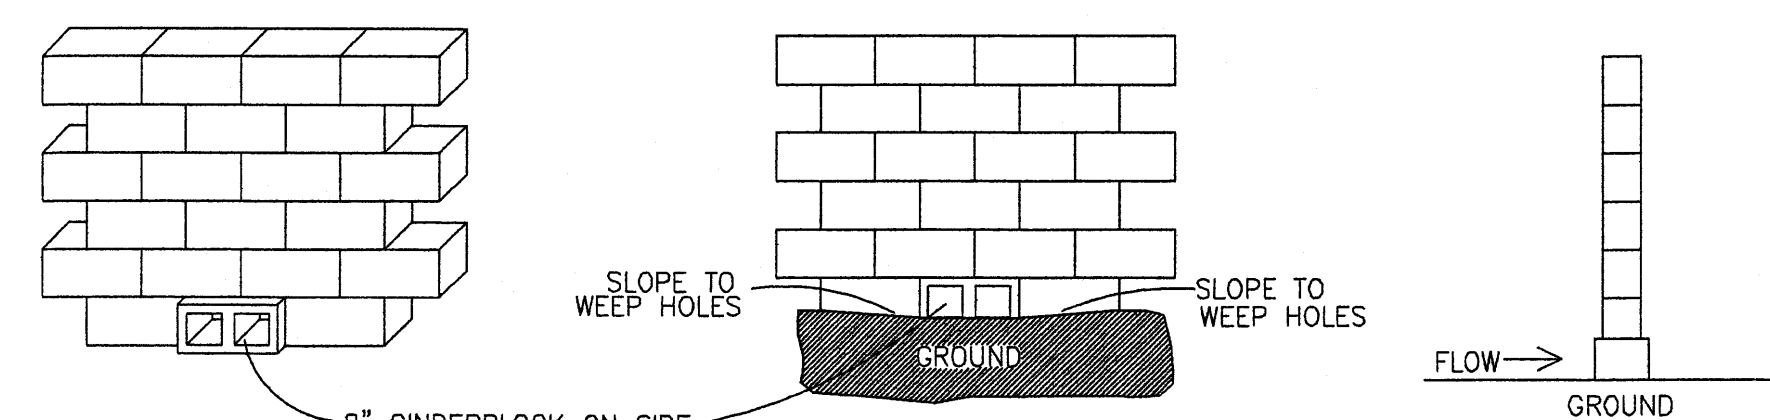
WEEP HOLE DETAIL

- NEW DRIVEWAYS TO BE BUILT USING COA STANDARD DRAWING 2425.
- WHERE SOLID MASONRY WALLS ARE USED IN THE REAR YARD PROVIDE WEEP HOLES IN THE WALL AT GROUND LEVEL (SEE DETAIL).
